Incident Summary (Reference #5616609) (DRAFT)

SUPPORTING INFORMATION	Incident Date		May 24 2017	
	Location		South Surrey	
	Regulated industry sector		Refrigeration system	
	Impact	Injury	Qty injuries	0
			Injury description	None
			Injury rating	None
	Damage		Damage description	Man hole gasket seal failed resulting in release of approximately 16lbs of ammonia (NH3) in the machine room
			Damage rating	Moderate
	Incident rating		Moderate	
	Incident overview		Manhole gasket seal on an oil separator pressure vessel failed to hold ammonia in the vessel which resulted in the exhaust ventilation system to be activated.	
INVESTIGATION CONCLUSIONS	Site, system and components		<p>Frozen food storage facility has a mechanical room separate and self-contained from the warehouse.</p> <p>In an ammonia refrigeration system, ammonia in a gas state is compressed from the compressor to high pressure high temperature ammonia gas. The compressed gas heats as its pressurised. The hot gas enters an oil separator where the ammonia gas and compressor oil is separated so that oil is not carried over with the ammonia gas to the coils and other components. The hot ammonia gas is directed to the coils where

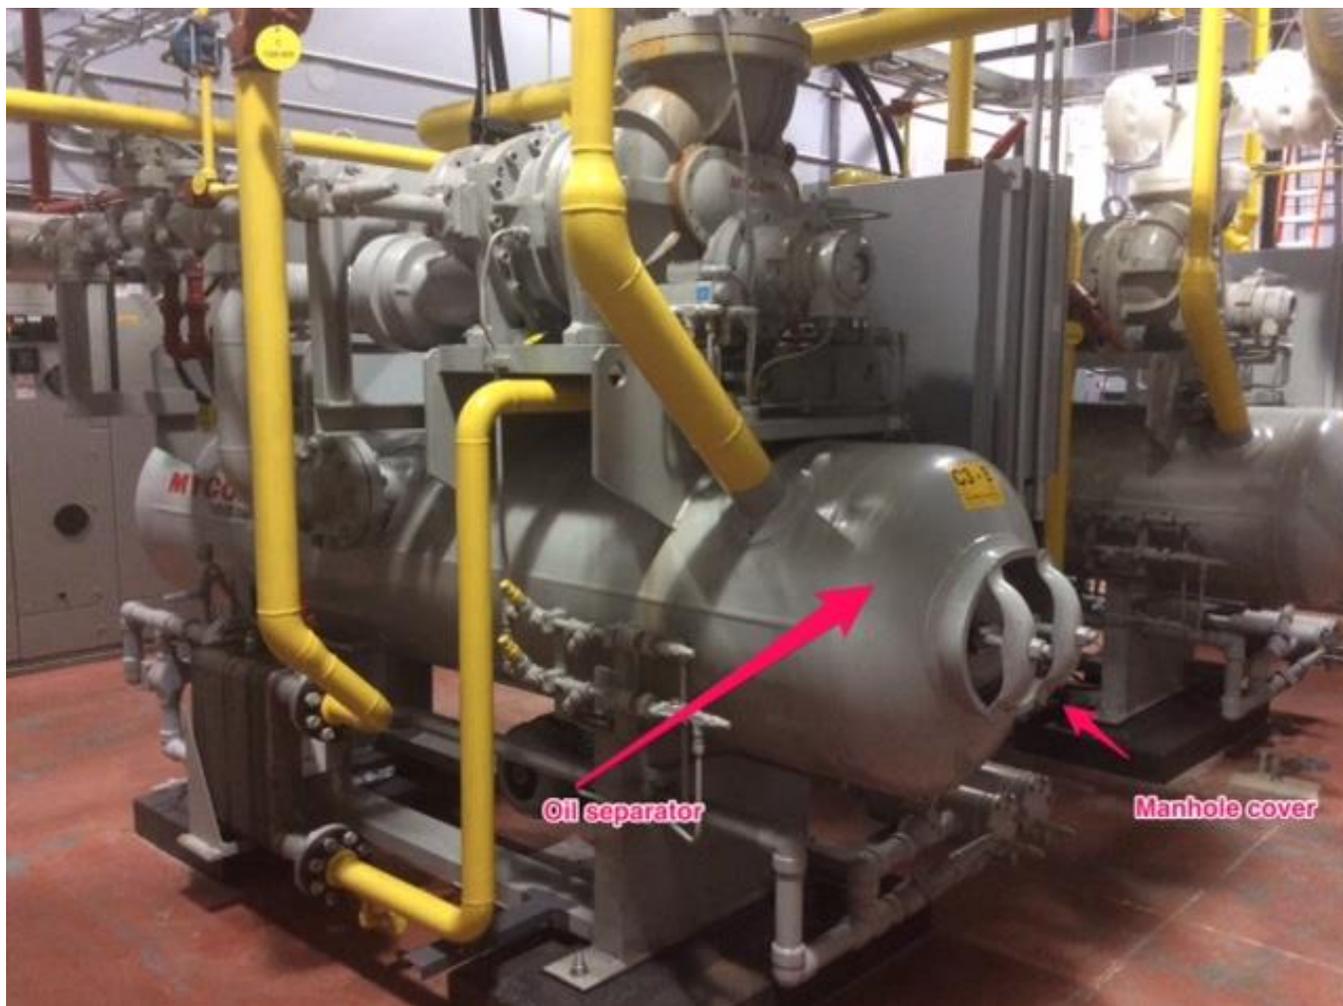
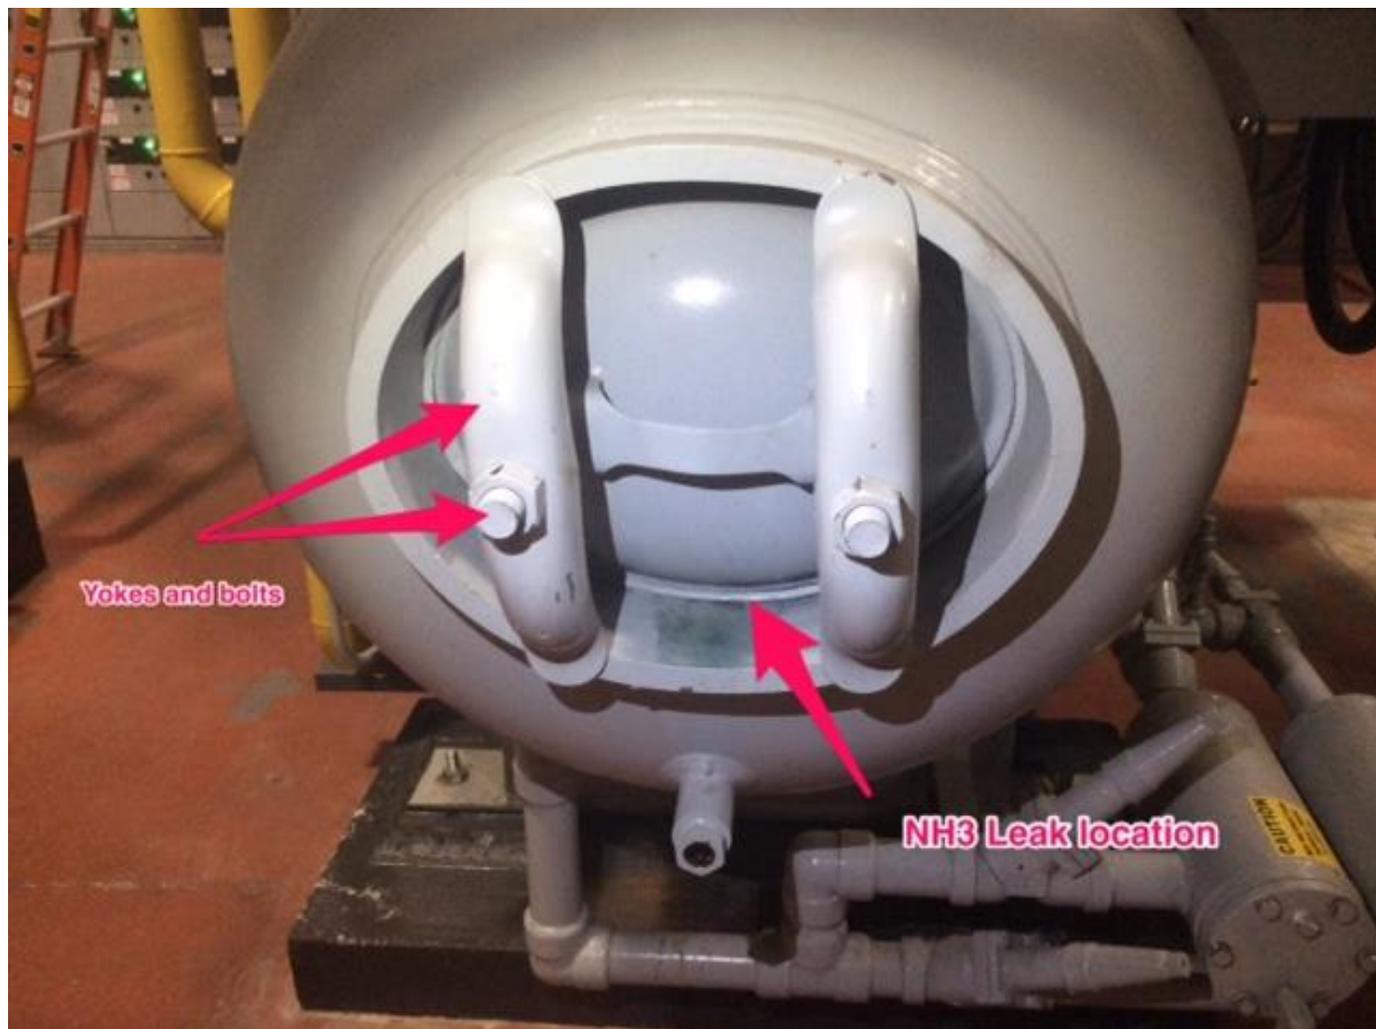
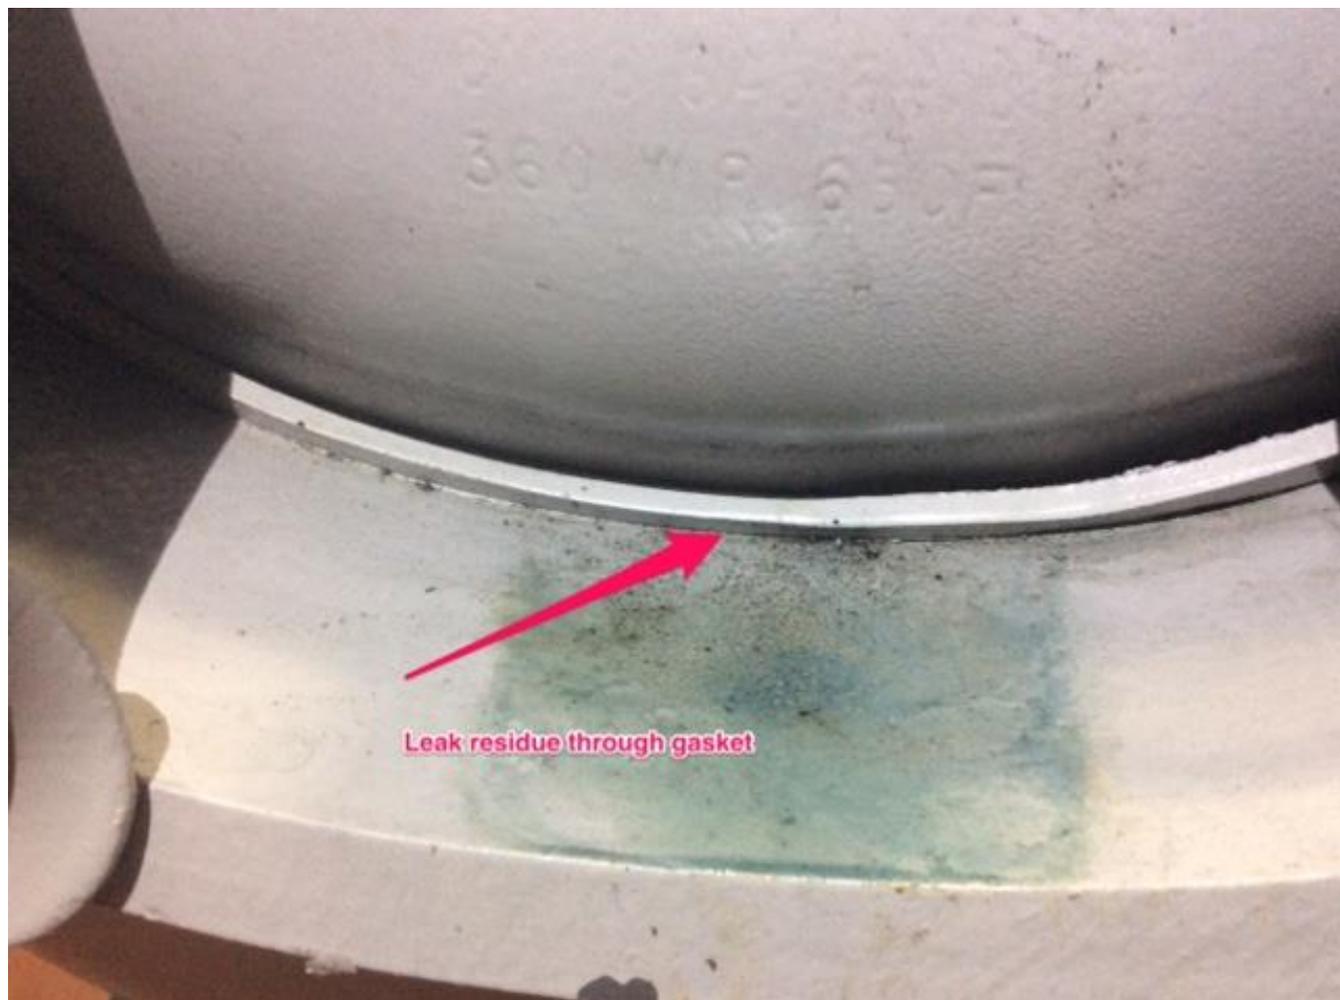
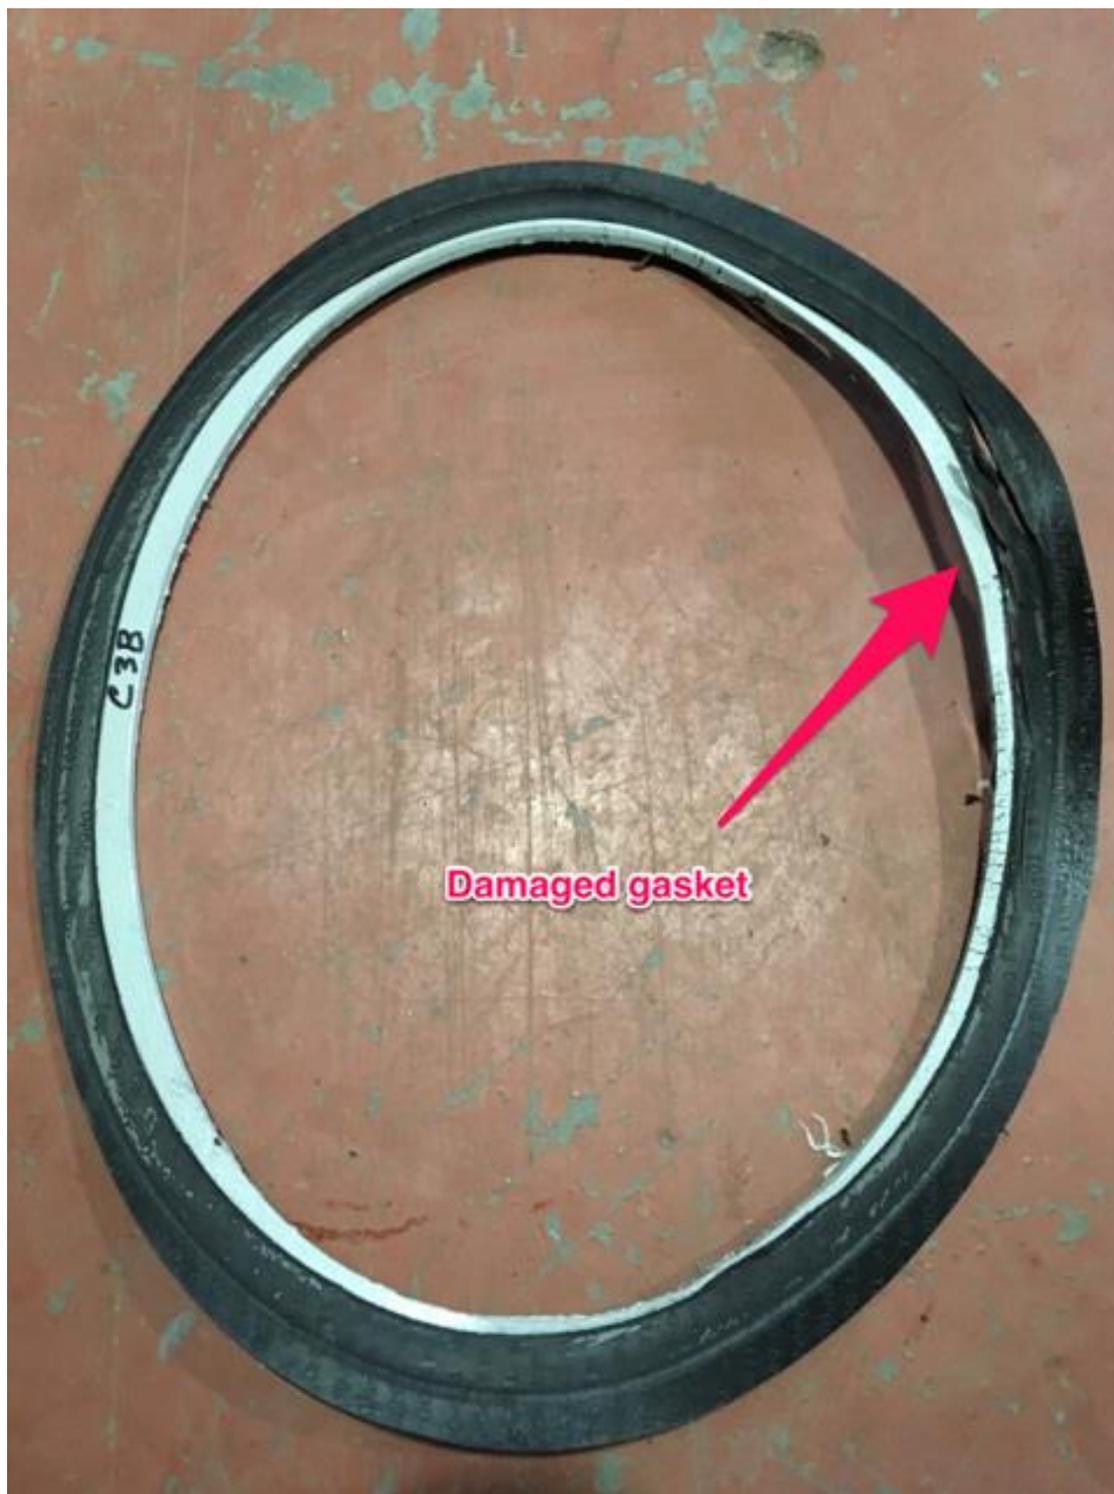
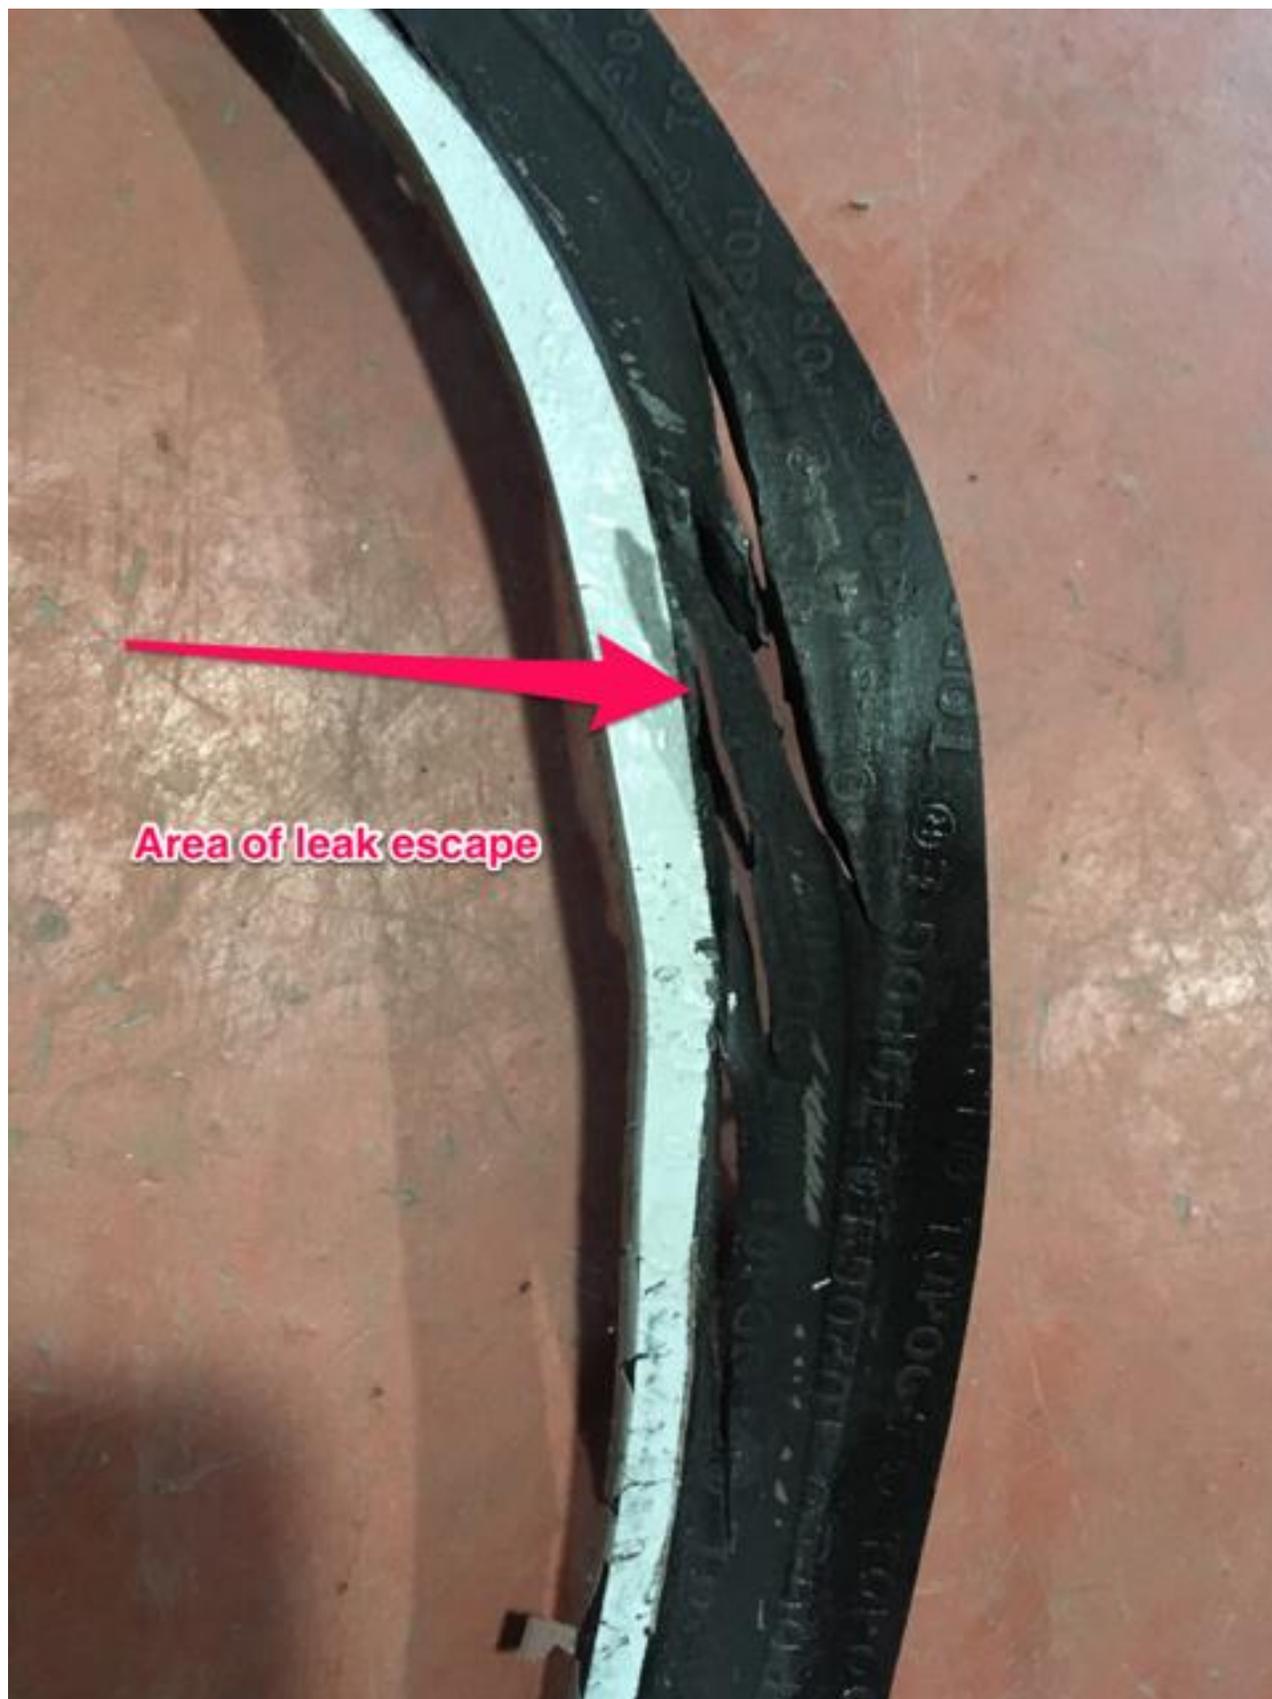
Photos or diagrams (if necessary)

Failure scenario(s)		New compressor addition to ammonia system installed in 2016, within 1 year of the installation a leak developed at the lower half of the manhole access from a factory installed gasket.	
	Facts and evidence

<p>Causes and contributing factors</p>	<p>It is likely that over torqueing on the manhole cover against the flanged connection damaged the gasket.</p>
