# LEITNER-POMA SERVICE BULLETIN

Re: Omega lift Lateral rail entrances

## **SERVICE BULLETIN**

**Re:** Terminal entrance lateral rails

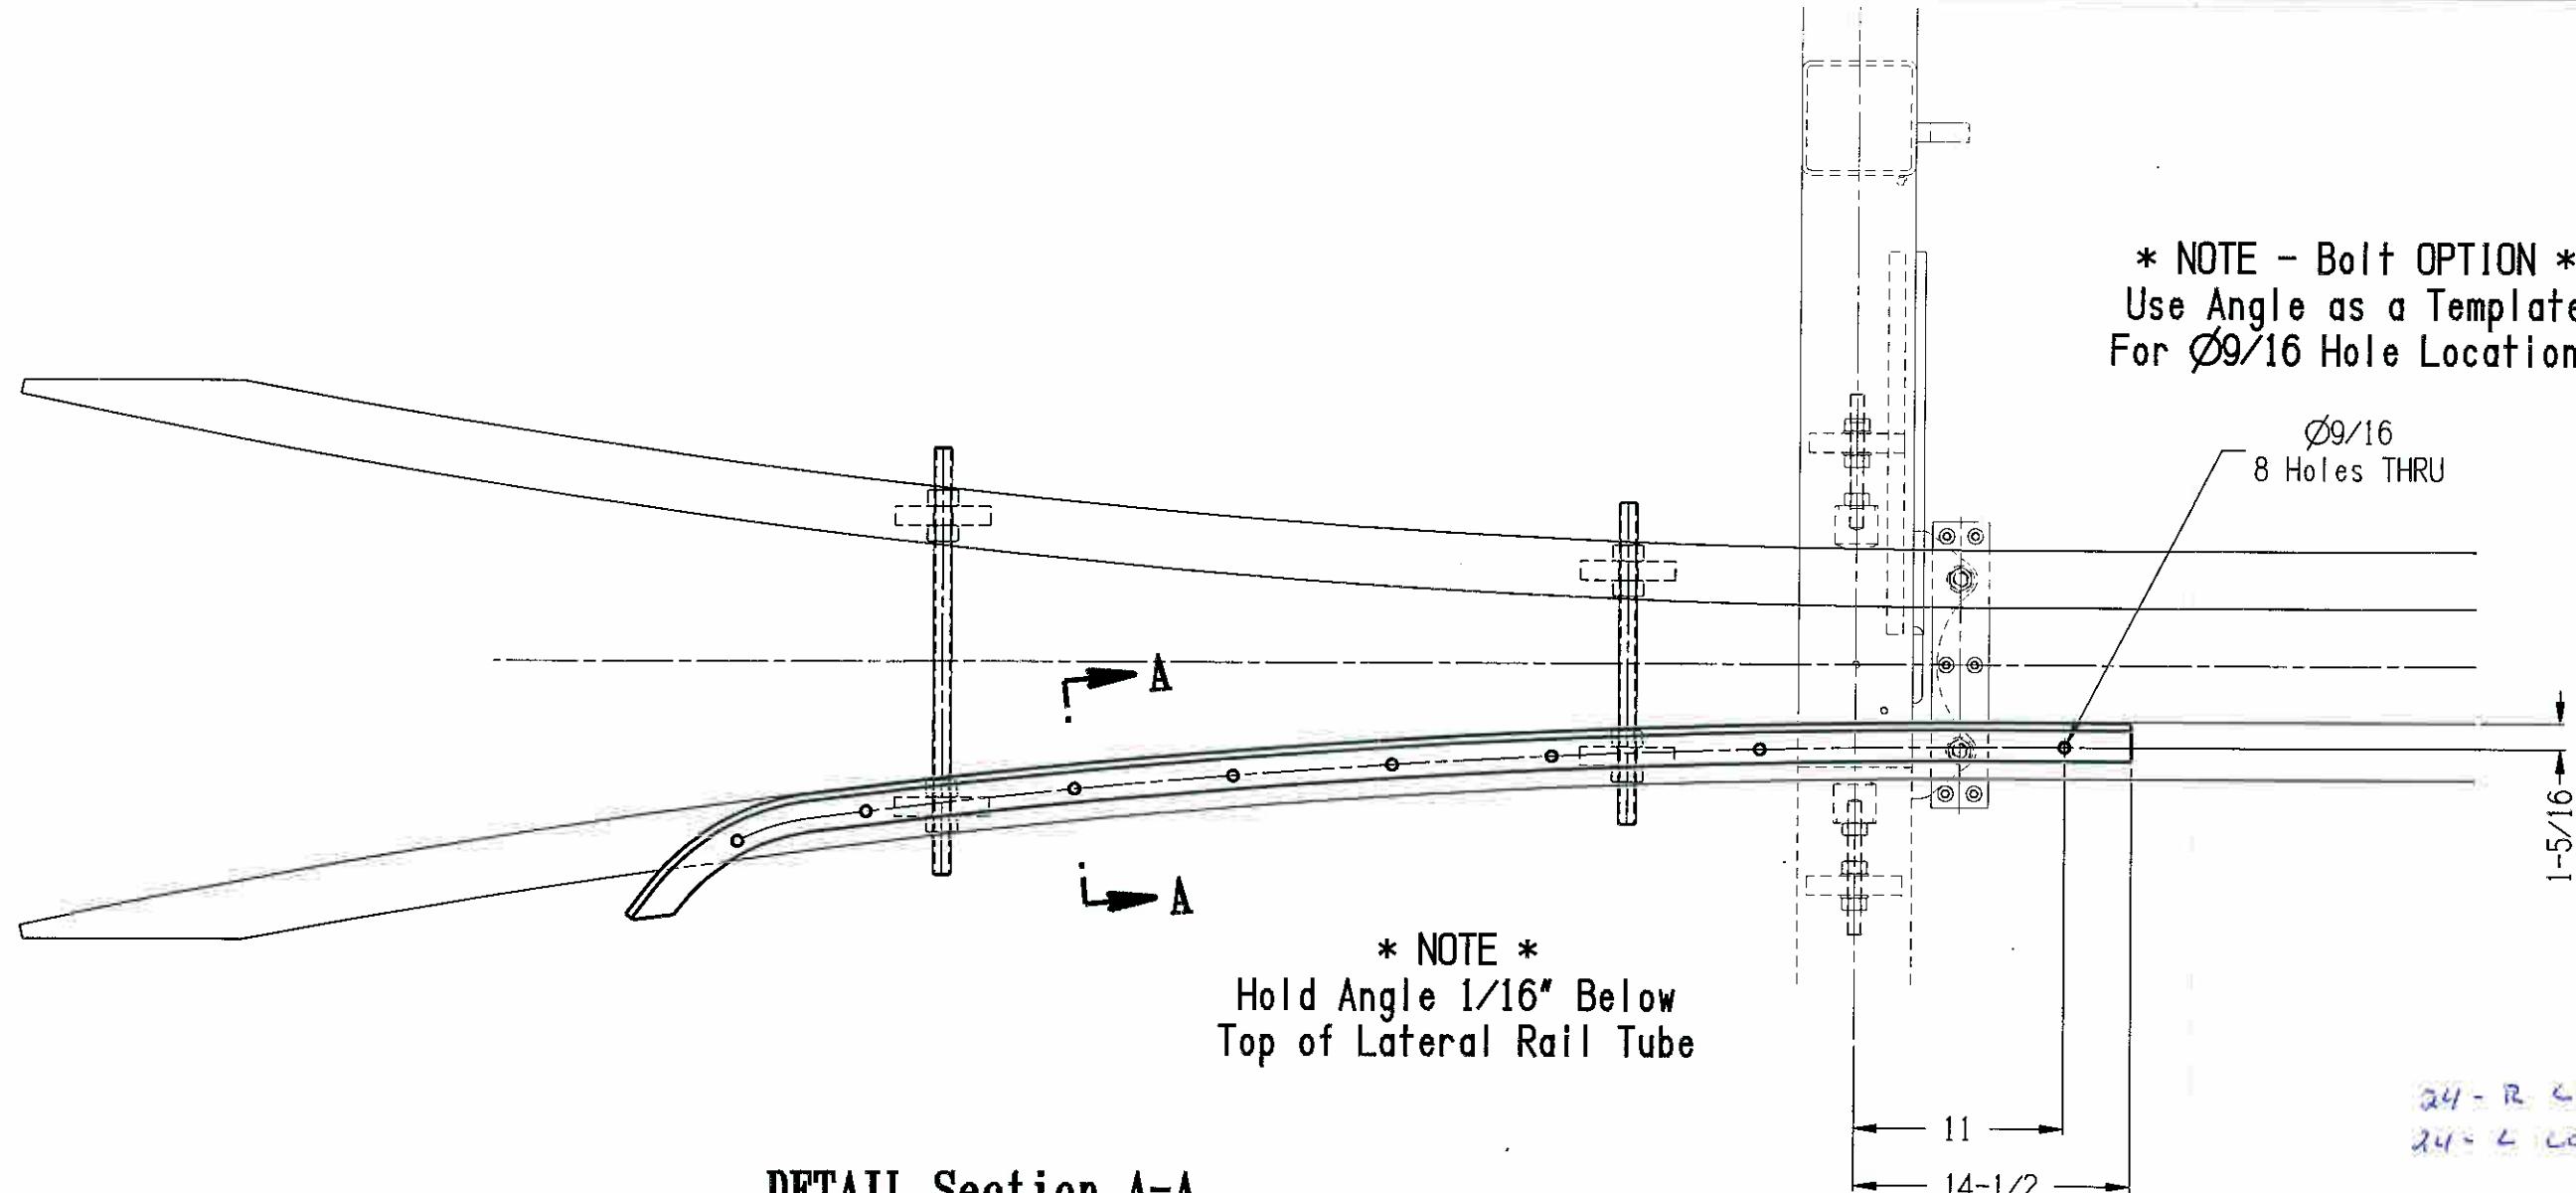
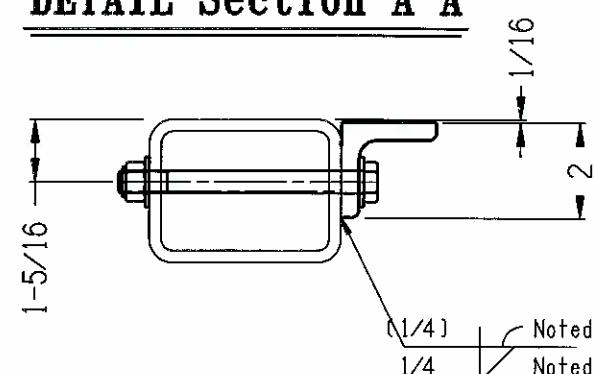
LATERAL RAIL ENTRY ANGLE ASSY

The addition of the assembly will increase the ability of the lateral rail entrance trumpets to properly capture a grip during excessive carrier swinging conditions.

This assembly, when installed properly on a correctly adjusted trumpet (drawing 3039322 attached), will reduce the possibility of a missed entrance during events that cause excessive carrier swing.

The accompanying drawing (3039.675) shows the mounting of the rail entry angle on a clock-wise lift, you will be sent free of charge the appropriate angle and hardware for your lift rotation. Please note that the addition may be mounted by drilling holes and using the bolts provided or welded in place, which ever works best for you. After installation please verify the trumpet is adjusted properly.

\* NOTE - Weld OPTION \*  
Step Weld with Minimum 1"  
Welds Above and Below Holes
