Incident Summary (Reference #5604819)

Incident Date			Sept 13 th 2016
	Location			Vancouver. BC.
	Regulated industry sector			Elevating Devices.(Escalator)
SUPPORTING INFORMATION	Impact	Injury	Qty injuries	0
			Injury description	No injuries.
			Injury rating	None.
		Damage	Damage description	There was no physical damage to the regulated product as a whole, however because of the failure of a system within the regulated product there existed the possibility of a release of a lethal amount of energy at the site of the installation.
		Ő	Damage rating	Moderate.
		ncident rating		Moderate.
	Incident overview			It was reported to BCSA that a down escalator at a busy downtown LRT (Skytrain) station had accelerated in an uncontrolled manner whilst fully loaded with passengers. The uncontrolled acceleration caused the passengers egressing the escalator to have to step off the unit in an uncontrolled and dangerous fashion. The incident overview can be seen in the attached video. The overview sequence is Normal operation-EPD trip-Uncontrolled acceleration-Chaotic egress of passengers-Reduction in load-Unit slowing and coming to a halt.

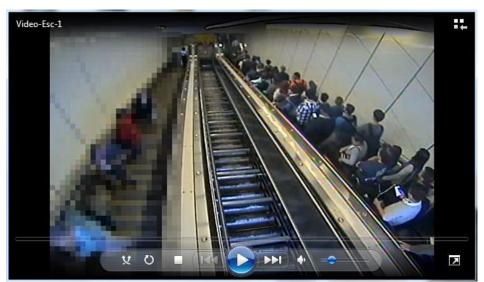
<u>Video 1:</u> Escalator Brake Failure – Uncontrolled Acceleration Clicking the image above will open the video in a browser. Alternately, <u>this link</u> will lead to the same video.

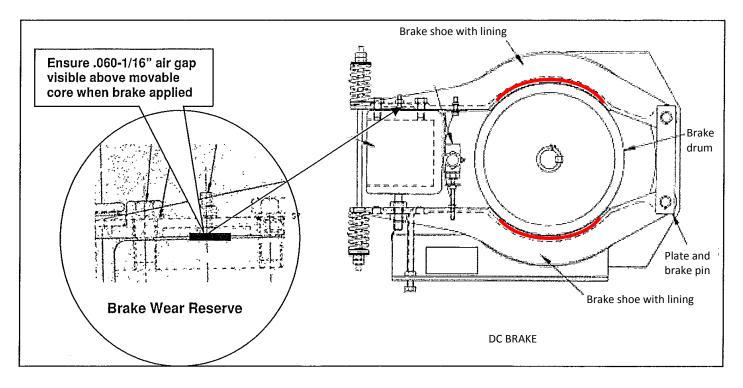
End View of DC Shoe Brake

Figure 1: Escalator Brake Arrangement: Two brake assemblies installed on escalator

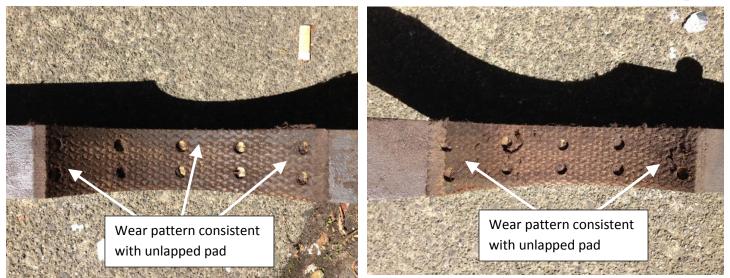
Causes and contributing factors	The uncontrolled escalator acceleration was very likely the direct result of one of the sets of brake linings not being lapped during a service replacement and the other set of linings being worn to a point where rivets and not lining material were contacting the brake drum.None of these conditions were detected during routine maintenance procedures. It is very likely that the mechanics and supervisors employed by the Licensed Elevator Contractor did not fully understand all the requirements for the correct operation of this braking system relating to the service replacement of parts, maintenance procedures and testing.

Figures 3 and 4: Brake Pad from one brake assembly – Brake pads not lapped on installation as evidenced by the inconsistent wear patterns resulting with ineffective brake force.

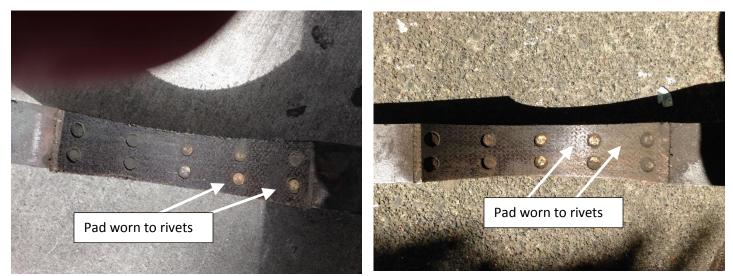
the Licensed Elevator Contractor, dismantled both sets of brakes. On the first set of brake arms it was observed that in one of the shoes the lining material was worn away and on the other shoe of that set the lining was worn away to the point that rivets were contacting the drum therefore giving little braking action for that driving machine brake. The second set of brake arms had brake linings that had not been seated (LAPPED) at the time of their installation by the Licensed Elevator Contractor. The braking action of this set of brakes was severely reduced as a result of the linings not being lapped. The overall condition of the brake linings meant that the braking system of the escalator was producing far less braking force than required to make the unit code compliant. From on-site observations, discussions and conversations with the mechanics and supervisors it became apparent that both parties did not have an in-depth knowledge of the braking requirements for the escalator equipment that they were maintaining. Questions to both the mechanics and supervisors on -site demonstrated to us that there was a general lack of understanding of the driving machine brake system installed on this model of escalator. The fact that one set of brake arms had linings that were worn with rivets contacting the brake drum and the other set had been replaced and the linings not lapped greatly reduced the braking capability of the system. The general condition of the linings made any mechanical adjustments to the brake unable to meet OEM (ORIGINAL EQUIPMENT MANUFACTURER) specifications. OEM specifications for brake adjustment are predicated on the brake linings being within a certain thickness (specification) and said material having adequate contact with the brake drum. If this is not the case then the required adjustments cannot be made. Maintenance procedures should have identified these inconsistencies but they didn't. There appeared to be an overall lack of understanding of the braking system

Figures 5 and 6: Brake Pad from second brake assembly – Brake pads worn to rivets resulting with ineffective brake force.
