Incident Summary #II-1889584-2025 (#57150) (FINAL)

INVESTIGATION CONCLUSIONS

Failure scenario(s)

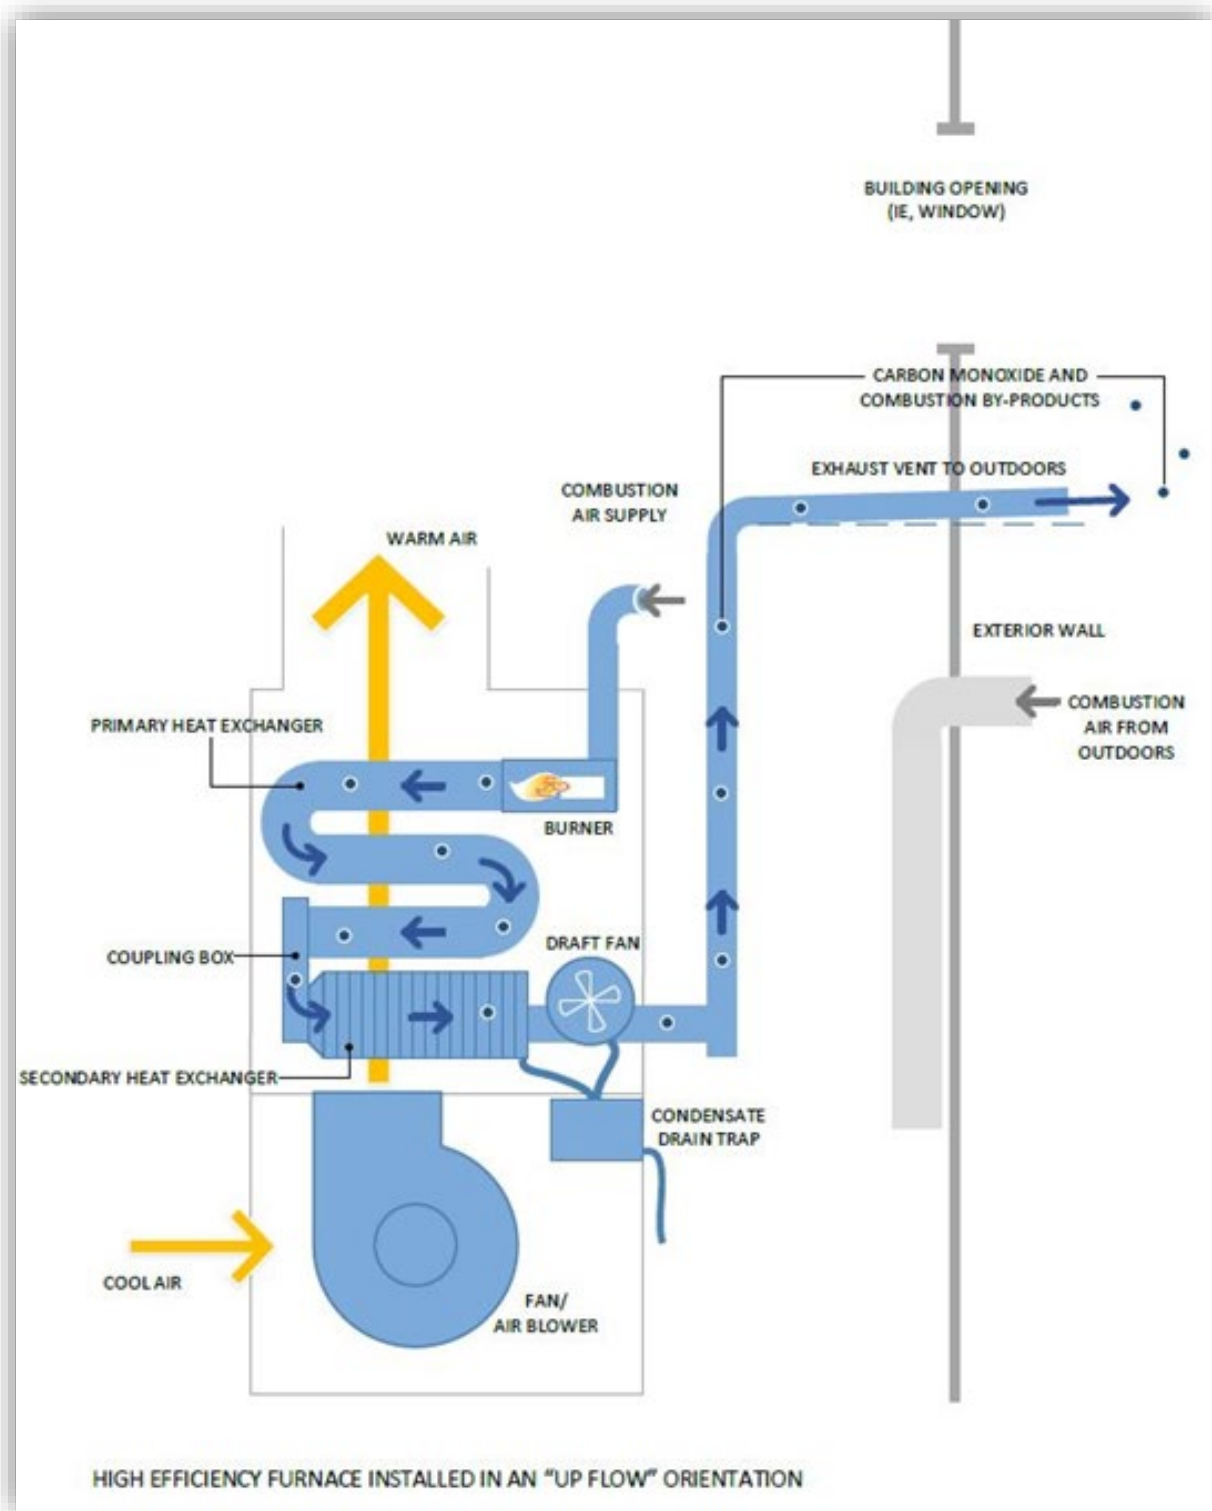
Residential gas furnaces use the heat produced from the combustion of a gas/air mixture to heat the home. The combustion occurs at the entrance to a heat exchanger. The flue gases produced by combustion pass through the inside passages of the heat exchanger and are carried safely to the outdoors through a venting system connected to the furnace. A blower draws air from inside the home and passes it around the outside of the heat exchanger. Heat transfers through the heat exchanger shell to the air on the outside which is then distributed throughout the home through a ducting system to heat the home ([Diagram 1](#)).

Diagram 1 – Typical furnace operation. Arrows represents the direction of flue gas flow and dots represent carbon monoxide.

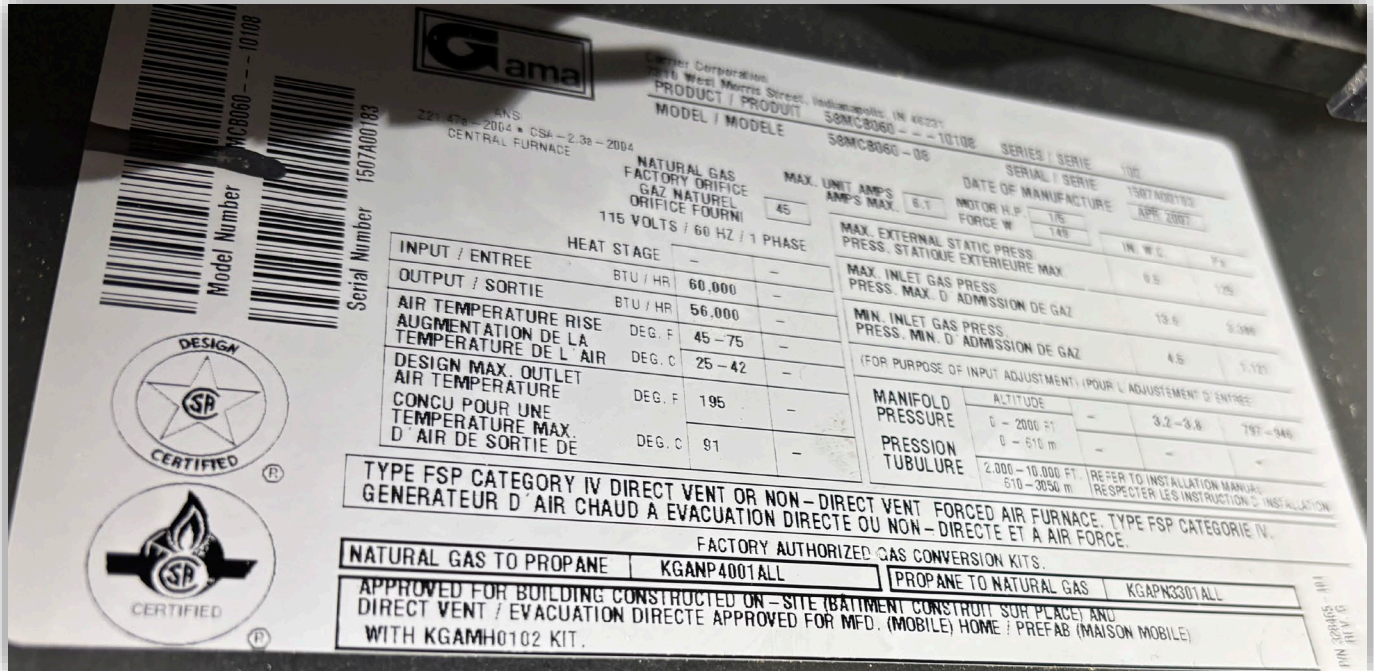
A natural gas furnace was installed in the new residential townhouse in 2008. The furnace was a Carrier brand high efficiency furnace model 58MCB060-0-8 manufactured in April of 2007. It was designed and manufactured with a polypropylene lined secondary heat exchanger.

Image 1 – Data tag of furnace installed in a sealed mechanical room located in the garage of the townhome.

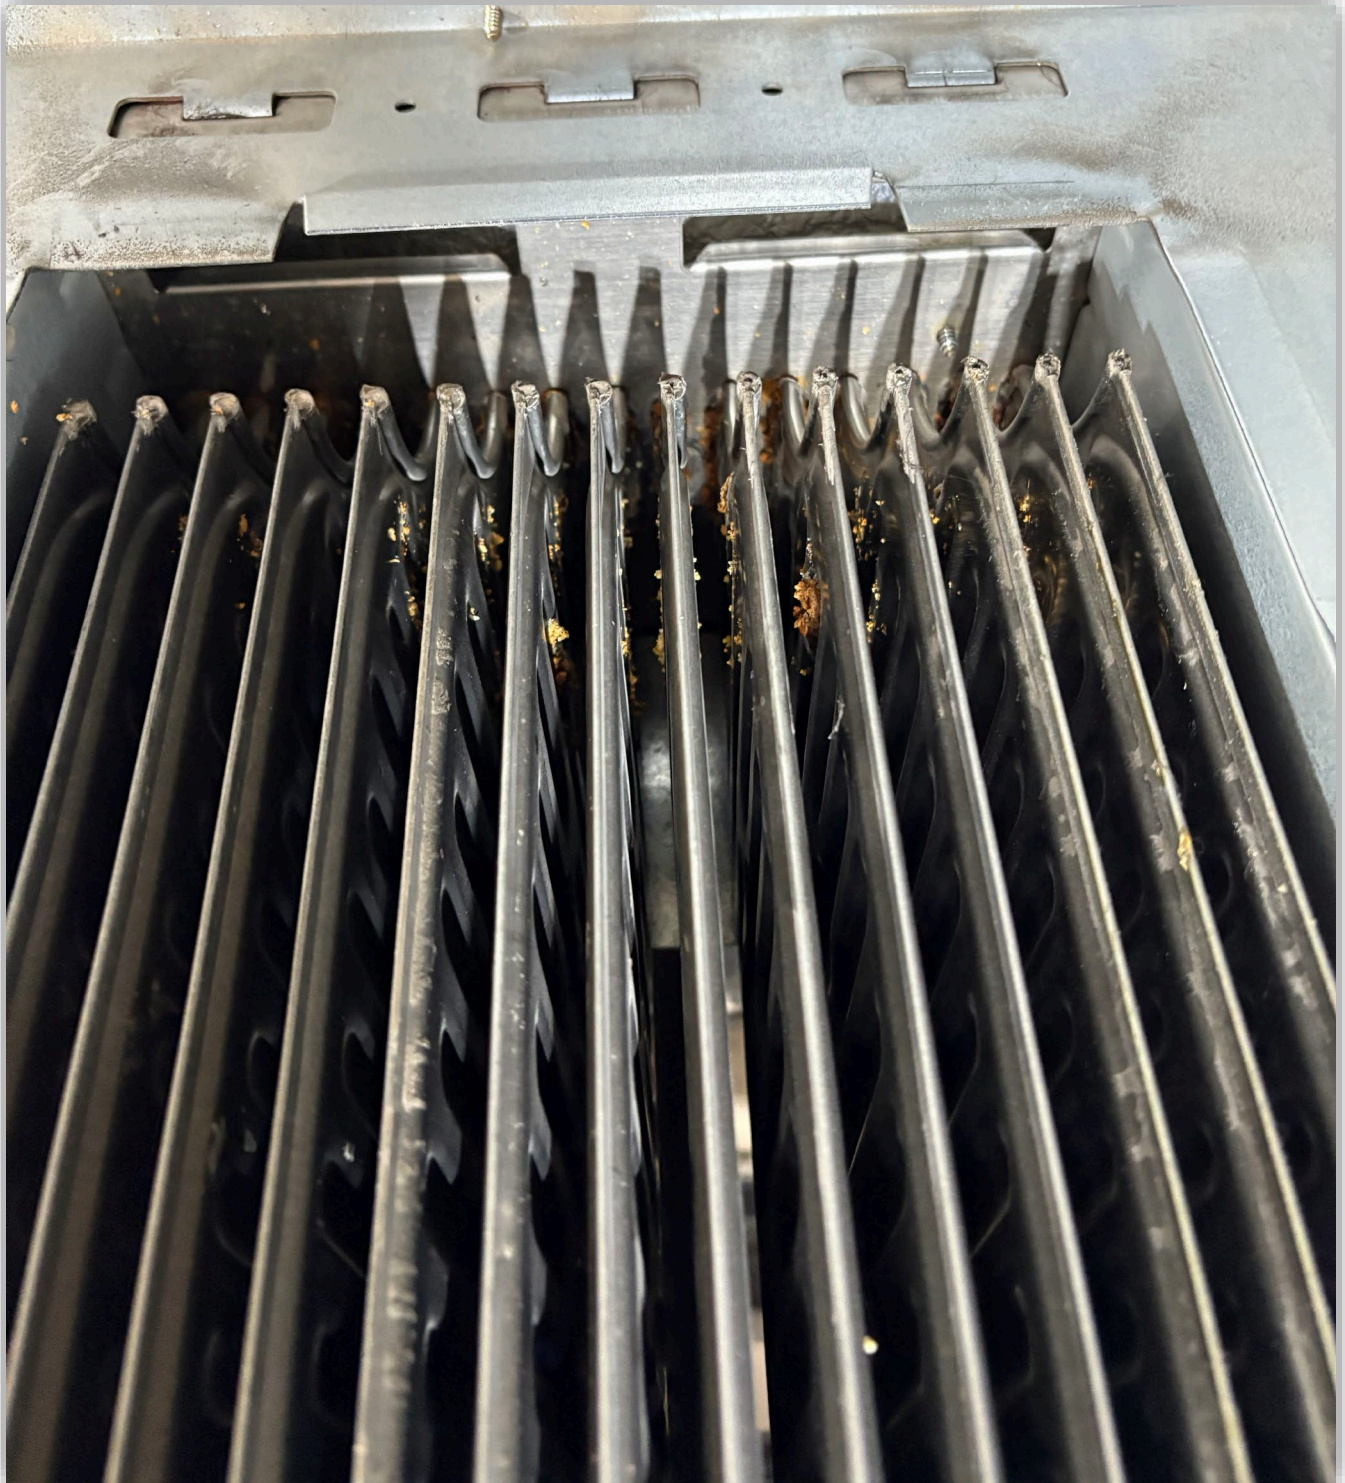
Over the furnaces 16 years of operation the polypropylene liner in the secondary heat exchanger failed creating a restriction of the flow through it and allowing the condensate to create corrosion and holes in the secondary heat exchanger tubes. The furnace safeties including the air pressure switch and flame rollout switch were ineffective at shutting down the operation of the furnace as the degradation progressed to the point of the furnace producing very high concentrations of CO in the flue gases. The very high concentrations of CO in the flue gas resulted in hazardous levels of CO to be recirculated back into the home even after being diluted with clean outdoor air.

The cause of the incident was the furnace secondary heat exchanger design which used polypropylene laminated steel materials. Rapid and excessive corrosion of these materials restricted airflow through the furnace resulting in production of carbon monoxide due to incomplete combustion, which then entered the home.

Image 2 – Secondary heat exchanger tubes with exterior corrosion.

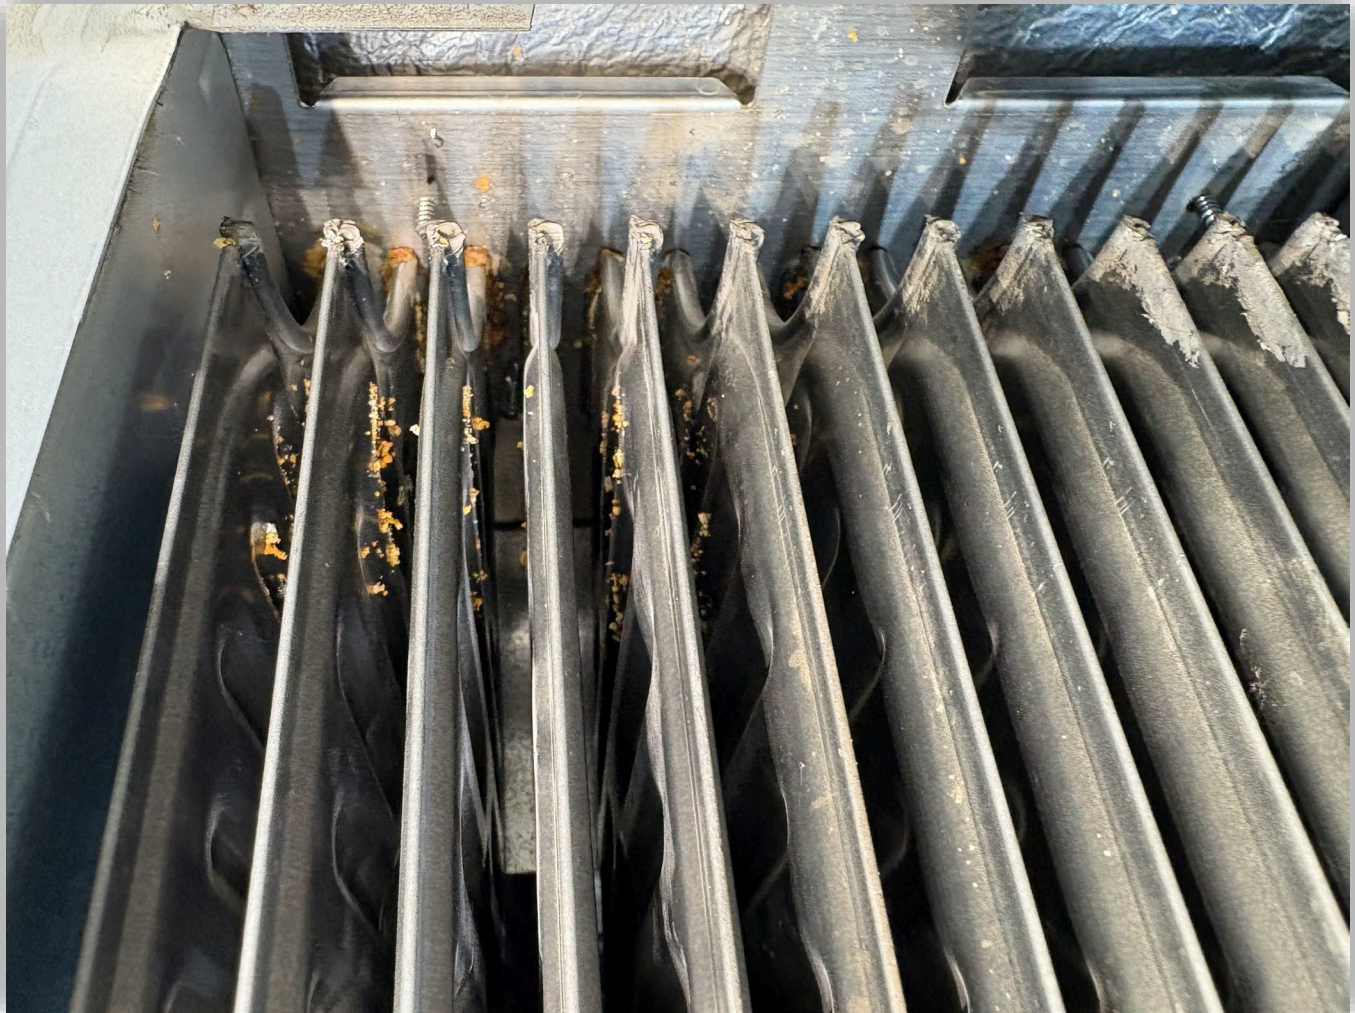
Image 3 – Secondary heat exchanger tubes with exterior corrosion.

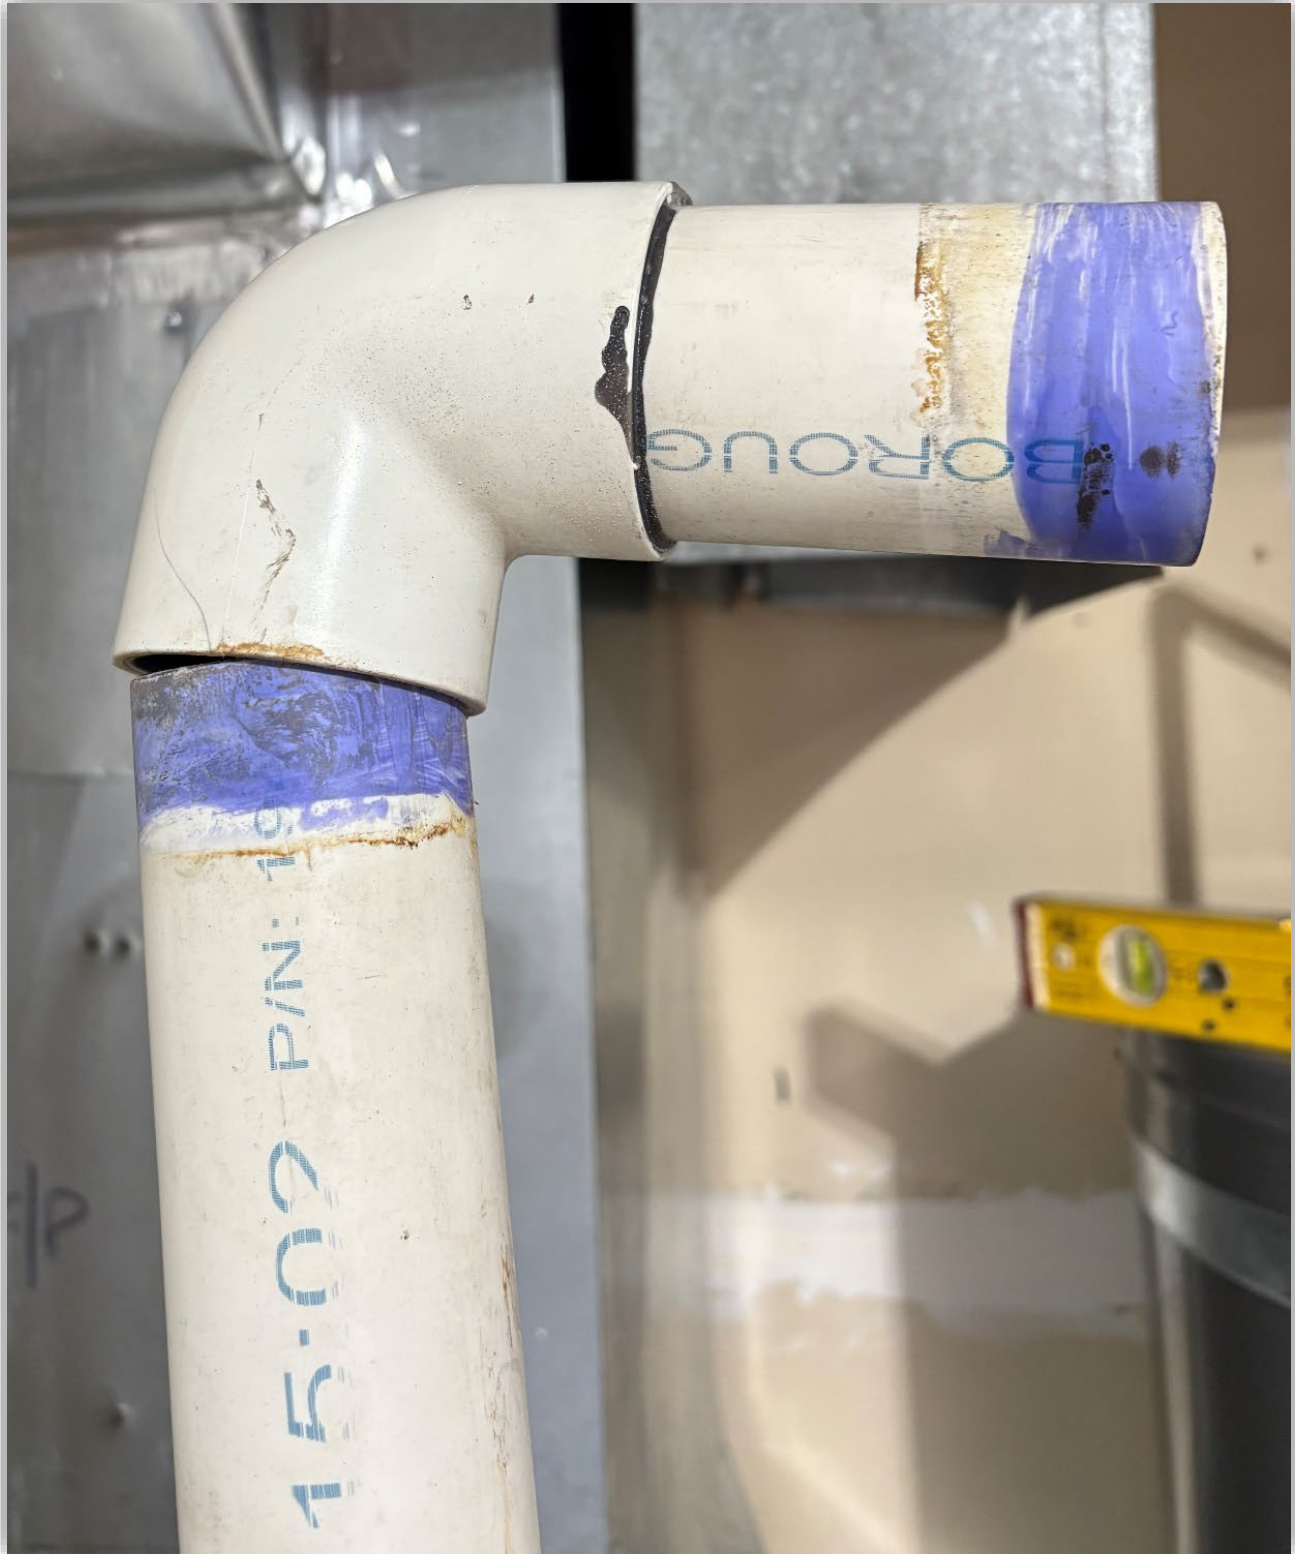
The furnace was installed in the townhome with a single pipe venting system that vented the furnaces flue gasses out through a continuous PVC vent pipe which terminated out the sidewall at the back of the townhome. Two of the vent pipe joints in the mechanical room were never properly solvent welded together and only had primer installed on them. The joints did not come apart but were easily separated by hand when they were being replaced after the incident.

- The furnace was a single pipe vented with a combustion air pipe ducted to the underside of the middle floor patio. The furnace vent termination was beside and slightly above the combustion air intake with a downward pointing elbow installed but not glued.
- New plug-in CO detectors had been installed in the home.
- The furnace was a Carrier brand high efficiency furnace model 58MCB060-0-8 manufactured in June of 2007 and manufactured with a polypropylene line secondary heat exchanger.
- An independent contractor was hired to replace the furnace and when they were disassembling the furnace venting in the mechanical room, they discovered that two of the pipe joints had not been properly solvent welded together and only had primer installed in the joints. Both pipe joints were held together by friction only and were able to be pulled apart by hand ([Image 4](#)).

Image 4 – Venting joints originally installed with primer only and without glue. Both joints were able to be pulled apart by hand.

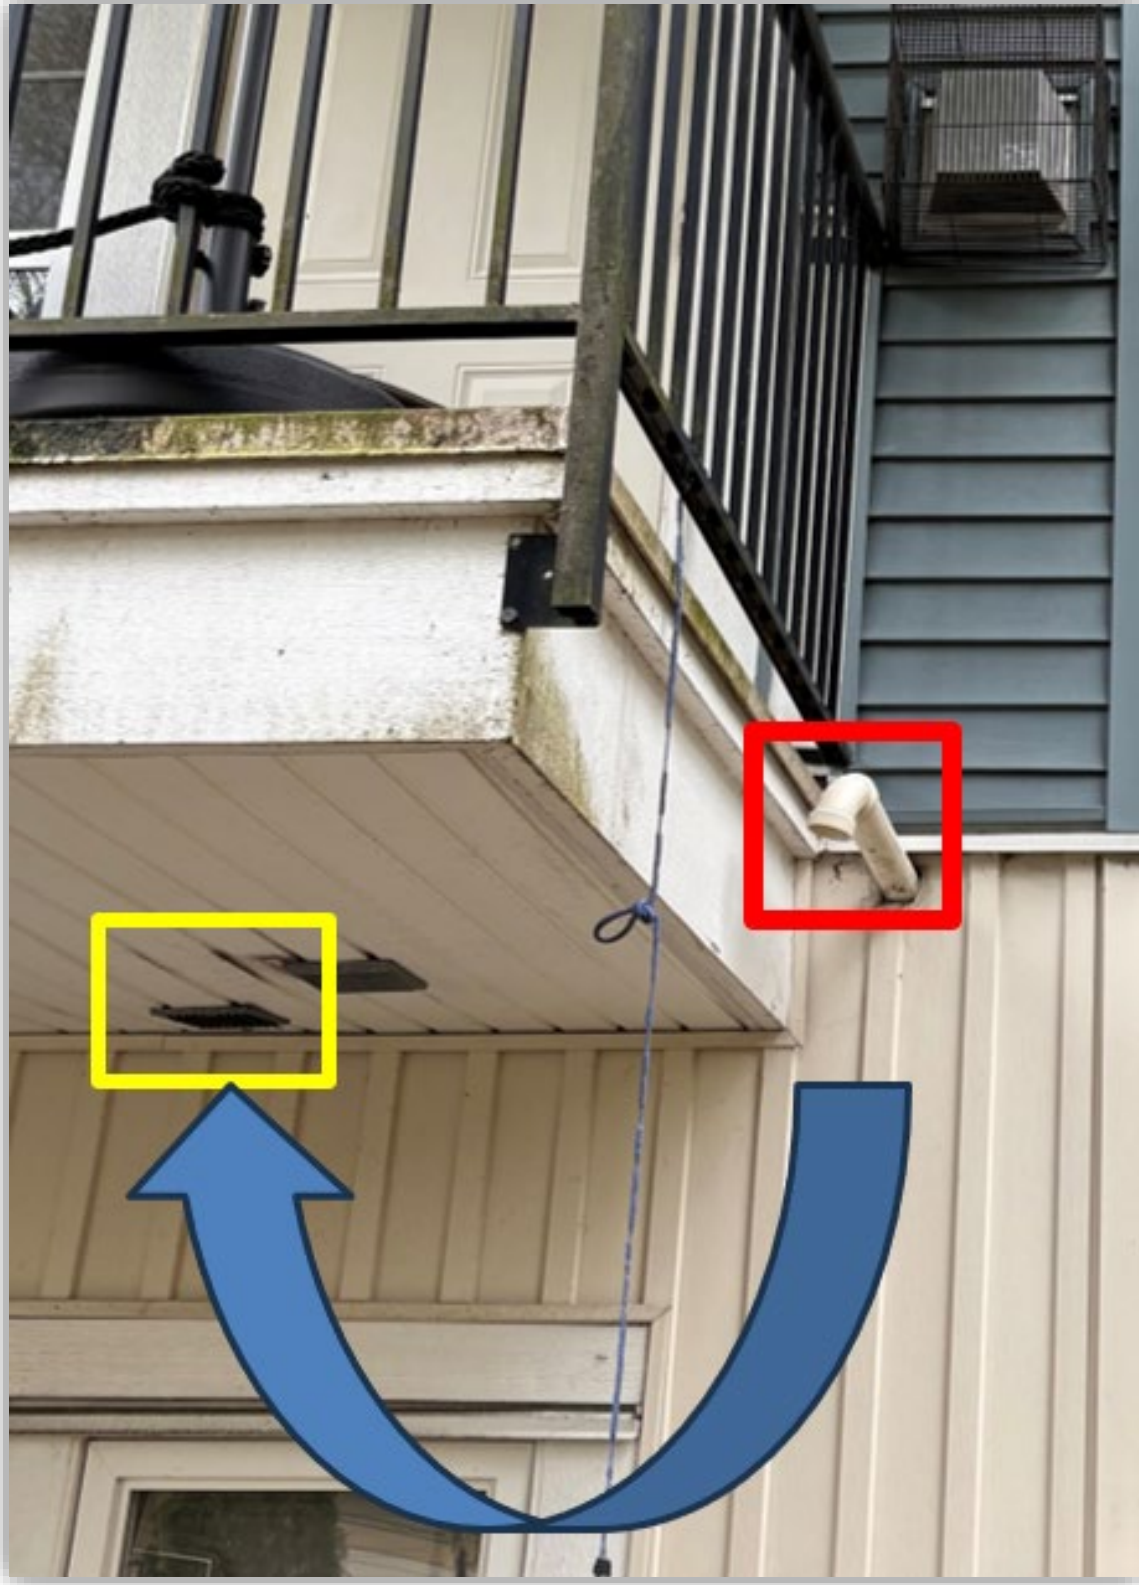
Combustion air for the furnace was ducted using a metal air duct which draws air from a grill installed at the underside of the patio at the rear of the home and supplied it, through natural ventilation means, into the sealed mechanical room housing the gas fired water heater and furnace located in the garage of the home. At some point a 90-degree elbow was placed on the outdoor termination of the furnace vent pipe outdoors. The elbow directing the flue gas straight down was non-compliant to the furnace and vent manufacture's required installation. It was not glued in place but was held in place by friction only. The 90-degree elbow directed the warm flue gasses from the furnace straight down beside the outdoor patio. While the furnace was operating, the flue gases exited the pipe and rose due to natural convection and recirculated back into the mechanical room through the combustion air ducting ([Image 5](#)).

The installation and operating instructions provided by the manufacturer for the furnace identify that all acceptable side-wall vent piping for the furnaces terminate horizontally and not vertically up or down.

- The incorrectly installed 90-degree elbow placed on the end of the vent termination allowed the flue gasses containing hazardous concentrations of CO to be drawn back into the home through the combustion air grill located under the exterior patio.
- The failure of the furnace safeties to stop the operation of the furnace allowed the furnace to continue operating in a hazardous state.
- The non-solvent welded vent pipe joints created a high hazard for CO poisoning by potentially separating indoors while there were very high concentrations of CO in the furnace flue gases.

Image 5 – Horizontal furnace vent termination with 90-degree elbow pointing down.
