Incident Summary (Reference # II-624127-2017)

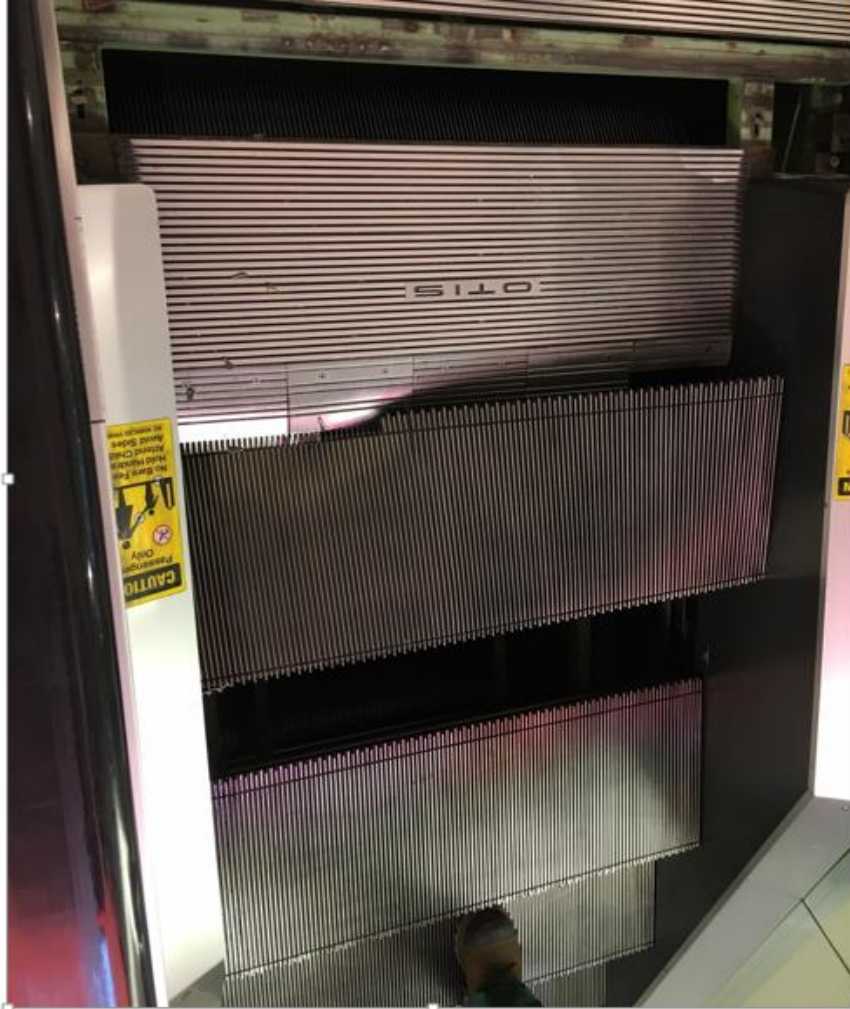
Facts and evidence	<p>All records indicate that the steps were replaced in July of 2017. The C-shaped step clamp was reported to be not locked into the step axial rotatable bushing.</p> <p>See photo's attached.</p>
	Causes and contributing factors	<p>It is highly likely that the incident was a result of a securing pin not being fully engaged into the step axle bushing at the time of installation.</p> <p>A person riding the escalator step caused further misalignment of the step and which might have contributed to the incident.</p> <p>Worn step and chain rollers may have contributed to the incident.</p>

Step risen above upper landing
comb plate
