Incident Summary (Reference #5580487)

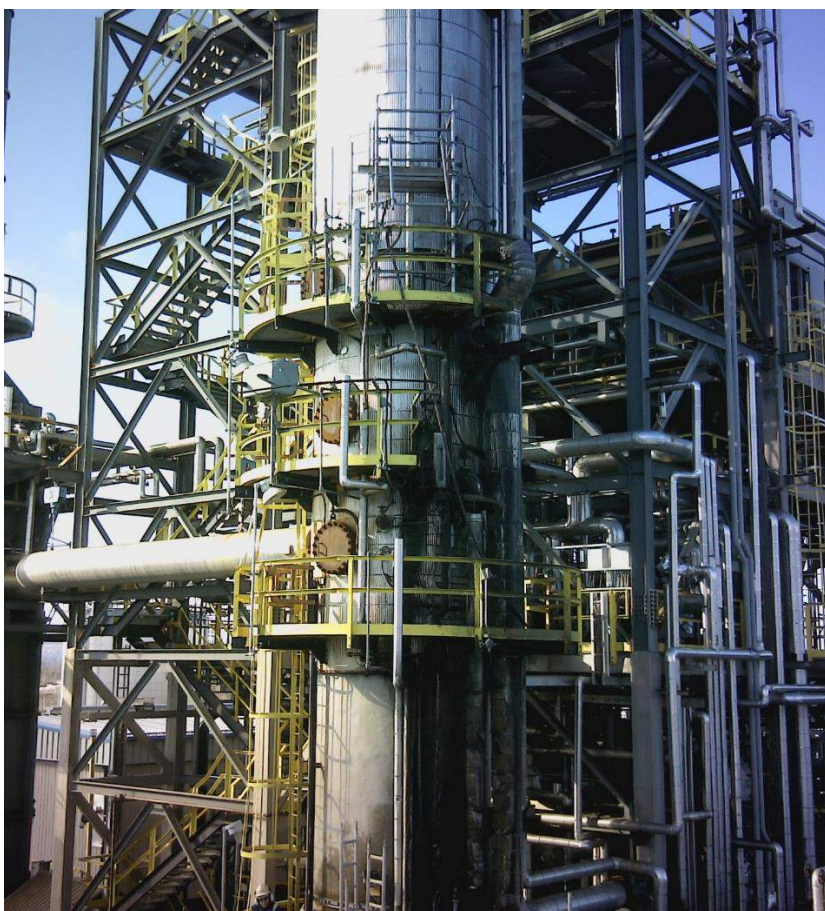
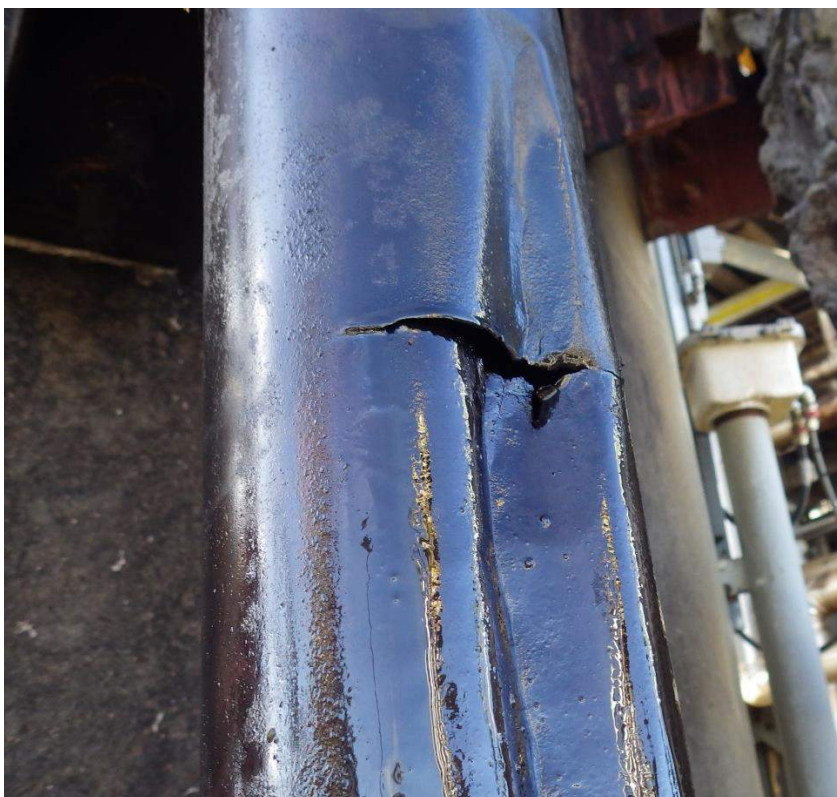
SUPPORTING INFORMATION	Incident Date		February 26, 2016	
	Location		Prince George	
	Regulated industry sector		Boiler Pressure Vessel – Pressure Piping	
	Impact	Injury	Qty Injuries	0
			Injury description	No injuries
			Injury rating	None
	Damage	Damage description	A 4 inch diameter pipe collapsed under a vacuum and developed a longitudinal crack.	
		Damage rating	Minor	
Incident rating			Minor	
DESCRIPTION	Incident overview		A small fire occurred at the base of a Vacuum Tower located at a light oil refinery. The fire was quickly extinguished and there were no injuries. A loss of containment on one of the process piping systems associated with the vacuum tower released a hydro carbon which self-ignited and caused the fire. Minor damage to piping, cladding & insulation resulted.	
	Site, system and components		The process piping runs vertically up the side of the Vacuum Tower. The product transferred in the lines is a hydrocarbon solution with a high sulphur content, it operates at a temperature of 600-700 degrees Fahrenheit (F) and an auto ignition temperature of approximately 500 F and operates under a vacuum. The 4” piping material is a made of 5% chrome alloy which provides a degree of resistance to corrosion. The piping is insulated.

CONCLUSIONS	Failure scenario(s)		The process piping wall thickness was thinned due to corrosion, to the extent that the operating vacuum pressure collapsed the pipe. The pipe rupture occurred due to the collapse, the vacuum pressure was broken and hydrocarbon released. The high temperature contents self-ignited upon exposure to atmosphere. A fire exited at the base of the insulated pipe but was largely contained in the pipe cladding.	
	Facts and Evidence		Inspection of the pipe found extensive thinning evenly along its entire length. The product in the piping has a high sulphur content which is very corrosive. The piping was replaced in 2008 with piping of a lower chrome alloy than originally constructed. The piping failed prior to its expected life span.	
	Causes and Contributing Factors		It is highly probable that corrosion is the damage mechanism. It is probable that changes to material used in prior construction and/or changes to process resulted in accelerated corrosion.
