Incident Investigation Report

Tube Slide Injury

**TECHNICAL
SAFETY BC**

February 2025

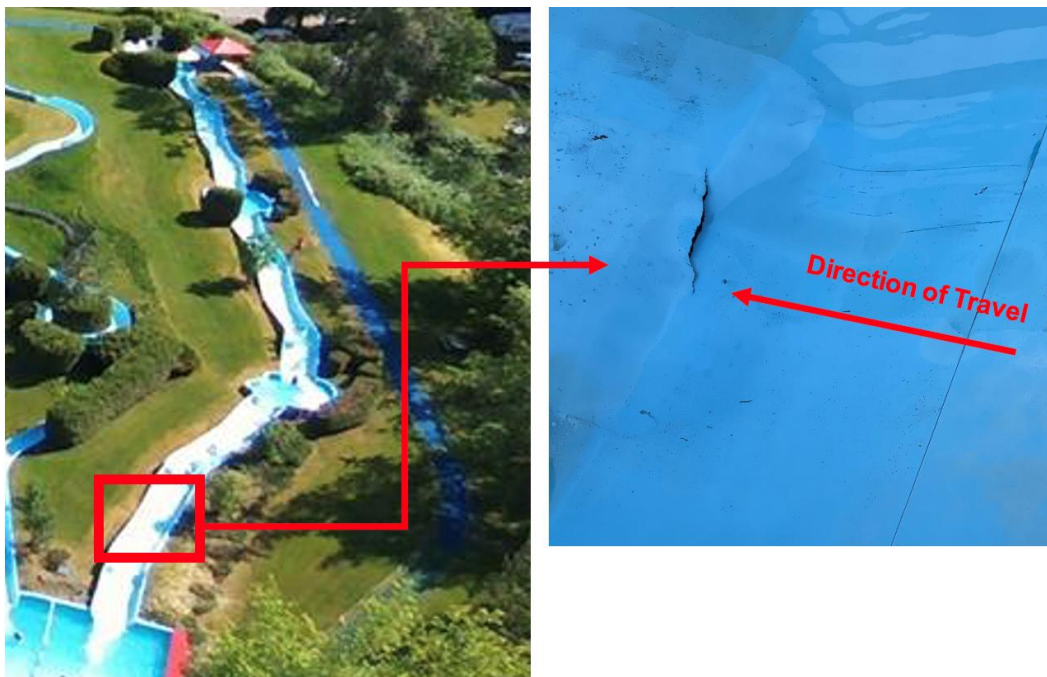
The crack was located in a section of the fibreglass that had deformed into a convex shape compared to its original form. The crack occurred approximately at the transition from the sloped flume section to the nominally horizontal section that redirected riders out into the fibreglass pool.

Figure 4 - Overall view of the tube side with the area of the failure highlighted (Photograph provided by Fiberglass Contractor)

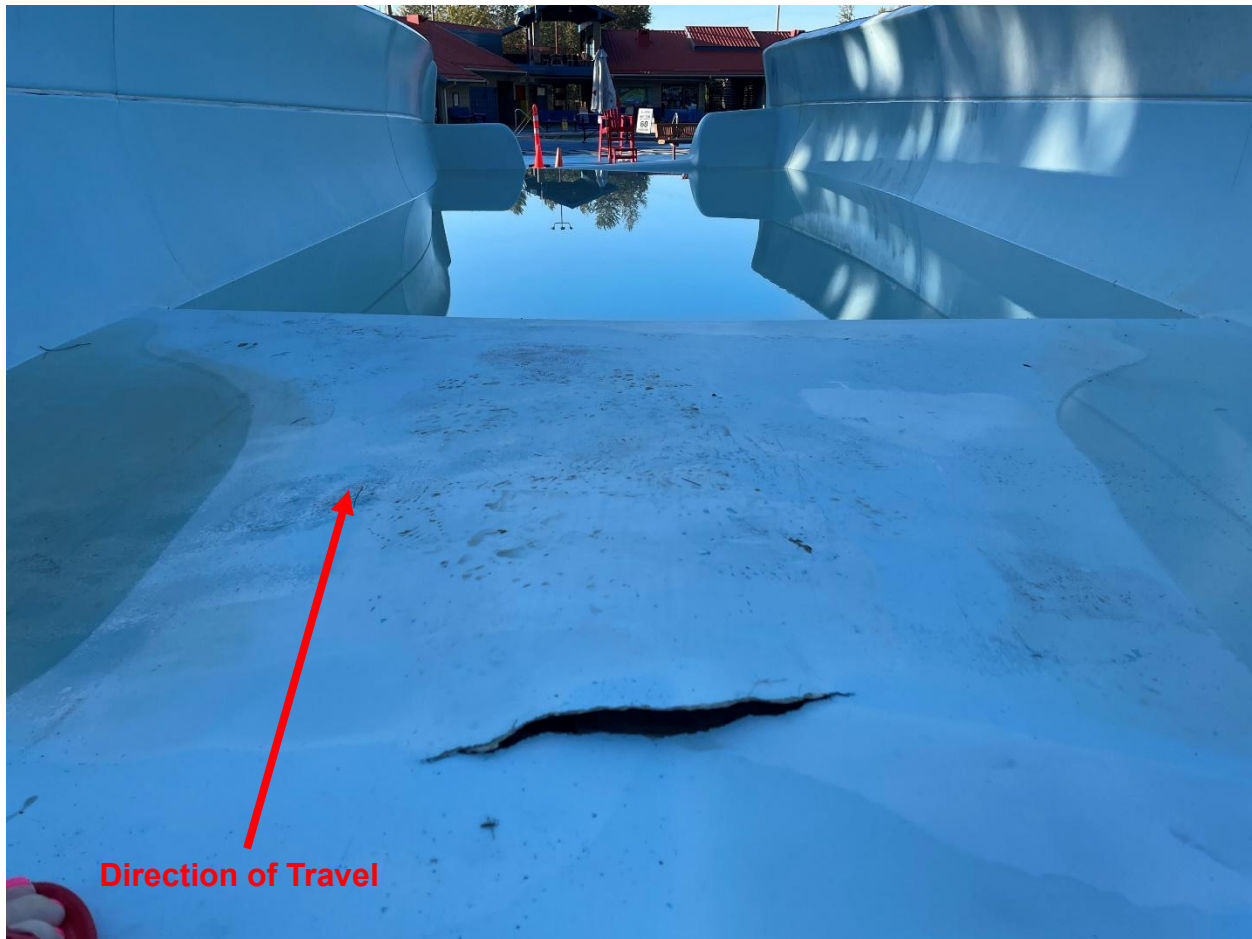
The failure location was documented by staff and the fibreglass contractor post incident, and prior to removal. The failed location was cut out prior to Technical Safety BC’s involvement but was retained for further analysis. The documentation identified an approximately 8-inch crack was present at the base of the seventh sloped flume section. The crack was jagged and protruded upward on the downstream side of the crack creating a significant hazard to those progressing down the slide.

Figure 5 - Close-up of the failure showing direction of patron travel (Photograph provided by a Lead from the Waterpark)

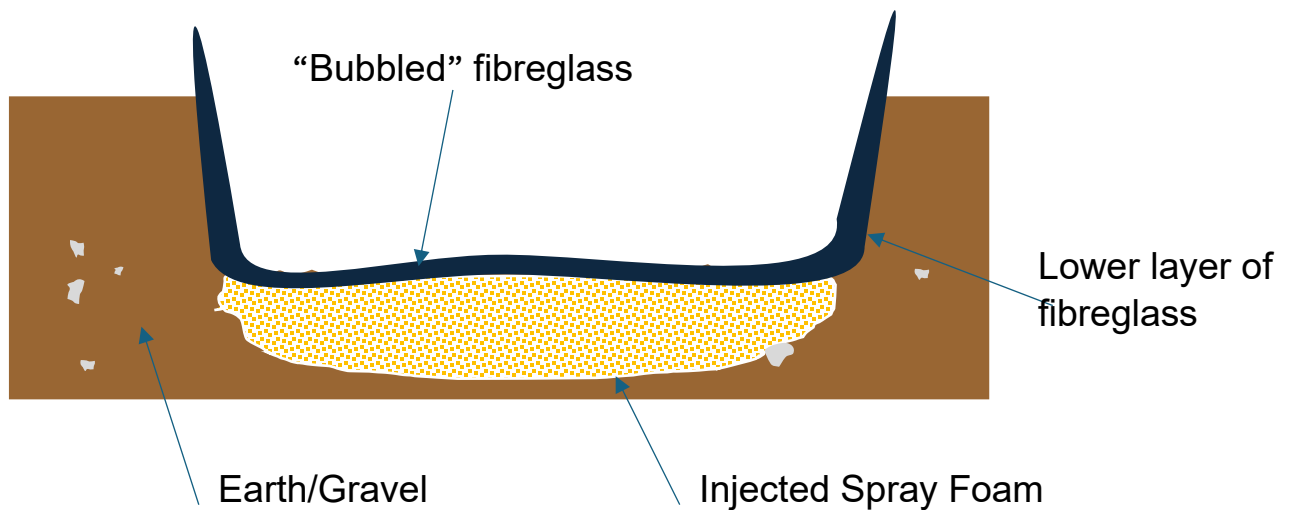
Figure 6 - Representation of the slide cross section at the time of the incident

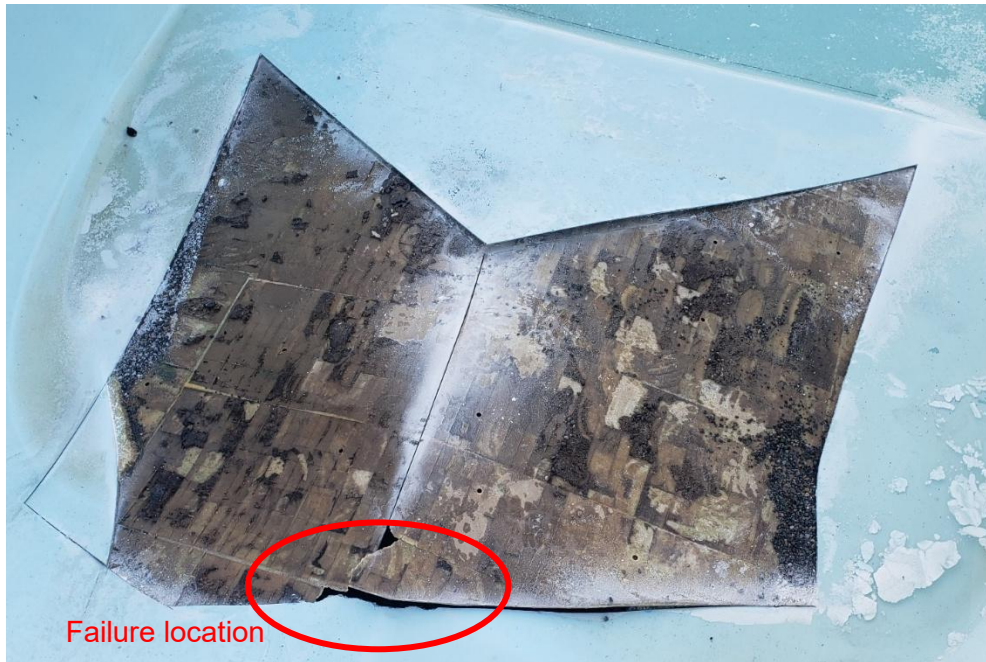
Upon removal of the first layer of fibreglass, there was evidence of gravel being washed into the space between the two layers of fibreglass. The wood core was rotten and disintegrated to the point of no longer being present. The bottom layer of fibreglass was also fractured with the crack extending much further (and in multiple directions) compared to the crack on the top surface.

Figure 7 - Failure location, top layer of fibreglass removed. Note the wood core has completely disintegrated (Photograph provided by Fiberglass Contractor)

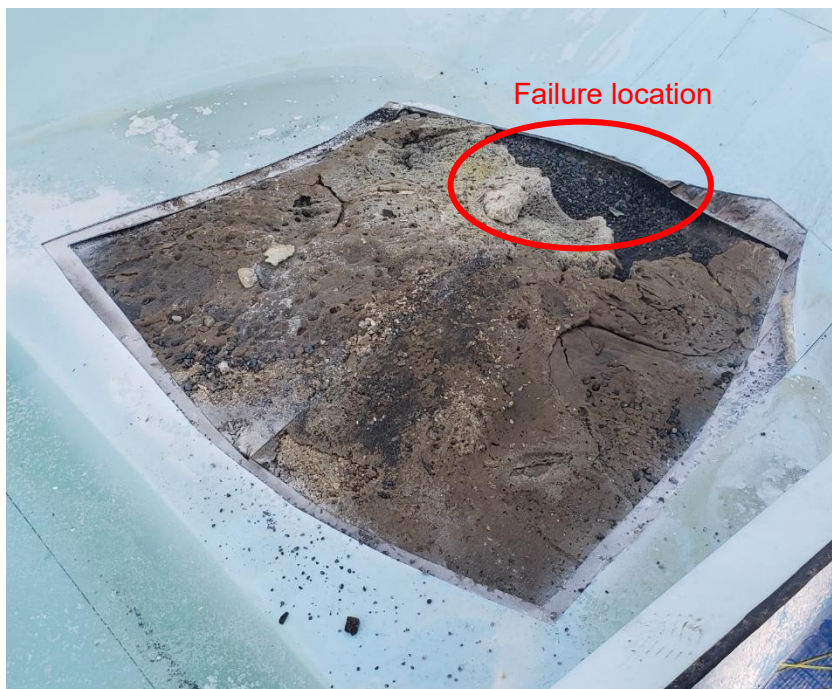
The bottom layer of fibreglass had a series of round holes drilled through it. Upon removal of the bottom layer of fibreglass, there was a thick layer of spray foam visible that had been injected beneath the slide to support it at some time in the past. However, the spray foam stopped short of where the crack was located leaving a gap between the ground and fibreglass flume.

Figure 8 - Failure location after bottom layer of fibreglass was removed. A large mass of spray foam was located beneath the flume, but did not fill the area below the failure (Photograph provided by fiberglass contractor).

However, the spray foam was injected from above through holes drilled in the fibreglass. This resulted in some areas receiving excessive foam which expanded as it cured (resulting in bulging), and other areas that were not supported by the foam (such as in the area of the failure which had no foam below it). Materials analysis of the cracked area found that, missing support in the area of the failure was a primary factor in the cause of the crack.

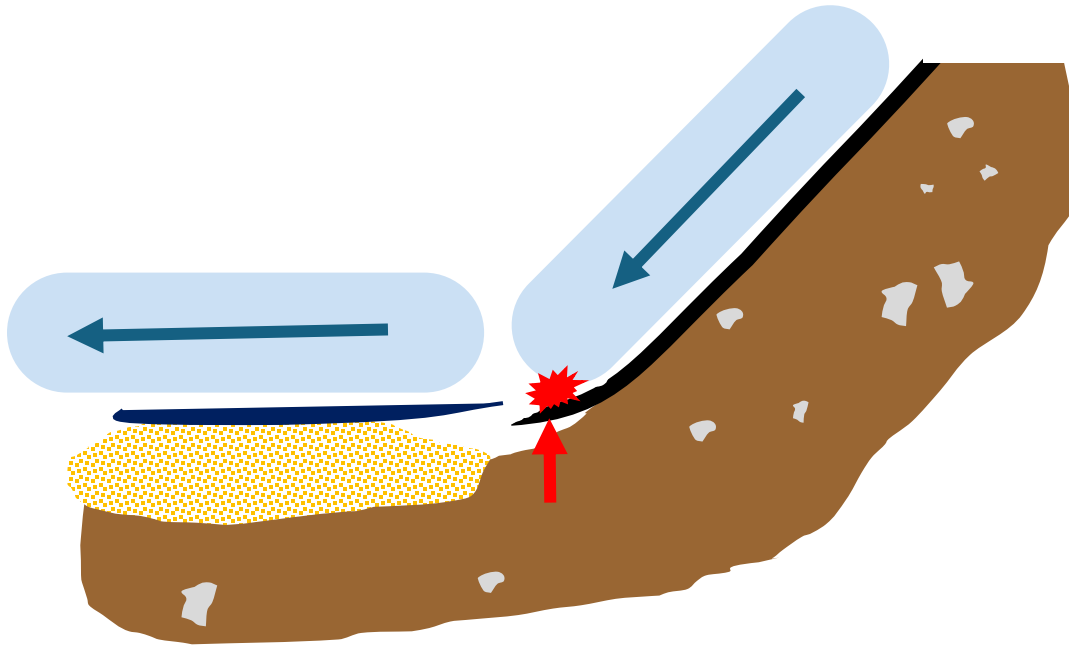
Figure 9 - Representation of the slide profile post failure. Tubes showing direction of travel and impact location.

When the failure did occur, downstream bulging of the fibreglass, and the unsupported area upstream resulted in a height difference between the two edges which significantly increased the hazard associated with the crack and contributed to the severity of the injuries that followed.

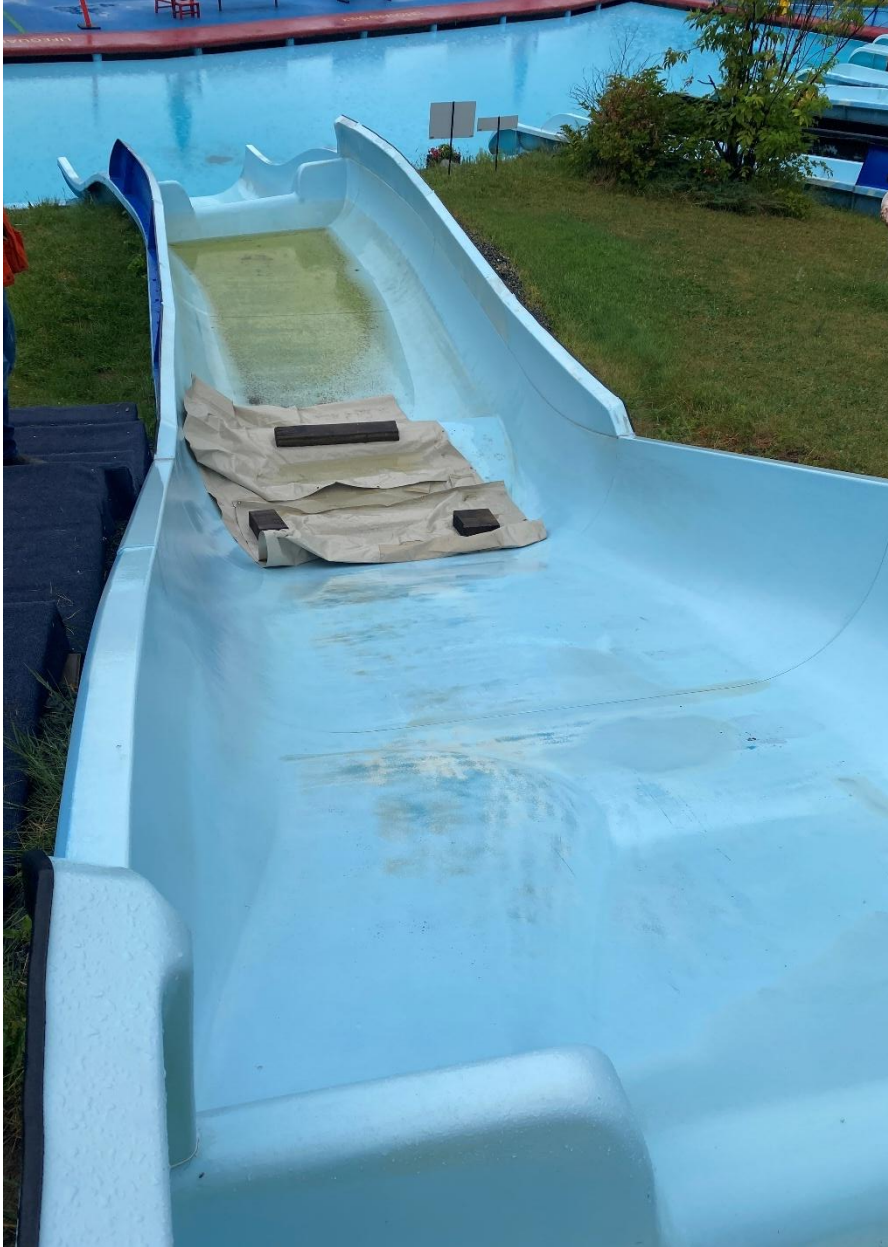
Based on the perceived level of hazard created by the crack, the General Manager instructed one of the slide attendants to stand in the pool located upstream of the cracked flume section, and to try to push the tubes away from the crack as the riders went down (see image below). Several patrons and tubes progressed around and/or over the crack without injury.

Figure 11 - Photograph taken from the position of the slide attendant who was tasked with trying to direct tubes around the downstream failure.

The visual assessment of the crack was primarily hampered by two factors. First, the visual assessment was done from outside the slide, standing on the hillside. This perspective would not have been ideal for observing the crack because of the distance which may not have made the size of the crack, or vertical offset between the two sides obvious. Second, the crack was located beneath a layer of turbulent water during Tube Slide operation. As a result, the visual inspection would have been hampered significantly by the water. This was reflected in the statements of the two observers who provided very different accounts of the size of the crack when it was first inspected. The General Manager stated that they also observed several of the tubes pass over the crack “without snagging” and therefore felt the risk was low. Still, instruction was provided to slide attendants to try and direct the remaining patrons being evacuated down the slide from going over the crack, which indicated that they perceived that the crack posed some level of hazard. There was no attempt to have staff members enter the flume to investigate or feel the crack, despite it being normal for slide attendants to stand in the water during morning inspections or during operation to help patrons down the slide.
