## Incident Summary #II-2019876-2026 (#60509) (FINAL)

| | Regulated Industry Sector | | Gas - Natural Gas System | |
| | Incident Overview | | <p>In an occupied fully detached dwelling, a damaged gas furnace was being decommissioned to allow for installation of a replacement unit later that day. The damaged furnace and a gas-fired water heater were located close together in a small hallway enclosure inside the residence. Two unsupervised labourers began preparing the furnace for removal while the gas supply remained on. During this work, the labourers disconnected the appliance shut-off valve and removed the gas supply riser, resulting in the uncontrolled release of natural gas into the immediate work area. The escaping gas was subsequently ignited by the standing pilot light on the water heater, which was situated directly next to the furnace.</p> <p>A small explosion and localized fire followed. The fire was confined to the appliances and the surrounding wall area. Both labourers sustained burns during the Incident.</p> | |

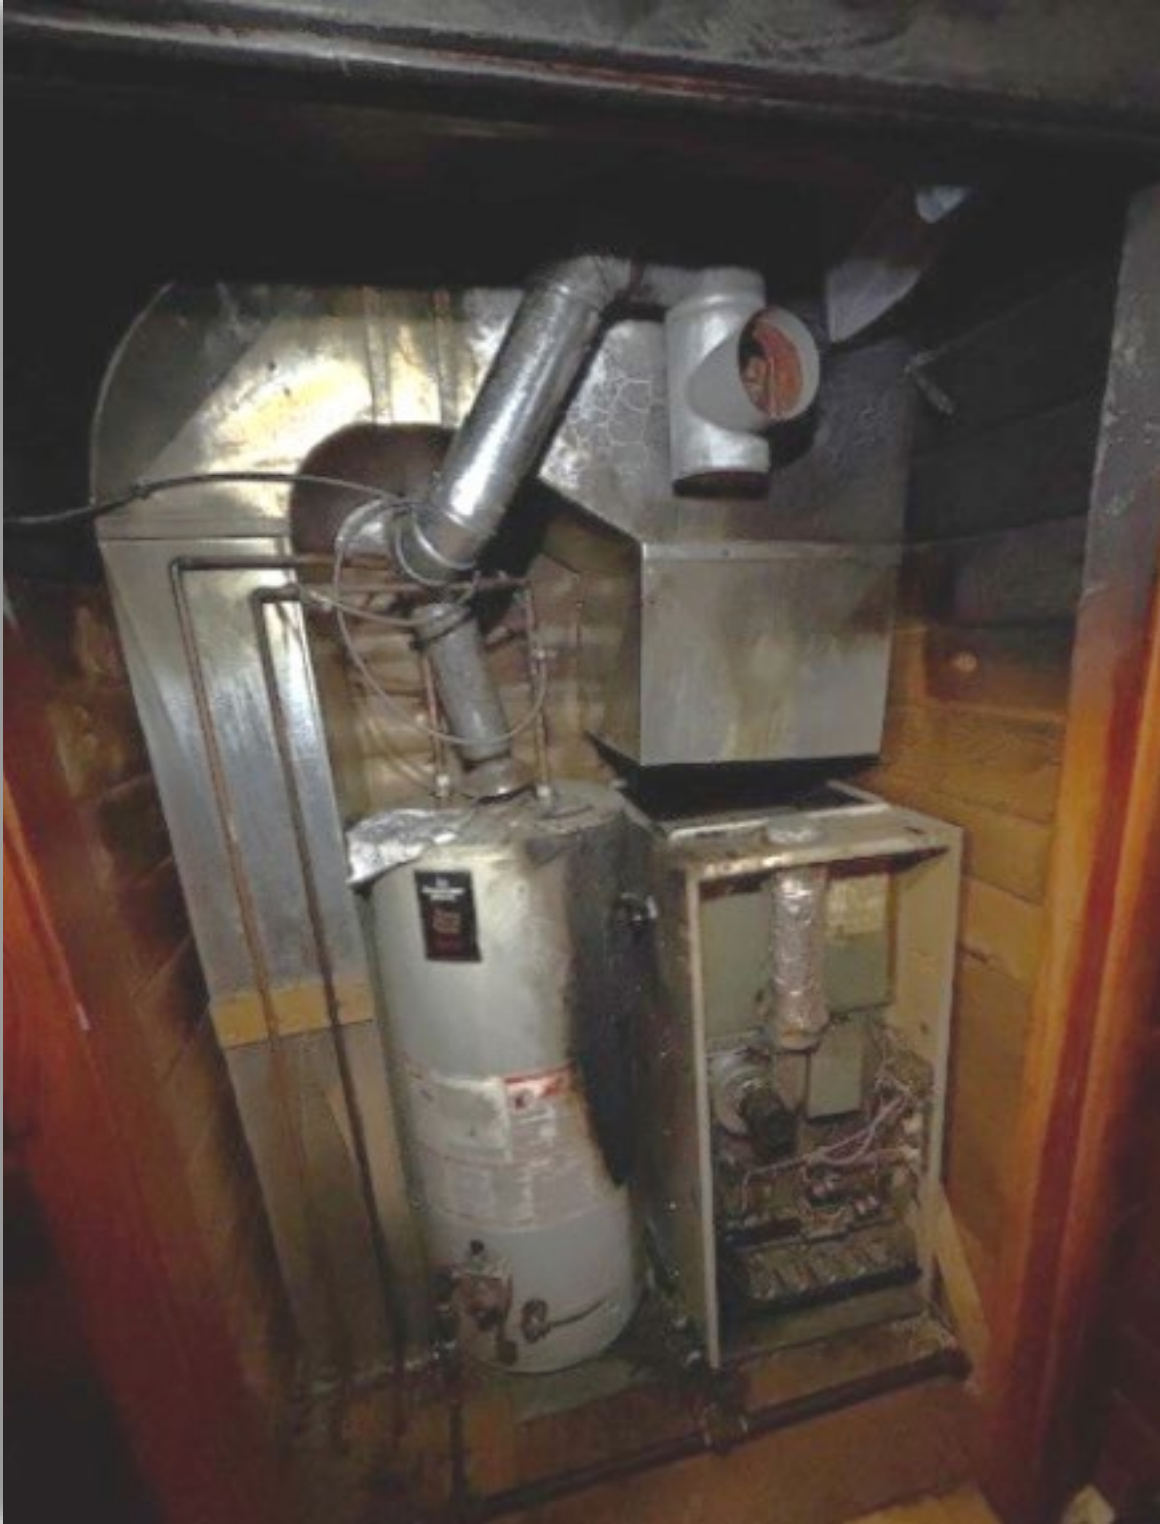
The Incident occurred during the winter, and as such, it was expected that the furnace be replaced the same day to restore heat to the dwelling house. The subject furnace and gas-fired water heater were installed very close together in the same hallway enclave near the entry of the dwelling house. In this case, the water heater and subject furnace were directly side-by-side and nearly touching ([Image 1](#)).

Image 1 – Furnace and water heater post-Incident in place. *(Photo taken by Restoration Company.)*

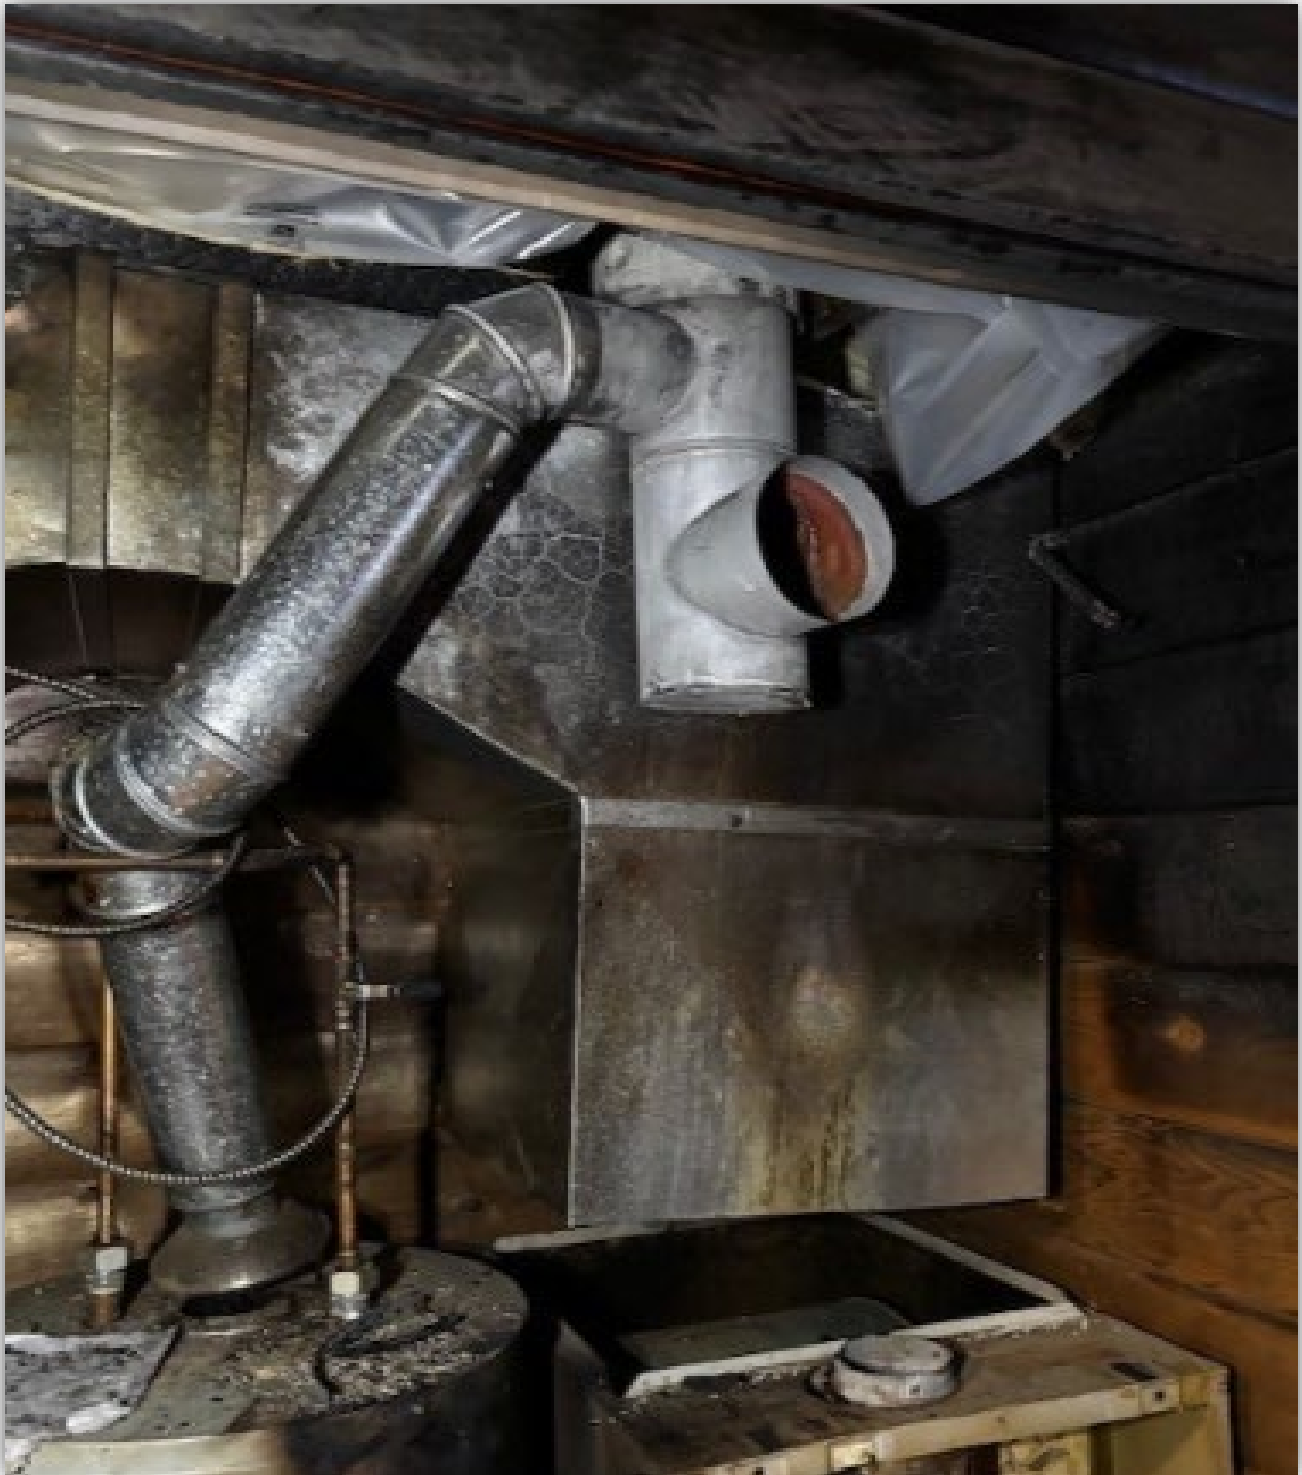
- The resulting flame travelled upward and caused fire damage above the appliances.
- Labourer 1 exited the residence and shut off the gas supply at the meter.
- Labourer 2 escorted the homeowner out of the dwelling house.
- Smouldering continued briefly due to the log construction but was contained.
- No emergency services involvement was noted during the interview.

Image 2 – Close-up of damage from explosion/fire above furnace and water heater.

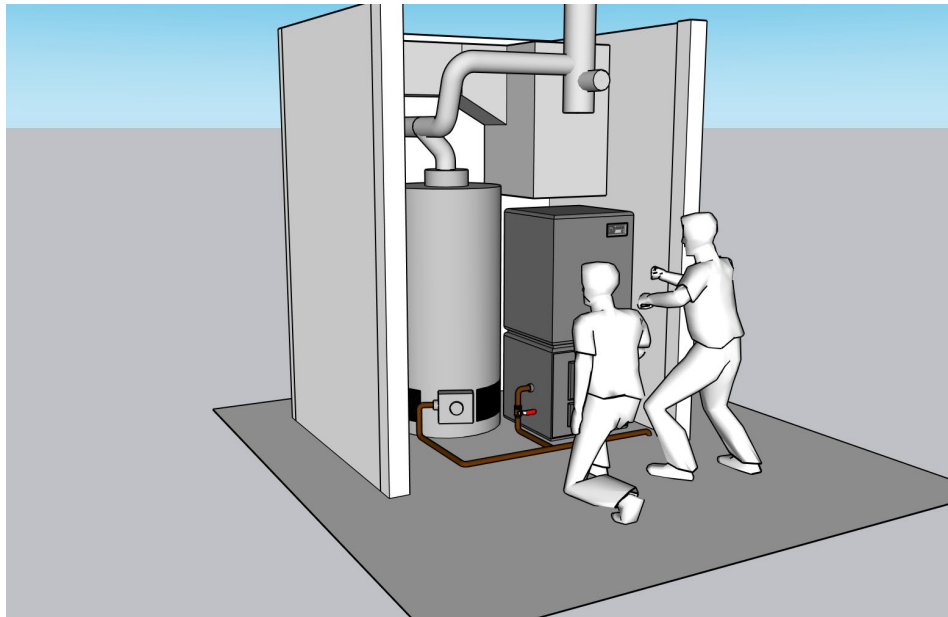
To access and remove all ducting in the confined worksite, the labourers needed to move the subject furnace away from the wall and the adjacent water heater ([Image 3](#)). They proceeded to disconnect the subject furnace's electrical connection and gas piping and attempted to move the appliance, despite being aware the gas supply was active and had not been shut off at the main valve at the exterior of the dwelling house.

Image 3a - 3D model of Incident layout for demonstrative purposes.

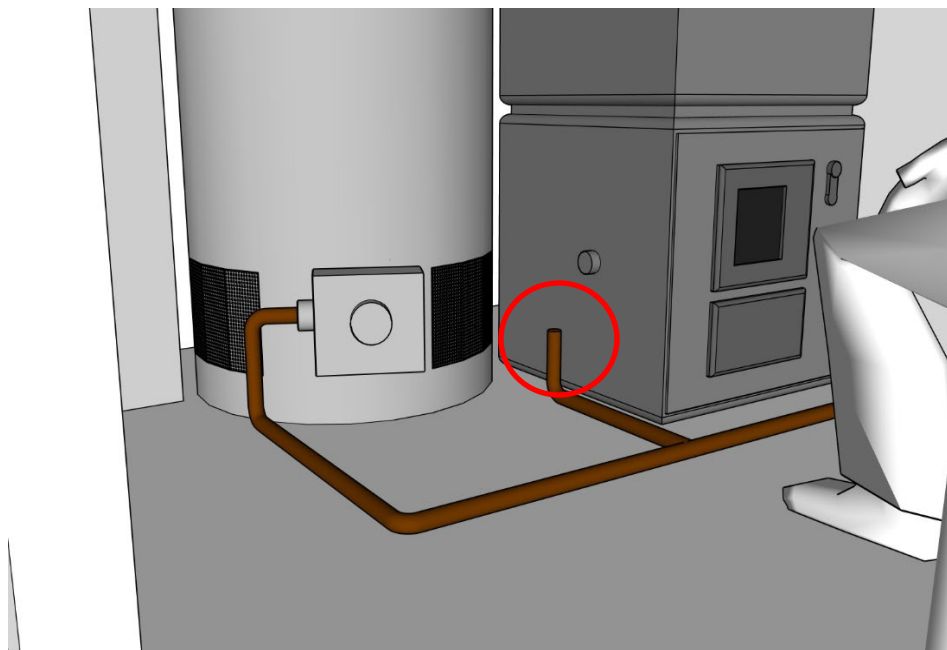
In the course of the disconnection work, the labourers closed the appliance shut-off valve, removed the union on the ½-inch black iron pipe, and attempted to remove the subject furnace. As the remaining riser prevented removal, the labourers proceeded to unthread the riser on the supply side of the shut-off valve, resulting in an open and flowing gas line ([Image 3](#)). They stated that they intended to cap the opening while manually restricting the low-pressure gas flow using thumb pressure over that opening; however, gas escaped.

The immediate cause of the Incident was the intentional disconnection of the furnace gas piping and shut-off valve without isolating the natural gas supply (attempted live-capping). This created the conditions for the escaping gas to ignite at the pilot flame on the neighbouring water heater, resulting in fire damage and injuries.

Image 3b – 3D model of incident gas riser after disconnection of the shut-off valve, where a worker attempted to cover the opening with thumb pressure as gas escaped ("live-capping" of the line).

- Maintenance on gas piping systems must not be performed while the system is under pressure, unless specifically permitted by code.
- Gas piping must be isolated from the gas supply before any energized portion is altered or disconnected.

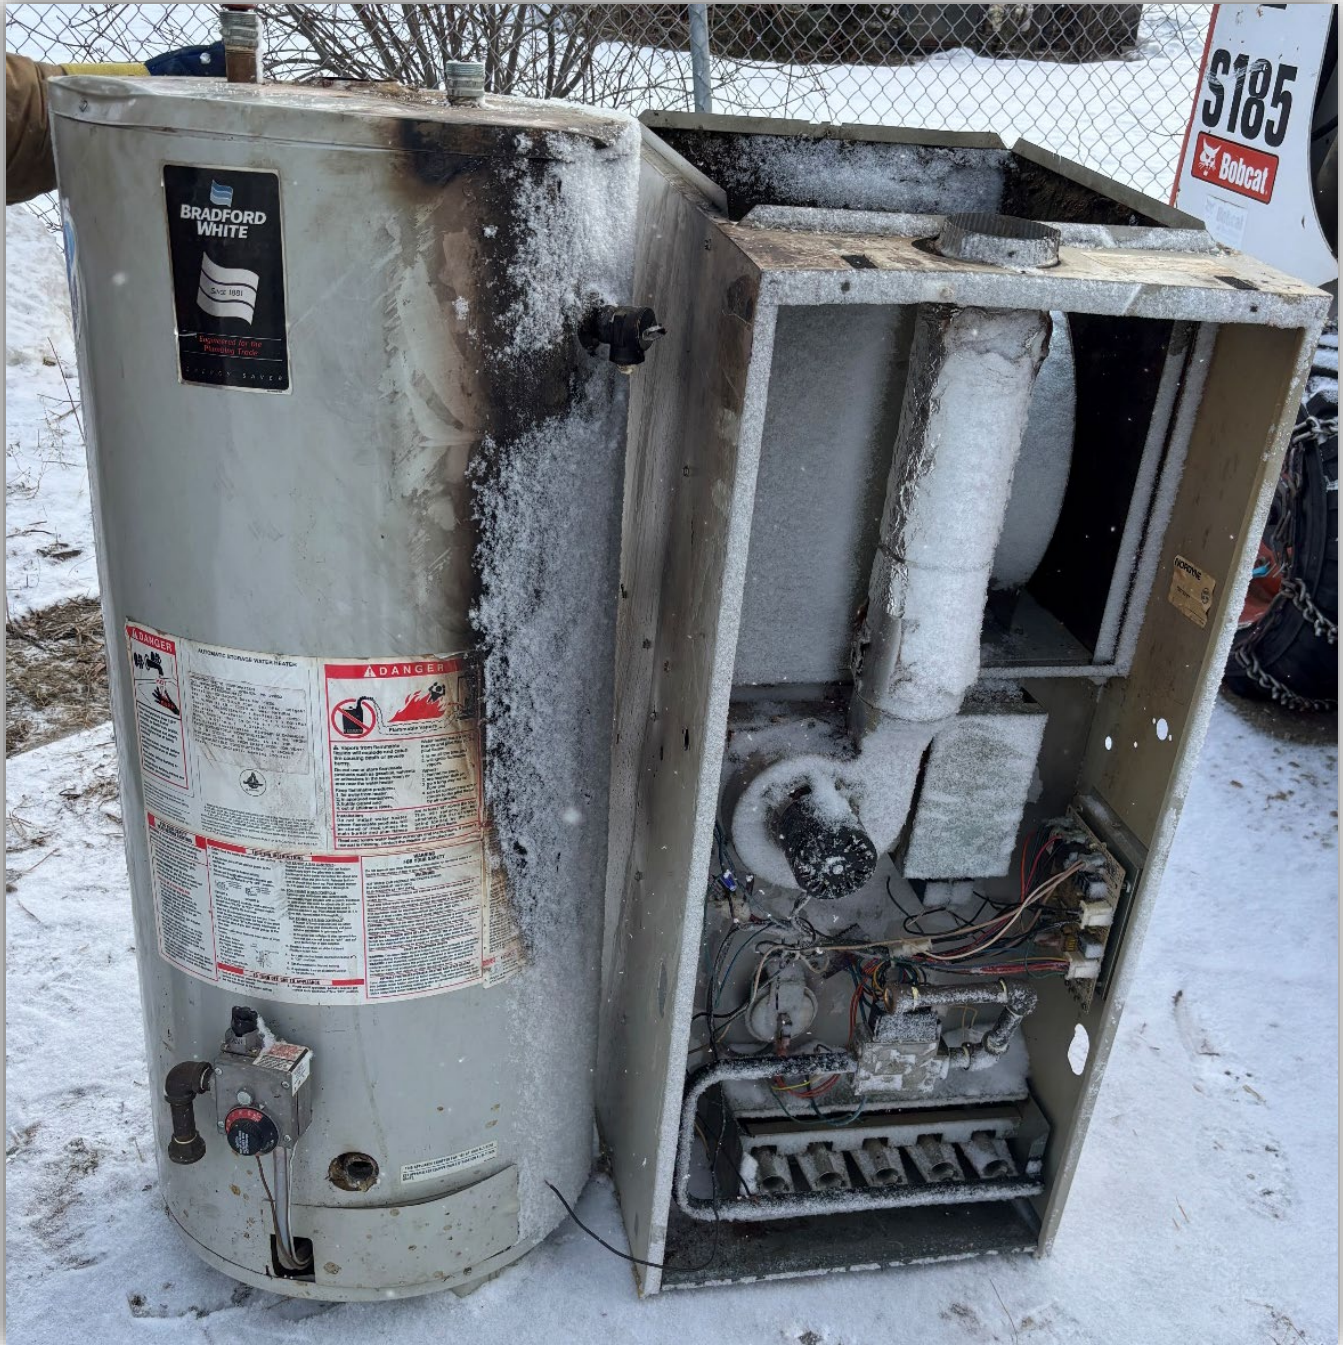
Following the Incident, the subject furnace and water heater were removed from the dwelling house. [Image 4](#) shows both damaged appliances after the Incident.

Image 4 - Furnace and water heater damaged and removed post-Incident.

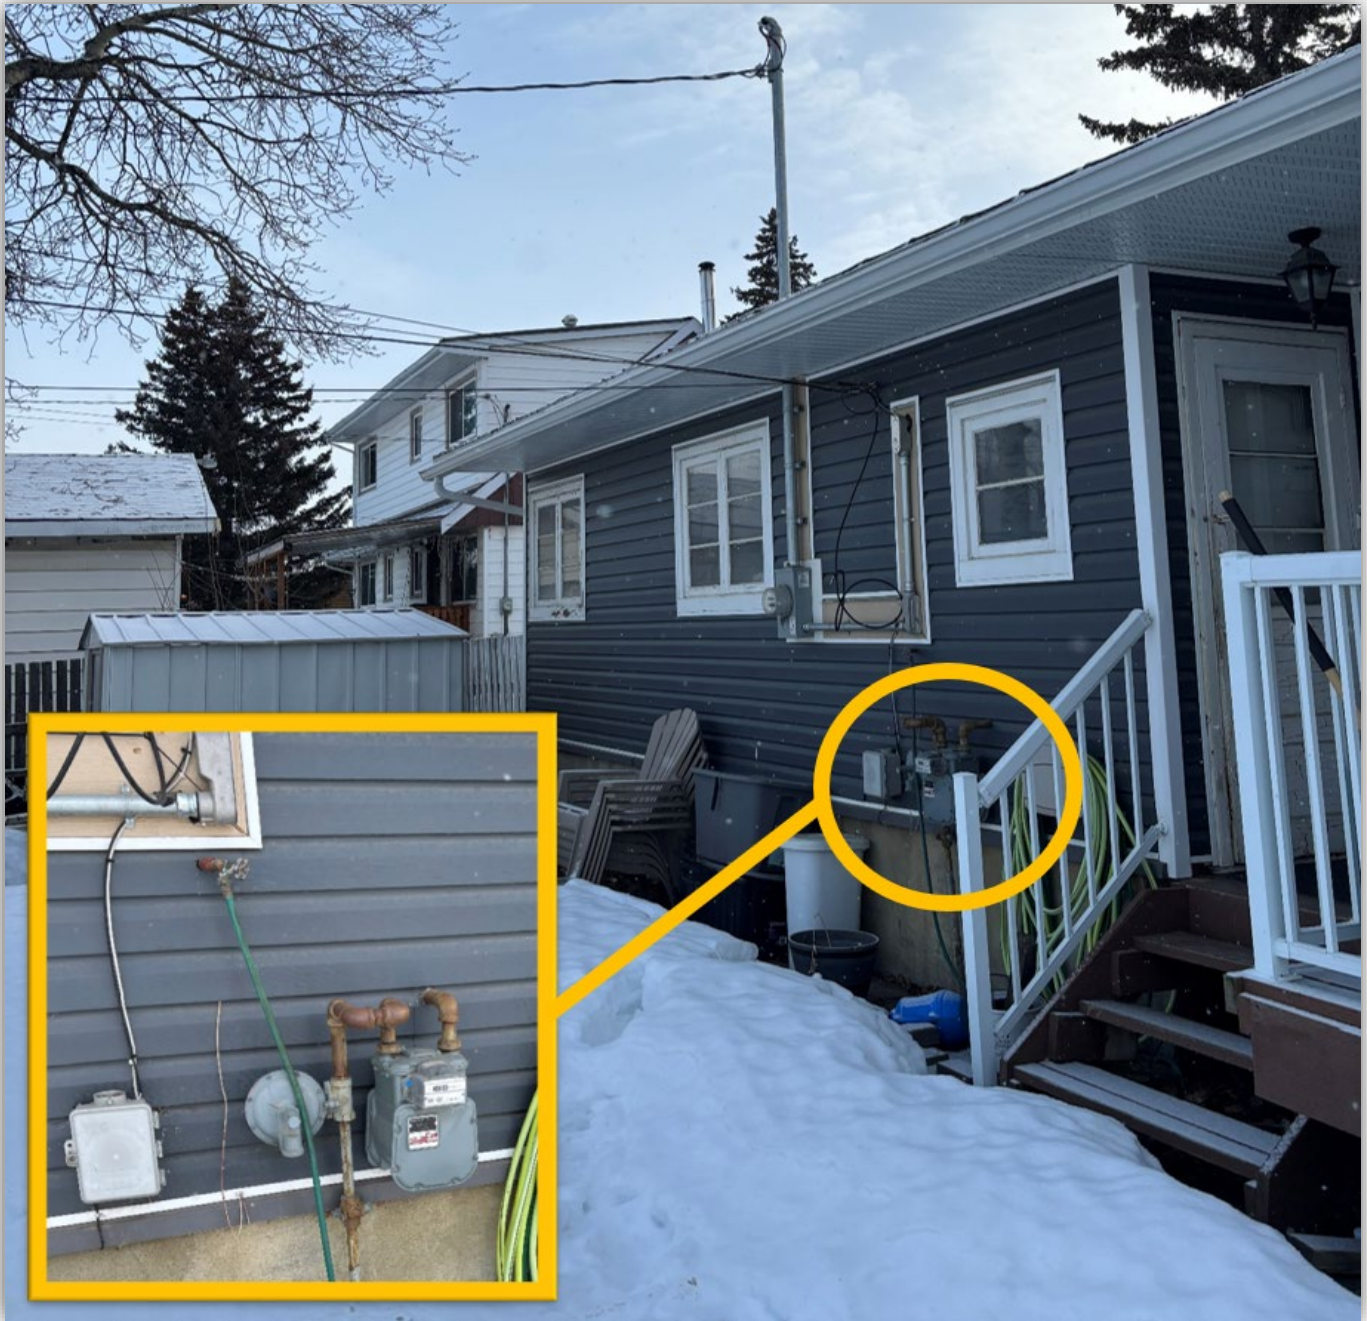
The pilot light in the neighbouring water heater ignited the escaping gas, resulting in a fire that was confined to the appliances and the surrounding wall area. One labourer ran outside to shut off the gas supply at the meter and then applied water to the burning walls and appliances, while the second worker evacuated the occupant from the dwelling house.

Image 5 - Location of shut-off at the rear of the dwelling house. It was accessed by the labourers only after the fire started.
