Incident Summary #II-1637869-2023 (#41677) (FINAL)

Incident Date		November 20, 2023
SUPPORTING INFORMATION	Location		Vancouver
	Regulated industry sector		Gas - Natural gas system
	Impact	Qty injuries	0
		Injury description	N/A
		Injury rating	None
	In Damage	Damage description	Dislodgement of a boiler vent stack and the emission of exhaust gas containing carbon monoxide into an indoor space.
		Damage rating	Minor
	Incident rating		Minor
	Incident overview		A boiler serving a commercial space experienced a combustion event that dislodged the boiler vent. The appliance continued to operate with the vent dislodged allowing products of combustion to exhaust into the mechanical room.
INVESTIGATION CONCLUSIONS	Site, system and components		Two gas-fired hydronic boilers located in a roof-top mechanical room provide building heat and domestic hot water. The hydronic boilers incorporate a system of pumps, valves and fittings that distributes hot water to the building heat emitters which, in turn, modulate the building temperature. A gas-fired boiler ignites natural gas to create heat within a combustion chamber, which transfers the heat to water through a heat exchanger. The products of c

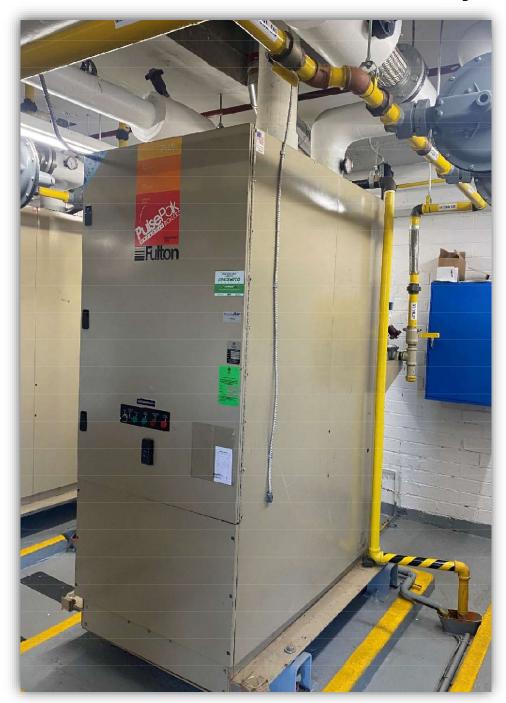
Image 1 - Fulton Boiler.

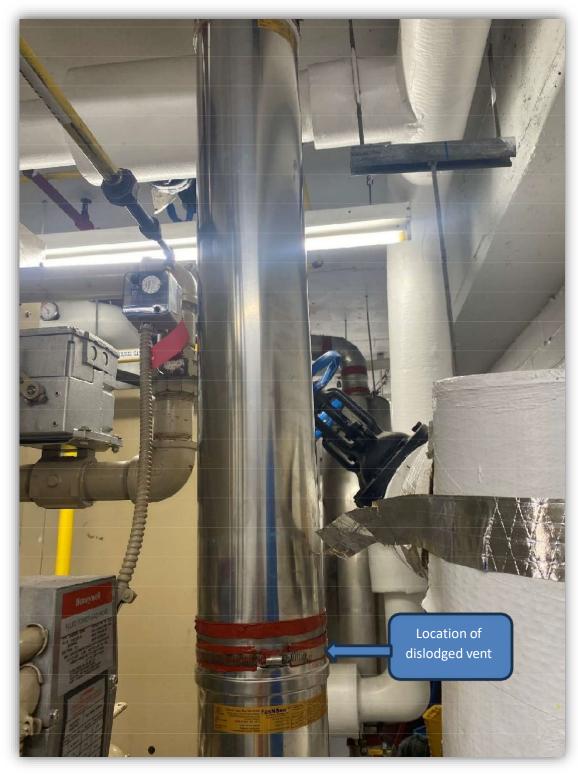
During a daily mechanical room inspection, the building manager noticed a large volume of water spread throughout the boiler room ceiling. Assuming it was a water leak he called a plumbing technician to inspect for leaks. The technician identified that the boiler vent had become dislodged and was emitting exhaust gases into the mechanical room, which condensed on the boiler room ceiling.

It is probable that the failed appliance regulator allowed an excessive amount of gas into the boiler combustion chamber, resulting in a hard light off that was significant enough to dislodge the boiler vent. The boiler continued to run, exhausting flue gas directly into the mechanical room.

Image 2 - Boiler Vent.

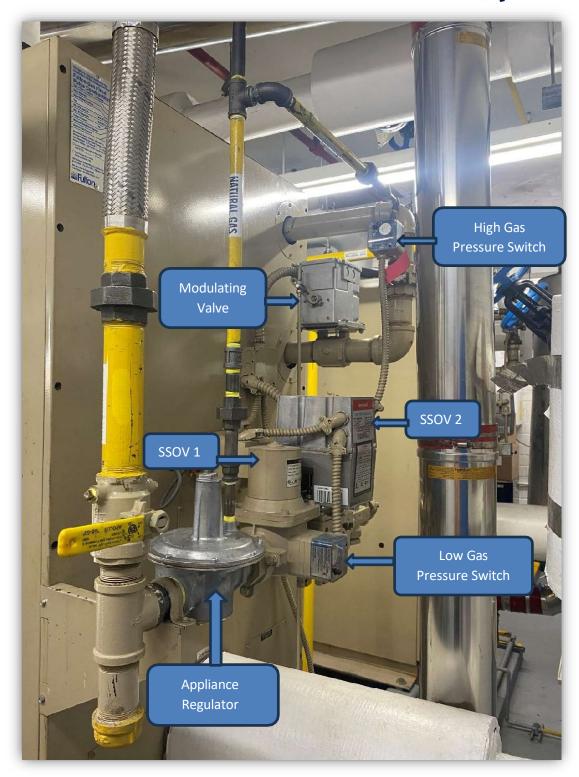
The boiler appliance regulator item was inspected by the technician and found to be faulty:

- The appliance regulator's downstream pressure was tested in multiple locations. The downstream pressure was 14"WC, the same as the inlet pressure. Any attempt to adjust the regulator resulted in the same pressure reading (14"WC), indicating a failed regulator.
- The technician installed a new appliance regulator and was able to adjust the regulator to the required manifold pressure of 3.5"WC.
- After installing the new appliance regulator, the technician cycled the boiler numerous times and found no ignition delay and no indications of faulty operation.

Image 3 - Boiler Valve Train Components.
