Incident Summary #II-740302-2018 (#775050) (FINAL)

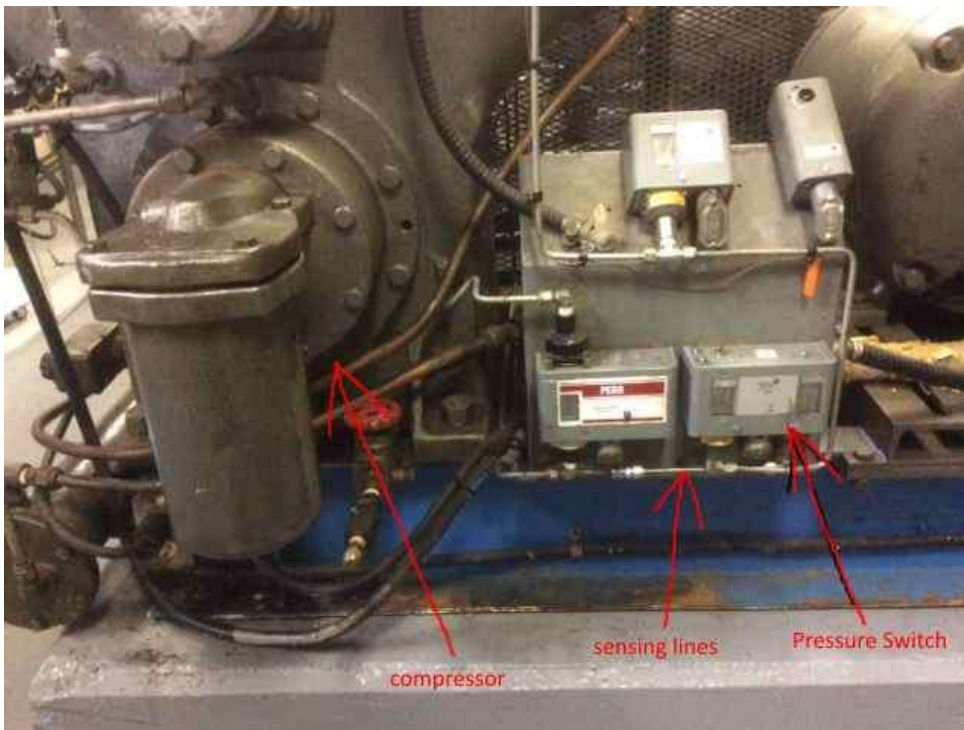
Show location of mounted control in proximity to compressor and location of pressure switch and sensing lines

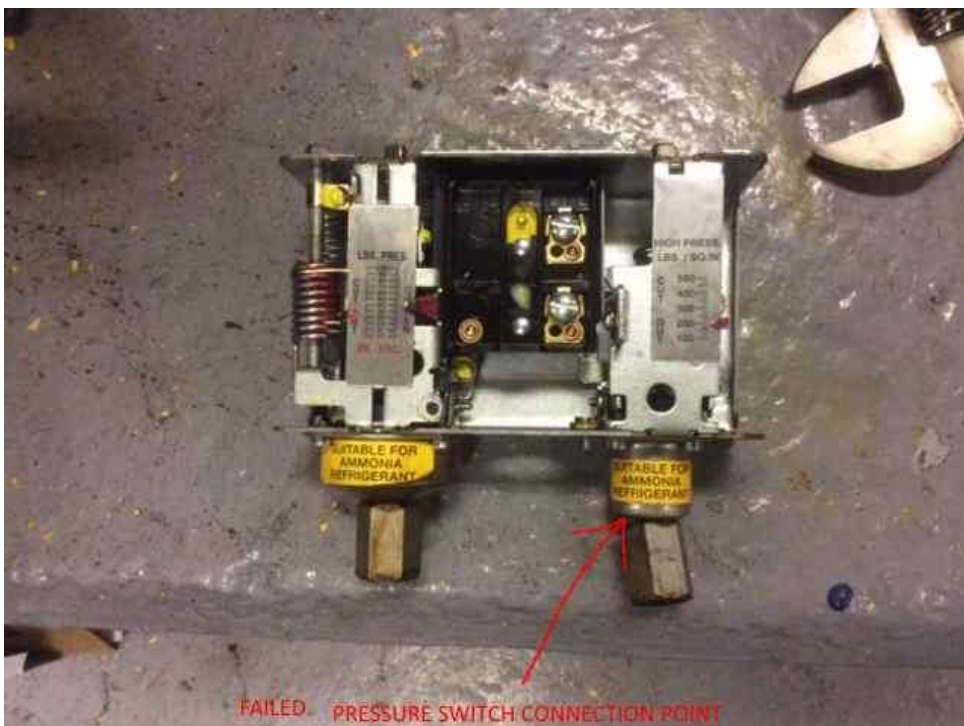
SUPPORTING INFORMATION	Incident Date		September 5, 2018	
	Location		North Delta	
	Regulated industry sector		Boilers, PV & refrigeration - Refrigeration system	
	Impact	Injury	Qty injuries	0
			Injury description	none
			Injury rating	None
	Damage		Damage description	Cracked bellows fitting on Ammonia compressor Pressure switch.
			Damage rating	moderate
	Incident rating		Moderate, due to the release of ammonia in a ventilated space	
Incident overview		In a public assembly arena mechanical room an Ammonia leak occurred at the connection point of ¼ inch pressure sensing line connected to a pressure switch bellows for an ammonia compressor.		
INVESTIGATION CONCLUSIONS	Site, system and components		The arena refrigeration system Pressure switch, which starts and stops the compressor, is attached to 3 feet of ¼ inch stainless steel sensing line that leads to the compressor discharge piping. Anti-Vibration clamps are commonly used on most sensing lines to dampen the vibrations caused by the pulsations of reciprocating compressors.

Shows failed pressure switch connection point, Note: the Pressure switch connection fitting has been bent or opened up to show where the crack started.

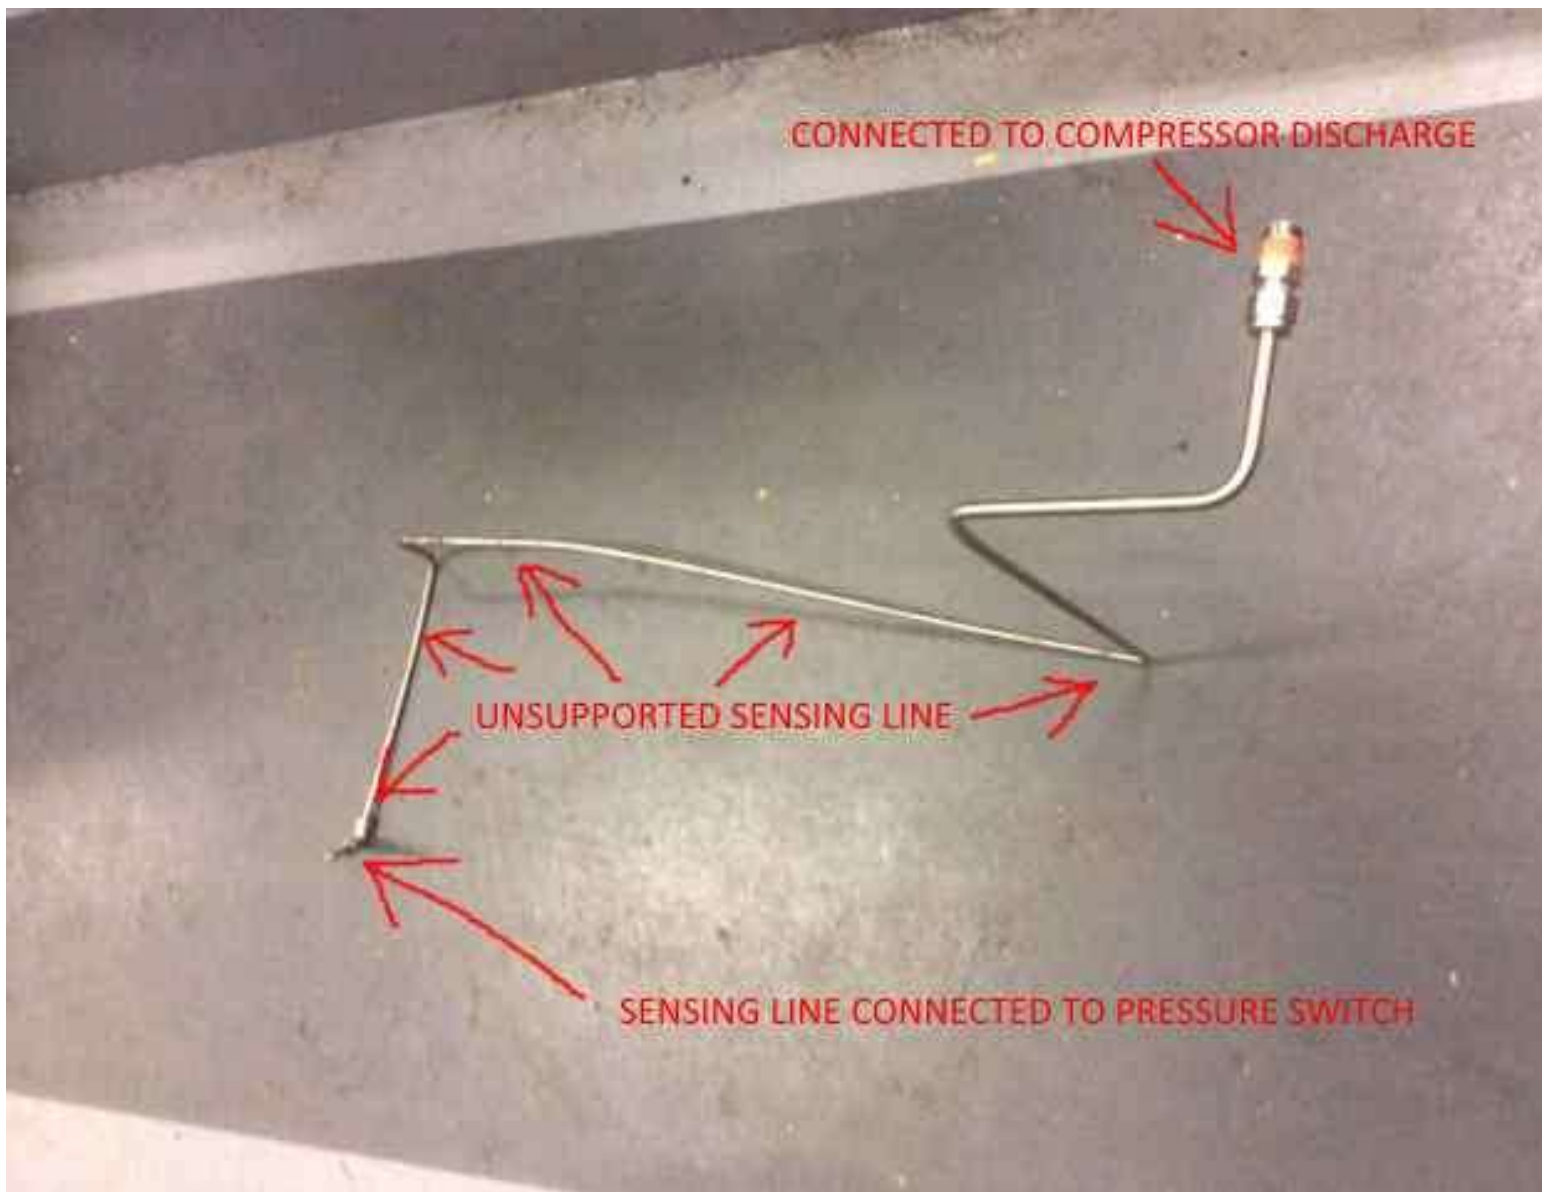
Failure scenario(s)		The lack of anti-vibration clamps on this particular sensing line would allow the constant vibration will over a period of time to cause metal fatigue and cracking on the pressure switch bellows. Vibrations are often amplified due to harmonic effects if the sensing lines that are not clamped down tight with anti-vibration clamps.	
	Facts and evidence		Pictures attached show the location of the crack on the pressure switch bellows and a sensing line that did not have any anti vibration clamps near the failed switch. Examination by an Industry service and maintenance expert indicated the sensing line vibrations had also started to rub or erode the line against a contact point on an electrical fitting. In consultation with the industry service provider this line has been replaced.	
	Causes and contributing factors		The Likely cause is the lack of anti-vibration clamps on the sensing line that would allow the constant compressor vibrations will over a period of time to cause metal fatigue and cracking on the pressure switch bellows. The age of the plant is a contributing factor as the date of installation over 20 years ago did not commonly use anti-vibration clamps. Industry practice is to now clamp sensing lines at various points to ensure vibration is not amplified and allowed to travel up the sensing lines to connection points on pressure switches.

Shows unsupported section of sensing line that was connected to the pressure switch
