Incident Investigation Report

Kicking Horse Gondola

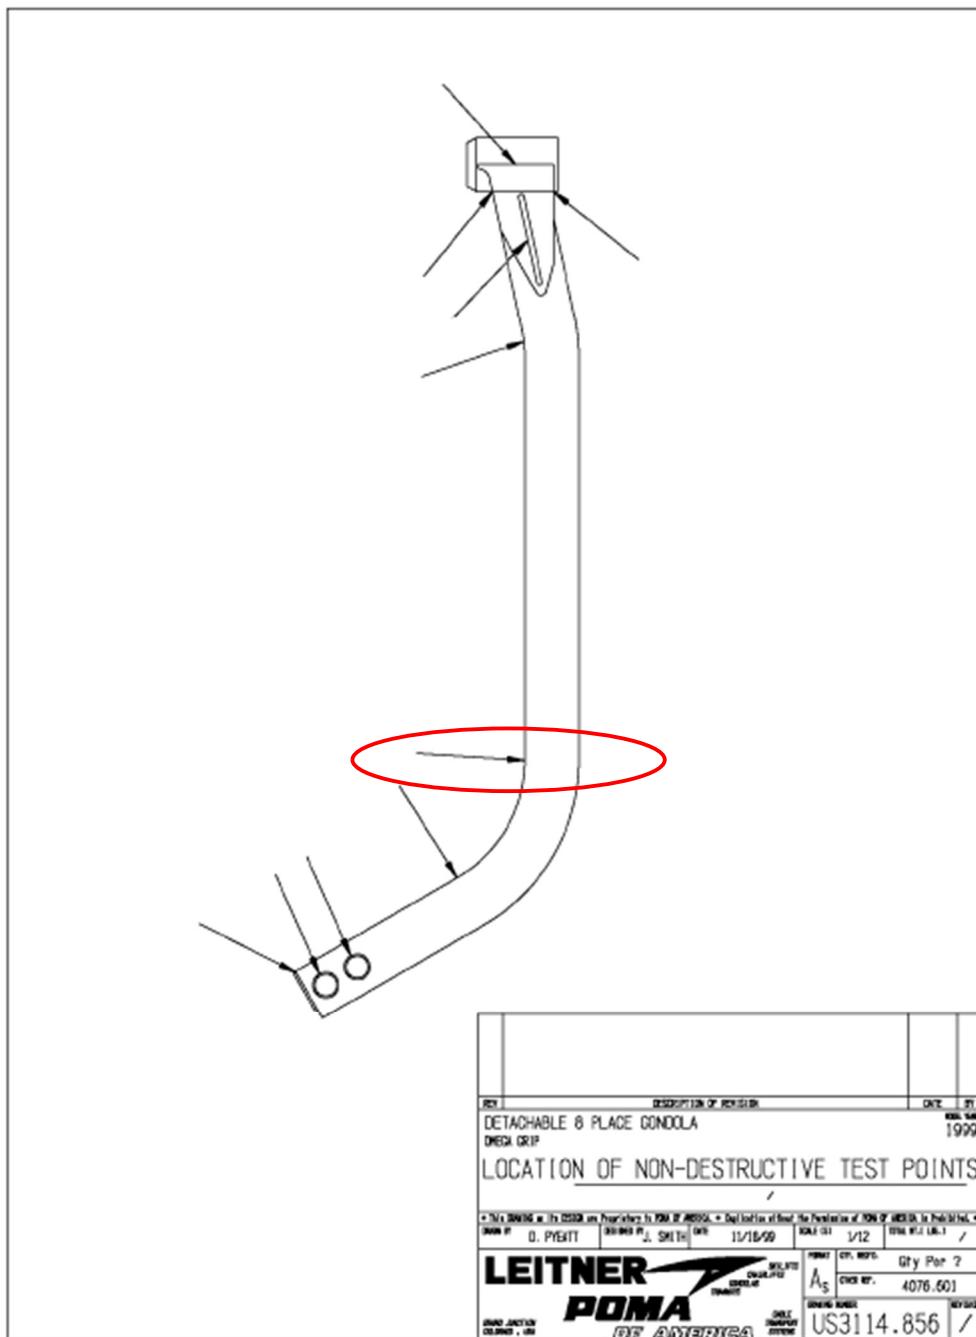
Figure 6 - Manufacturer's NDT Diagram for the hanger arm. The area of the failure was near a noted check point and is highlighted.

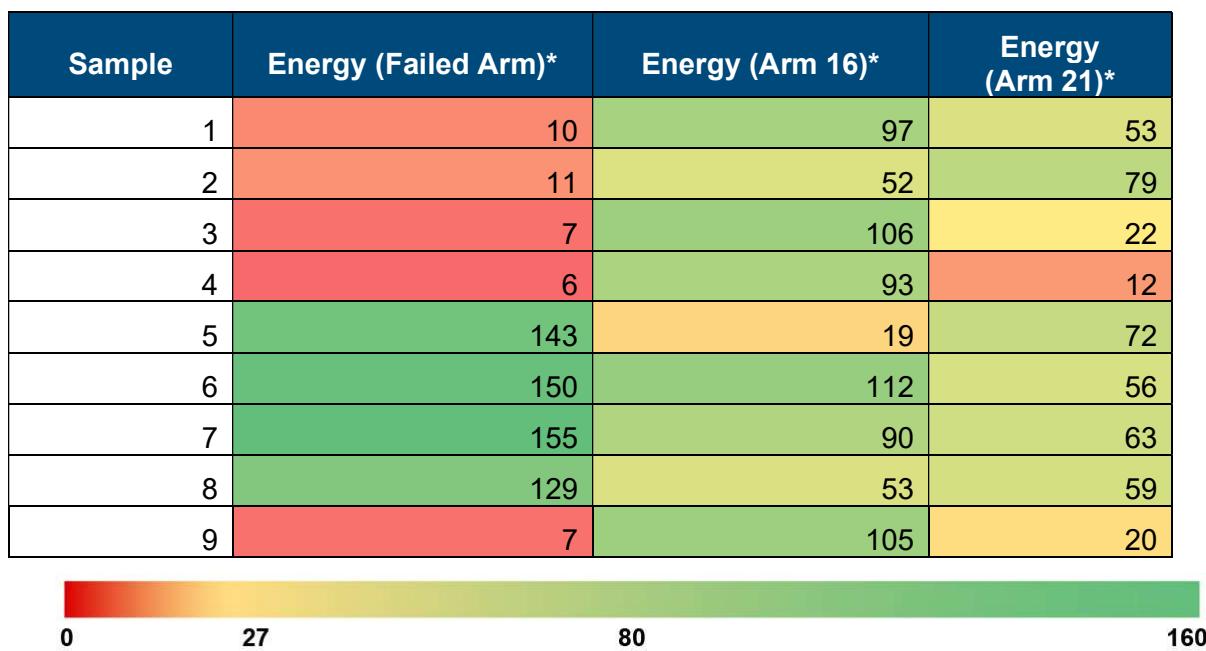
Table 1 - Charpy V-Notch Impact Test Results from Bent areas of Hanger Arm.

the manufacturing process which had resulted in the metal on the inside of the failed bend becoming extremely brittle. Comparisons with other arms showed a general reduction of cold weather fracture toughness in that area, but not to the same extent as the failed arm. Reduction in cold weather fracture toughness also reduces the size of the crack necessary before final brittle fracture occurs (known as critical crack length). The table below provides a visual representation of the difference between the failed arm and others tested. Note that all tests were conducted at 10 deg C or above which is well above typical operating temperatures for the GEE Gondola. Tests at lower temperatures were not conducted since it was clear the material was already breaking in the lower shelf area of the Charpy curve for the material and was unlikely to drop further at lower temperatures.

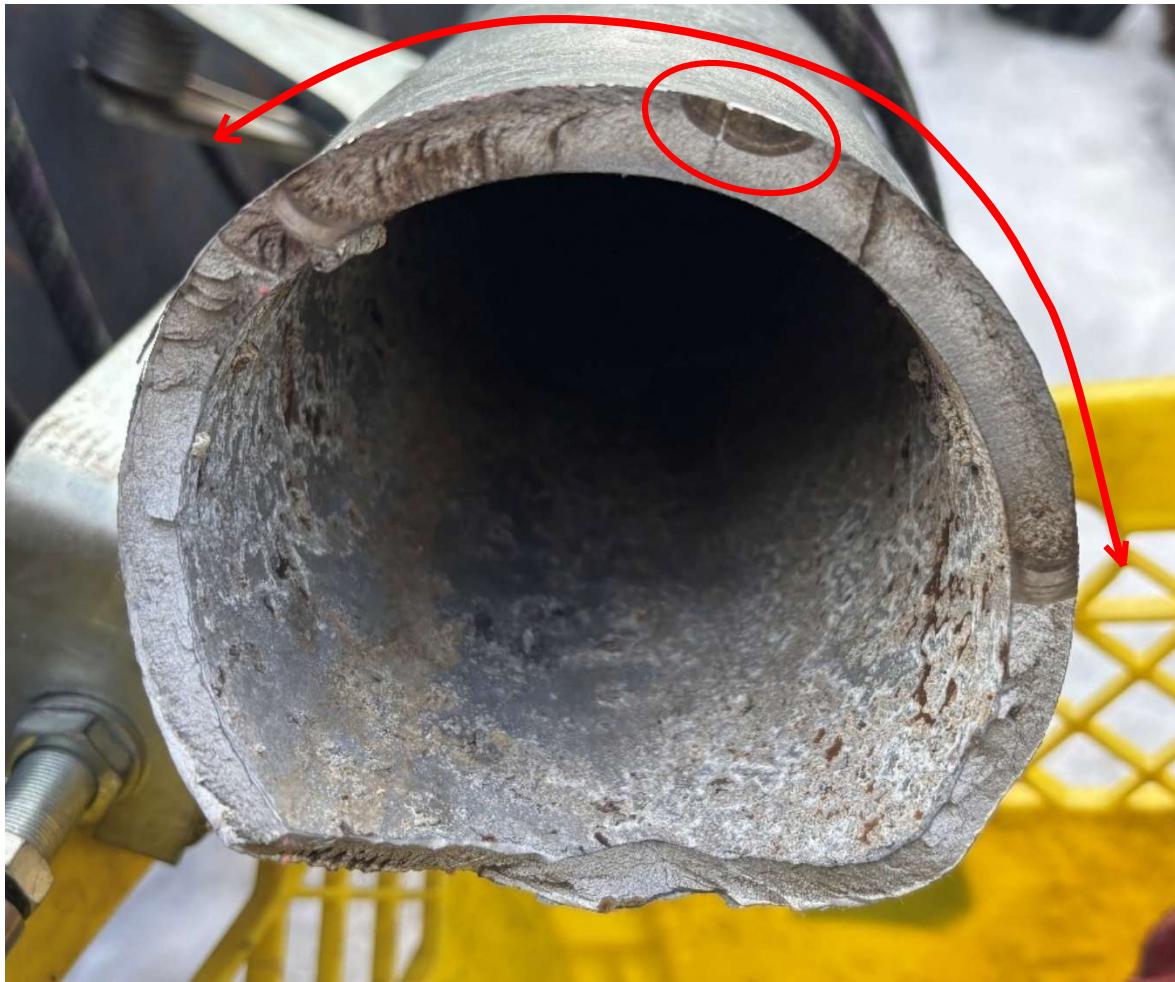
Examination of the fracture surface in the failed hanger arm identified a “thumbnail” shaped origin which had progressed in several phases. It began with two separate brittle progressions, followed by alternating fatigue, and brittle progression. Acuren’s analysis determined that the crack likely progressed through a combination of the initial residual stress and materials properties, combined short term, high magnitude forces (such as the impact between the hanger arm gusset and station structure). The critical size of the thumbnail prior to the first large brittle fracture event was approximately 18 mm.

Figure 7 - Overview of the fracture face. Circle – “thumbnail” initiation site. Arrow – Approximate length of the crack present during operation leading up to the incident. Note the colour differences from corrosion products between the “thumbnail”, the first large progression (noted by the arrow), and the bright silver of the fresh fracture face.

Similarly, the area between the thumbnail, and additional fatigue cracking located in the weld metal heat affected zone (see arrow in Figure 7) displayed a rust discolouration indicating it had also been open to atmosphere for some time, albeit less than the thumbnail area.

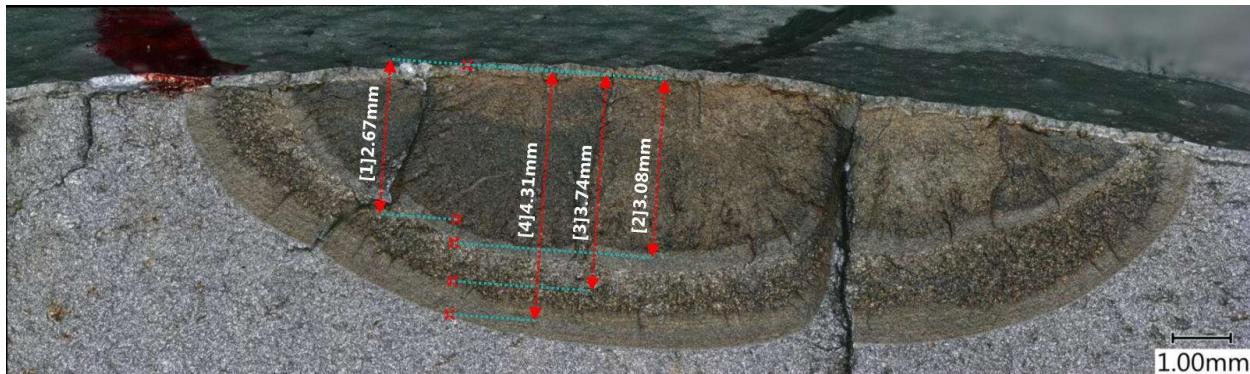
Figure 8 - Keyence Microscope image of the initiation site showing the areas of progression (Acuren Inc.) The initial brittle progressions were small and were followed by long term, high cycle fatigue that progressed over thousands of cycles.

Acuren's report concludes that corrosion products and zinc oxide on the surface of the "thumbnail" initiation site provided evidence that the crack had been open to atmosphere (i.e. exposed), likely through several seasons.

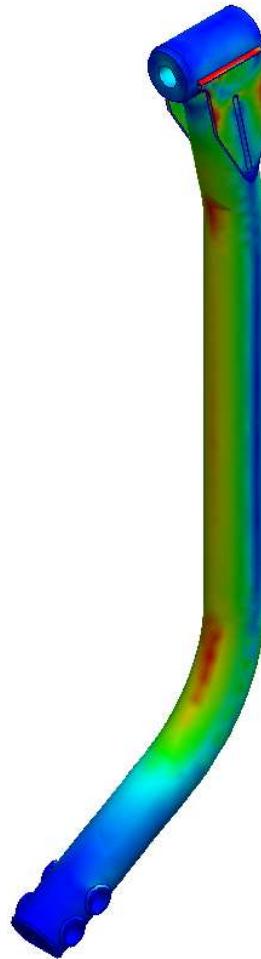
Figure 9 - Heat map showing relative stress concentrations in the hanger arm during static loading. The intrados of the bend experiences elevated stress levels.

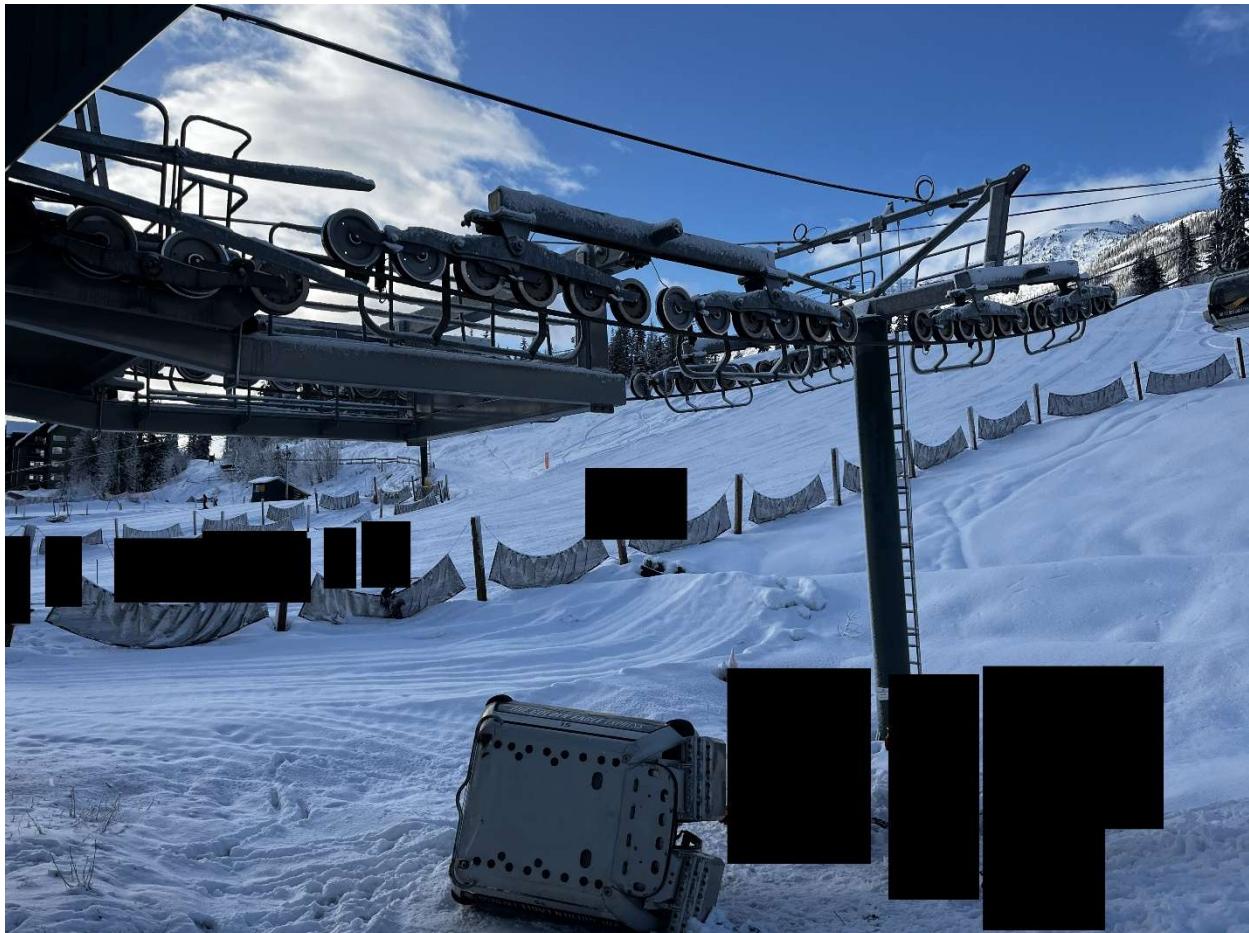
On March 10, 2025, just before 9:30 am, a hanger arm from the Golden Eagle Express (GEE) Gondola broke just after it left the bottom station at the Kicking Horse Mountain Resort (KHMR) (Images 1 and 2). The gondola cabin fell to the ground from a height of approximately 1 to 1.5 m and the gondola was stopped by operations staff. The eight passengers inside were able to exit the cabin and were attended to by local ski patrol with only minor injuries reported.

Image 1 – Aftermath of the gondola cabin falling (Photograph Provided by Resorts of the Canadian Rockies)

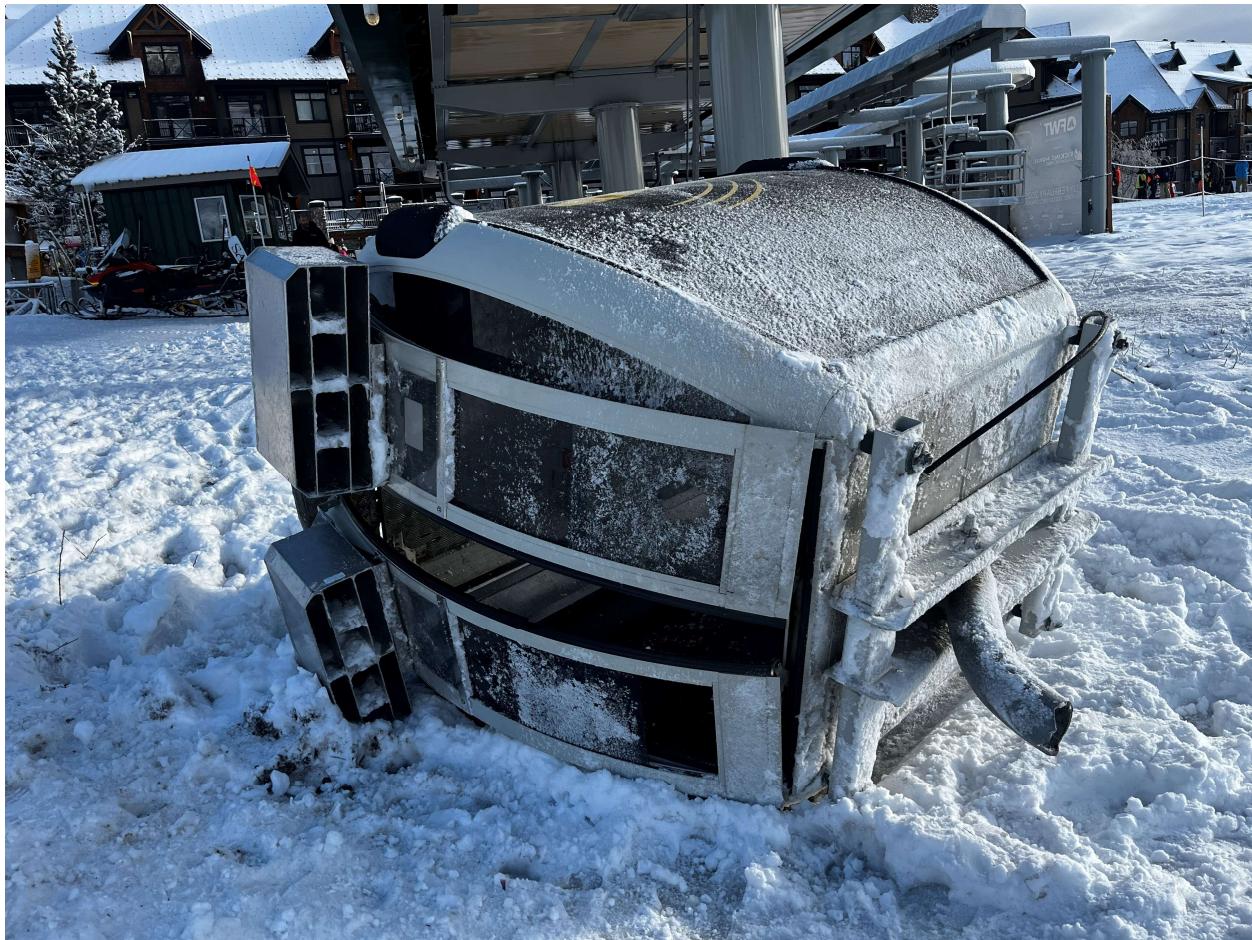
Image 2 – The fallen gondola cabin after evacuation (Photograph provided by Resorts of the Canadian Rockies)

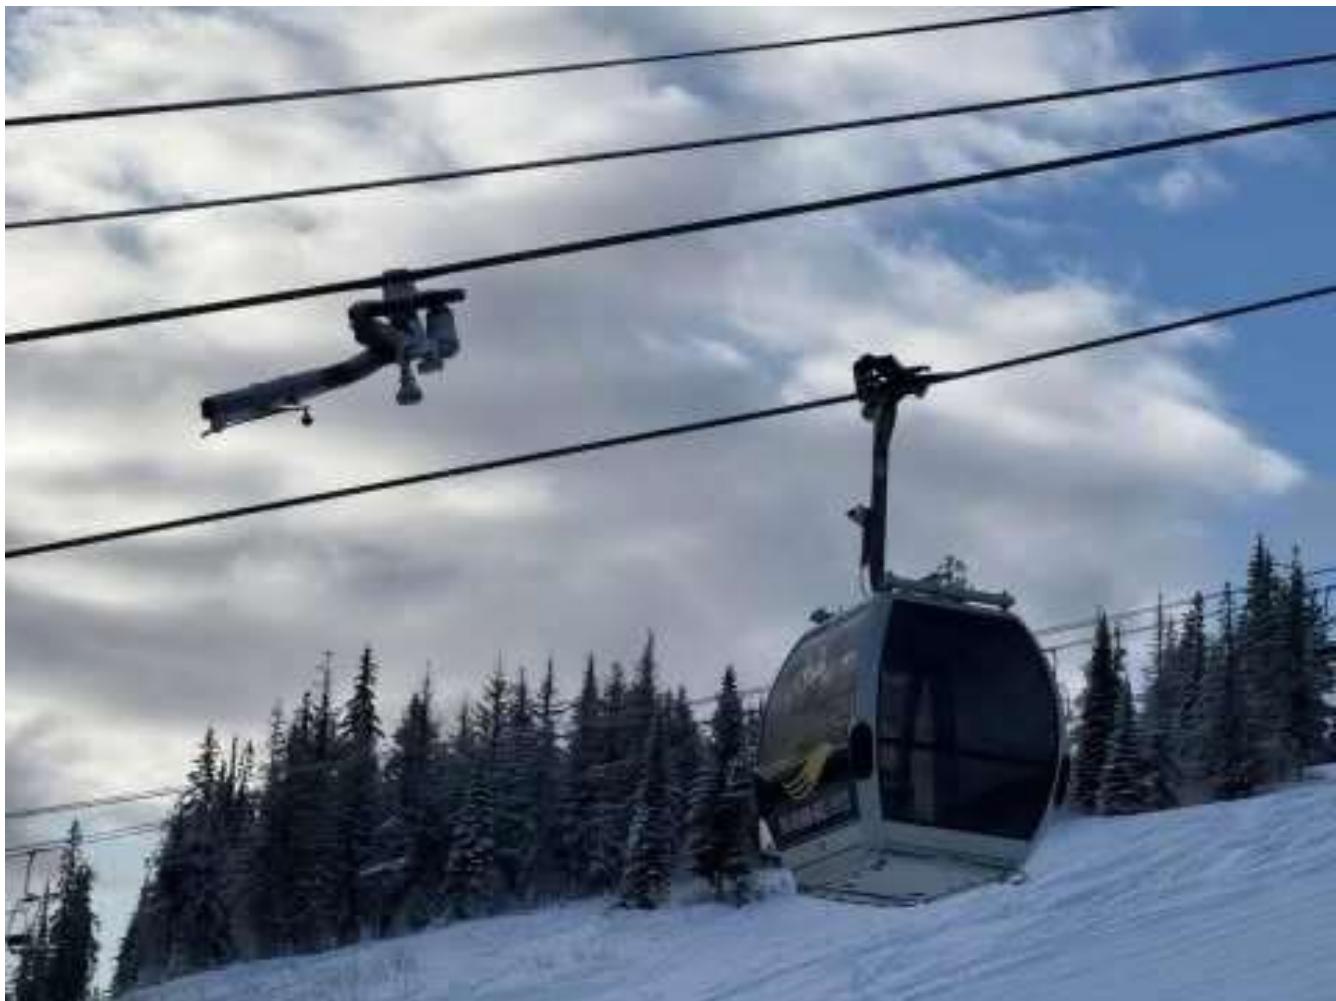
Image 3 - The remaining portion of the hanger arm and grip still connected to the lift line after the incident (Photograph provided by Resorts of the Canadian Rockies)

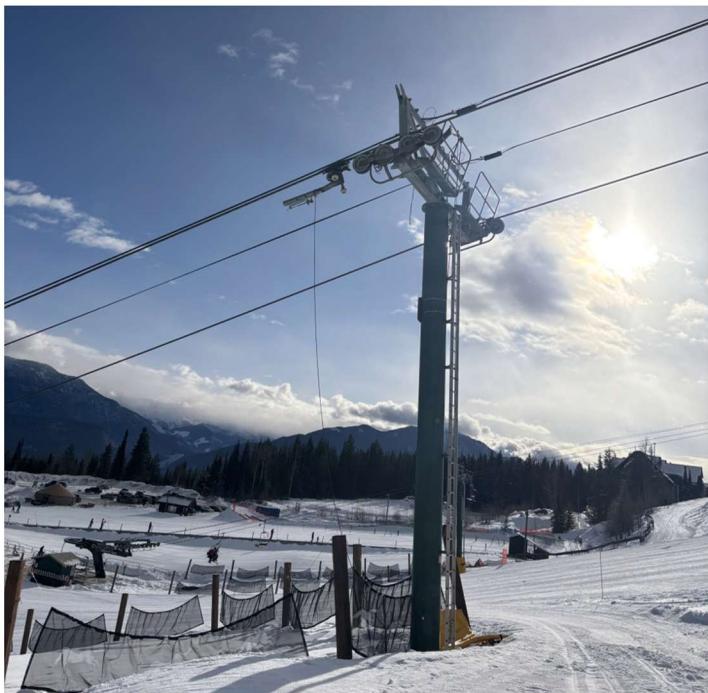
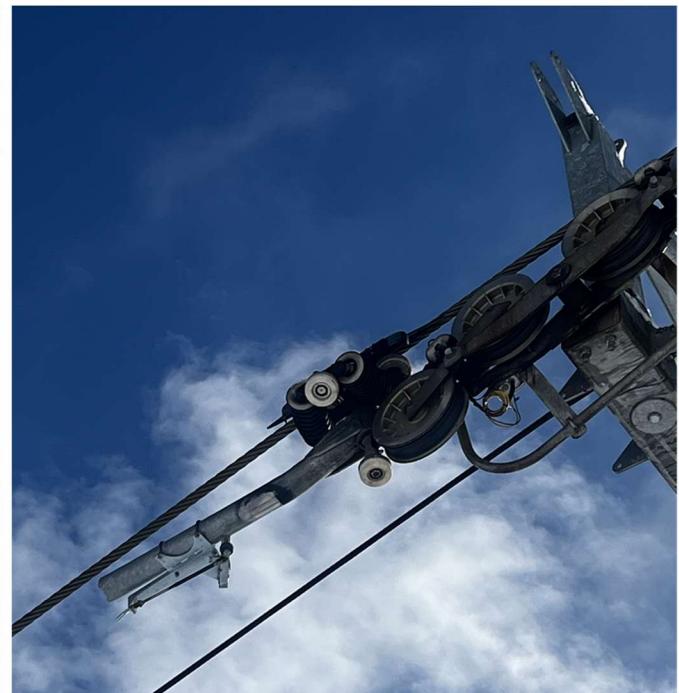
Image 4 – The remaining portion of the hanger arm lodged in the sheaves of tower 1, resulting in the need for a manual evacuation.

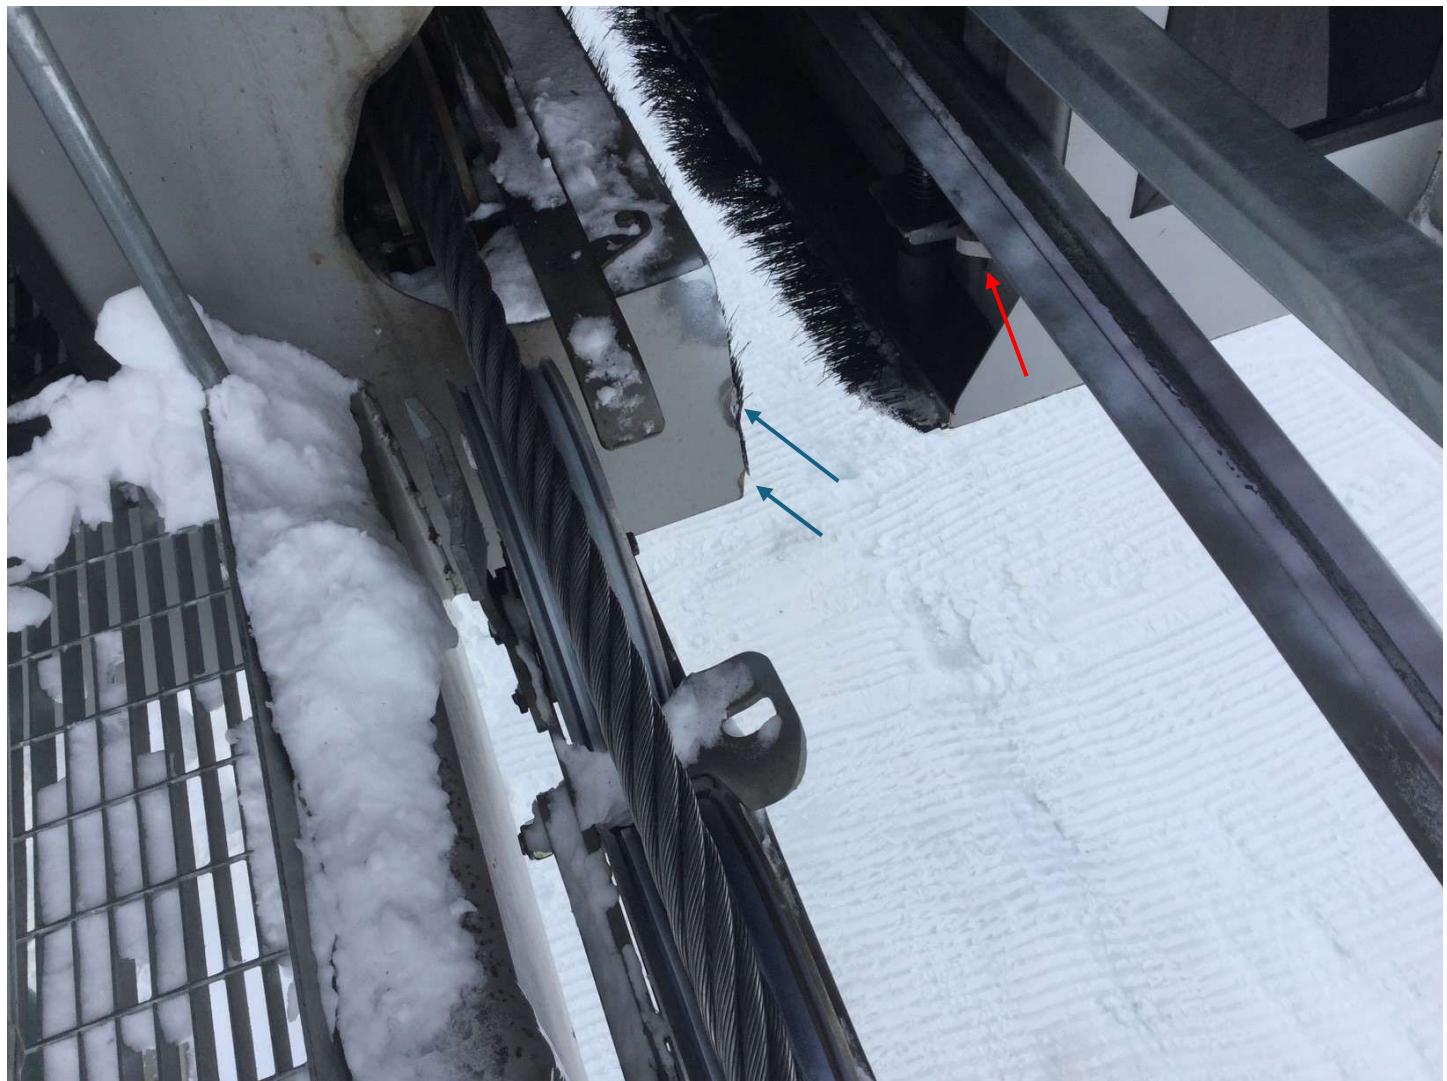
Image 11 – Photograph taken by a Safety Officer in 2017 showing the missing rubber bumper dampers on the guide rails (red arrow). Impact marks to the station rail can also be seen (blue arrows).

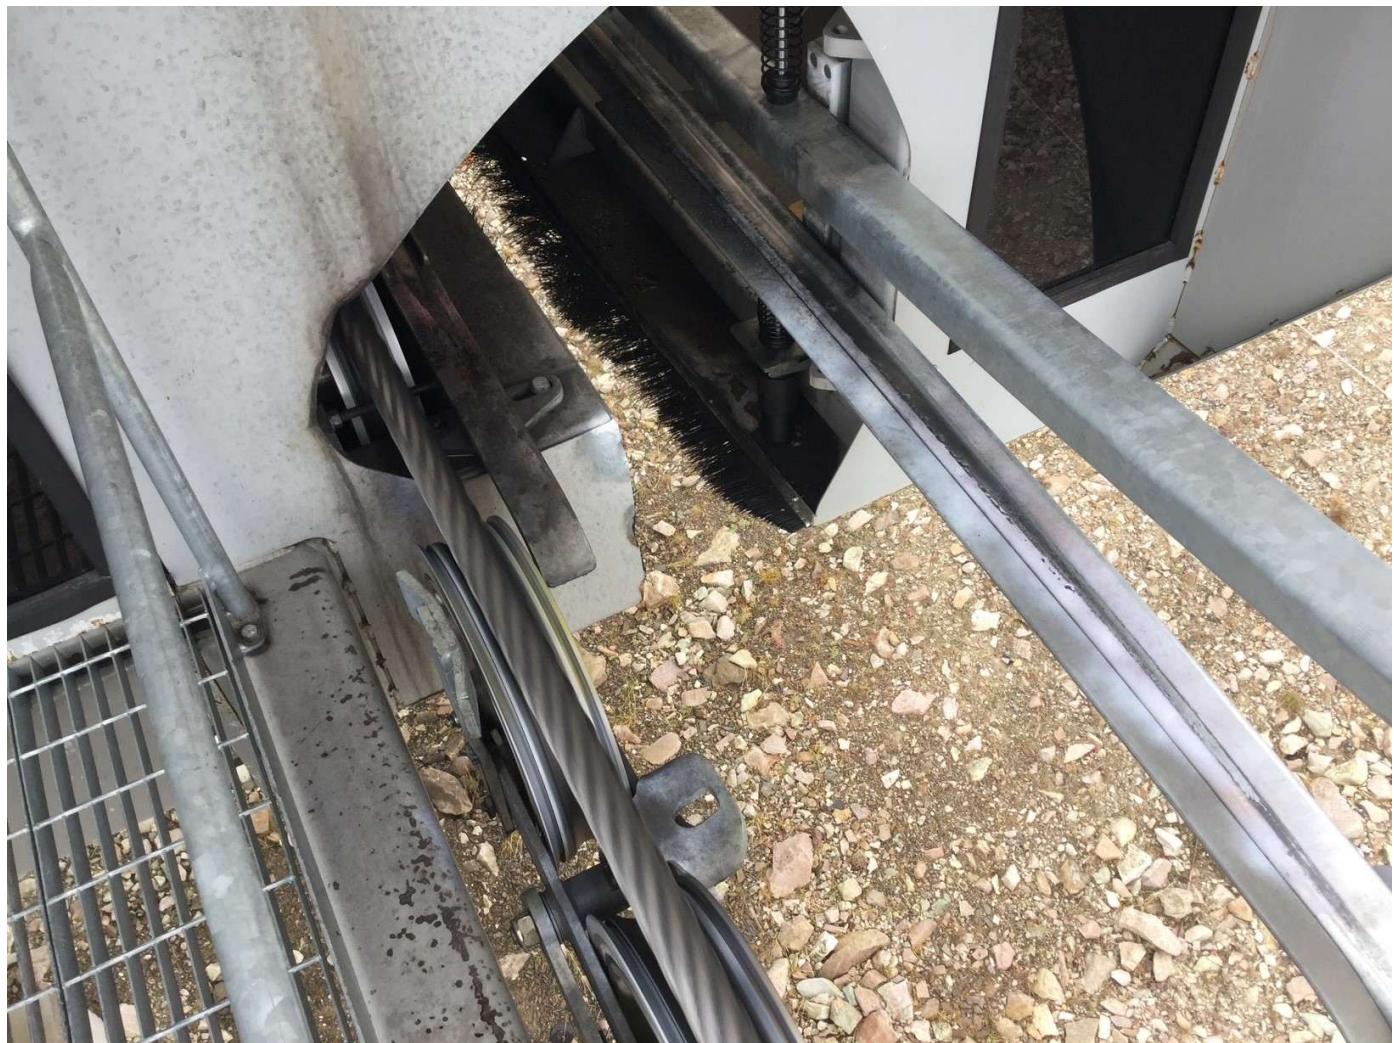
Image 12 – A similar photograph taken by a Safety Officer in 2018, approximately 1 year later. The rubber bumpers are still missing.

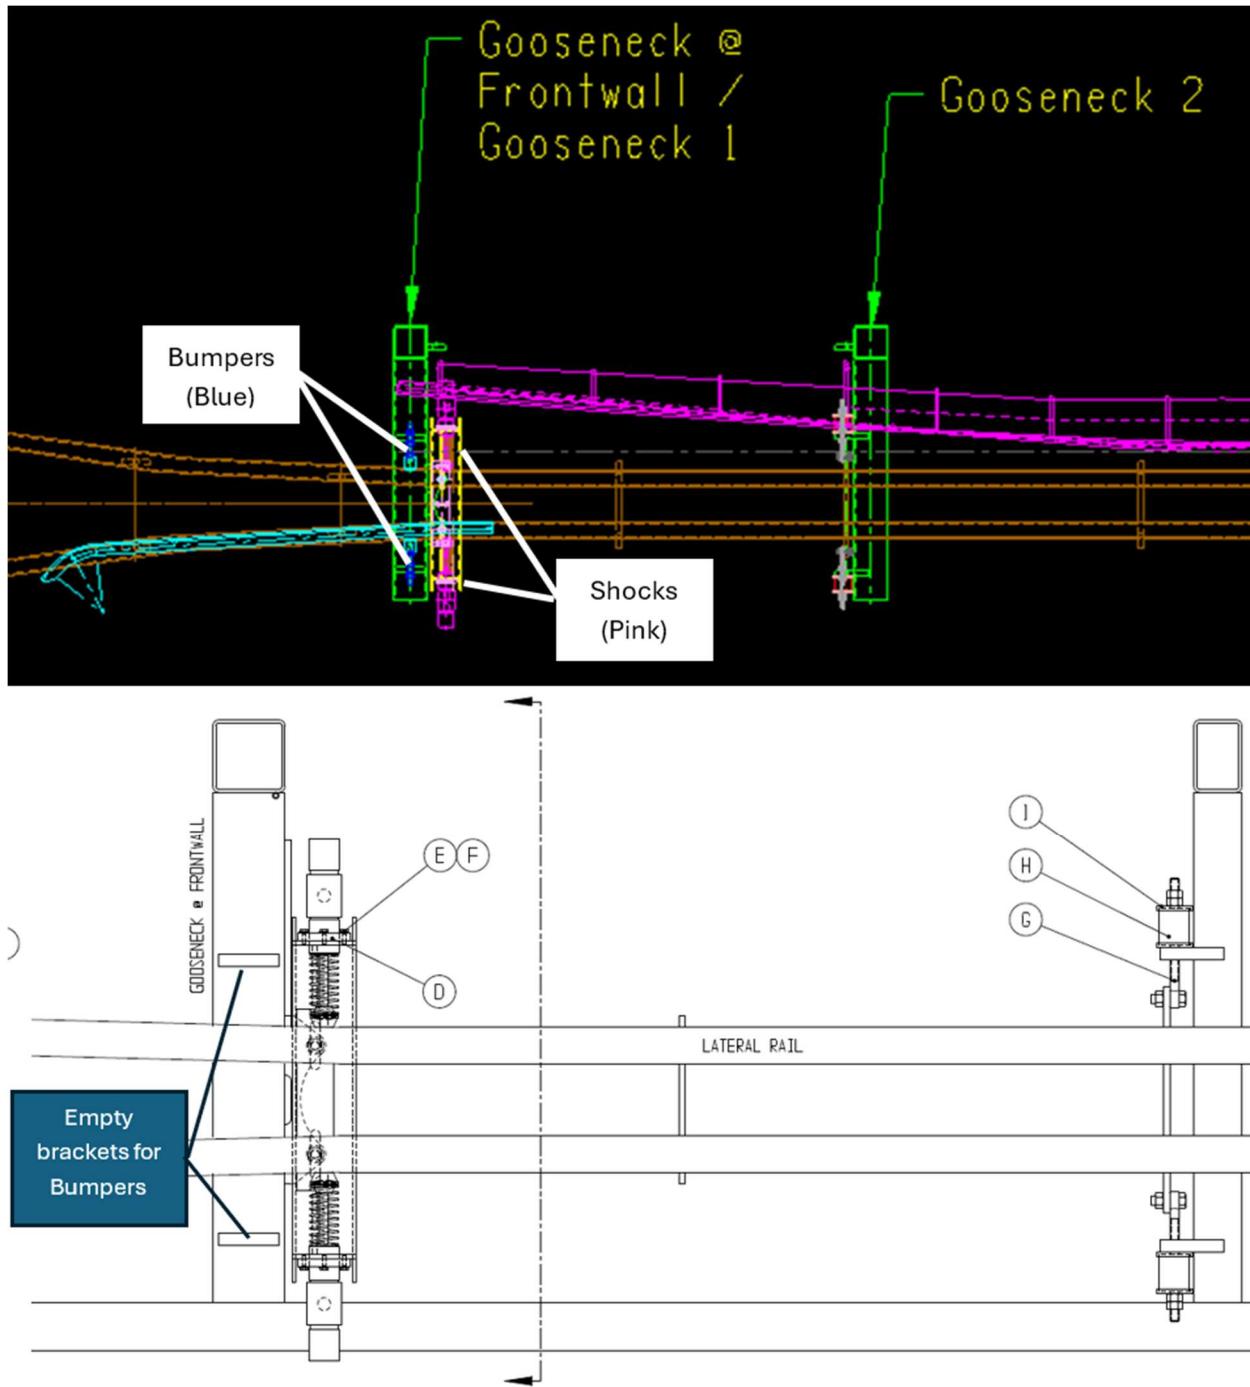
Image 13 - Manufacturer diagrams showing discrepancy in guide rail supports.

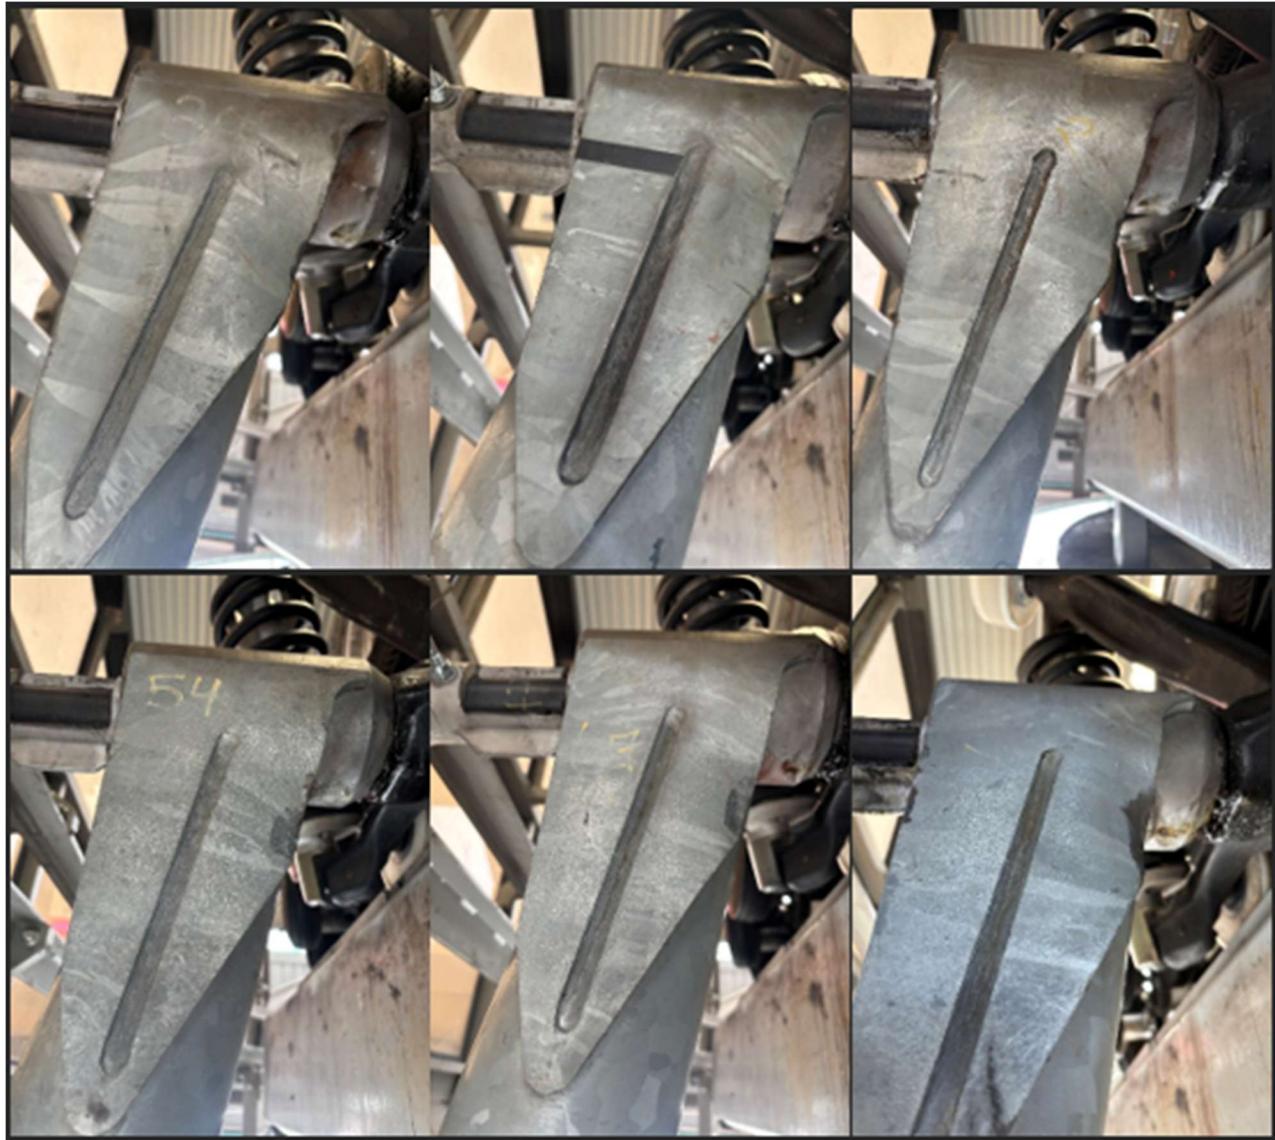
Following the incident, all hanger arms at KHMR were inspected by KHMR staff. Observations were documented and are shown in Appendix L. Approximately 60% of the arms had damage to the gusset at the top of the arm where they had struck the station during operation (image 14). The extent of damage varied from small scuffs to 27 mm (~1 inch) of gusset deflection. For reference, the gusset of hanger arm 15 (the failed arm) was deflected approximately 18 mm (~ $\frac{3}{4}$ inch) (Image 15).

Image 14 – A compilation of severely bent gussets on various GEE gondola hanger arms taken during investigation after the incident.

Assessing and removing affected carriers from service following impacts or similar severe loading events until non-destructive testing of all critical components is completed is an important measure to ensure ongoing reliability of the components. This is especially important for components that may have reduced capability of withstanding these types of unexpected events as a result of low material toughness characteristics.

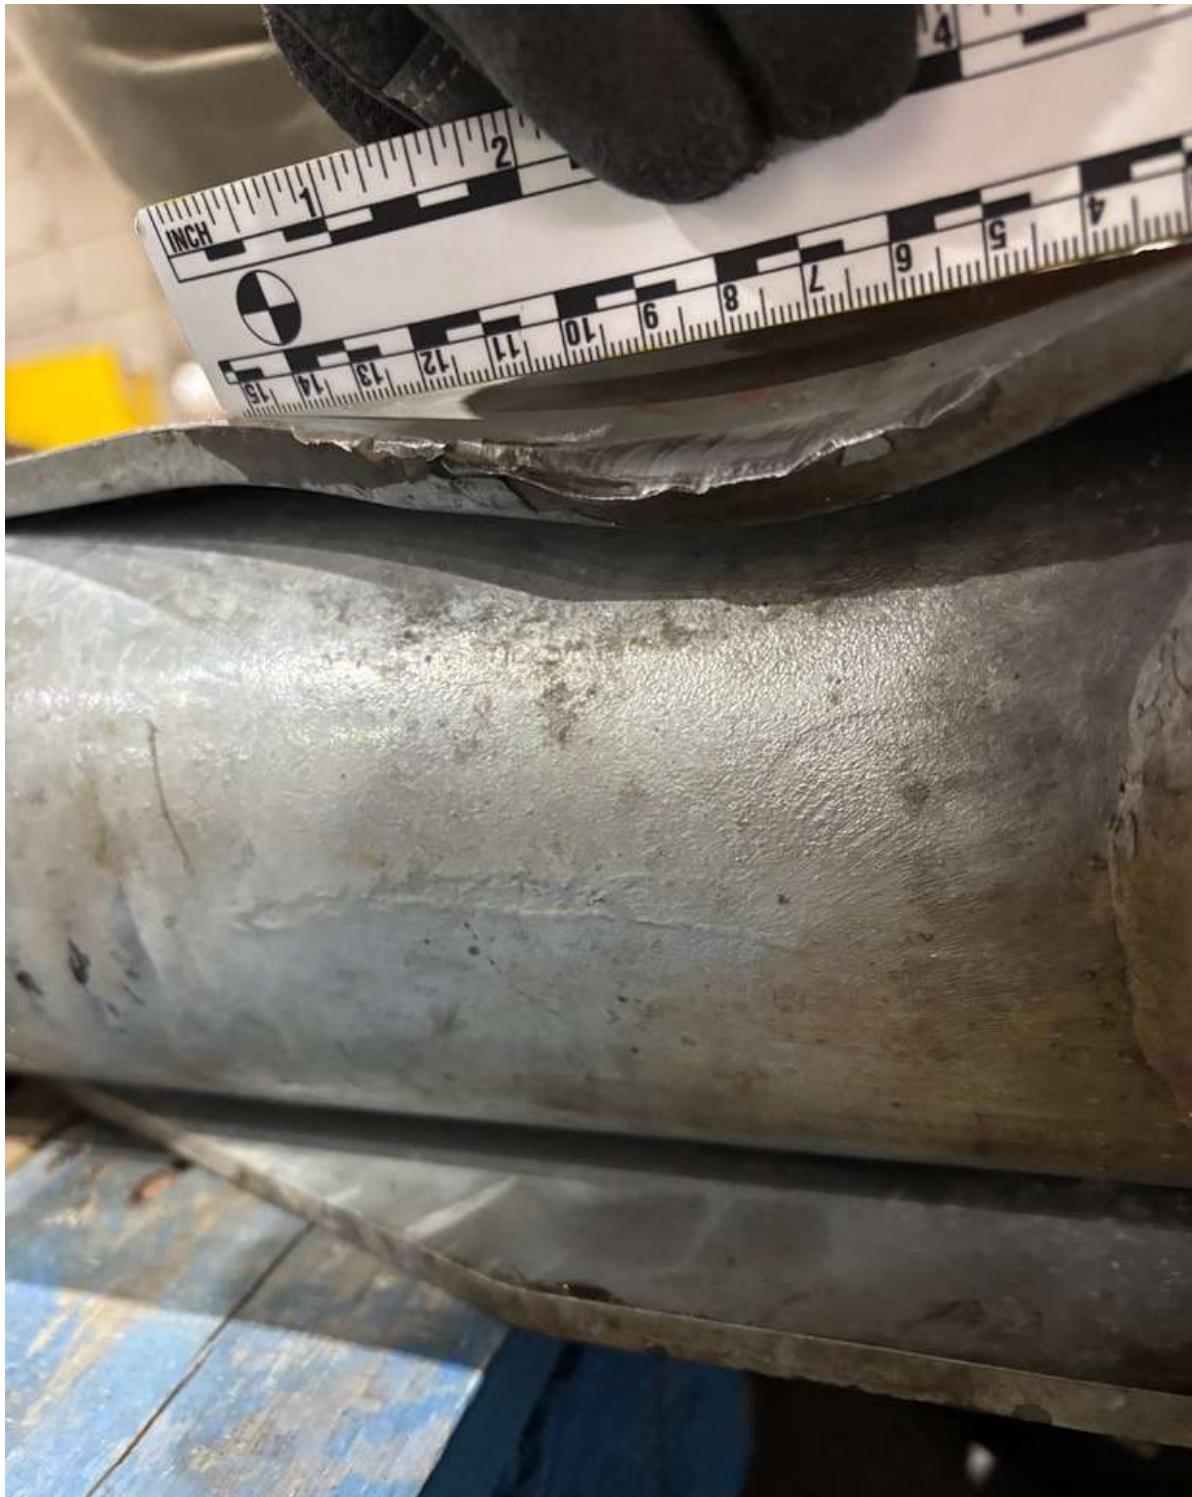
During operation, a large dent to the failed hanger arm gusset suggests it was subject to one or more large impacts with the station structure during operation. It is likely these major impacts played a critical role in the propagation of the crack. Station setup, including support of the guide (lateral) rails used to align the gondola cabins as they enter the station, contributed to the repeated impacts between cabins and the station's structural rail. Station impacts were a common occurrence on the GEE Gondola with nearly 60% of the arms having experienced an impact through the lifespan.

The failed hanger arm had evidence of multiple impacts to the top of the hanger arm on the reinforcing gusset. Fracture analysis indicated that the early brittle progressions of the crack were likely the result of a temporary, high force event such as one of these impacts.

Image 15 - A close up the deformation and damage to the gusset on the failed hanger arm for cabin 15.

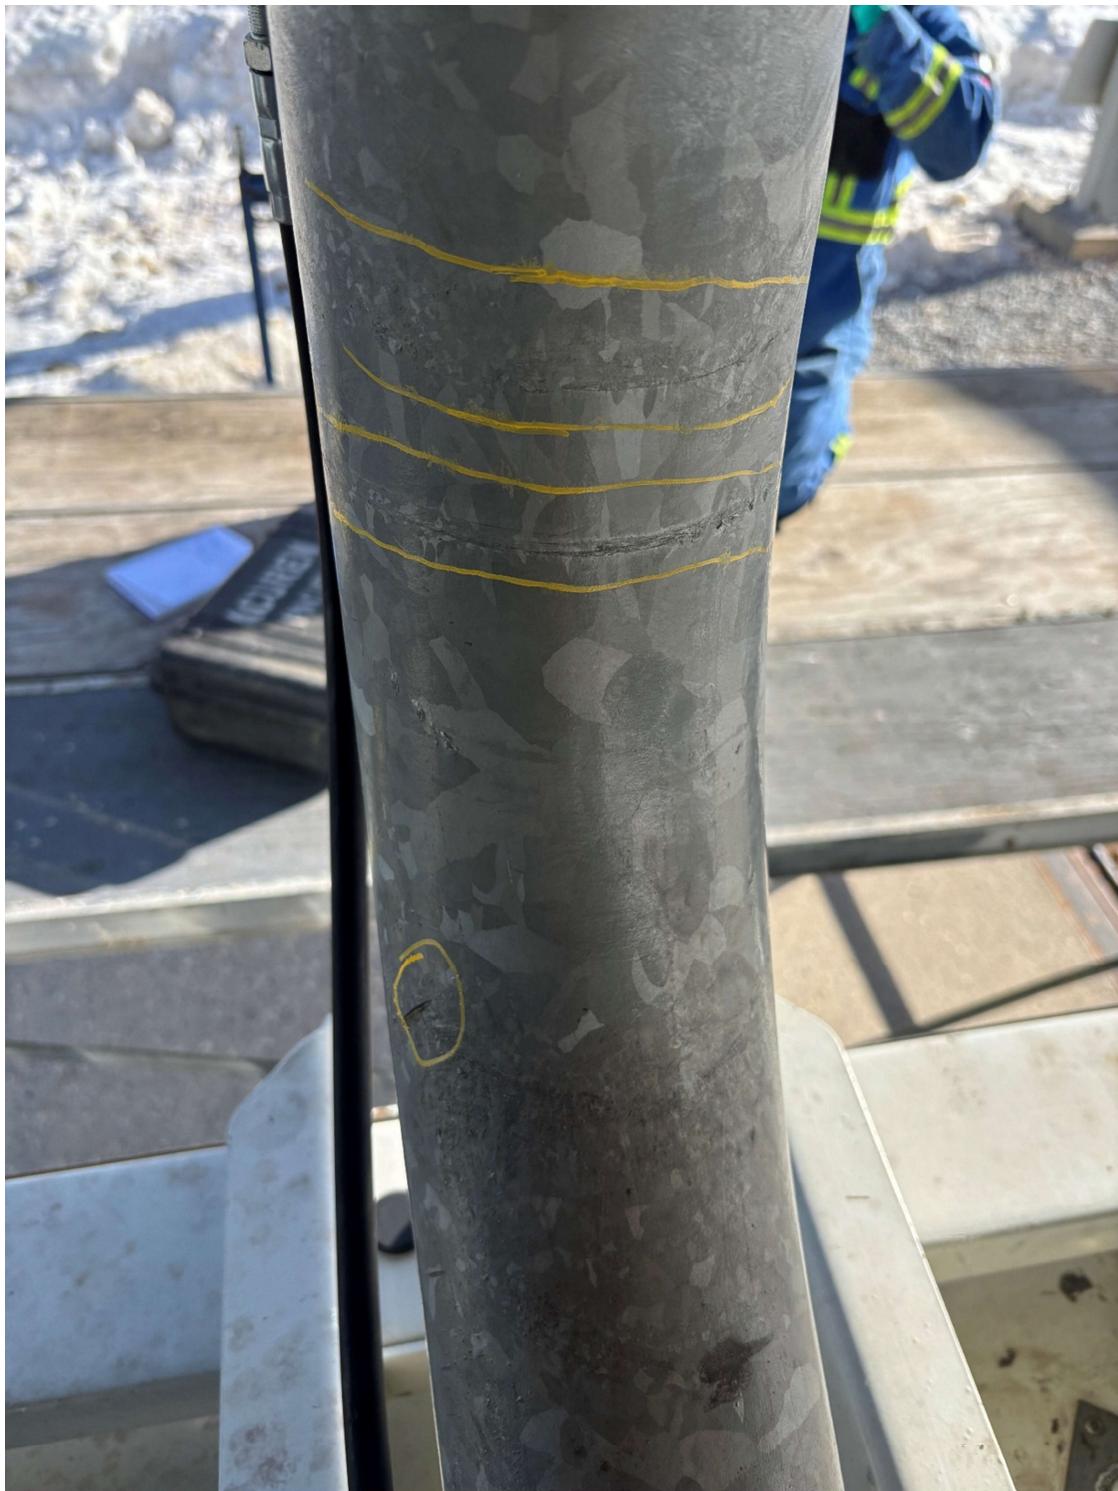
Technical Safety BC also inspected the arms while on site with Acuren NDT technicians. In addition to the gusset damage, irregularities and lines in the galvanizing were also noted on many arms (Images 16 and 17). The types of irregularities identified (including wrinkles, horizontal lines in the spangling, scratches, and dings) could contribute to making it more difficult to recognize a crack during visual inspections or even some NDT inspections.

Image 16 – A view of a hanger arm during inspection. Irregularities in the surface including lines, marks, and scrapes are highlighted.

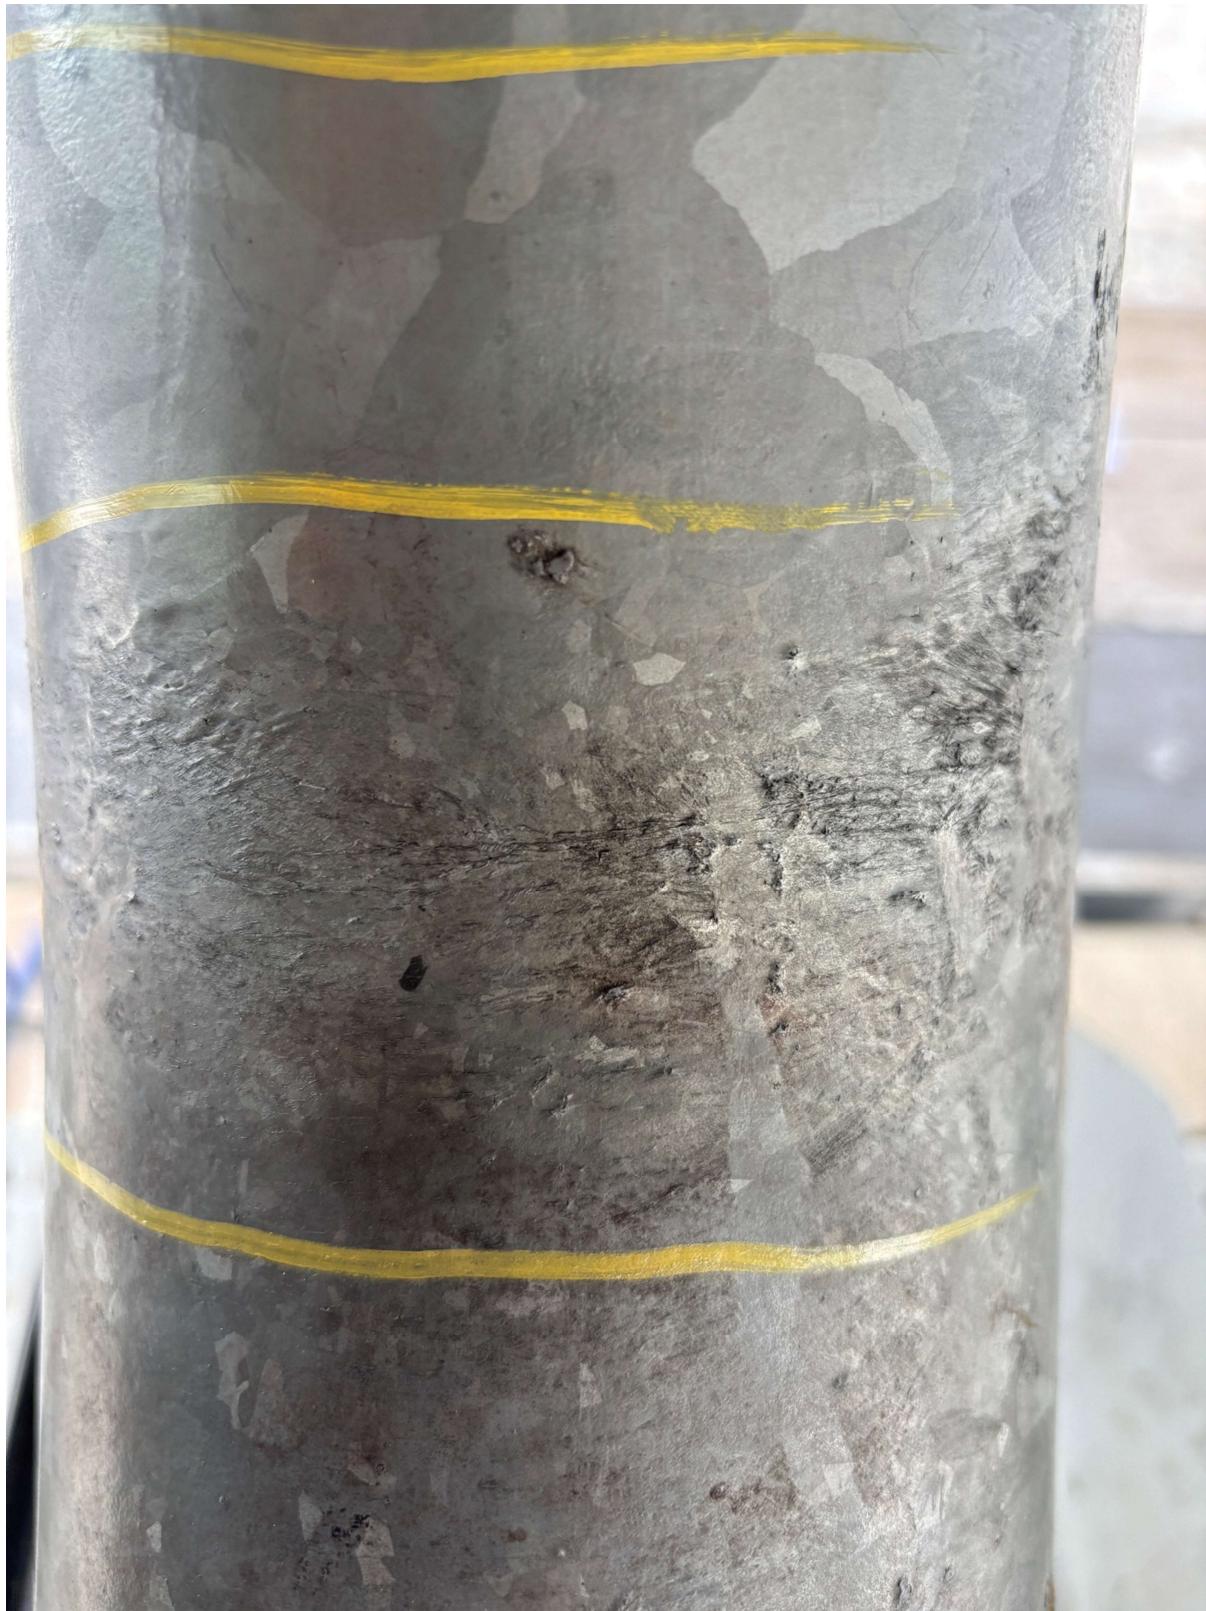
Image 17 – A close up of wrinkling and horizontal lines on another hanger arm during post-incident testing.
