Incident Investigation Report

Kicking Horse Gondola

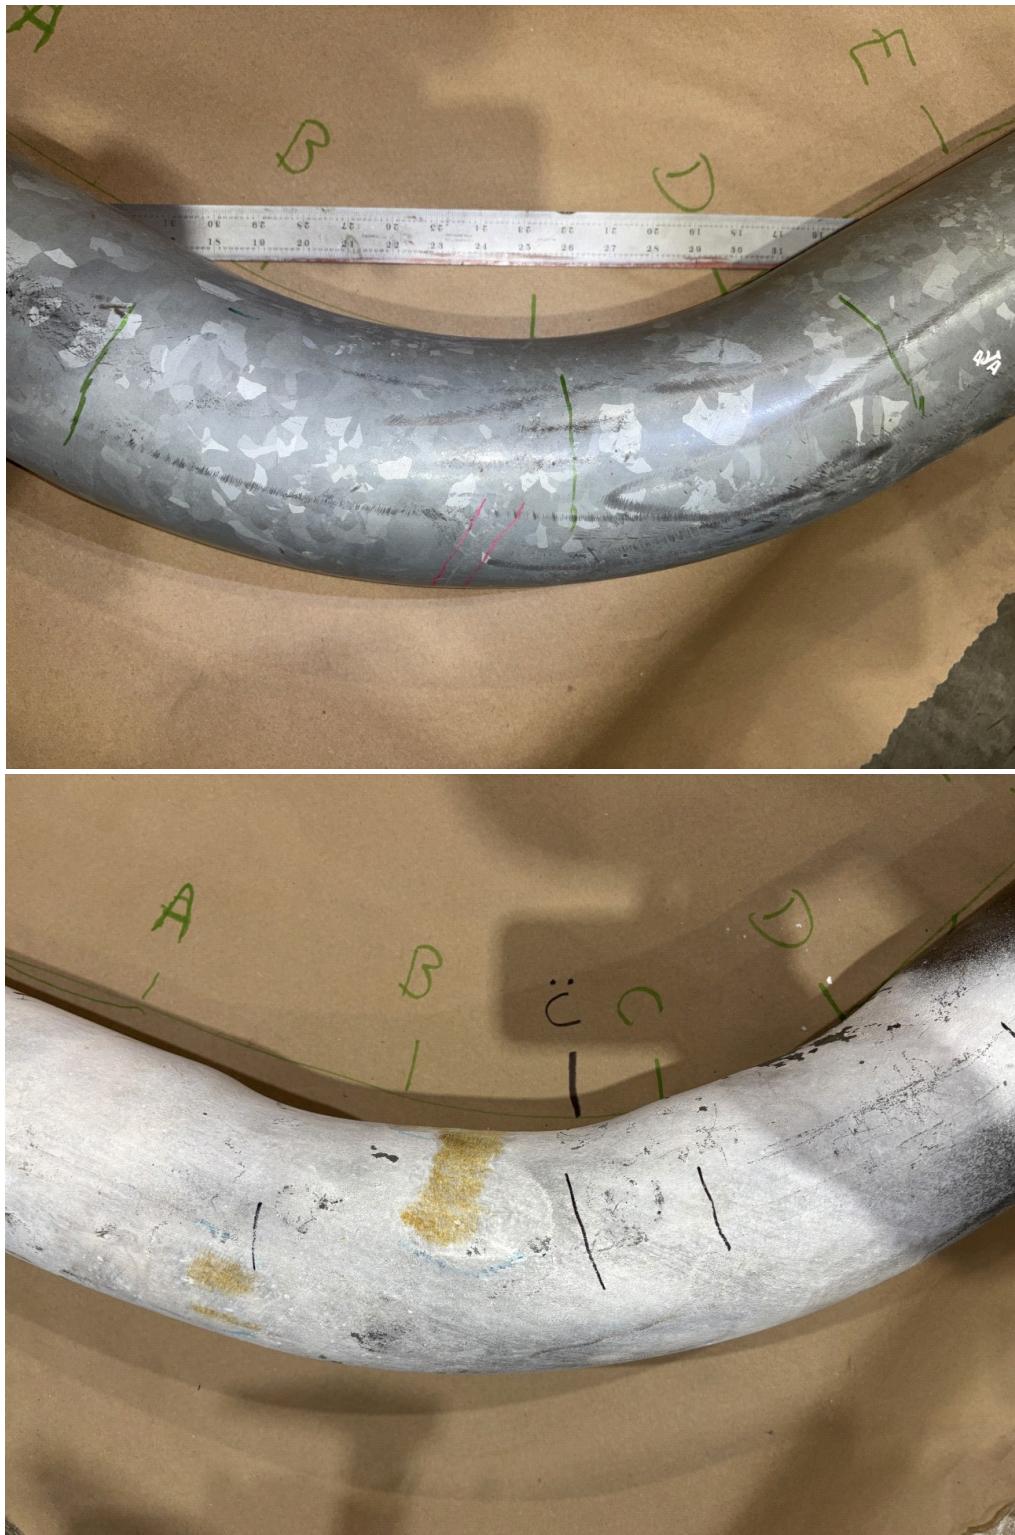
Inspection of these arms did not identify any cracks (aside from the failure in hanger arm 15). However, there were significant differences in bend characteristics in the arms (Image 20). Certain bends were found to have visual deformities in the bends with bulges and narrowing. In addition, measurements of ovality found significant differences between the x and y dimensions of up to 12 mm (0.5 inches). Finally, the seam location for the pipe varied between hanger arms and was not controlled in the manufacturing process. Using clock positions as directional indicators, the original drawing for the hanger arms specifies that the seam be located at the intrados of the bend in the 12 o'clock position. The seam for arm 47 was located at the 12 o'clock position, but the other arms had varying seam locations, including the 3, 5, 7, and 8 o'clock positions.

Image 19 – Comparison of the variation of smoothness of the interior bend geometries between two arms from the GEE Gondola.

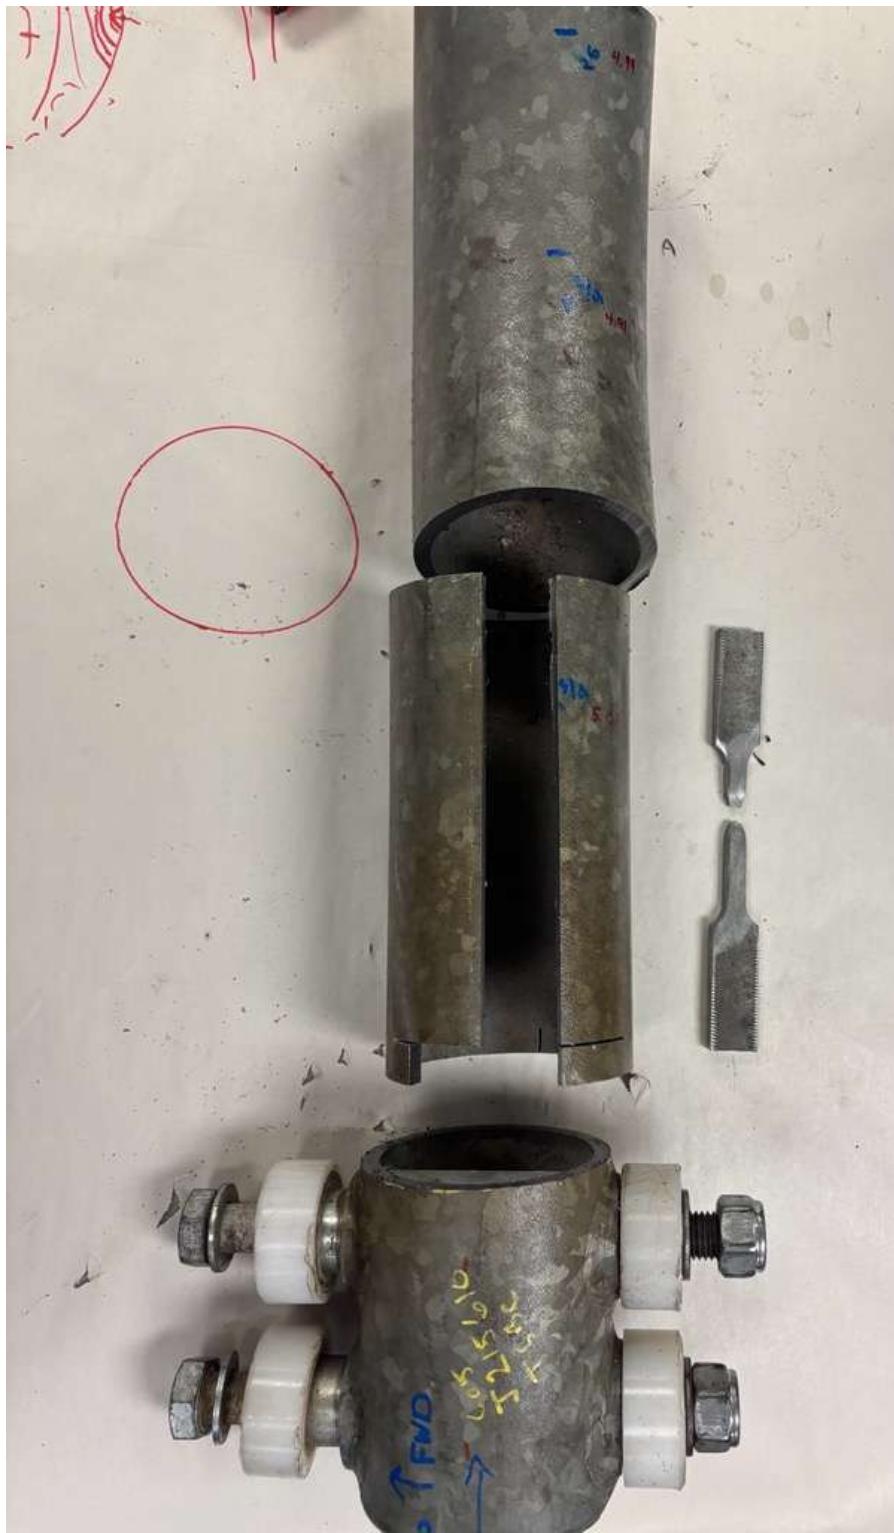
Image 20 – The bottom portion of the failed arm after being sectioned for various tests including metal chemistry, tensile tests, and fracture analysis.

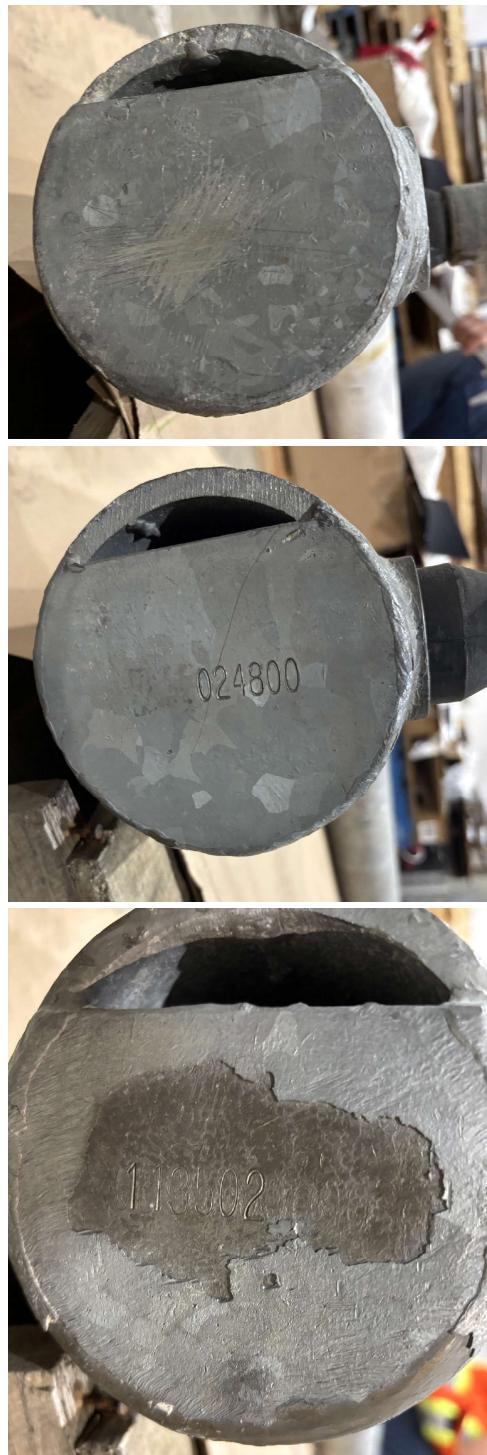
The serial numbers for each arm were also documented. One arm was missing a serial number, while others had very different serial numbers, both on top and under the galvanizing (image 21), indicating it is likely they came from different batches of steel.

Image 21 – Three arms from the GEE gondola. One with no serial number. One with the serial number stamped on top of the galvanizing. One with the serial number stamped beneath the galvanizing. The arms with numbers were not close to being sequential.
