## Incident Summary #II-1872877-2025 (#56576) (FINAL)

| SUPPORTING INFORMATION | Incident Date | February 24, 2025 |
| | Location | Castlegar, BC |
| | Regulated industry sector | Gas - Natural gas system |

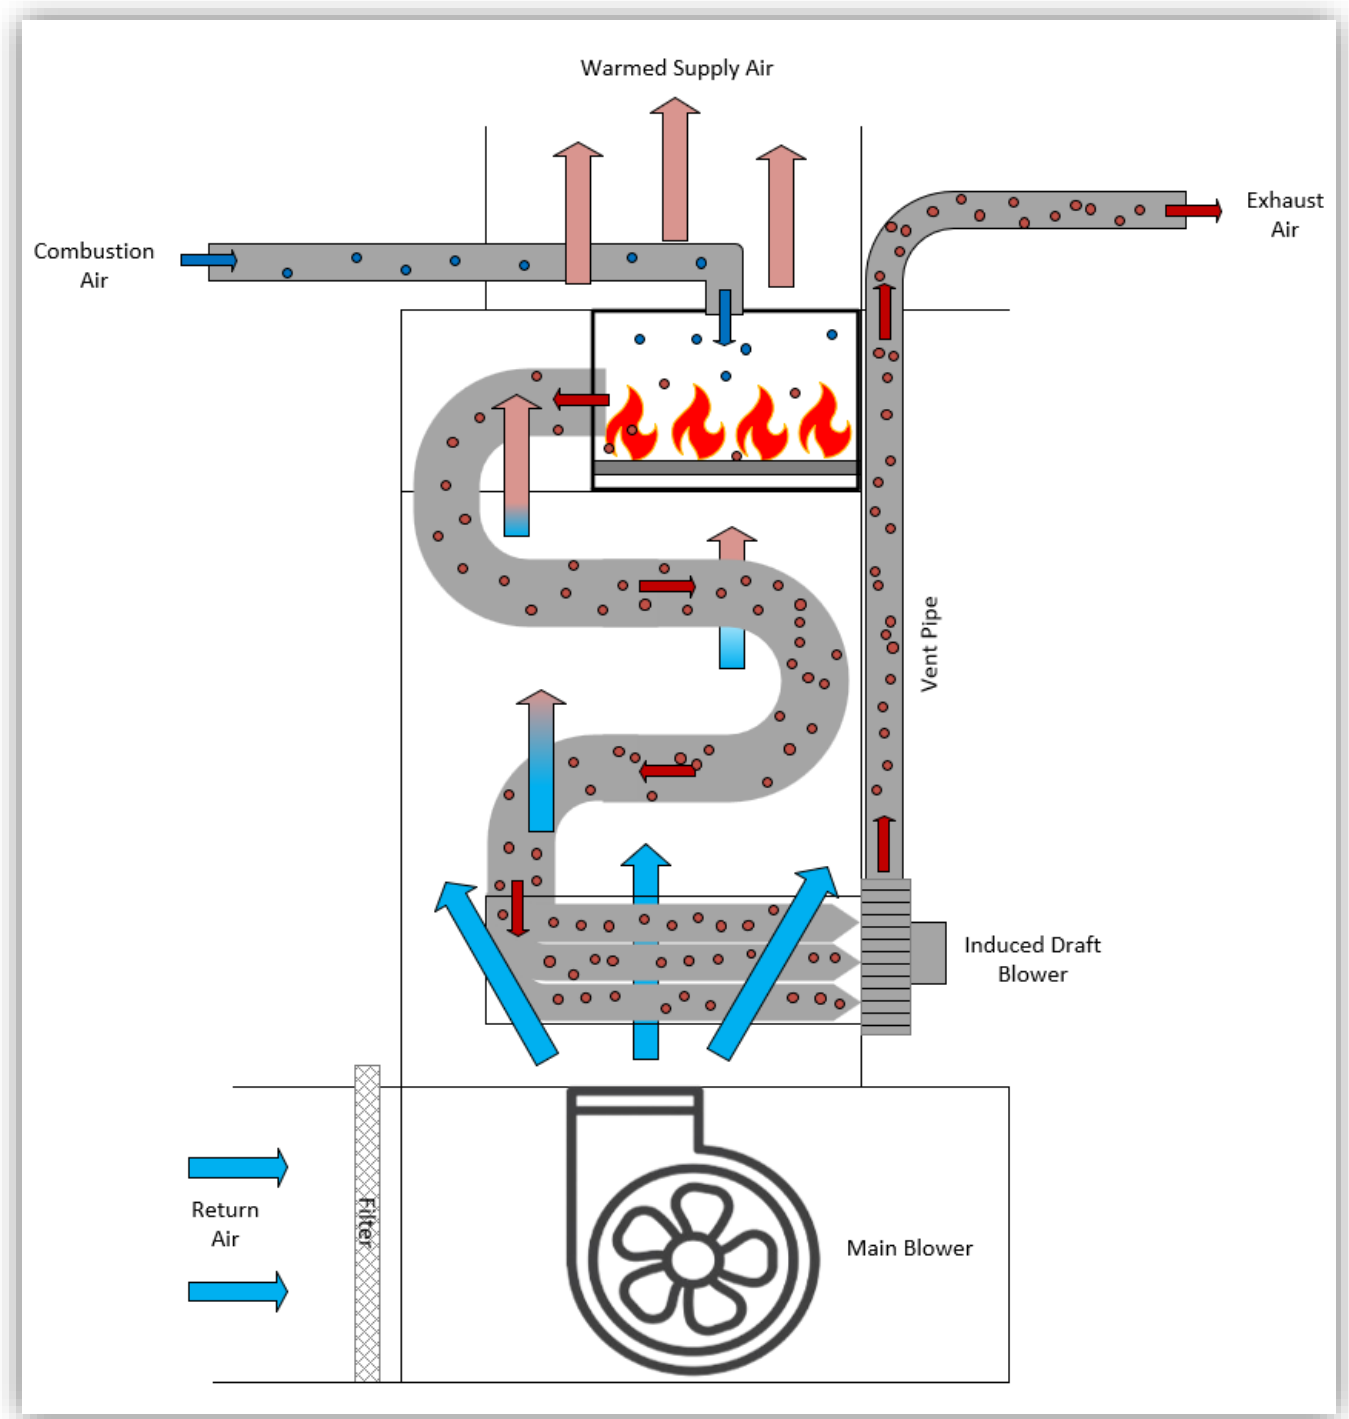
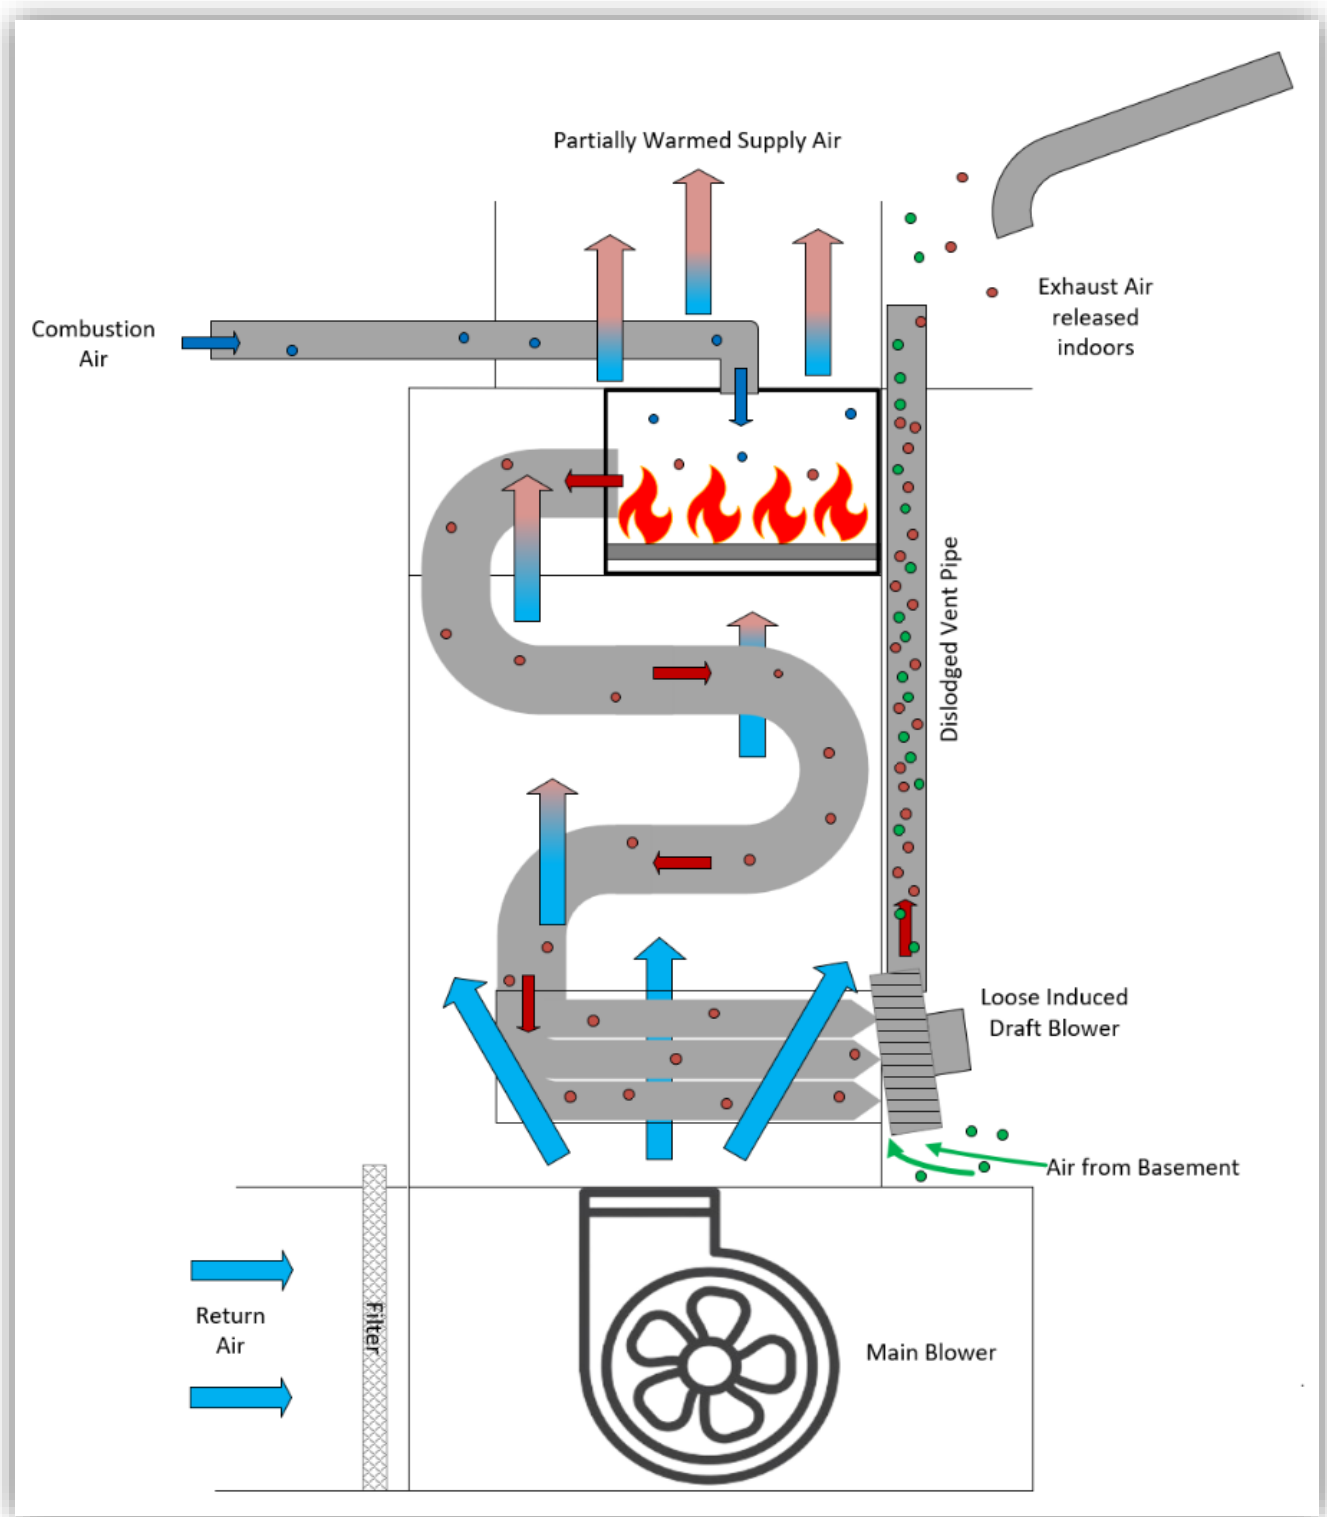
At some point, the bolts holding the inducer fan to the furnace were loosened breaking the seal between the inducer fan and the furnace. This allowed the inducer fan to draw some air from the room instead of drawing it all through the burners. This small change would have two significant impacts on the operation of the furnace:

1. As a portion of the air being pulled by the inducer fan now bypassed the burners, there was insufficient oxygen for combustion at the burners resulting in significantly elevated levels of CO in the flue gas (>400 ppm).
2. The cool air flowing into the inducer fan could have cooled the gasses at the location of the high limit switch and satisfied the pressure sensing safeties resulting in continued operation of the furnace, when otherwise it would have likely shut itself off due to the activation of one or multiple safety mechanisms.

Image 2 – Diagram of typical furnace operation (top) and furnace operation with loose induced blower and detached vent pipe (bottom).

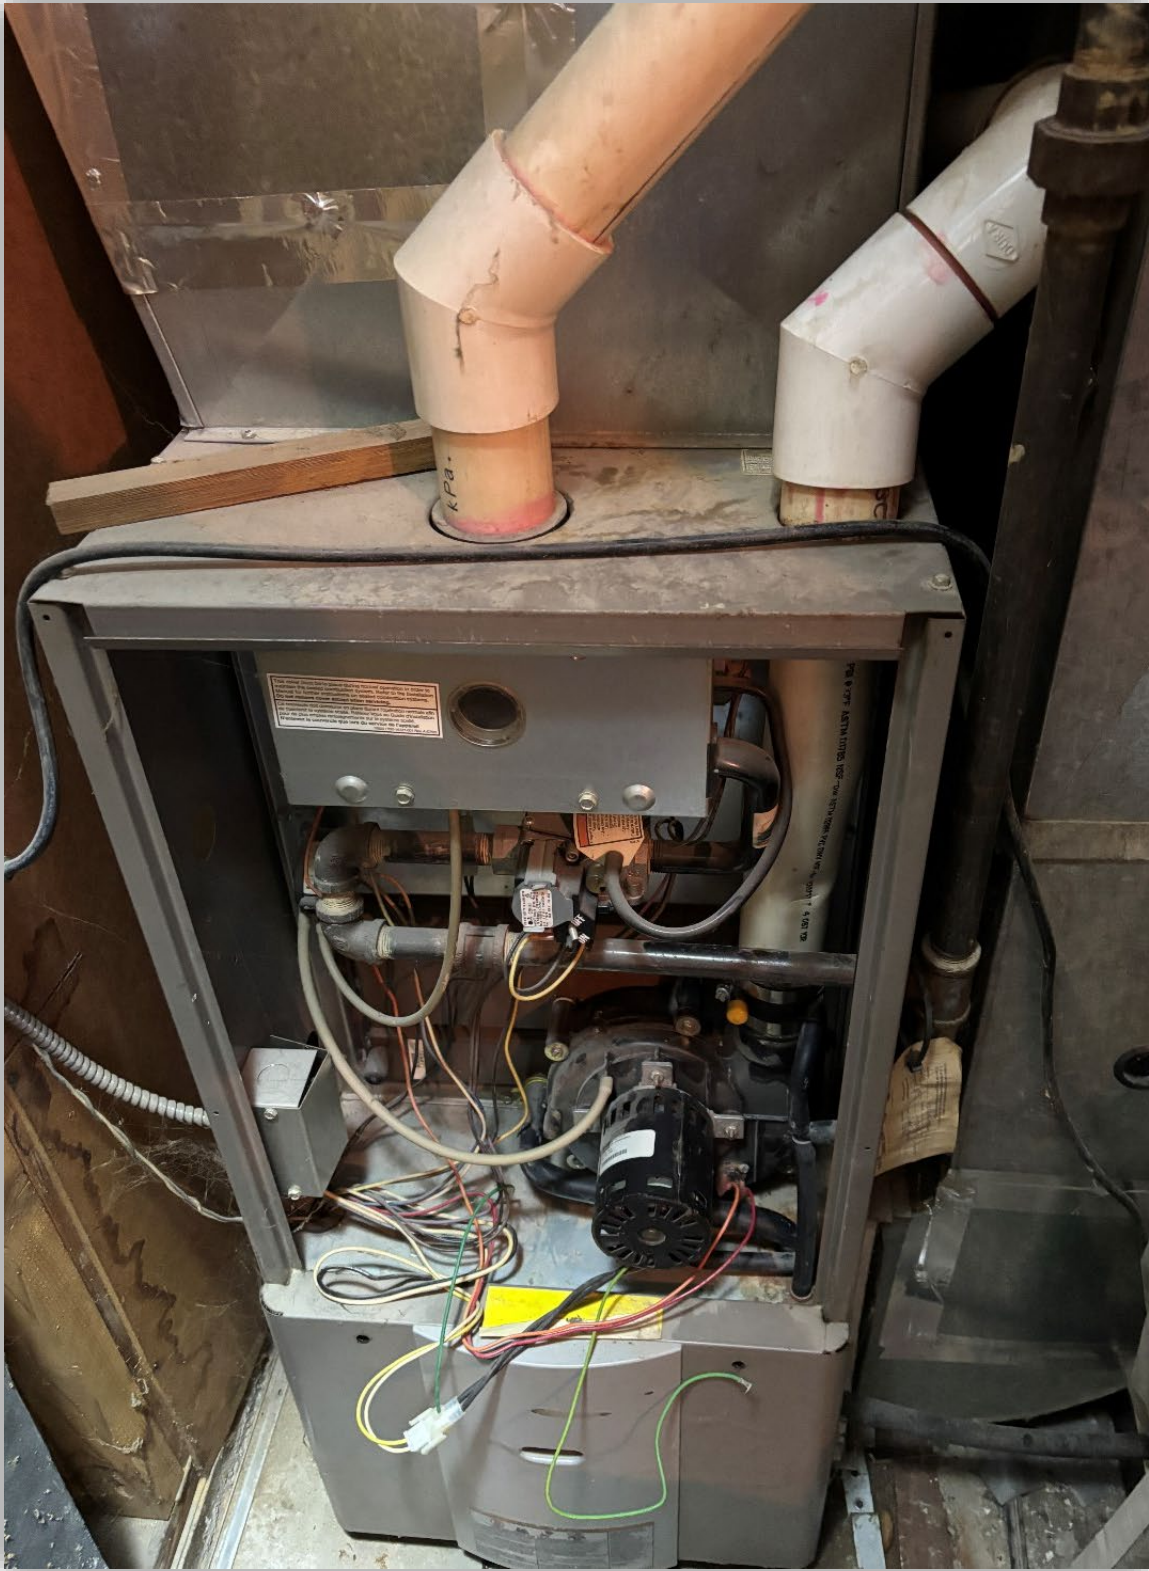
- No CO detectors were found on premises; however, eight different smoke alarms were found in the upstairs suite.
- The top cover of the furnace was found to be laying on the ground beside the furnace.

Image 3 – Gas furnace with upper cover removed as found after incident.

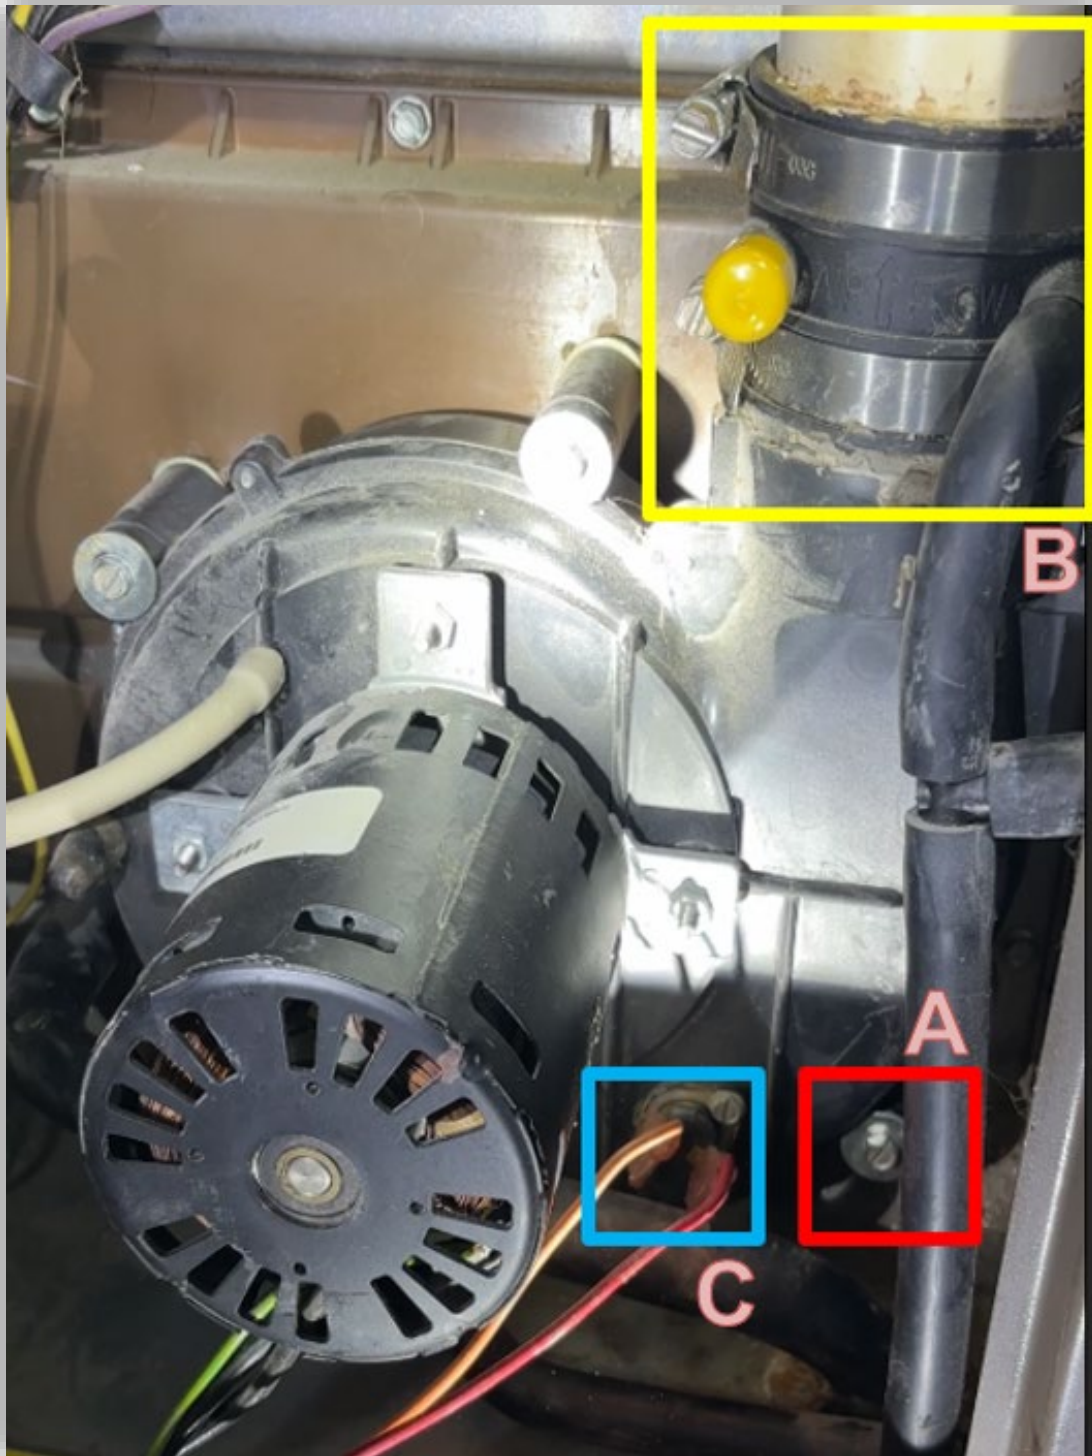
- Flue gas condensate was found forming in a pocket made by the failed vent section causing the induced-draft fan to intermittently surge in pressure.
- The induced-draft fan assembly was found loosely mounted to the furnace with 4 of 5 hold-down screws loosely installed and not making a tight seal.

- No action was taken in response to the licensed gas contractor's recommendations to replace and/or repair the furnace.
- The loose inducer fan housing bolts created insufficient air flow to the gas burner which caused incomplete combustion, the production of high levels of CO in the flue gases, and delayed ignitions. The change in airflow likely also limited the effectiveness of the inducer fan high limit switch.

Image 4 – Draft inducer motor showing loose mounting bolts [A] leaking “Fernco” vent pipe coupling [B], and high temperature limit switch [C].

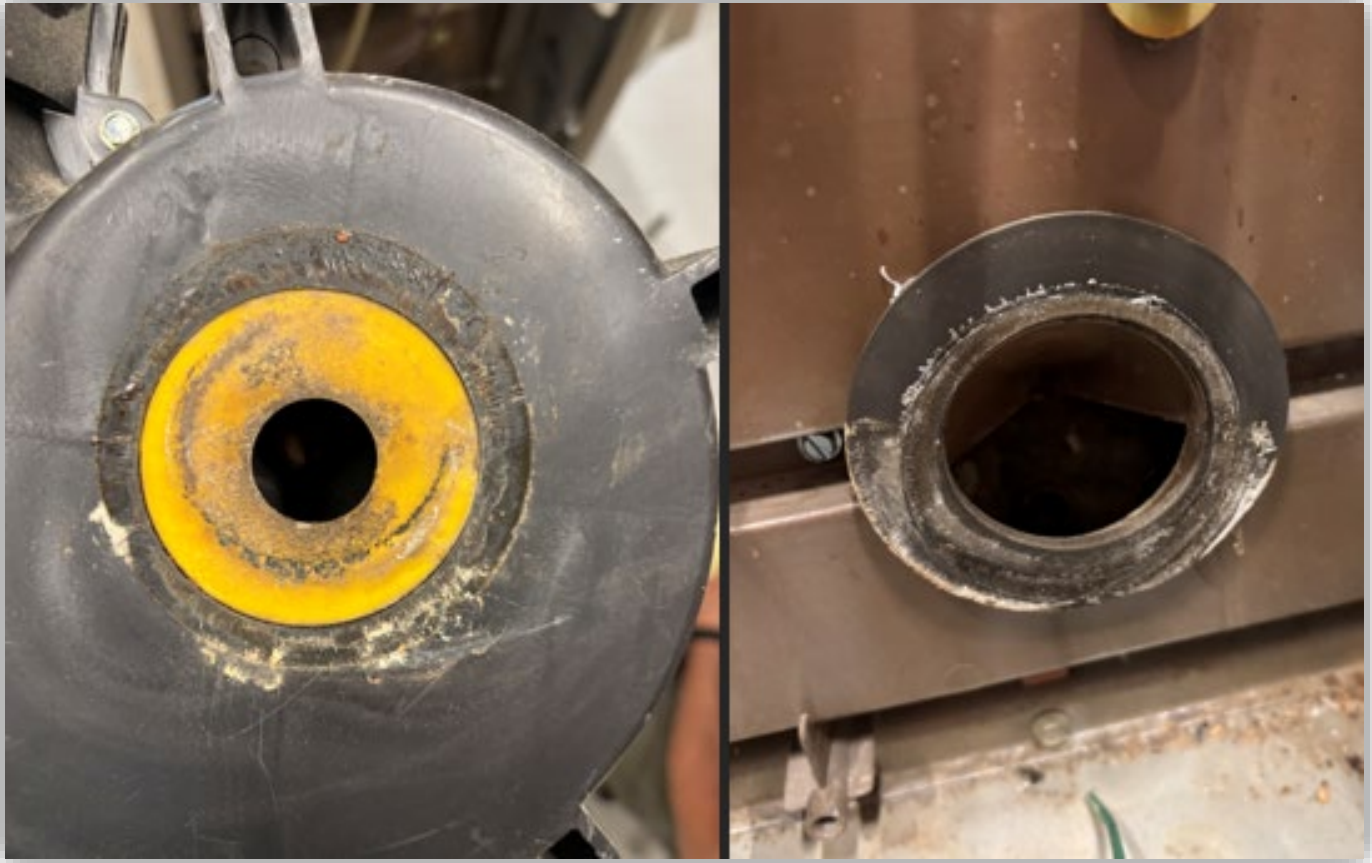
Image 5 – Draft inducer motor connection to furnace showing condensate leakage from improper seal from loose connection.

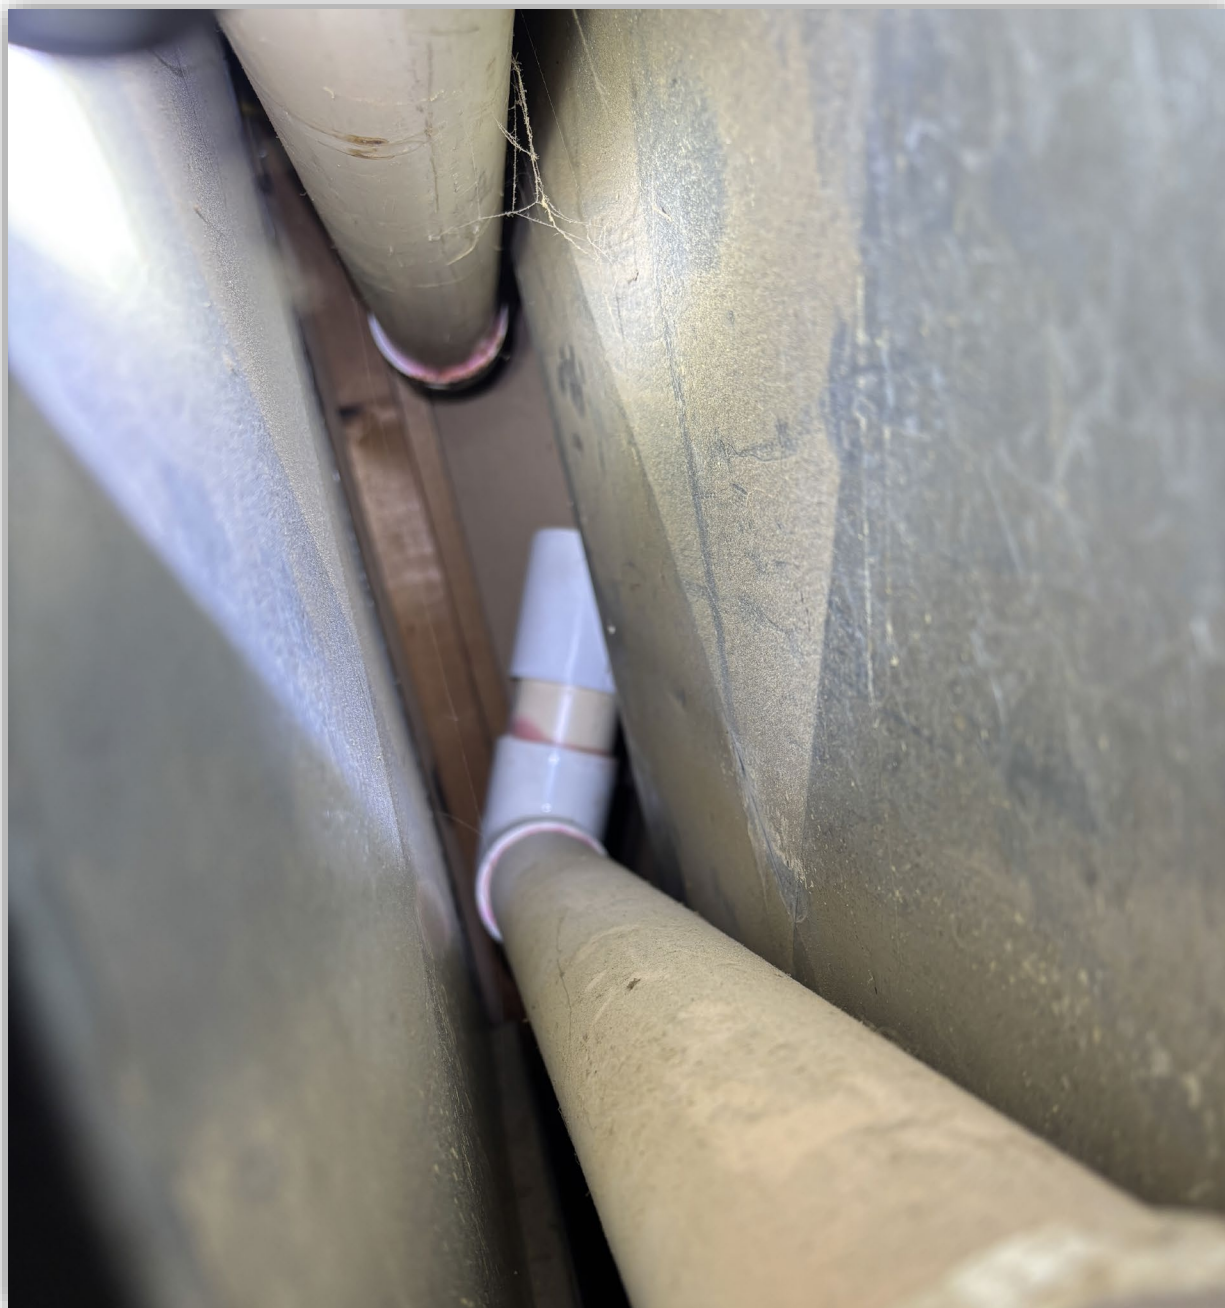
- The flue vent behind the furnace was found disconnected, solvent edging showed the pipe had been inserted at an angle and with insufficient depth.
- The flue vent as found was not completely inserted (prior to the incident) when installed at the furnace connection point, allowing it to distort in position and break the connection seal following the downstream vent section failure.

- The incorrectly assembled PVC vent pipe joint allowed it to come apart when strained, allowing flue gasses to enter the home.
- The furnace did not receive the required regular maintenance outlined by the manufacturer which led to an extremely dirty air filter and secondary heat exchanger that restricted airflow which would have caused operational issues and was likely related to the reported tripping of the high limit switch.

Image 6 – Disconnected flue vent pipe behind furnace as found after incident.

- Pipe should be cut square, deburred, cleaned of dirt, grease and moisture, and dry fit together.
- The proper cement should be applied to both the end of the pipe and the fitting socket.
- While the cement is still wet the pipe should be inserted fully into the socket and twisted ¼ turn.
- The pipe and fitting should be held together for approximately 30 seconds to eliminate push out.
- The joint should be left to set before in can be carefully handled.
- Set time for 2” PVC joints vary between 5-15 minutes depending on outdoor temperature.

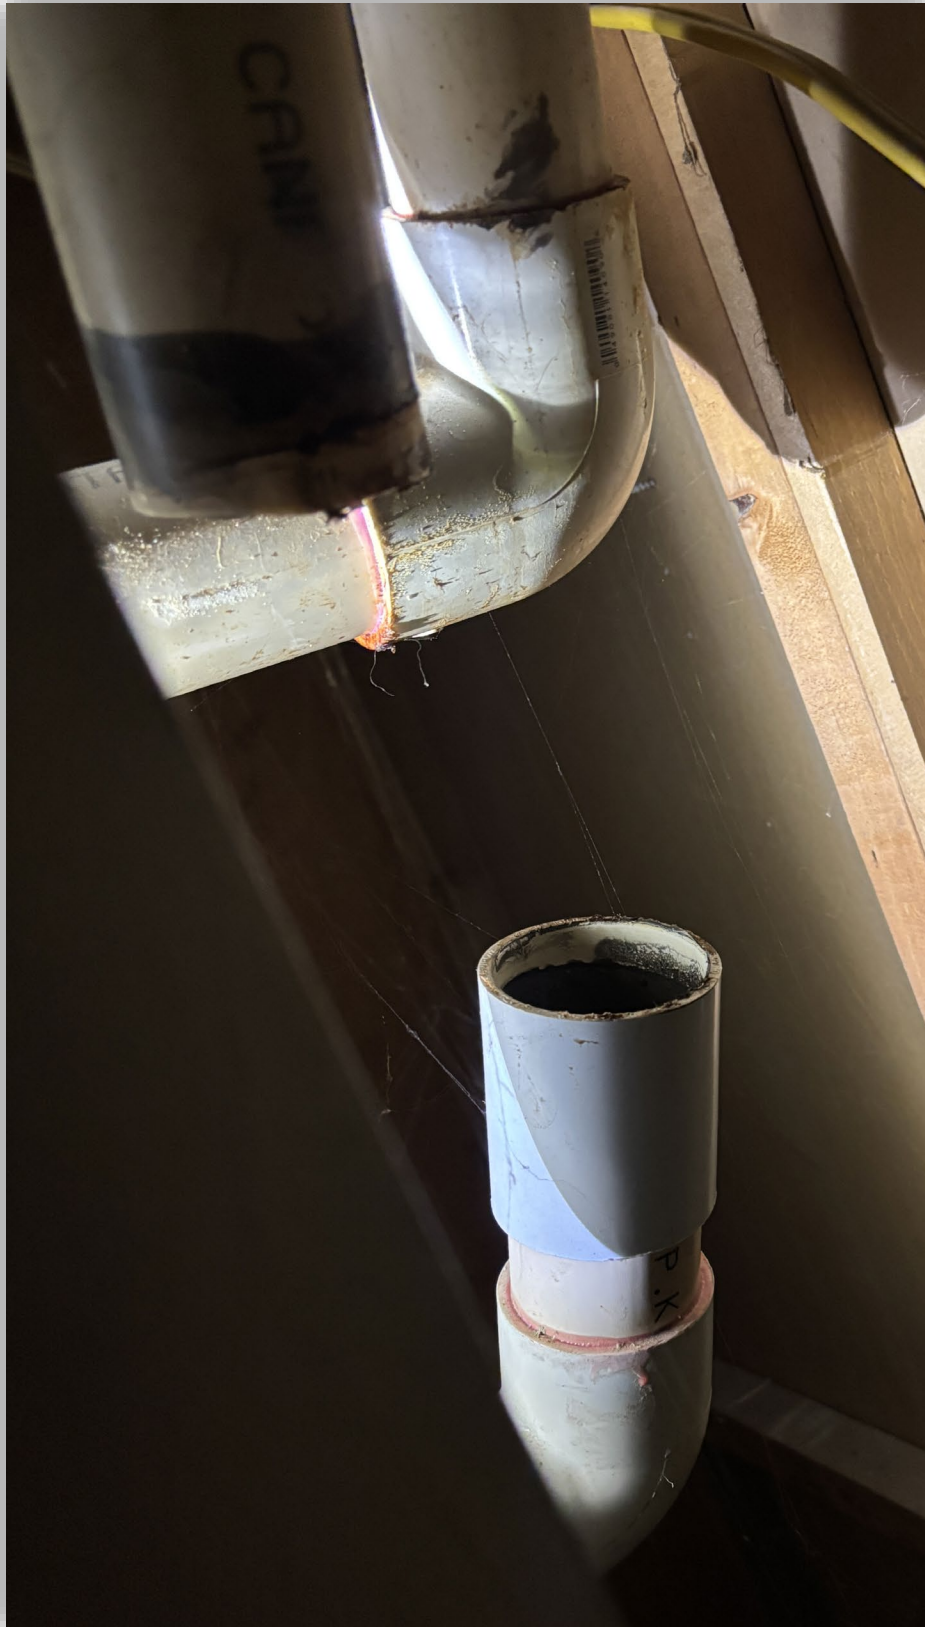
Image 7 – Disconnected flue vent pipe from other angle.

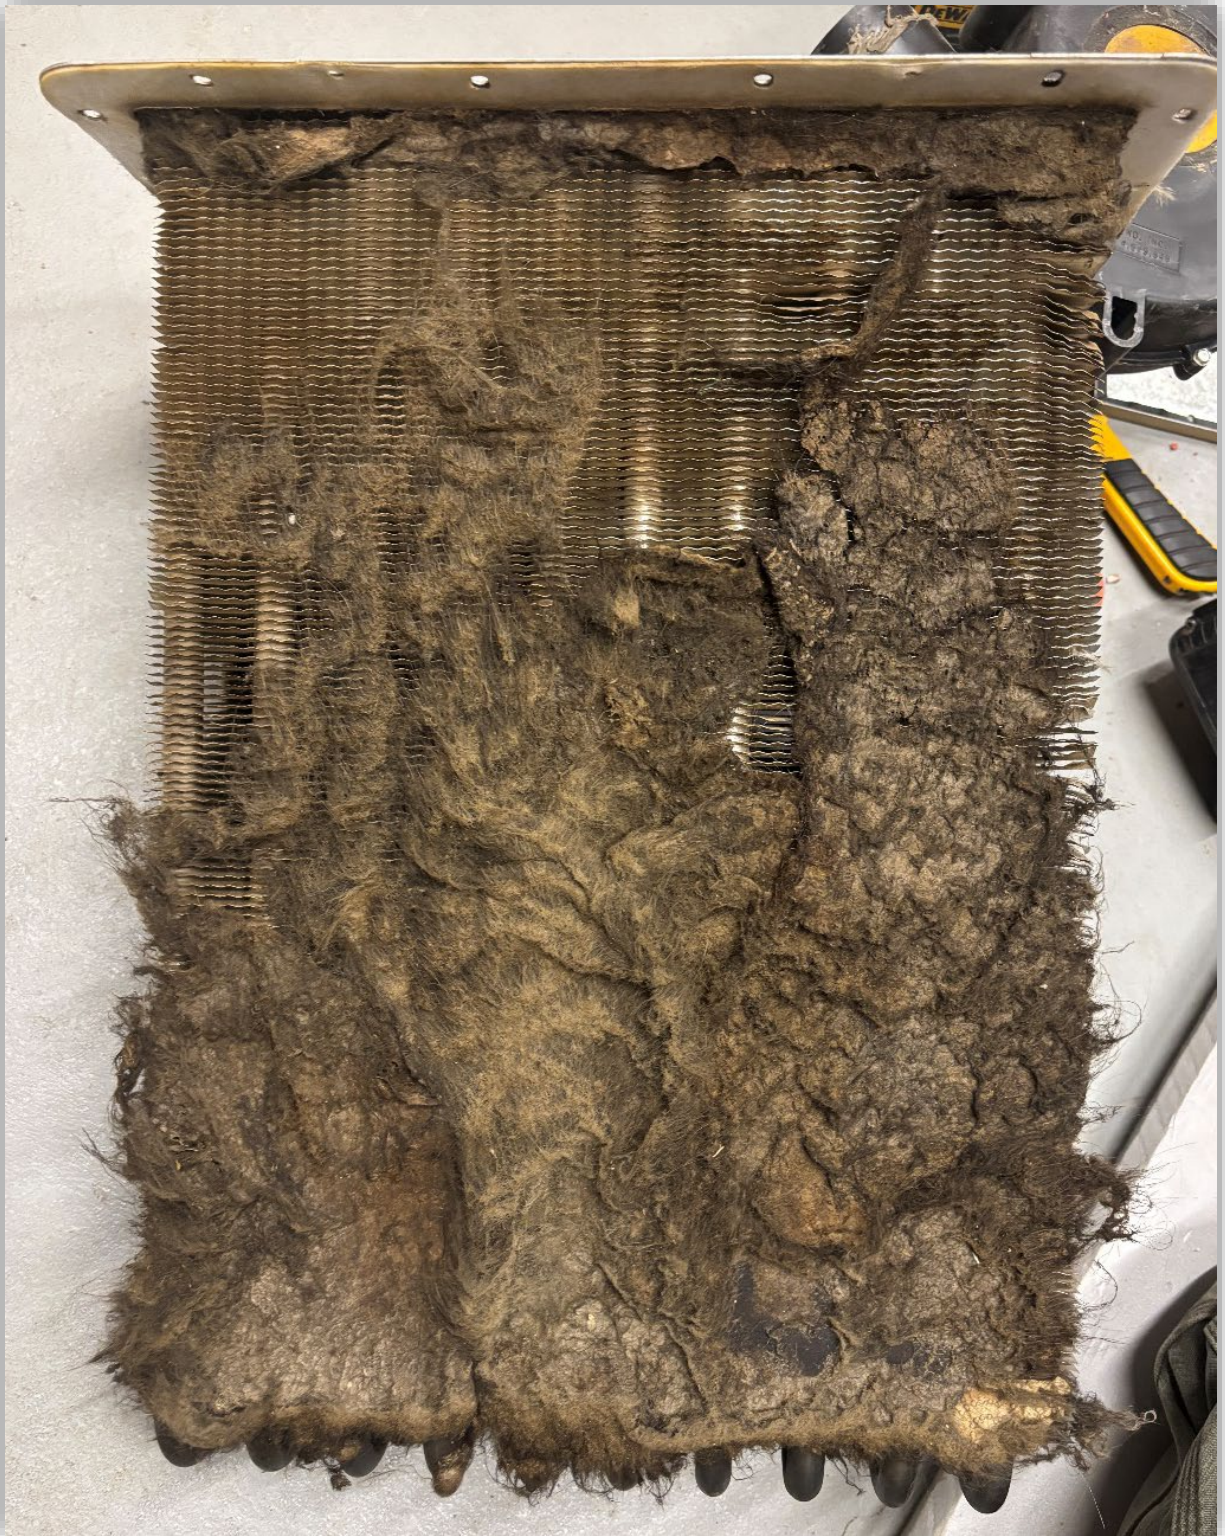
Image 8 – Dirty secondary heat exchanger found during furnace disassembly.
