Incident Summary #II-1238269-2021 (#23553) (FINAL)

SUPPORTING INFORMATION	Incident Date	August 15, 2021	
	Location	Chilliwack, BC	
	Regulated industry sector	Electrical - Low voltage electrical system (30V to 750V)	
	Injury	Qty injuries	0
		Injury description	N/A
		Injury rating	None
	Damage	Damage description	The 600-amp fused switch for this electrical service was destroyed as well as the service conductors inside the three service raceways that entered into the top of the fused switch from the building exterior. There was fire damage to the plywood surface that the fused switch was mounted to, as well as minor fire damage on the adjacent wall to the right of the fused switch.
		Damage rating	Moderate
Incident rating	Moderate		
Incident overview	Fire in the 600-amp main electrical service switch at a lumber drying facility that caused damage to the electrical service equipment and building wall.		
INVESTIGATION CONCLUSIONS	Site, system and components	<p>The 600-amp, 600-volt, 3 phase electrical service to this building is fed from an overhead private 14.4-kilovolt to 600-volt 3-phase transformer configuration. Overhead cables are ran from the transformers to the exterior of the

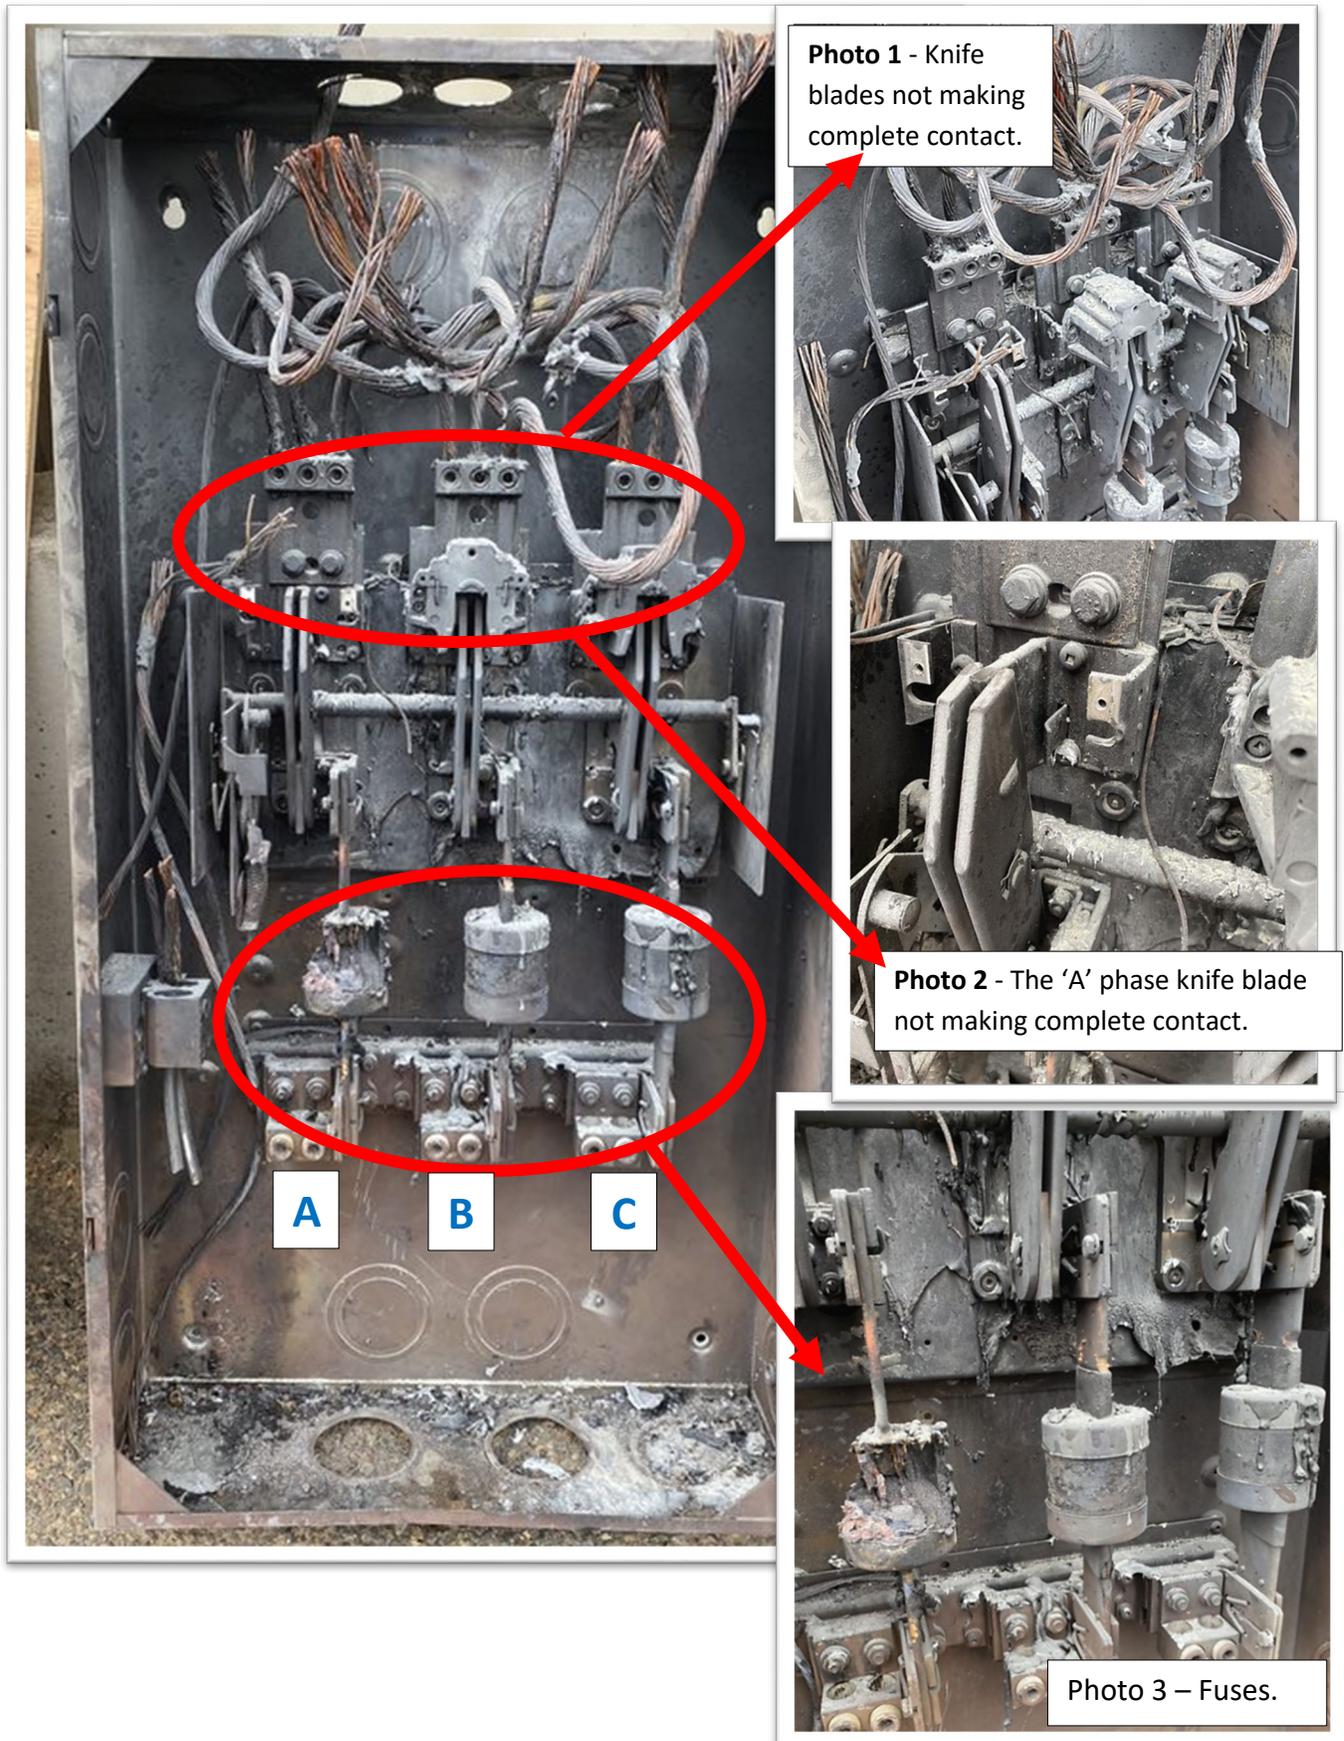
<p>Facts and evidence</p>	<ul style="list-style-type: none">• It was observed that the knife blades were not making complete contact with the lineside terminals (See Figure 1, Photo 1 and Photo 2).• The 'A' phase fuse had the most damage and appears to be the failure point (See Figure 1 and Photo 3).• It was observed that the insulation had been melted from the service conductors which would cause a short circuit to drop out the high voltage fuses (See Figure 2 and Photo 4). <p>Interview with the maintenance electrician who has been providing electrical maintenance to this building for 30 years.</p> <ul style="list-style-type: none">• Stated the 600-amp main switch had not been switched off for at least one year for maintenance.• Stated the 600-amp main switch was not turned off when the electrician arrived on scene because the high voltage fuses had dropped out disconnecting power from the building.• Stated the fuses are most likely original and have never been changed to his knowledge.• Stated the age of the service was approximately 40-50 years old.• Stated the high voltage fuses were blown when he arrived onsite.• Stated the temperature in the electrical room had recently reached 40 degrees Celsius due to summer temperatures.

<p>Causes and contributing factors</p>	<p>It is very likely that due to the old 600-amp main switch not functioning as it should, the knife blades inside the main switch did not make complete contact between the line side conductor terminals. This created a smaller than required current path between the line side terminals and knife blades, which caused excessive heat from more resistance that eventually melted the 'A' phase fuse starting a fire in the switch.</p> <p>A contributing factor to this fire likely could have been the ambient temperature in the room leading up to the incident, causing even more heat inside the 600-amp main switch.</p>

FIGURE 1 - 600-amp fused switch after incident.

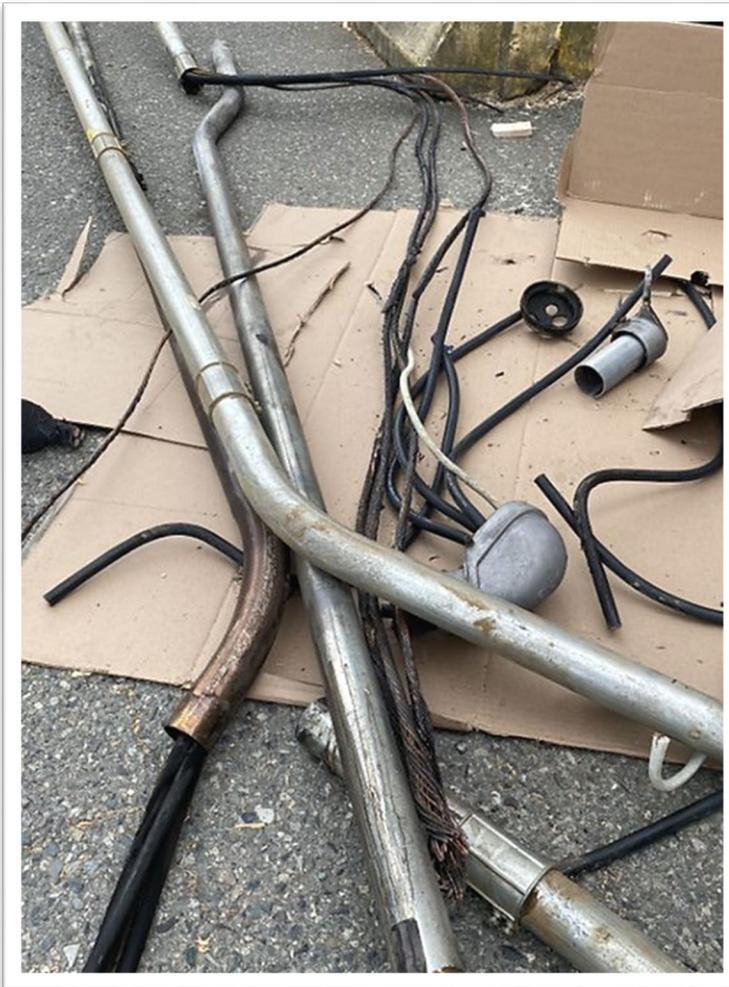
Photo 3 - Damaged service raceways and conductors.

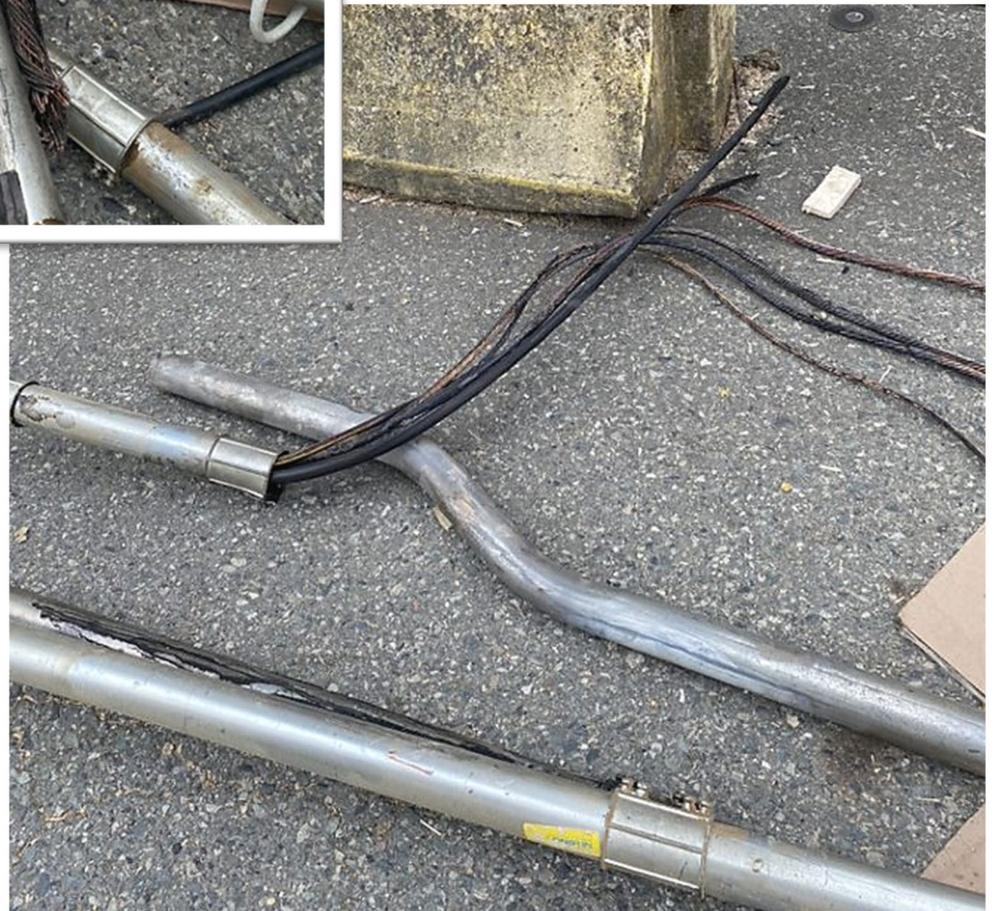
Photo 4 - Damaged service conductors with melted insulation.
