## Incident Summary (5613497 #) Final

Failure scenario(s)		- 100,000 BTU residential style boilers were operating below the required design temperature (180F supply temp, 135F return temp. minimum.)

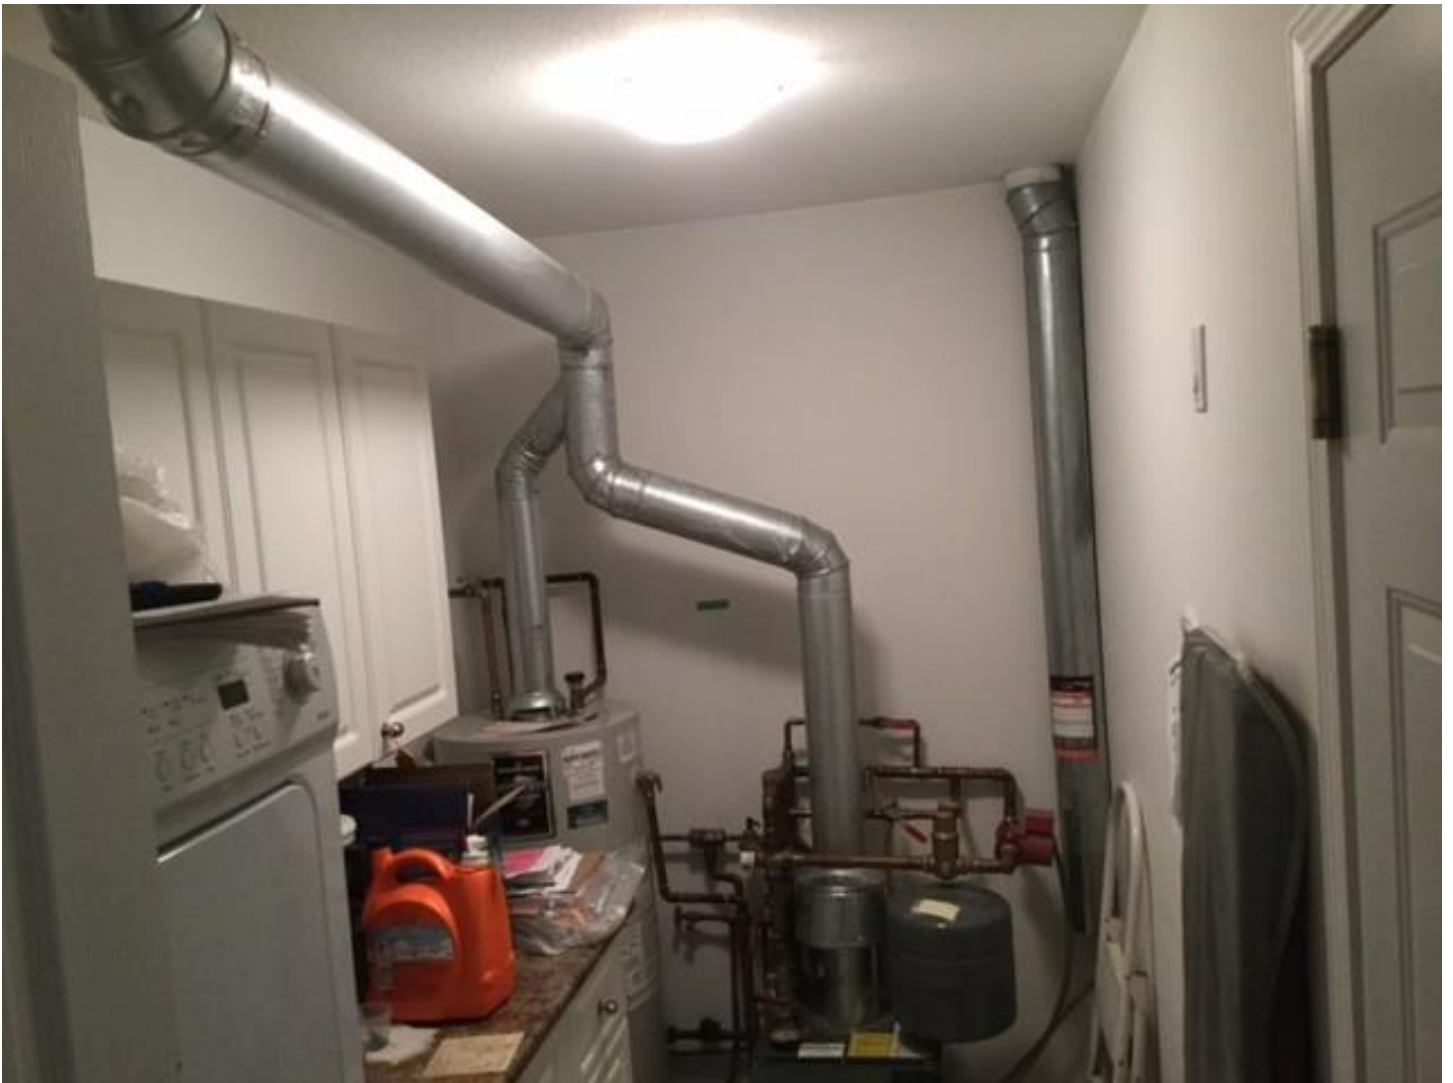
*View of the burners and combustion chamber. Note the arrow pointing to the temperature controller that must be set correctly.*

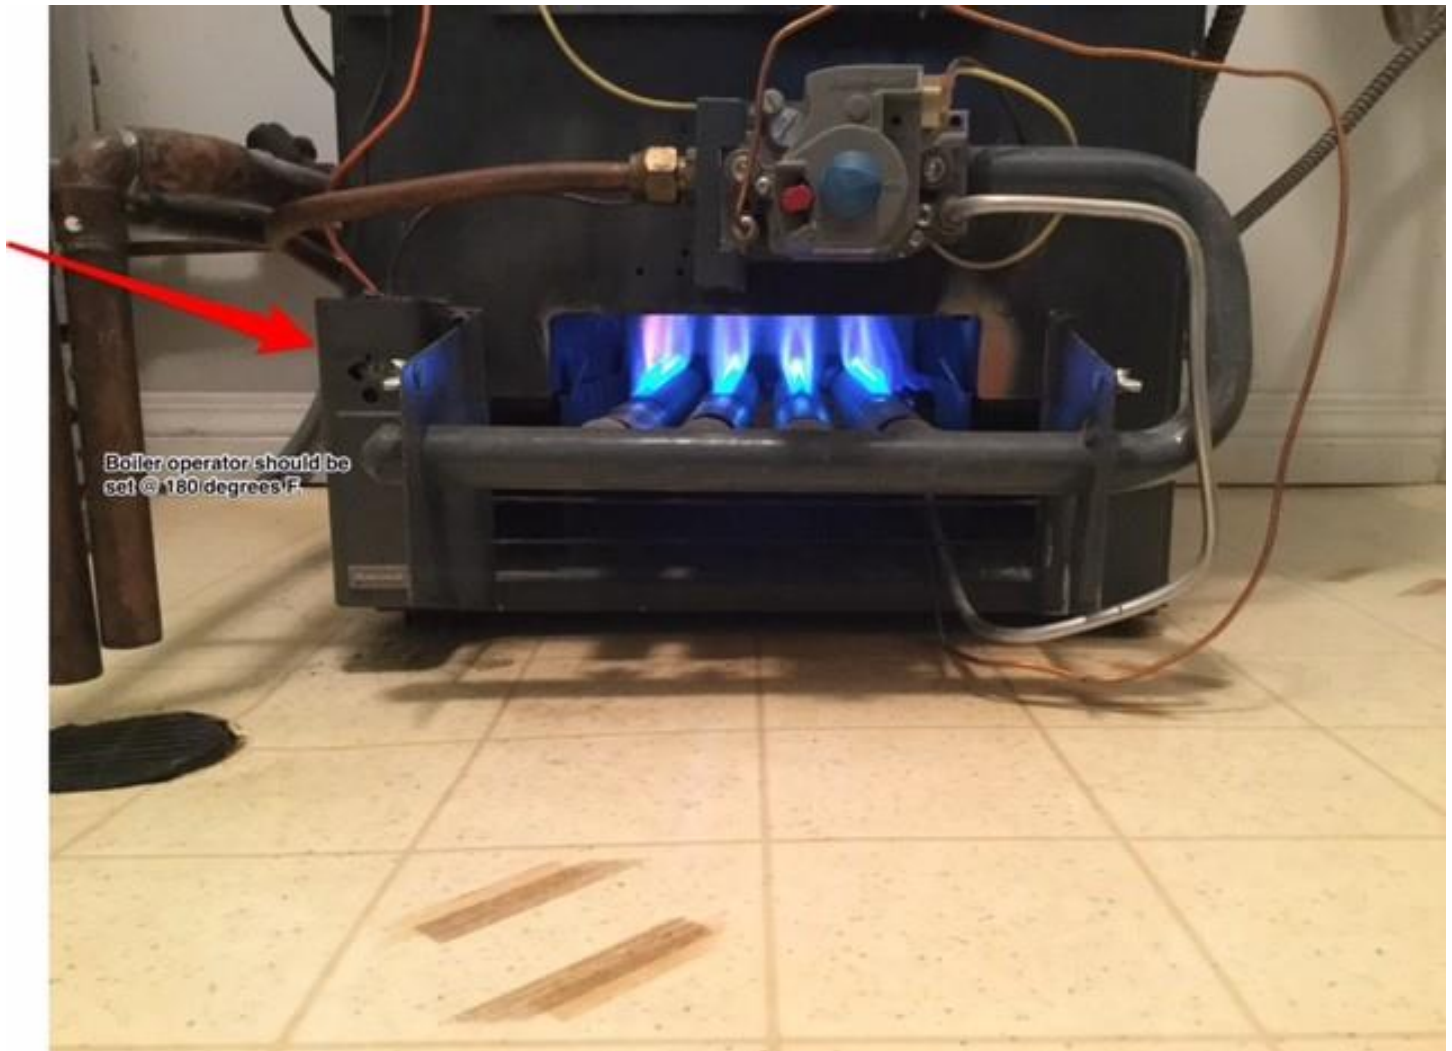
Temperature gauge mounted in well on top of boiler. Note the water temperature at the outlet side of the boiler is around 150F.
