Report No. RPT-5103-00

BC Safety Authority – Incident Investigation – Jurisdiction and Role

Incident Synopsis

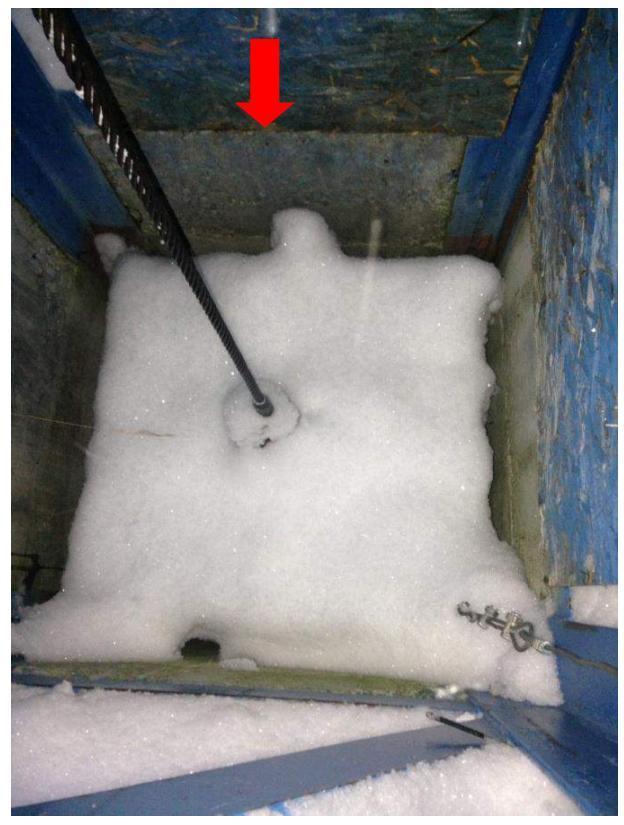
Only the top of the counterweight is visible during operation. The position of the counterweight relative to the bottom of the pit is not visible as shown in figure 4. The top of the counterweight relative to the ground level was visible to employees at the time of the incident as shown in photographs 2 and 3 below.

Photograph 2: Top of counterweight as viewed on the day of the incident. Note: the arrow indicates ground level.

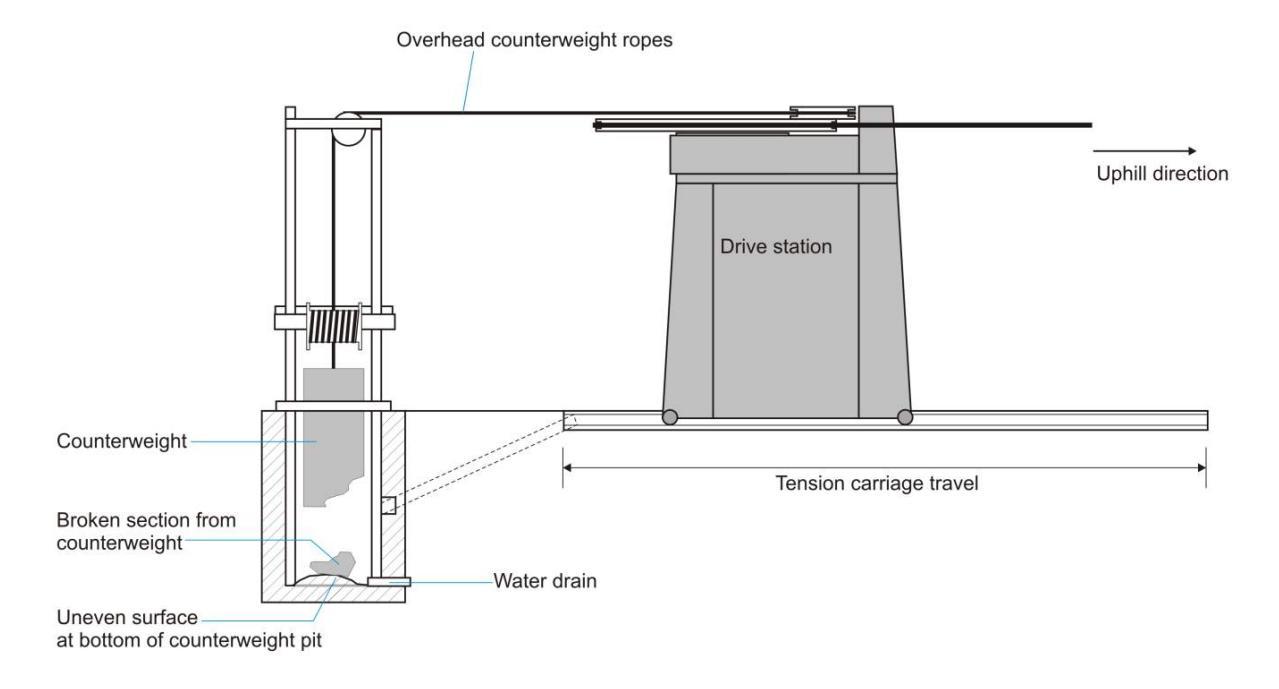
The counterweight monitoring system was found to be rigged in such a manner that the limit switch would not be actuated with the counterweight on the bottom of the pit.

The distance between the rear of the drive carriage and its physical limit of travel on the carriage rails was found to be 185 mm. It was observed that with the lift chairs empty, the counterweight could not be lifted off the bottom of the pit without the carriage contacting the rear physical limit of travel. This result indicates that compliance to CSA Z98-07 4.30.7 (b) could not have been achieved during operation.

Figure 4: Drive station tension system illustration – condition found during investigation Note: Figure 4 was produced from field observations and drawings provided by the manufacturer. Figures are not to scale and are intended for illustrative purposes only

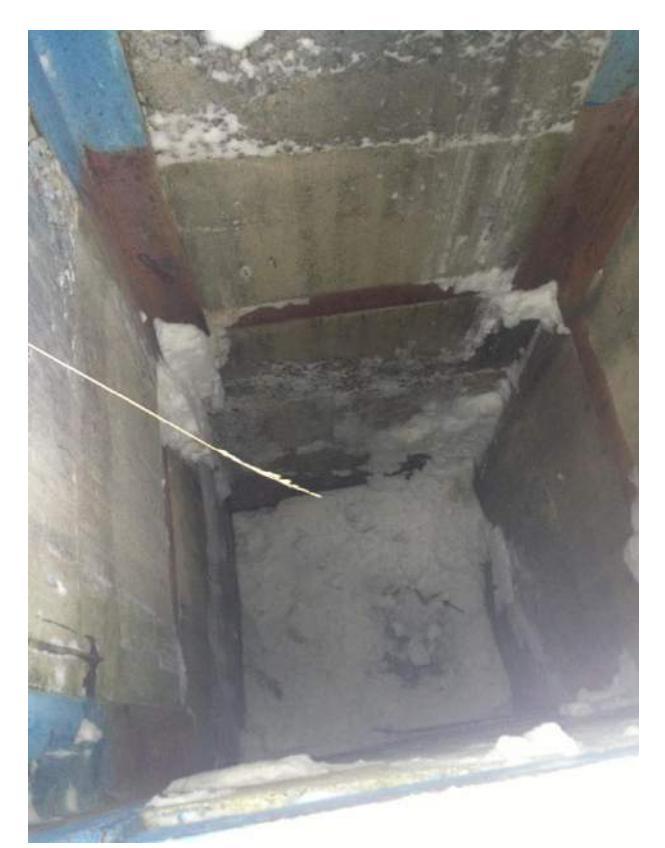
Photograph 5: Bottom of counterweight pit at time of incident

The counterweight was in contact with the bottom of the counterweight pit. It is likely that the method to determine 'free suspension' of the counterweight was resulting with the counterweight pivoting on the broken section and contamination at the bottom of the pit, providing a false indication of 'free suspension'. The condition of the counterweight does not comply with CSA Z98-07 12.5.1.2.

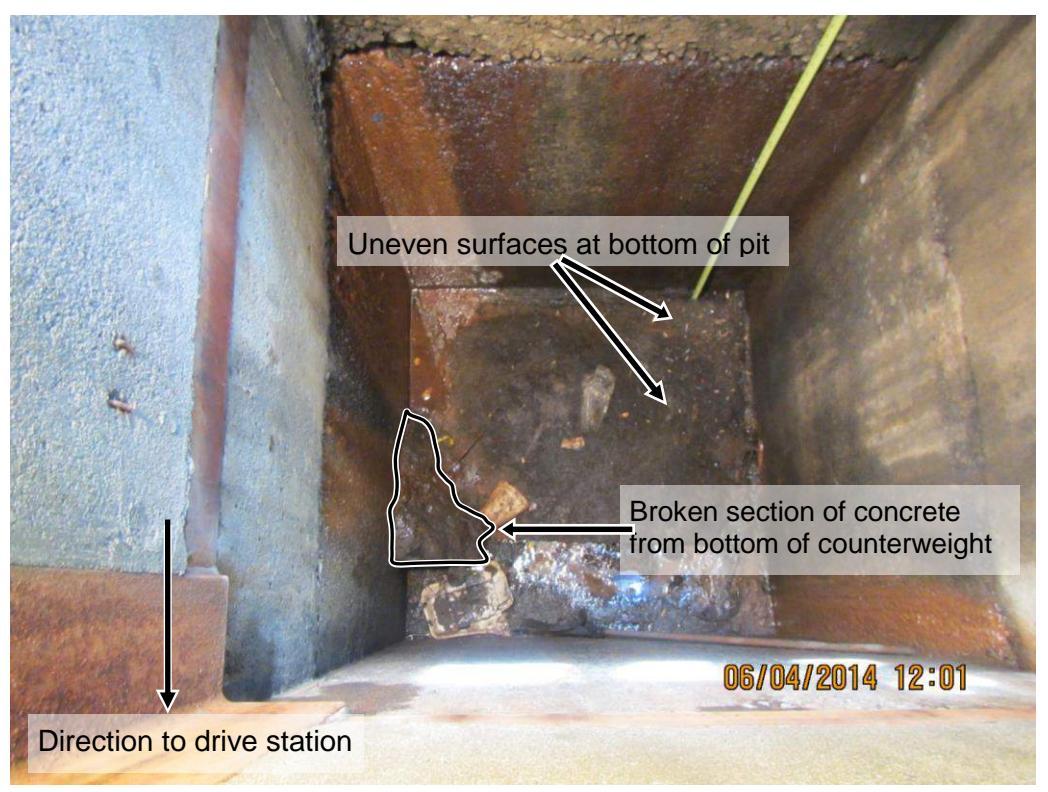
Upon inspection of the counterweight at the time of the investigation, it was discovered that the lower corner of the concrete block counterweight closest to the drive station carriage on the downhill side of the station was broken off and located at the bottom of the pit. The opposite bottom corner of the counterweight was also found to be missing but that broken section was not at the bottom of the counterweight pit. Material (organic decay, waste) was observed to be contaminating the bottom of the counterweight pit resulting in a build-up of approximately 4 inches in the middle of the counterweight pit as shown in Photograph 6.

Photograph 6: Bottom of Blue Chairlift counterweight pit

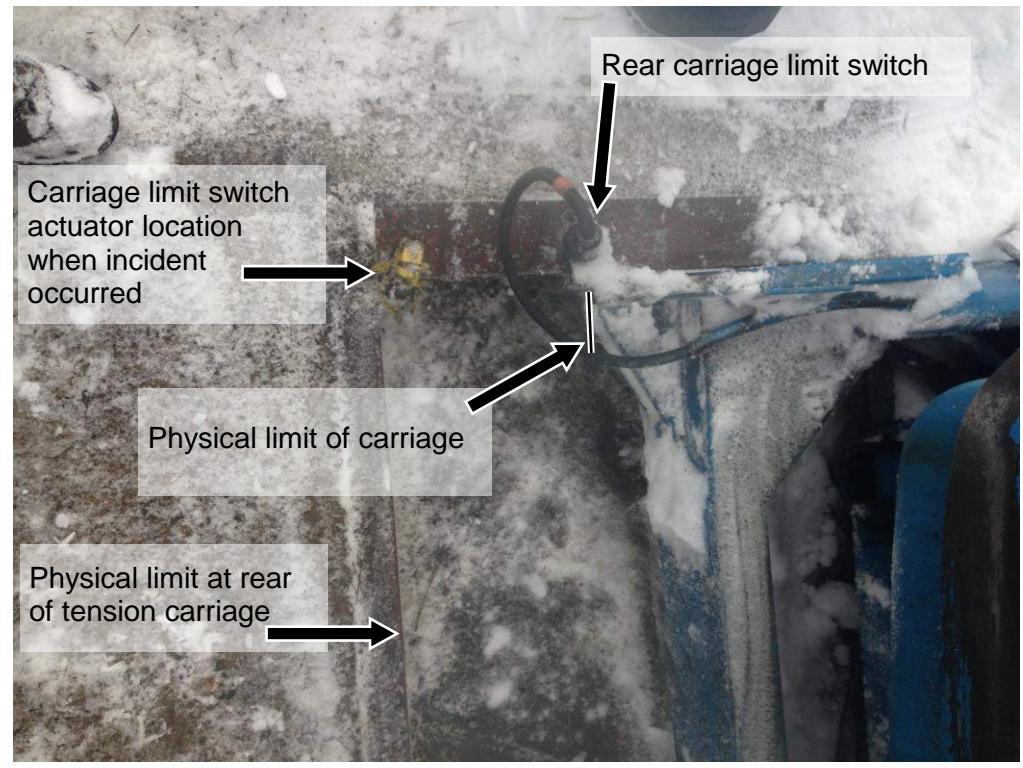
Photograph 7: Rear carriage monitoring system switch and actuator

While the drive carriage monitoring system was found to be rigged in such a manner that was not compliant to CSA Z98-07 4.30.7 (b), it did not contribute to a reduction of tension in the haul rope as the carriage did not likely reach the physical limits of its travel during operation.

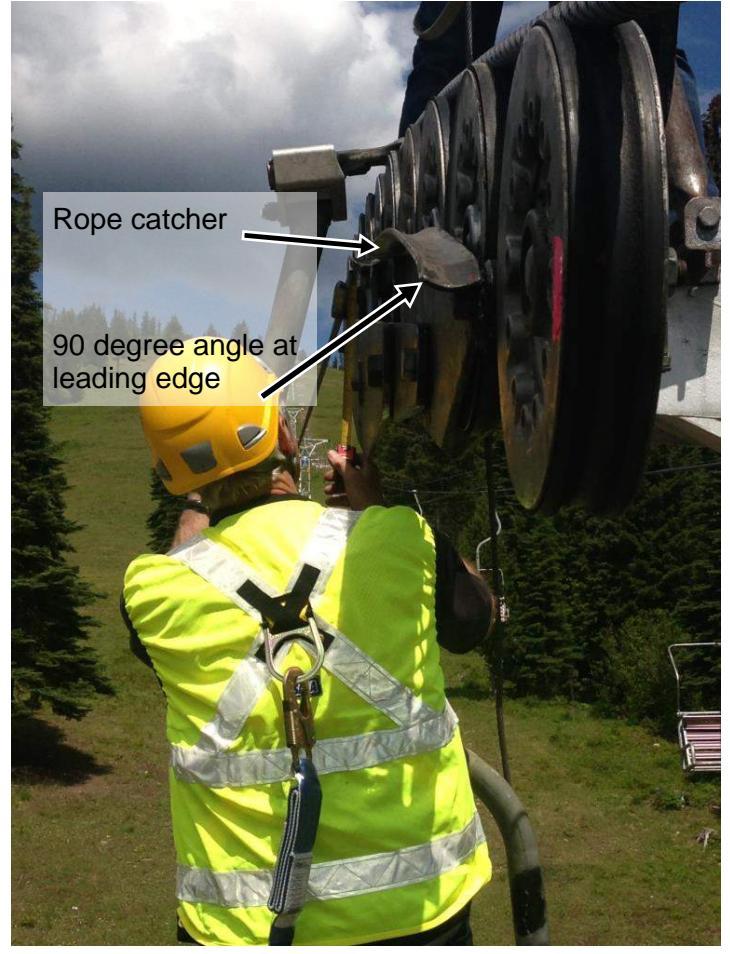
On the Blue Chairlift at tower #2, a contoured angle bracket is attached at the entrance, middle and exit sections, shown in figure 5, on the outside of the sheave assembly's frame located approximately half a sheave diameter below the haul rope. This design is common to all Mueller chairlift installations. The Mueller design has a sharp 90° corner at its leading edge in the horizontal plane as shown in photograph 8.

Photograph 8: Blue Chairlift Rope Catcher at Tower #2

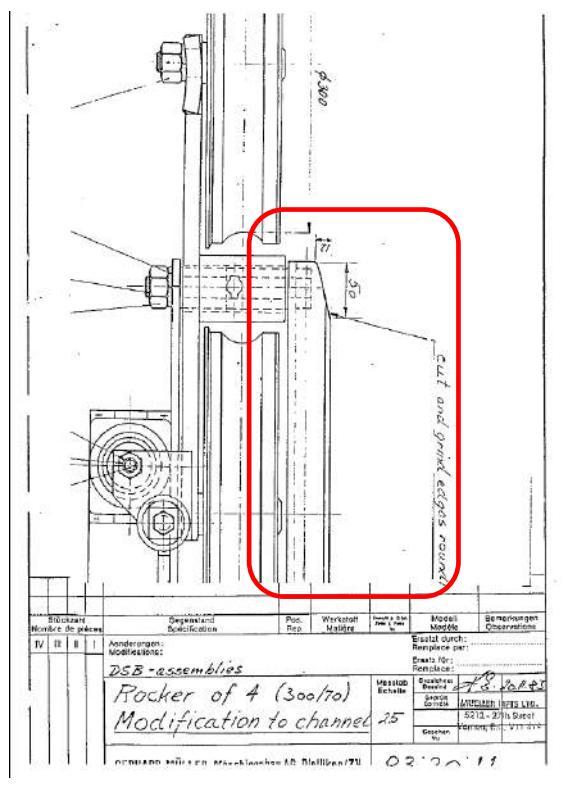
The 90° corner at the entrance to the sheave assembly was the subject of an instruction issued to Mueller chairlift owners that were in locations susceptible to high wind loading. The instruction allowed owners of these installations to modify the leading edge of the rope catcher so that it was less likely that damage or entrapment of the carrier hanger arm would occur in the event a swinging carrier made contact. A drawing that was provided by the manufacturer to instruct owners on how to perform this modification is shown in figure 6.

This modification was never performed on the Blue Chairlift due to a letter that was issued by Mueller Lifts to CMRL that stated if the hanger arms were replaced with a new design hanger arm with a profile that provided additional clearance then the modification was not necessary. The new design hanger arm was installed on the Blue Chairlift many years prior to this incident but the exact date of completion is not known. Figure 7 compares the profiles of the original and modified hanger arms.

Figure 6: Mueller Drawing Depicting the Rope Catcher Modification

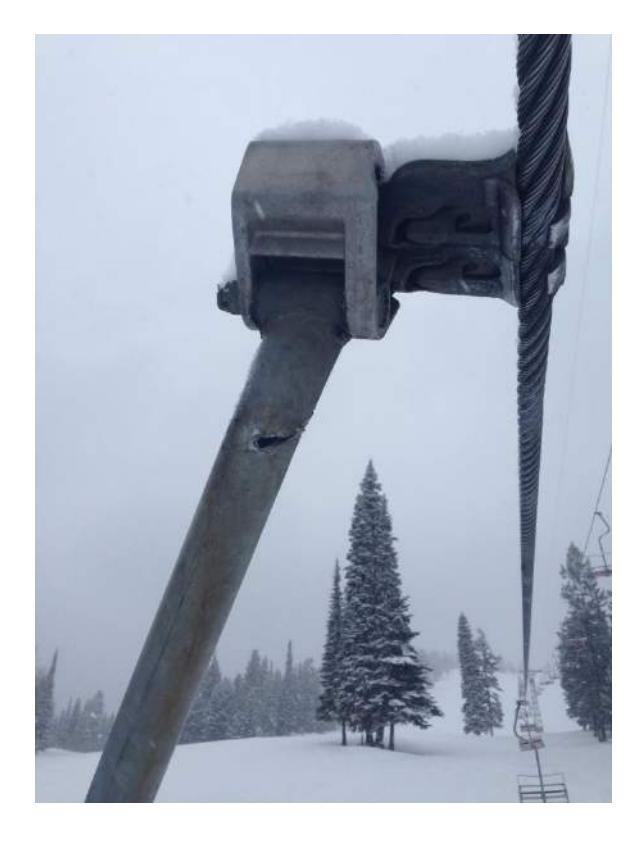
Carrier swing angles were recreated at the tower #2 site and confirmed that carrier #15 first made contact with sheave assembly rope catcher at an inward angle of 27° and a backward angle of 33°. Photographs10 and 11 below illustrates the damage made to the chair hanger arm from contact with the rope catcher. Given this discovery, the chair swing experienced during the incident would have been abnormally excessive.

Photograph 10: Carrier #15 hanger arm damage from contact with tower #2 rope catcher

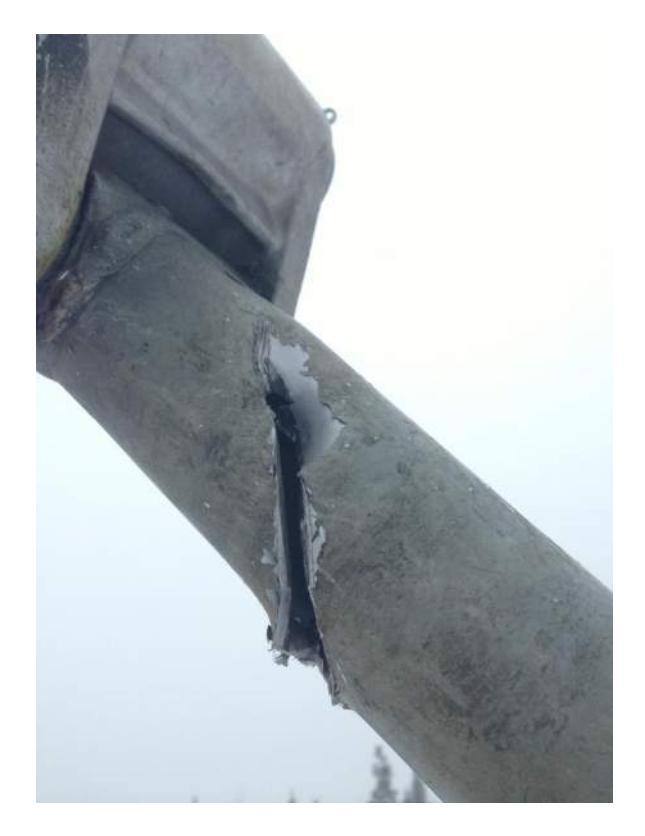
Photograph 11: Carrier #15 hanger arm damage as viewed looking away from the haul rope/tower

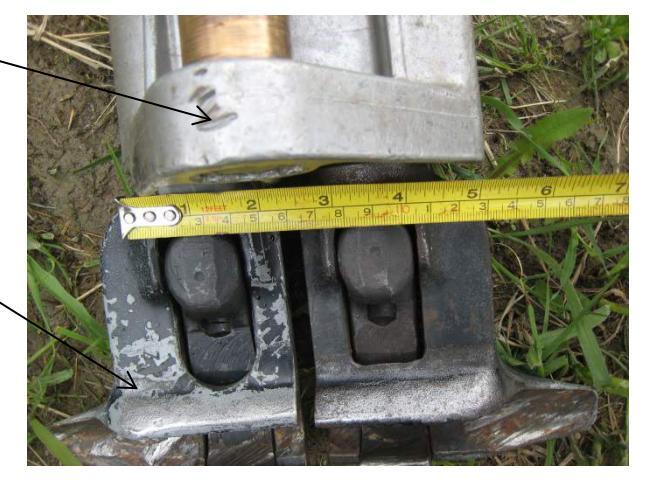
Damage from contact with sheave #3

Picture 2 – Grip Damage

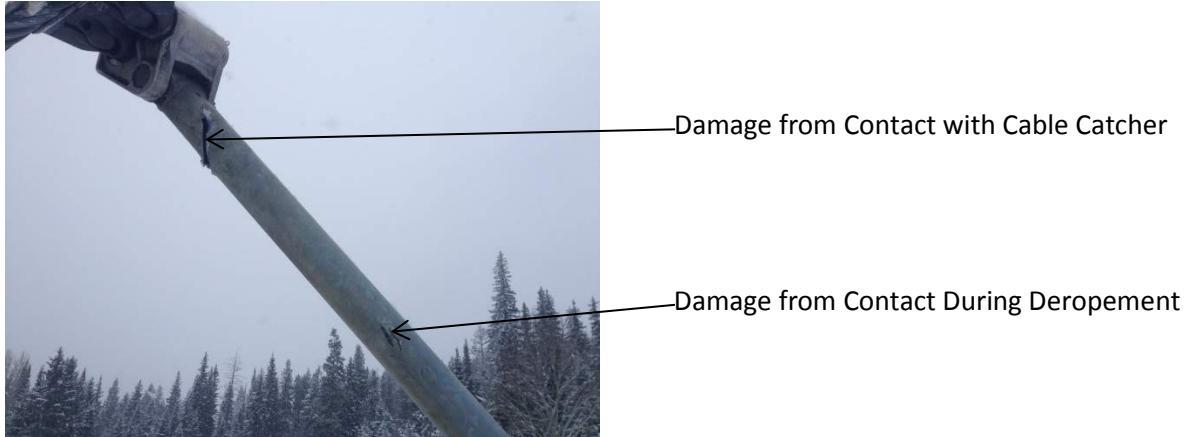
Picture 3 – Hanger Damage

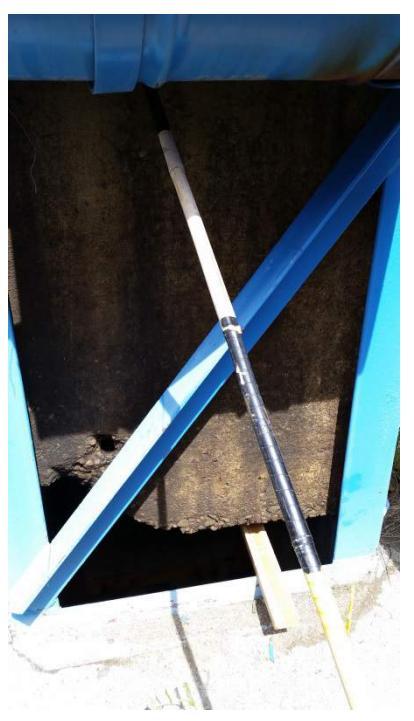
- 1. Observed chairlift operating with empty carriers. Noted that some chairs exiting the lower terminal bullwheel were swinging more than others.
- 2. The counterweight to carriage reeving was not as was shown on the drawing that had been provided. Instead of a 2-part connection to the counterweight there is a single connection.
- 3. Rear carriage wheels were not in place. Counterweight switch was not in place. These items had been removed during the initial post-accident site investigation by the BCSA personal.
- 4. Counterweight was not free to move. Could not see beneath the counterweight when first observed. Subsequently, the counterweight was raised and it was observed that two pieces at the bottom of the concrete block had dislodged. One piece was observed in the pit.

Picture 5 – CW Missing Piece 1

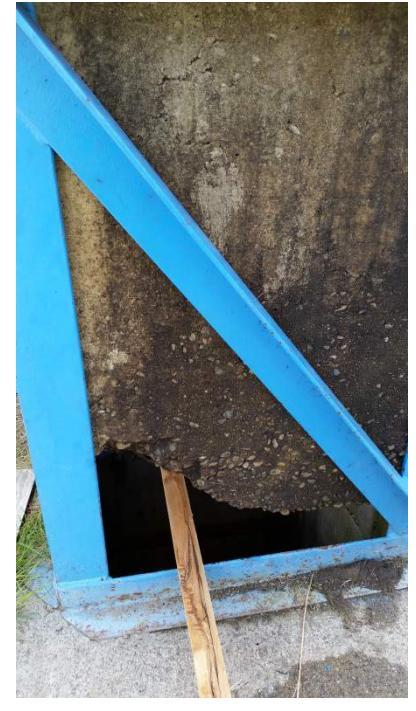
Picture 4 – CW Missing Piece 2

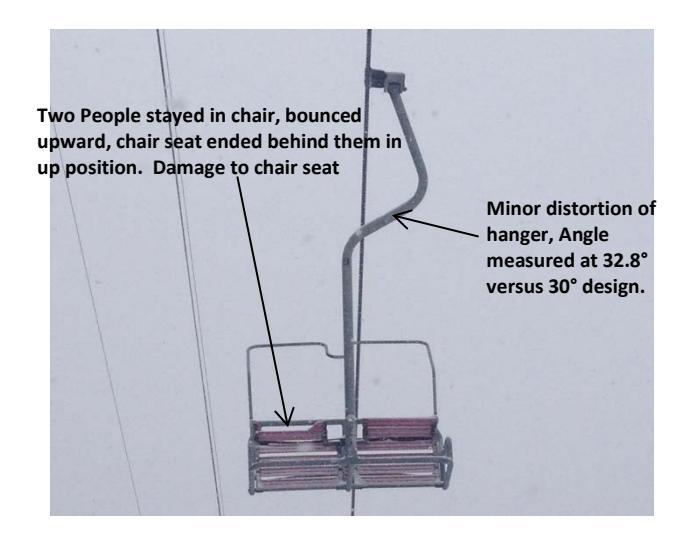
Picture 17 – Damaged Carrier 9

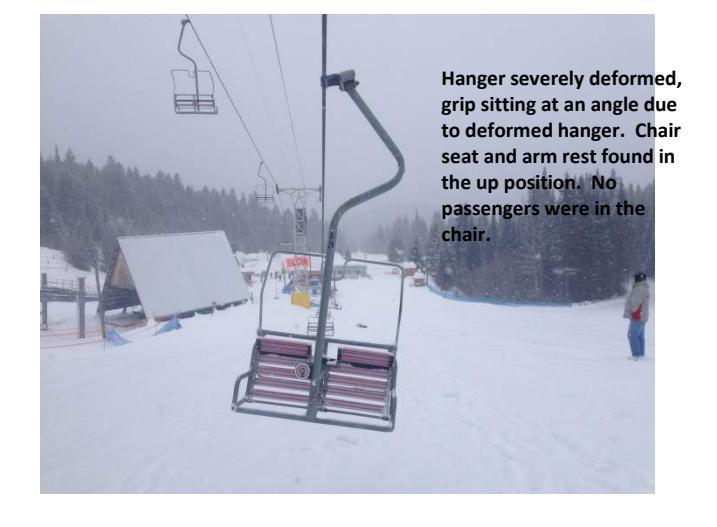
Picture 16 – Damaged Carrier 13

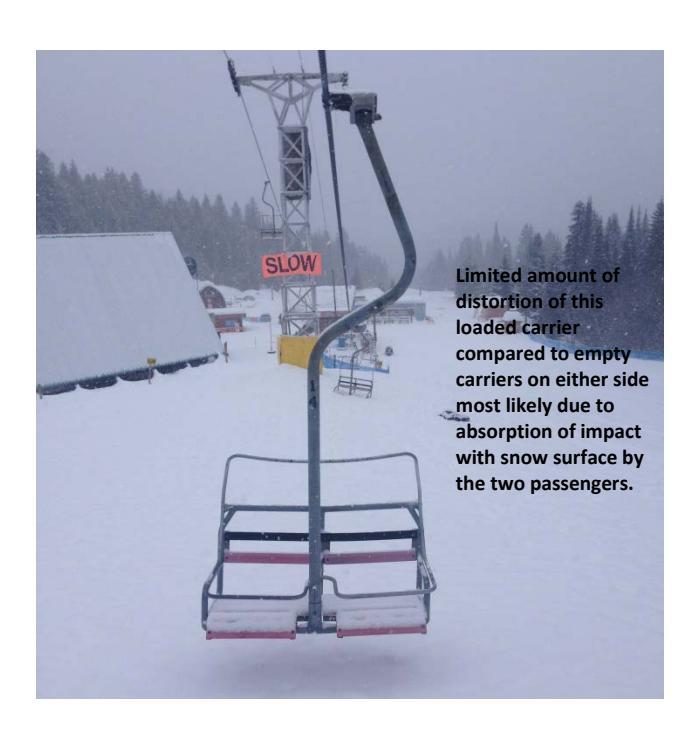
Picture 19 – Damaged Carrier 14

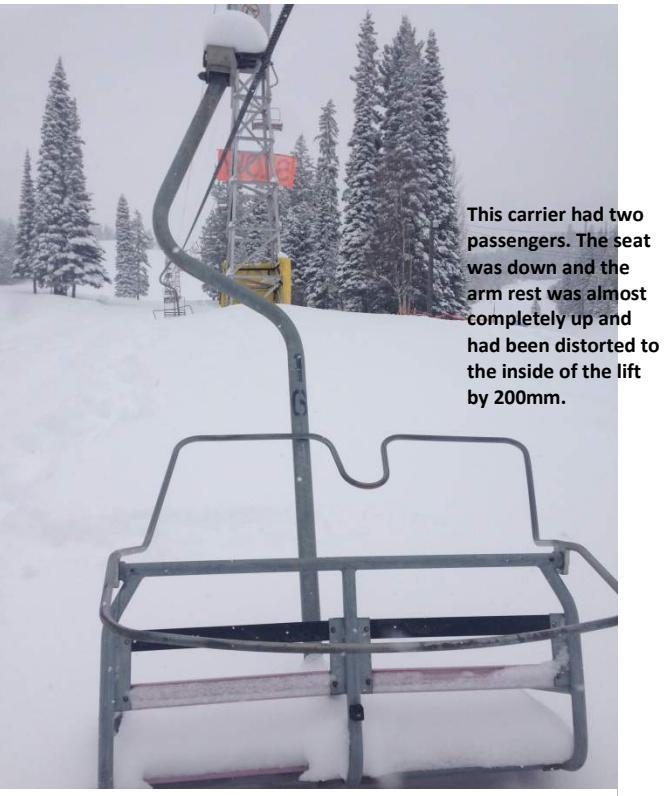
Picture 18 – Damaged Carrier 16

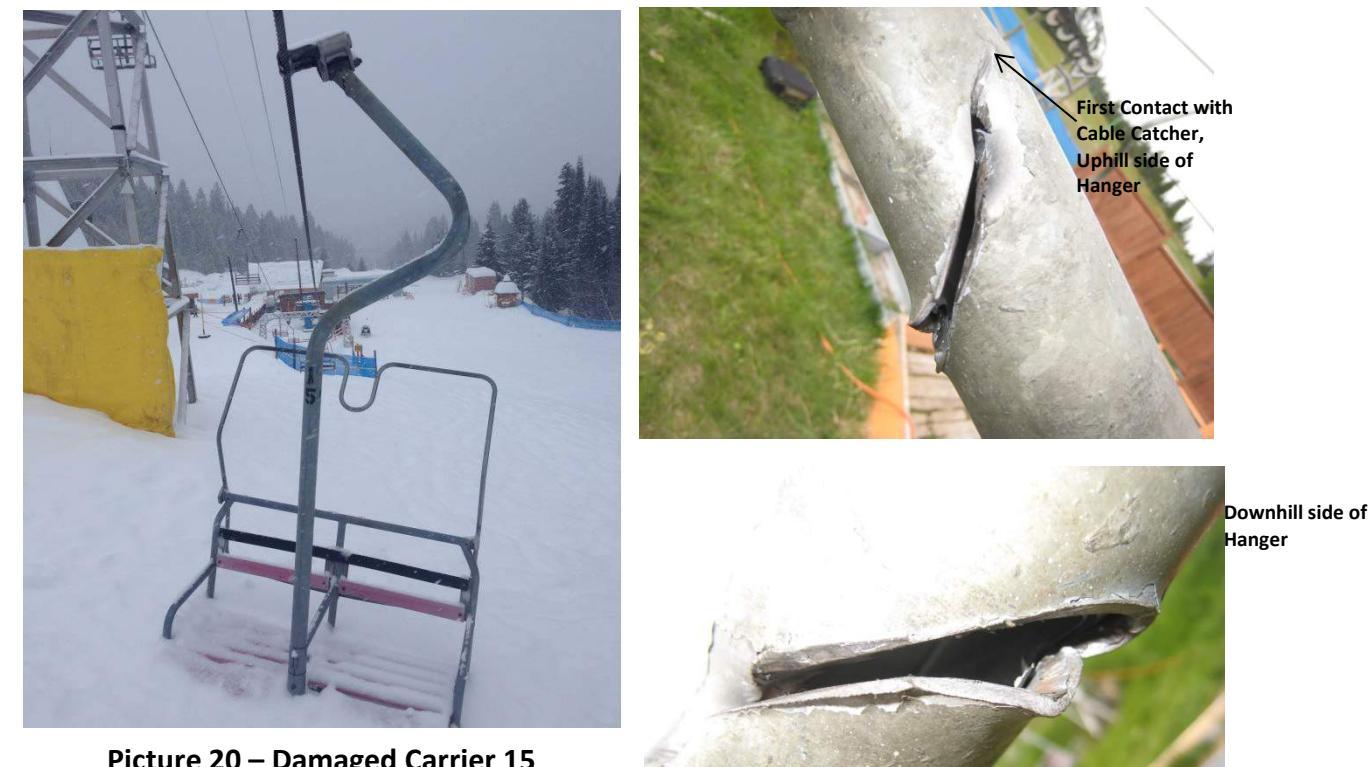
Picture 20 – Damaged Carrier 15

Carrier was empty and was caught and damaged by cable catcher. The seat was down and the arm rest was in the up position. The hanger was deformed and supported some of the weight of the haul rope. The profile shows that for the tower 2 deroped cases that the rope would be below the ground surface. There was severe hanger distortion as evidenced by the angle of the grip.

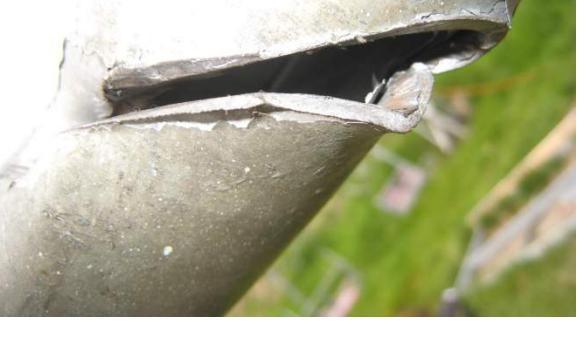
Picture 21 – Detail of Hanger 15 Damage

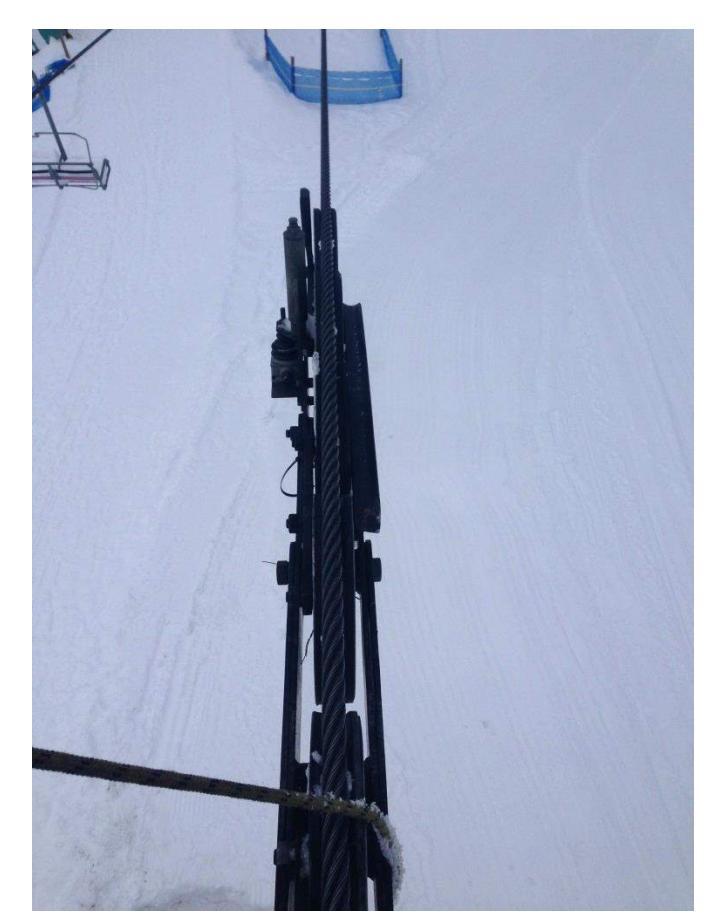
Picture 25 – After Raising Counterweight

Relative to misalignment, Picture 25 shows that most if not all of the damage caused by the deropement occurred on the outgoing end of the cable catcher. It would be most probable if misalignment shown in Pictures 22 and 23 had contributed, the rope would have started to derope at sheave number 1 or the lead-in sheave. The markings on the cable catcher at this point appear to be from a secondary contact of the rope after the start of the deropement or most likely from the "slicing" of the chair hanger since they are less severe and toward the outside of the cable catcher. This can be seen in the following picture.

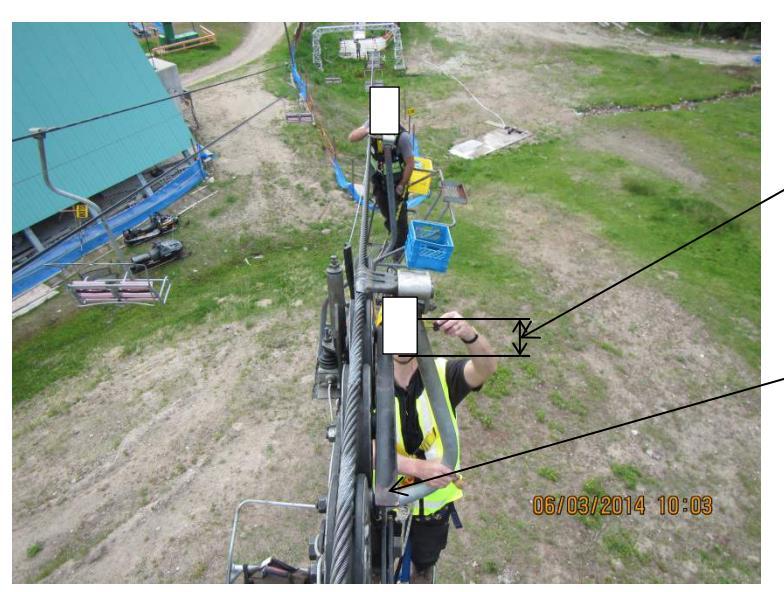
Picture 26 – Damage to Cable Catcher Uphill

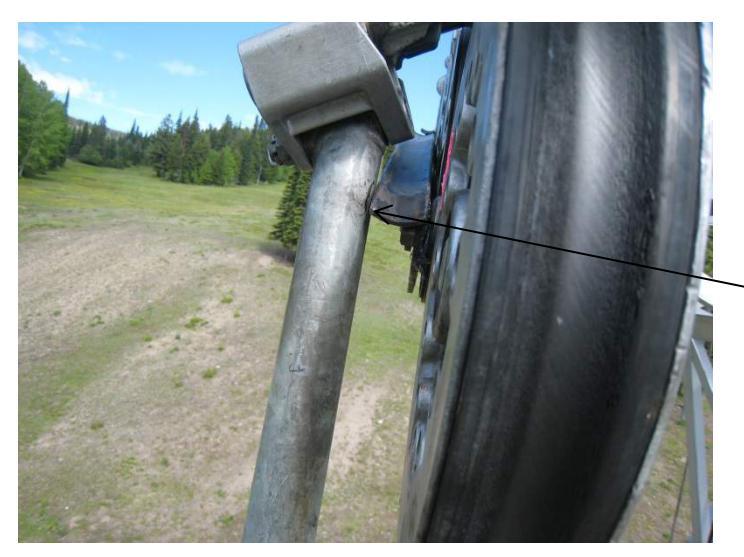
First Contact Point of Hanger with Cable Catcher
