SUPPORTING INFORMATION	Incident Date	September 30, 2021
	Location	Surrey
	Regulated industry sector	Gas - Natural gas system
	Qty injuries	0
	Injury Injury description	N/A
	ତି Injury rating ଅ	None
	=Damage ອີ, description ຍິ	Dangerous concentrations of carbon monoxide (CO) were created and distributed in the hallways of a multi-unit residential tower.
	Damage rating	Major
	Incident rating	Major
	Incident overview	A large air handling unit (AHU) in a 15-story residential tower created conditions in the mechanical room which allowed flue gas, containing high concentrations of CO, to be distributed throughout common hallway areas of the building on two separate occurrences, days apart.
INVESTIGATION CONCLUSIONS		Natural gas fired hot water boilers are used to provide domestic hot water to the units in the building. The boilers vent their flue gases to the outdoors by means of natural draft vent pipes, which pass through the mechanical room roof. Natural draft vent pipes use an open draft hood (Image 4), which draws air from the room into the vent as the hot gases rise in the pipe. The draft hoods of natural draft appliances need to operate in a neutral pressure environment to avoid ba

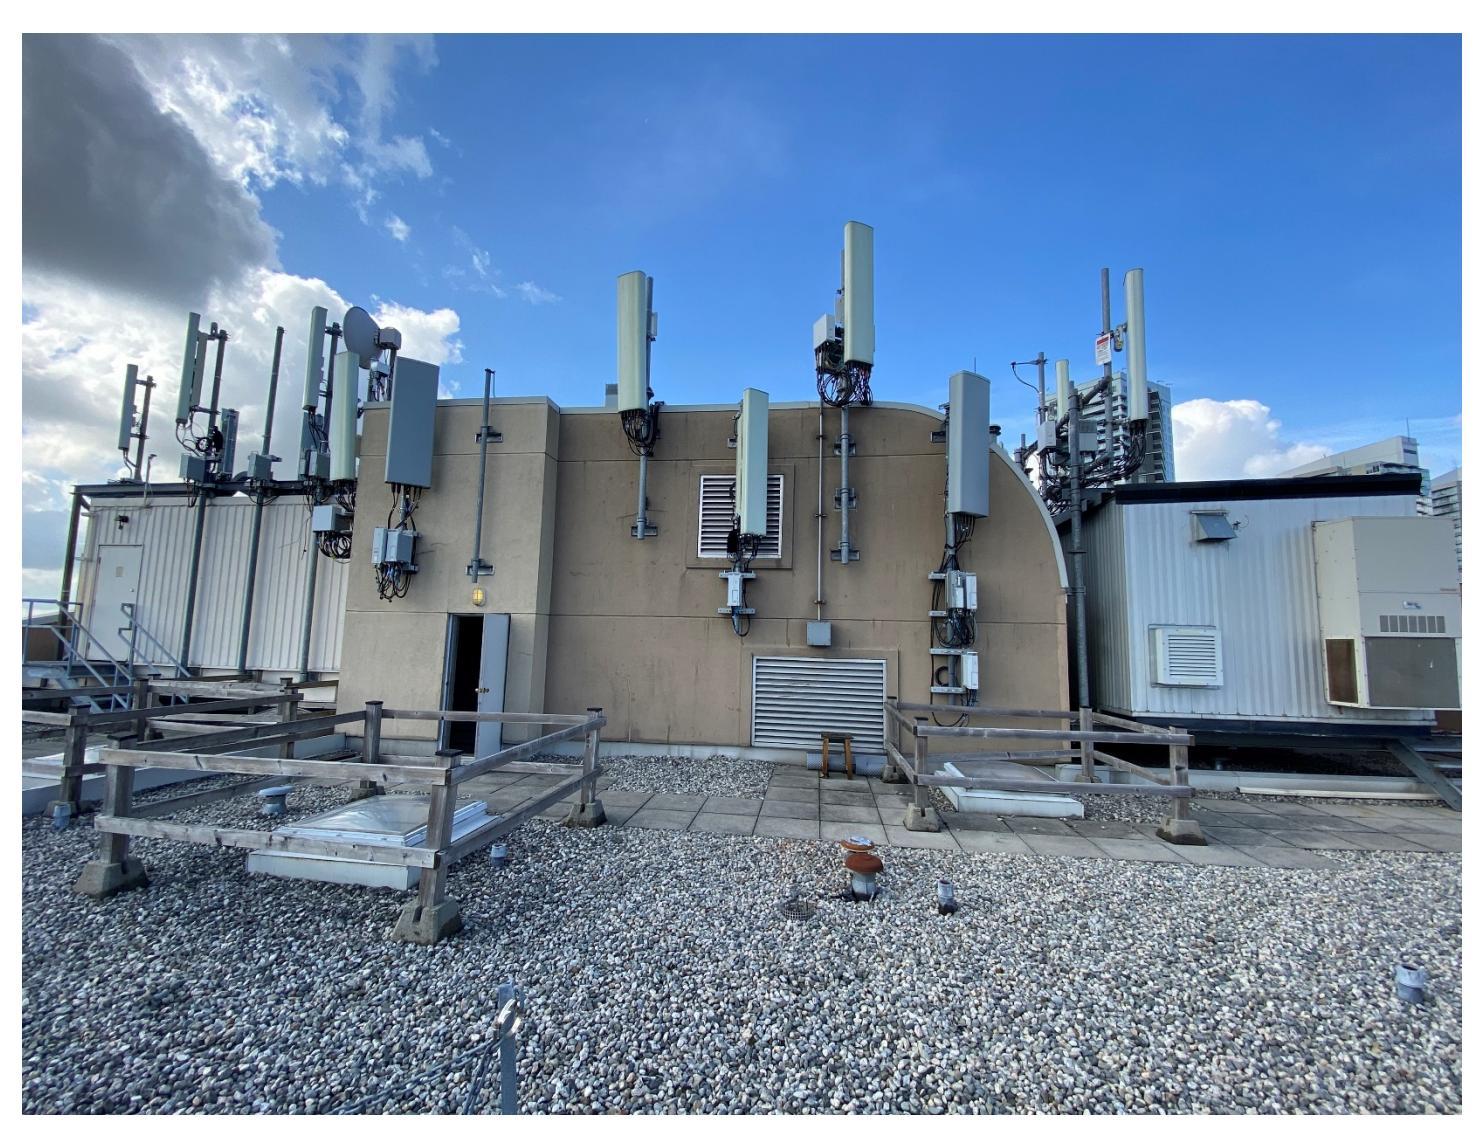
Image 1 – Mechanical room on roof of tower.

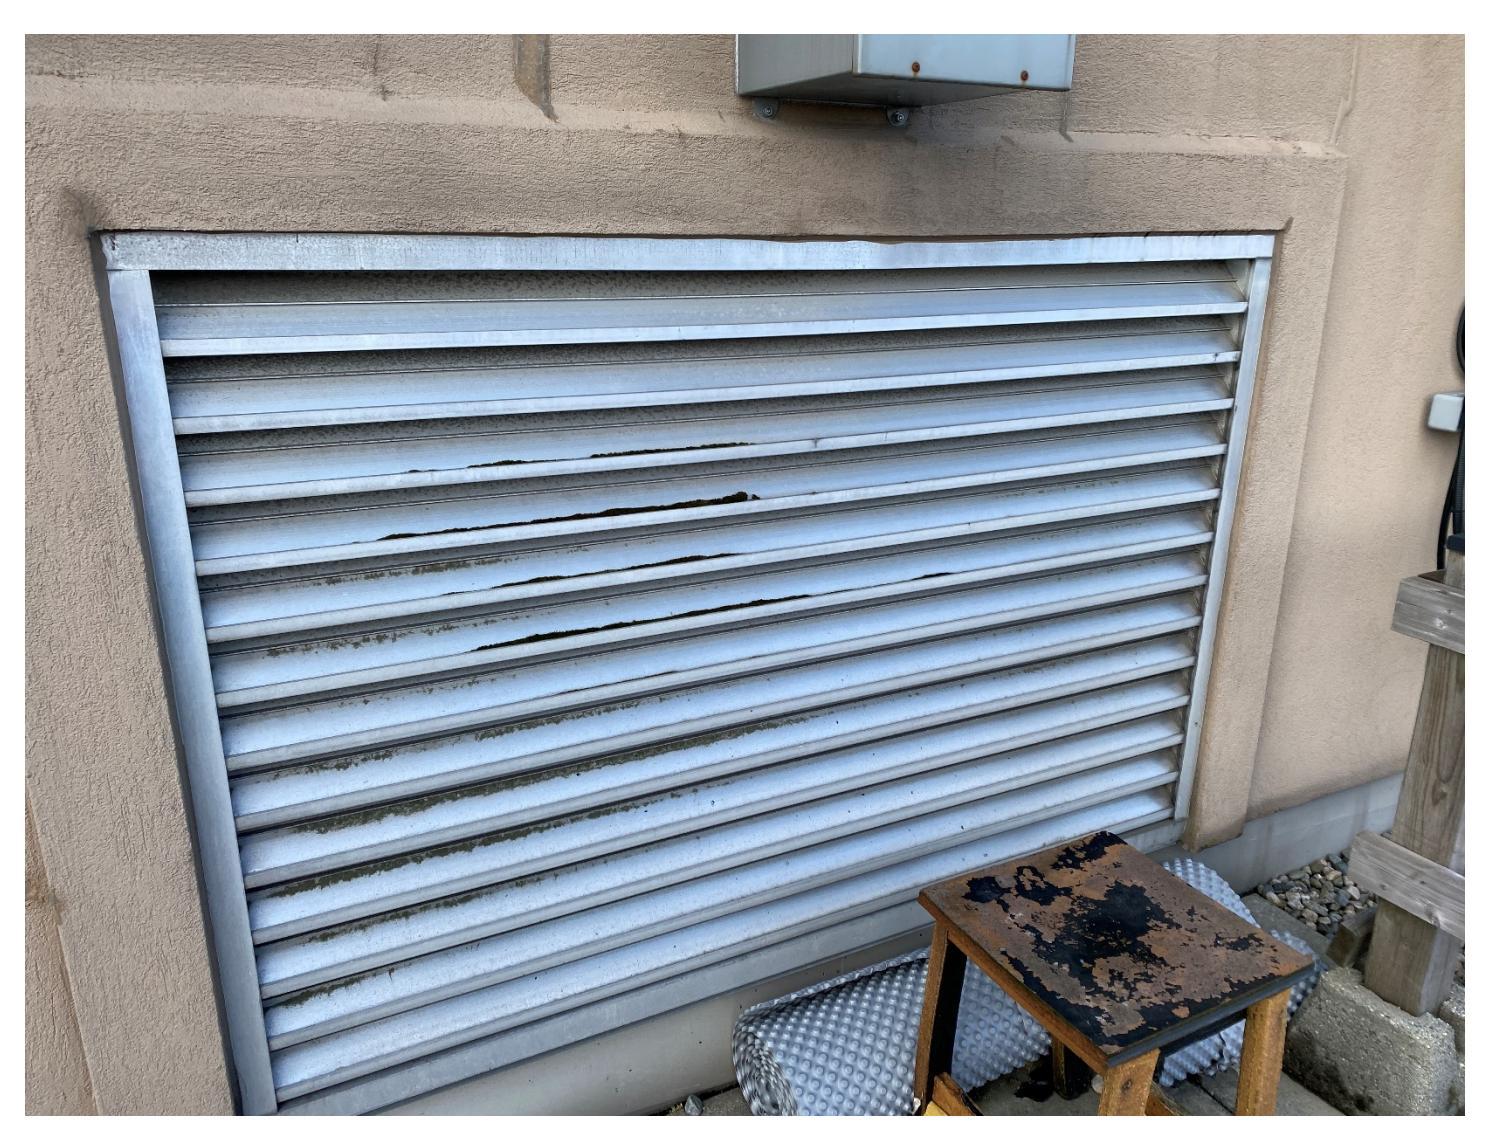
Image 2 – Air intake louver for AHU taking intake air from outside the mechanical room.

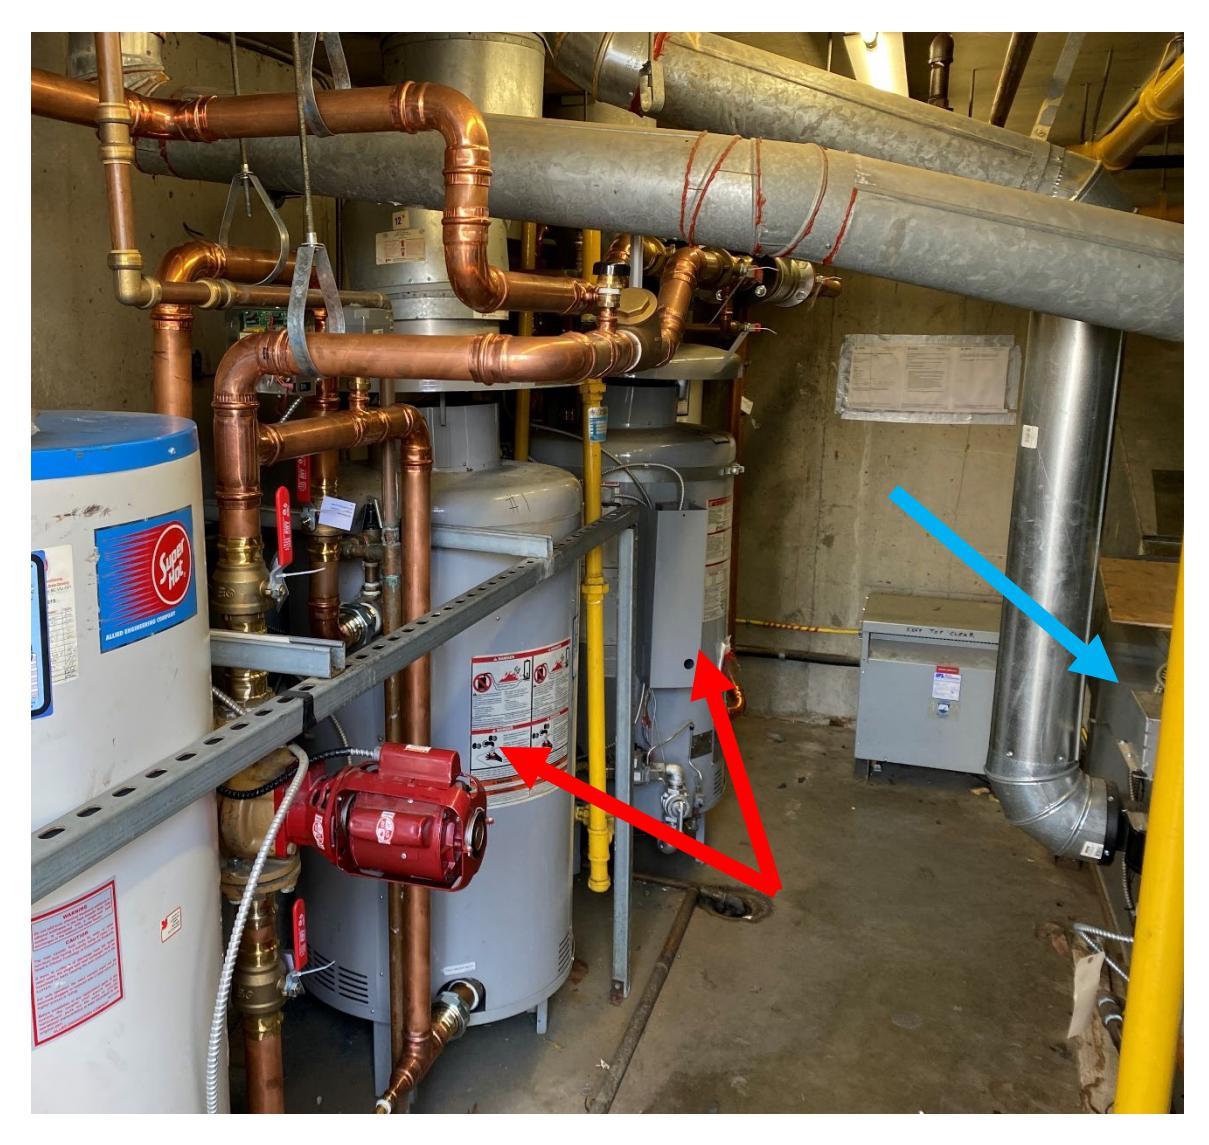
Image 3 – Mechanical room containing the natural draft boilers (red arrows) and the AHU for hallway pressurization (blue arrow).

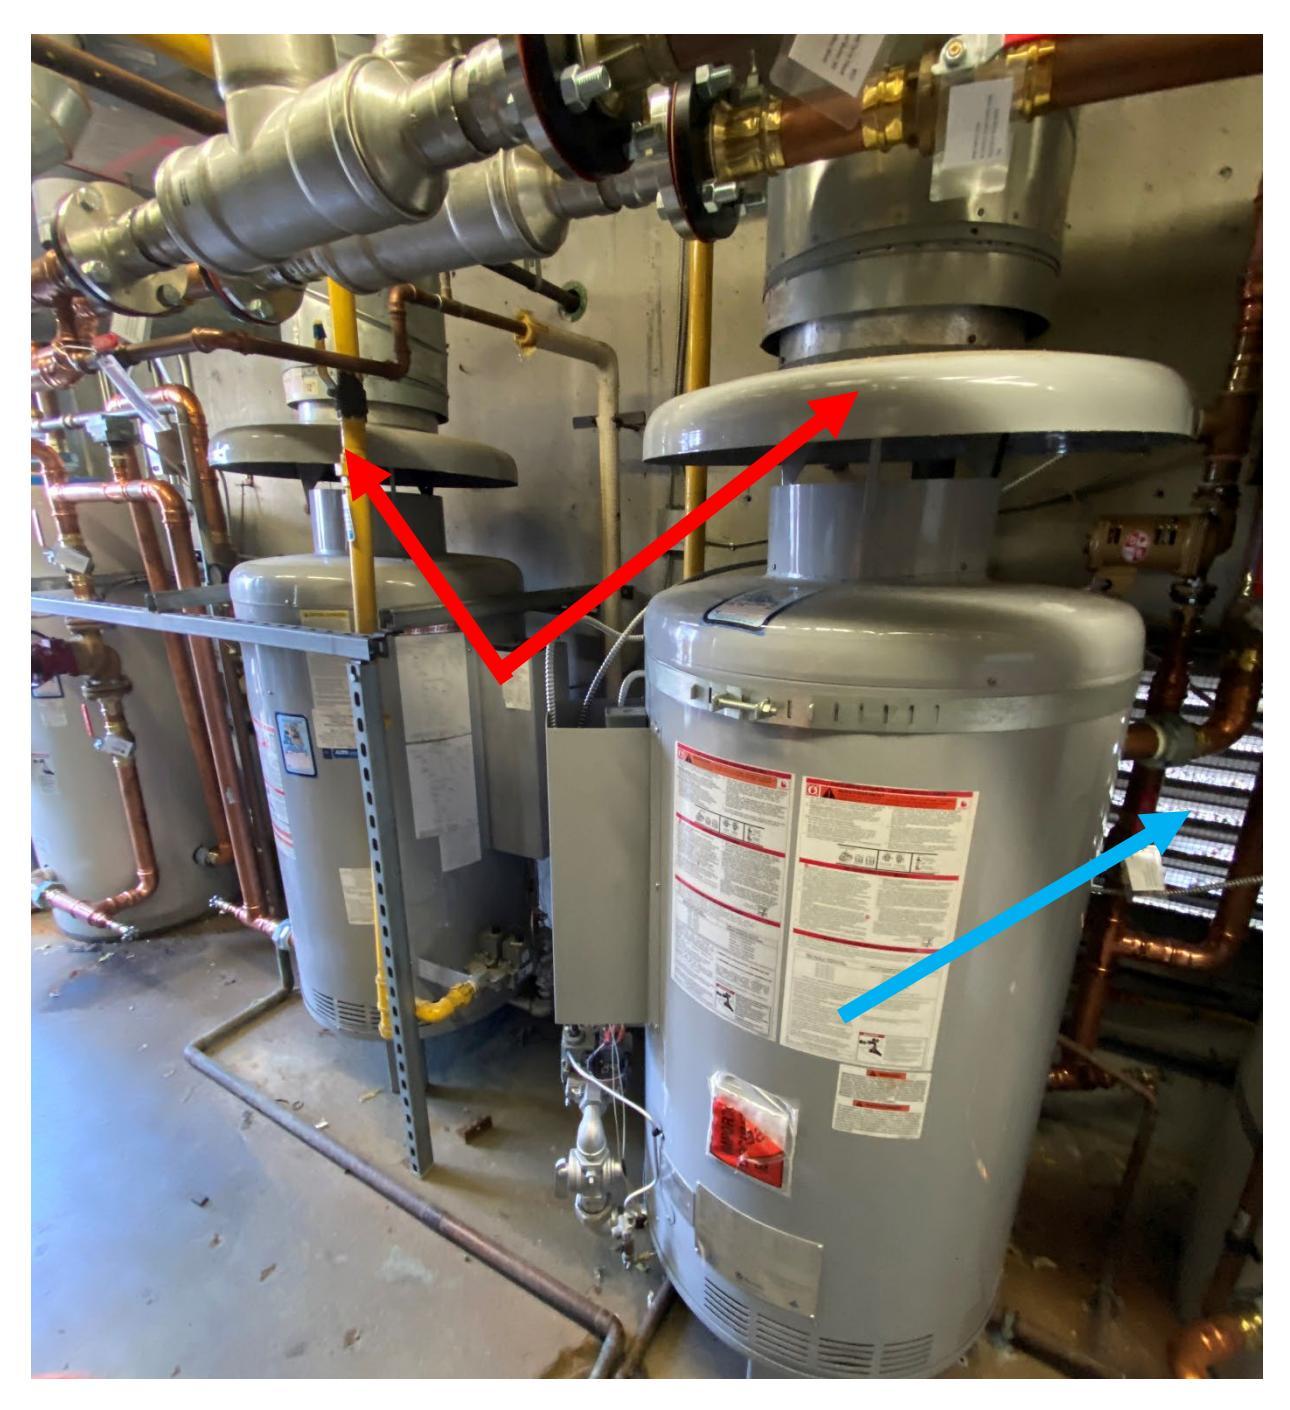
Image 4 – Gas fired hot water boilers. Draft hoods (red arrows), combustion air opening (blue arrow).

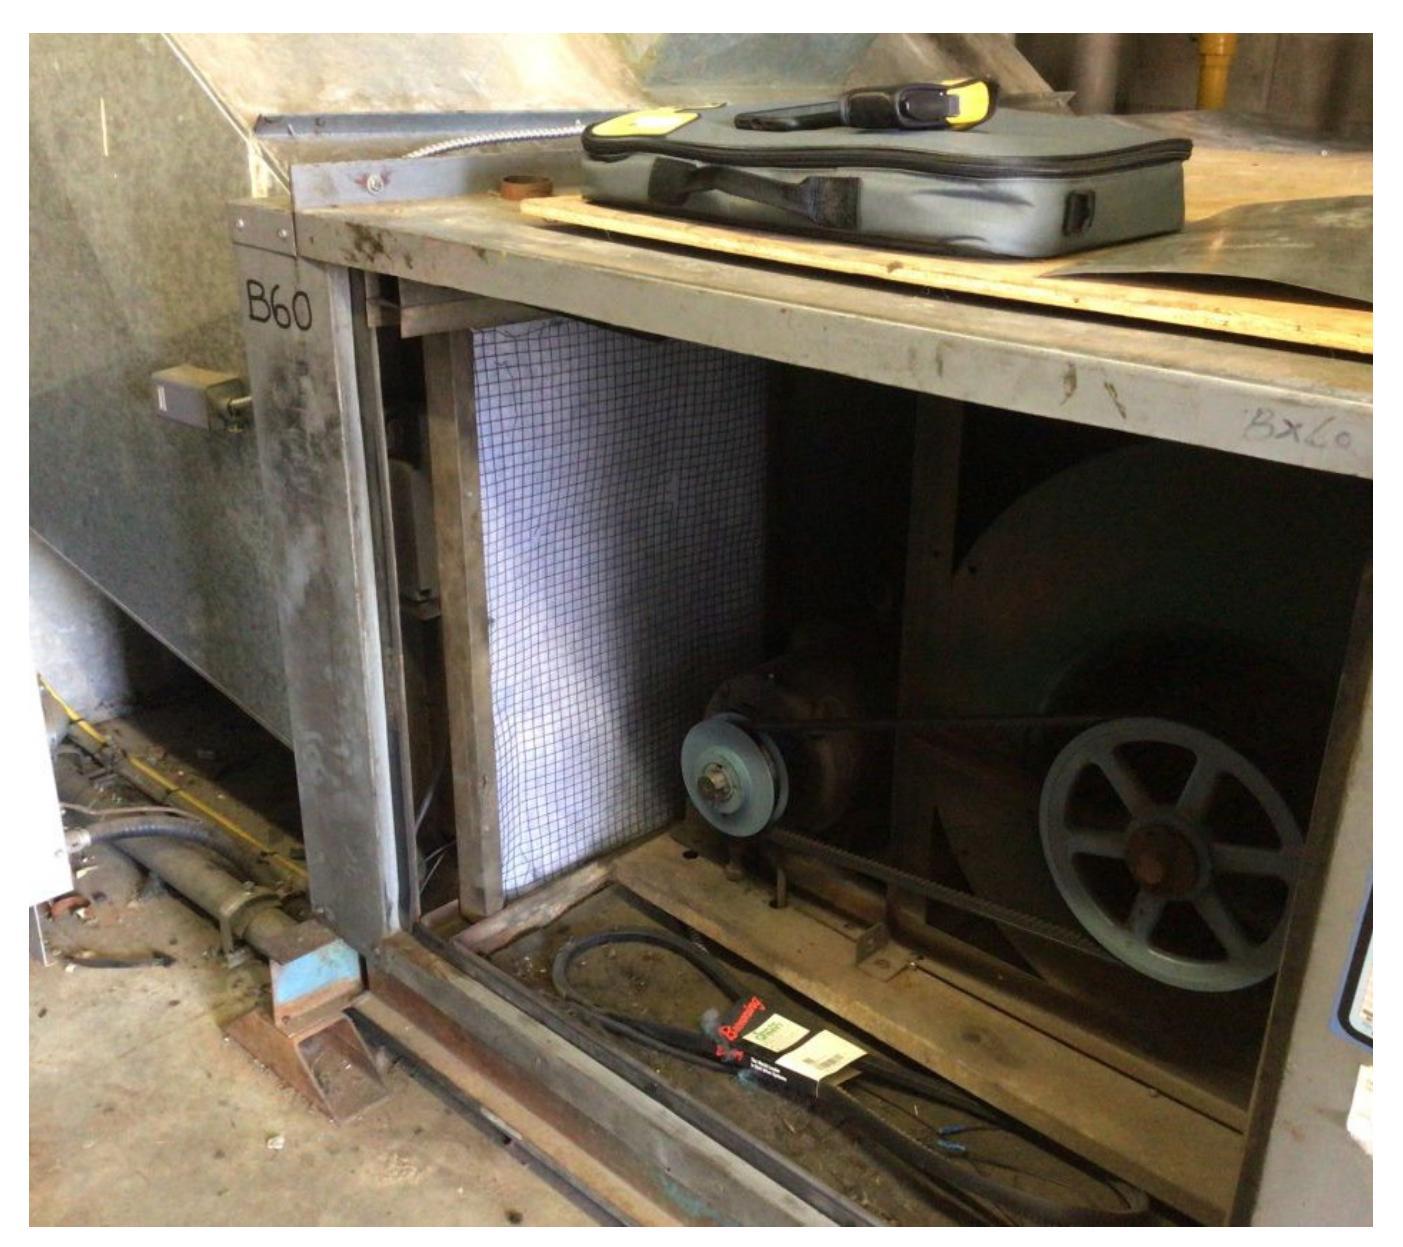
of the mechanical room. Filters are installed inside the intake ducting to filter dust and debris from the incoming air (Image5). The filters need to be changed on a regular basis, or as needed to avoid restriction of the air as they become dirty and clogged. The B149.1 Gas installation code states that gas appliances shall not be operated when other equipment, including fans, adversely affect the venting or combustion of the appliance.
Failure scenario(s)	The mechanical room on the rooftop of a 15 story residential tower houses two gas fired boilers, and an air handling unit (AHU) used for ventilation and hallway pressurization. The two boilers were operating with elevated levels of CO in the flue gases up to 1300ppm. The AHU has a metal duct which allows all the intake air to be drawn through a louvered opening in the mechanical room directly from the outdoors. The ducting contains filters, which filter the incoming air from dust and debris. The filters are scheduled to be changed quarterly, and they had become dirty and restrictive since they were last changed three months prior. Extensive plumbing work had taken place in and around the mechanical room during that time, which may have accelerated the rate the filters became dirty. The ducting, metal case, and access doors for the AHU has several unsealed gaps which allowed air to be drawn in from the mechanical room. The restricted filters and unsealed gaps between the filters and the blower, caused the AHU to draw in excessive amounts of air from the mechanical room instead of from outdoors. This created a negative pressure environment in the room and allowed back drafting of the boiler flue vents. The flue gasses containing hazardous levels of CO was drawn into the unsealed openings and through the AHU, which then distributed it into the hallways of the tower through the AHU ducting.

maintenance. If elevated levels of CO are being generated by the appliance, they may not be identified if the appliance is venting correctly.
	<ul> <li>Once a year, or as required, they submit a request to the strata management</li> </ul>
	company for a more in-depth disassemble and cleaning of the appliance. If
	the request is approved, the appliance is disassembled, cleaned,
	reassembled, and tested including combustion analysis.
	Maintenance contractor heating technician
	<ul> <li>On September 27<sup>th</sup>, they attended the site and met with the gas utility technician.</li> </ul>
	<ul> <li>They tested the draft of the boilers with a smoke test while the AHU was off, and the boilers vented properly.</li> </ul>
	<ul> <li>When the AHU was turned on, they could physically feel the warm flue gases</li> </ul>
	back drafting into the mechanical roof from the boiler vents.
	<ul> <li>They opened the AHU and found the filters were very dirty and restricting the intake airflow.</li> </ul>

Image 5 – AHU with access door open showing blower and new intake filters installed after the incident.

• The filters were removed, and the mechanical room was tested for spillage of
	CO, and the AHO and boller were left operating.
	• September 29", new inters were installed in the And and the mechanical room was tested again with a basic CO detector without a digital display and
	it did not alarm.

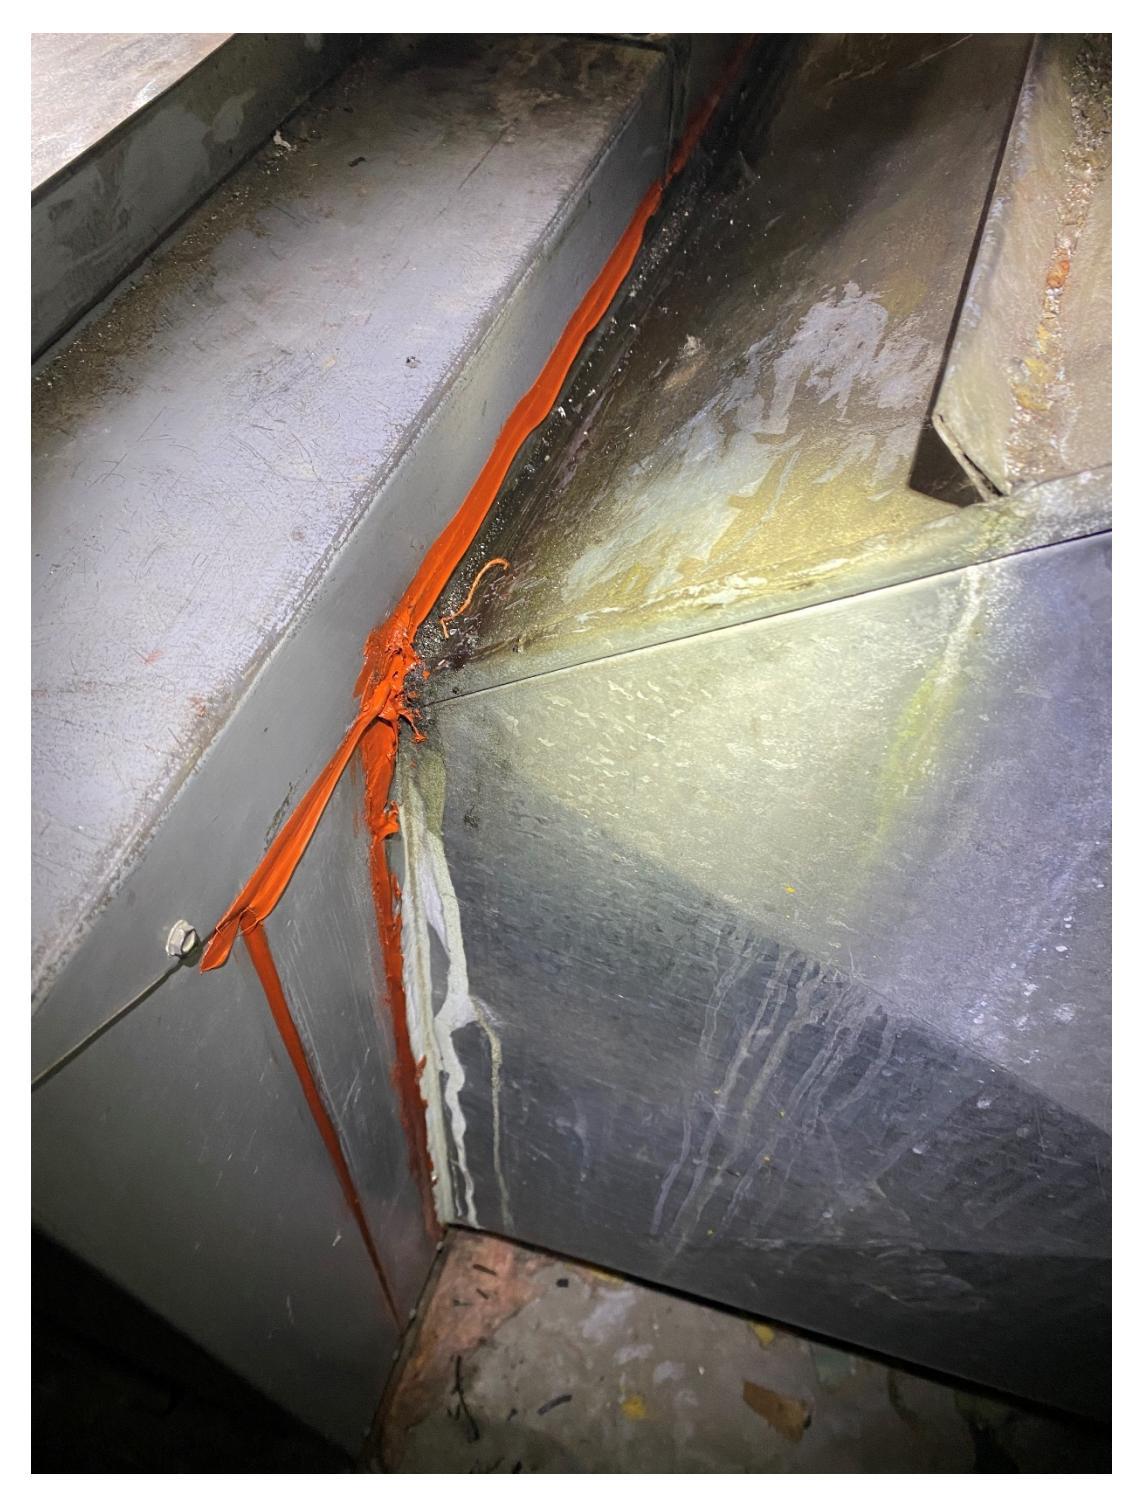
• On September 30 <sup>th</sup> , they were called out again for the second occurrence of
	CO detected in the building.
	<ul> <li>Gaps were found in the intake ducting and access doors for the AHU, which allowed air to be drawn in from the mechanical room.</li> </ul>
	<ul> <li>The Fire Department was on scene and was evacuating the building</li> </ul>
	<ul> <li>The boilers and AHU were shut off.</li> </ul>
	<ul> <li>During on-site testing of the boilers for the investigation, the technician</li> </ul>
	stated that they did not believe that the 1300ppm CO measured in the flue
	gas was a concern. They stated they thought the appliances would produce
	this amount in normal operation.
	Strata management company
	There is a preventative maintenance program, and a maintenance contract
	with gas contractors.
	<ul> <li>The contractor does quarterly maintenance checks and provides cost estimates for any additional maintenance and repair work</li> </ul>

Image 6 – Gaps around intake air duct connection inside mechanical room between the filters and the blower that were sealed with red silicone after the incident.

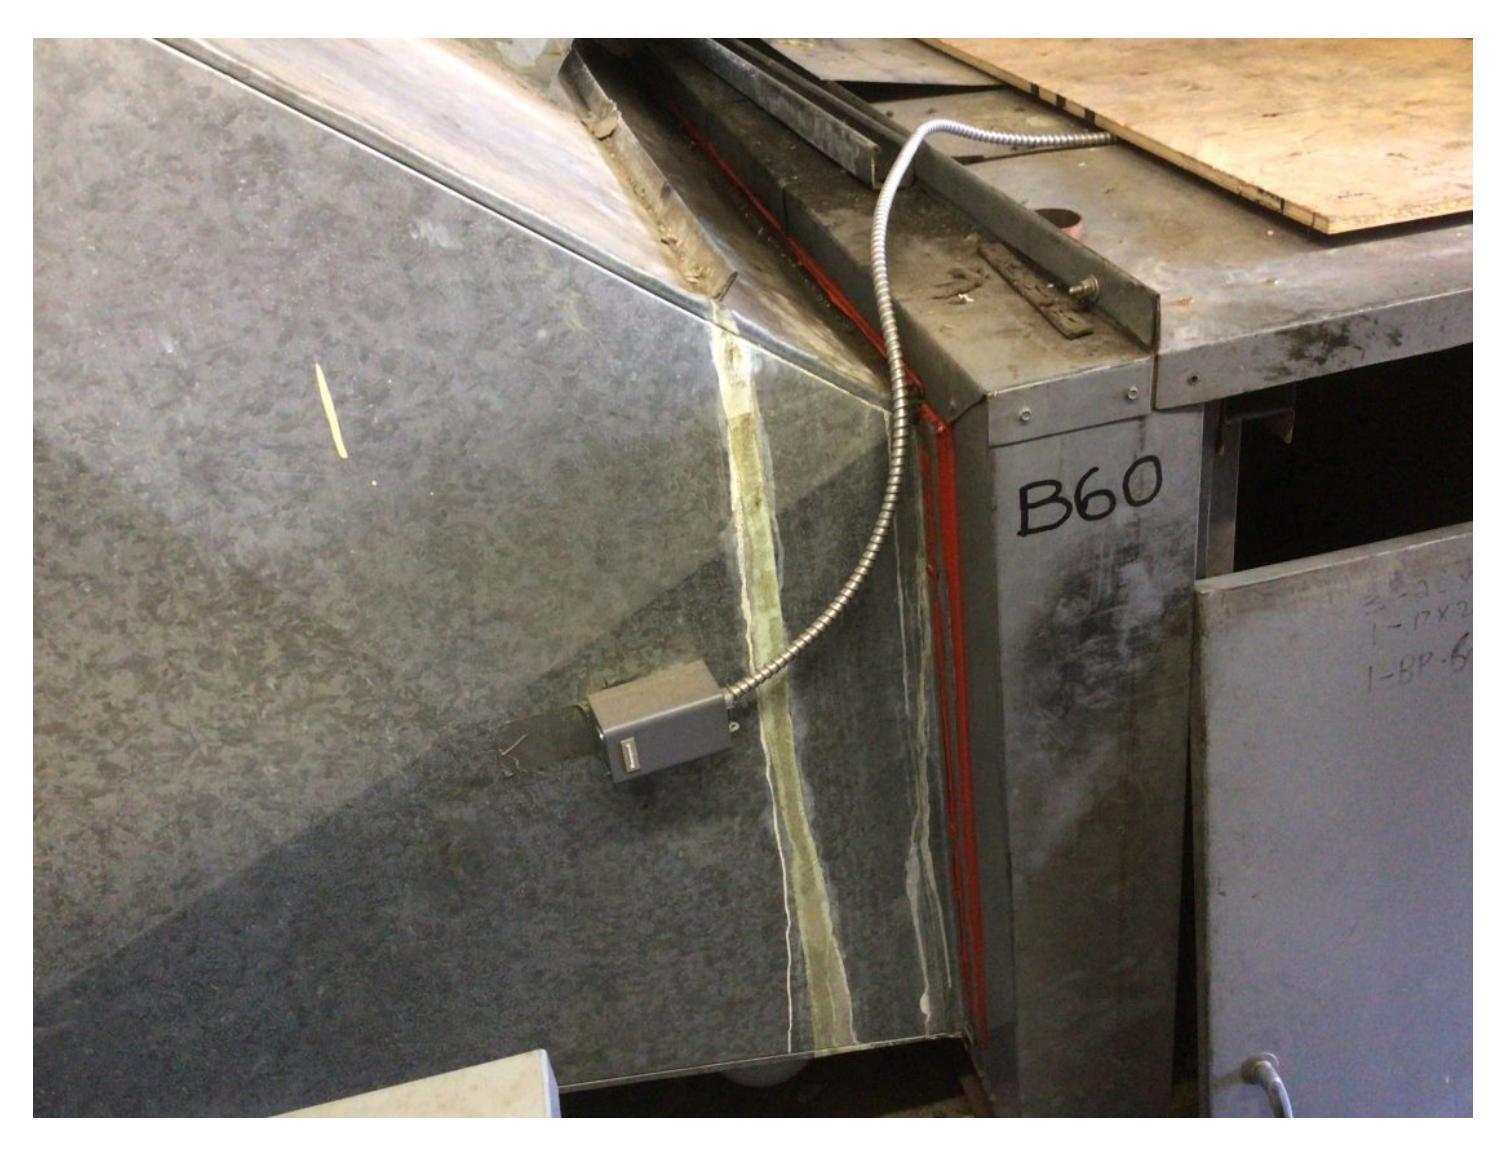
Image 7 - Gaps around intake air duct connection inside mechanical room between the filters and the blower that were sealed with red silicone after the incident.
