Revised on May 15, 2025

## Incident Summary #II-1865169-2025 (#56294) (FINAL)

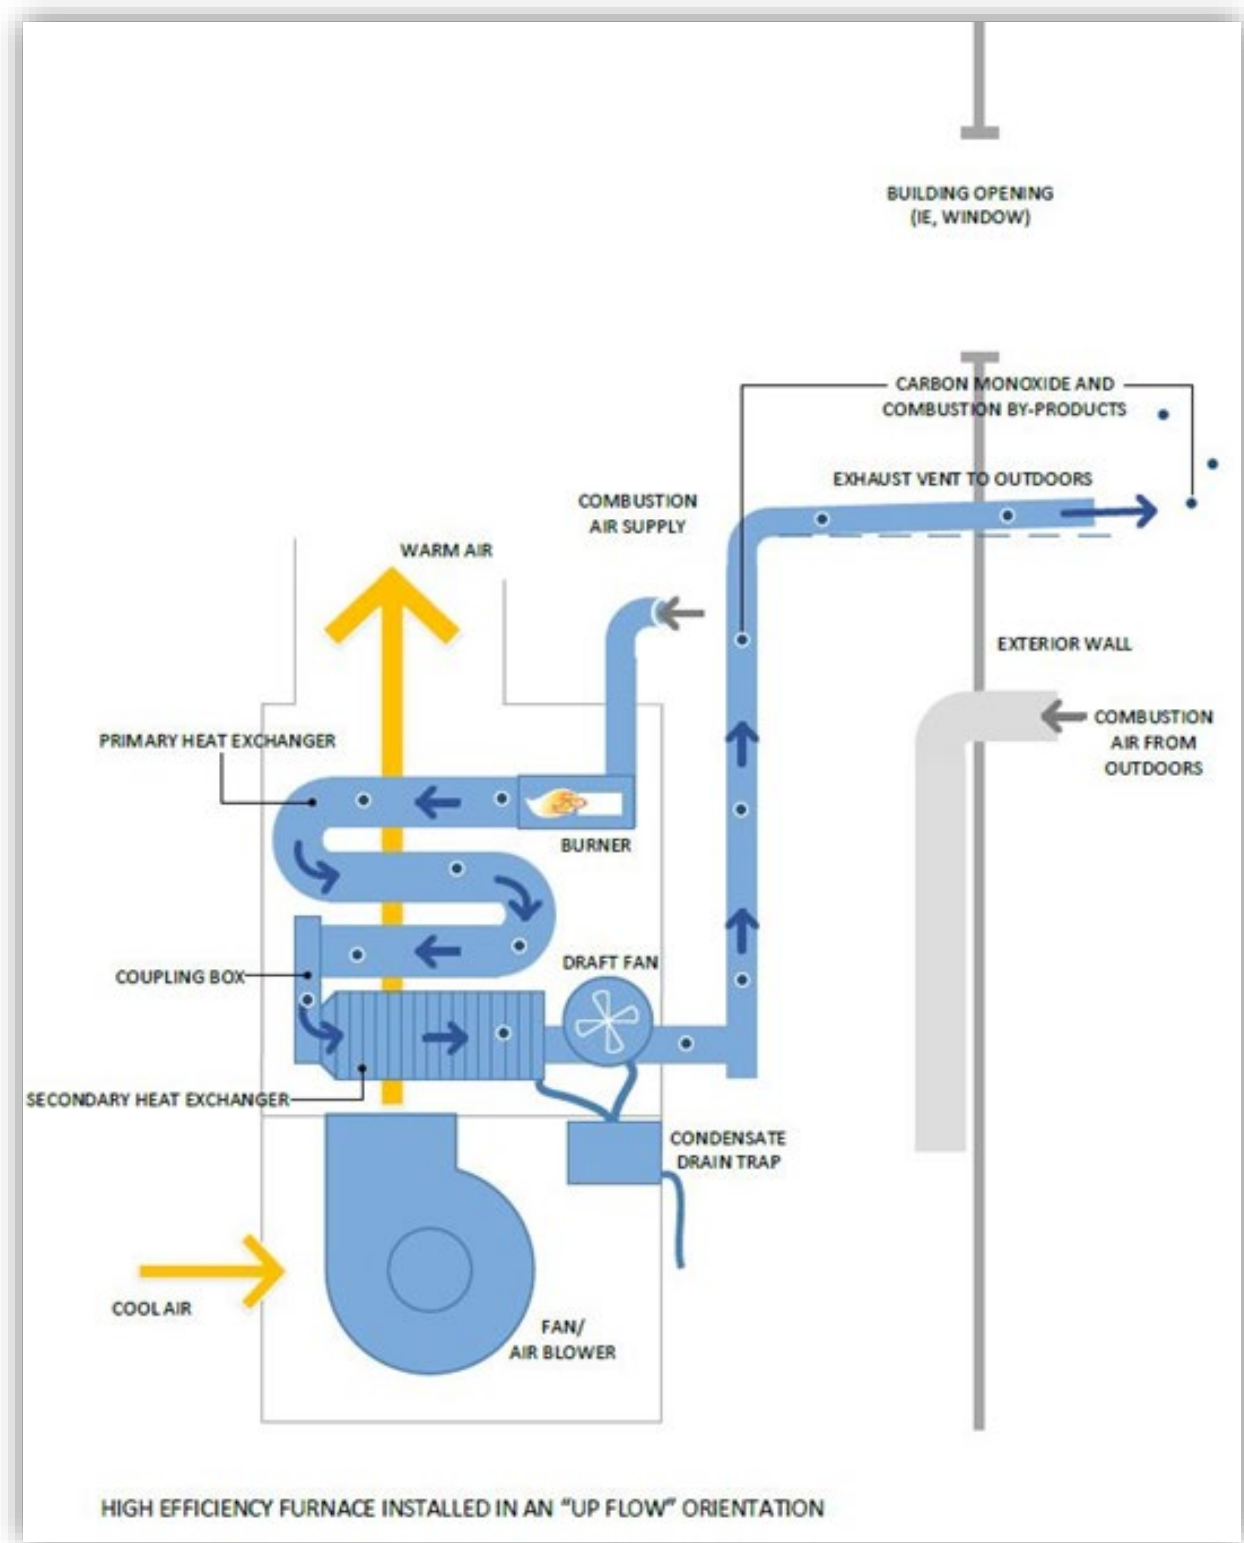
Diagram 1 – Typical furnace operation. Arrows are in the direction of flue gas flow and dark coloured dots represent carbon monoxide.

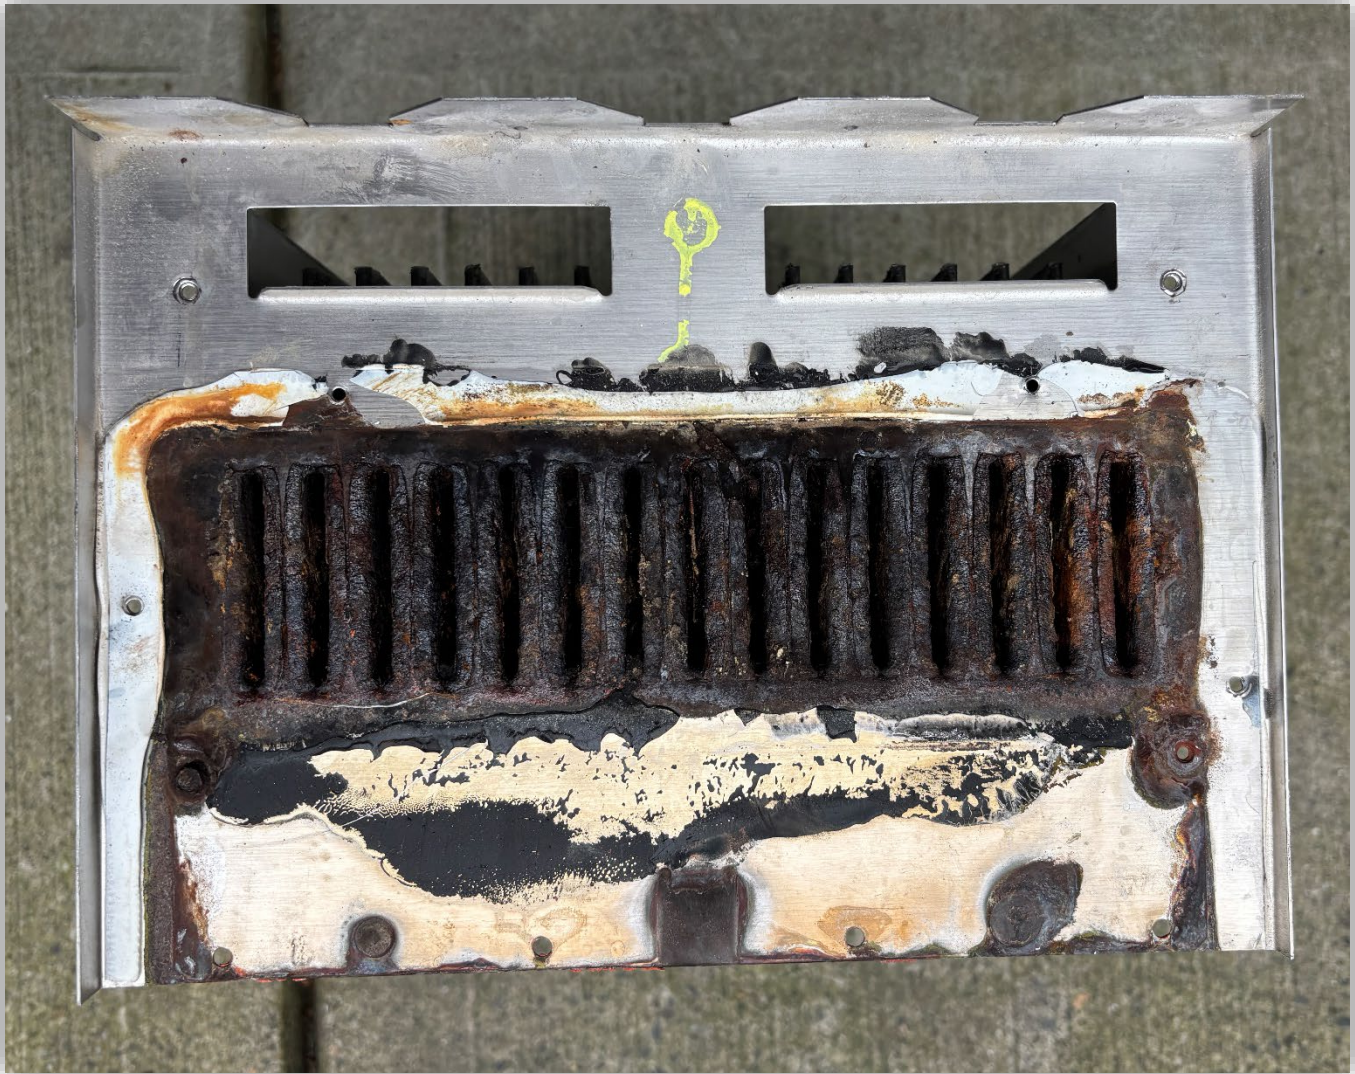
Image 6 – Inlet to secondary heat exchanger showing corrosion and blockages.

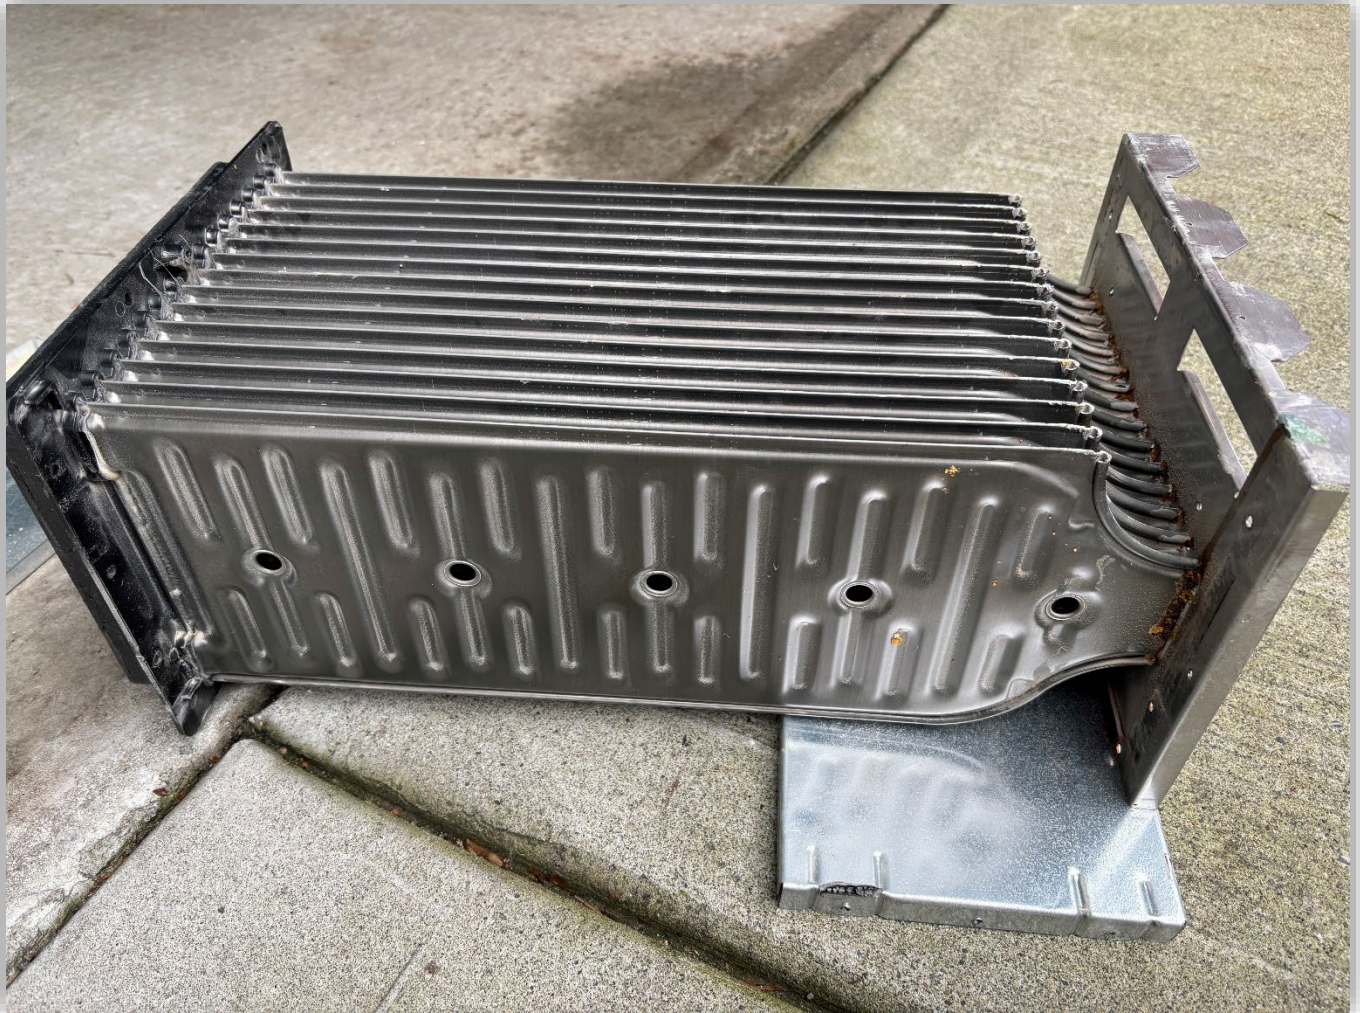
Image 7 – Exterior of secondary heat exchanger tubes.

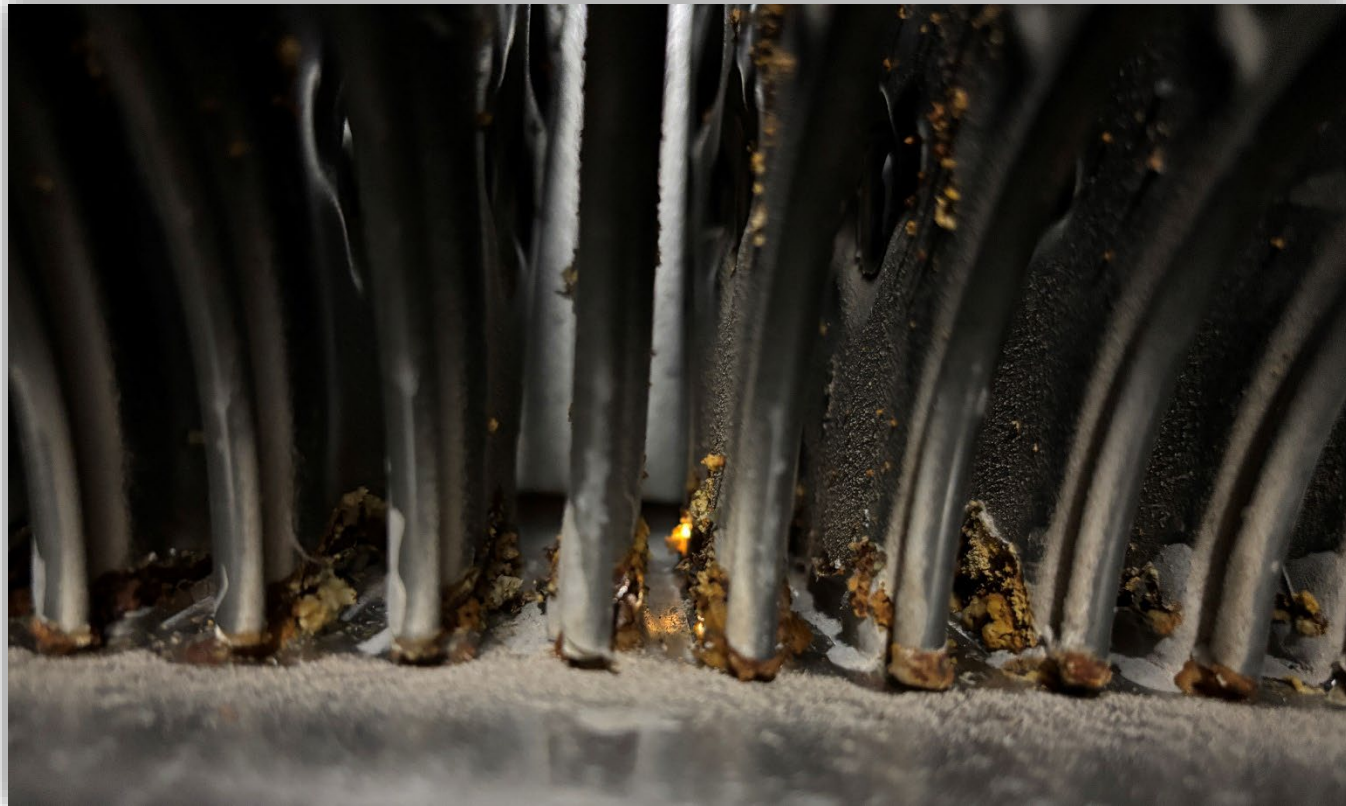
Image 8 – Closeup of secondary heat exchanger tube inlets showing corrosion.

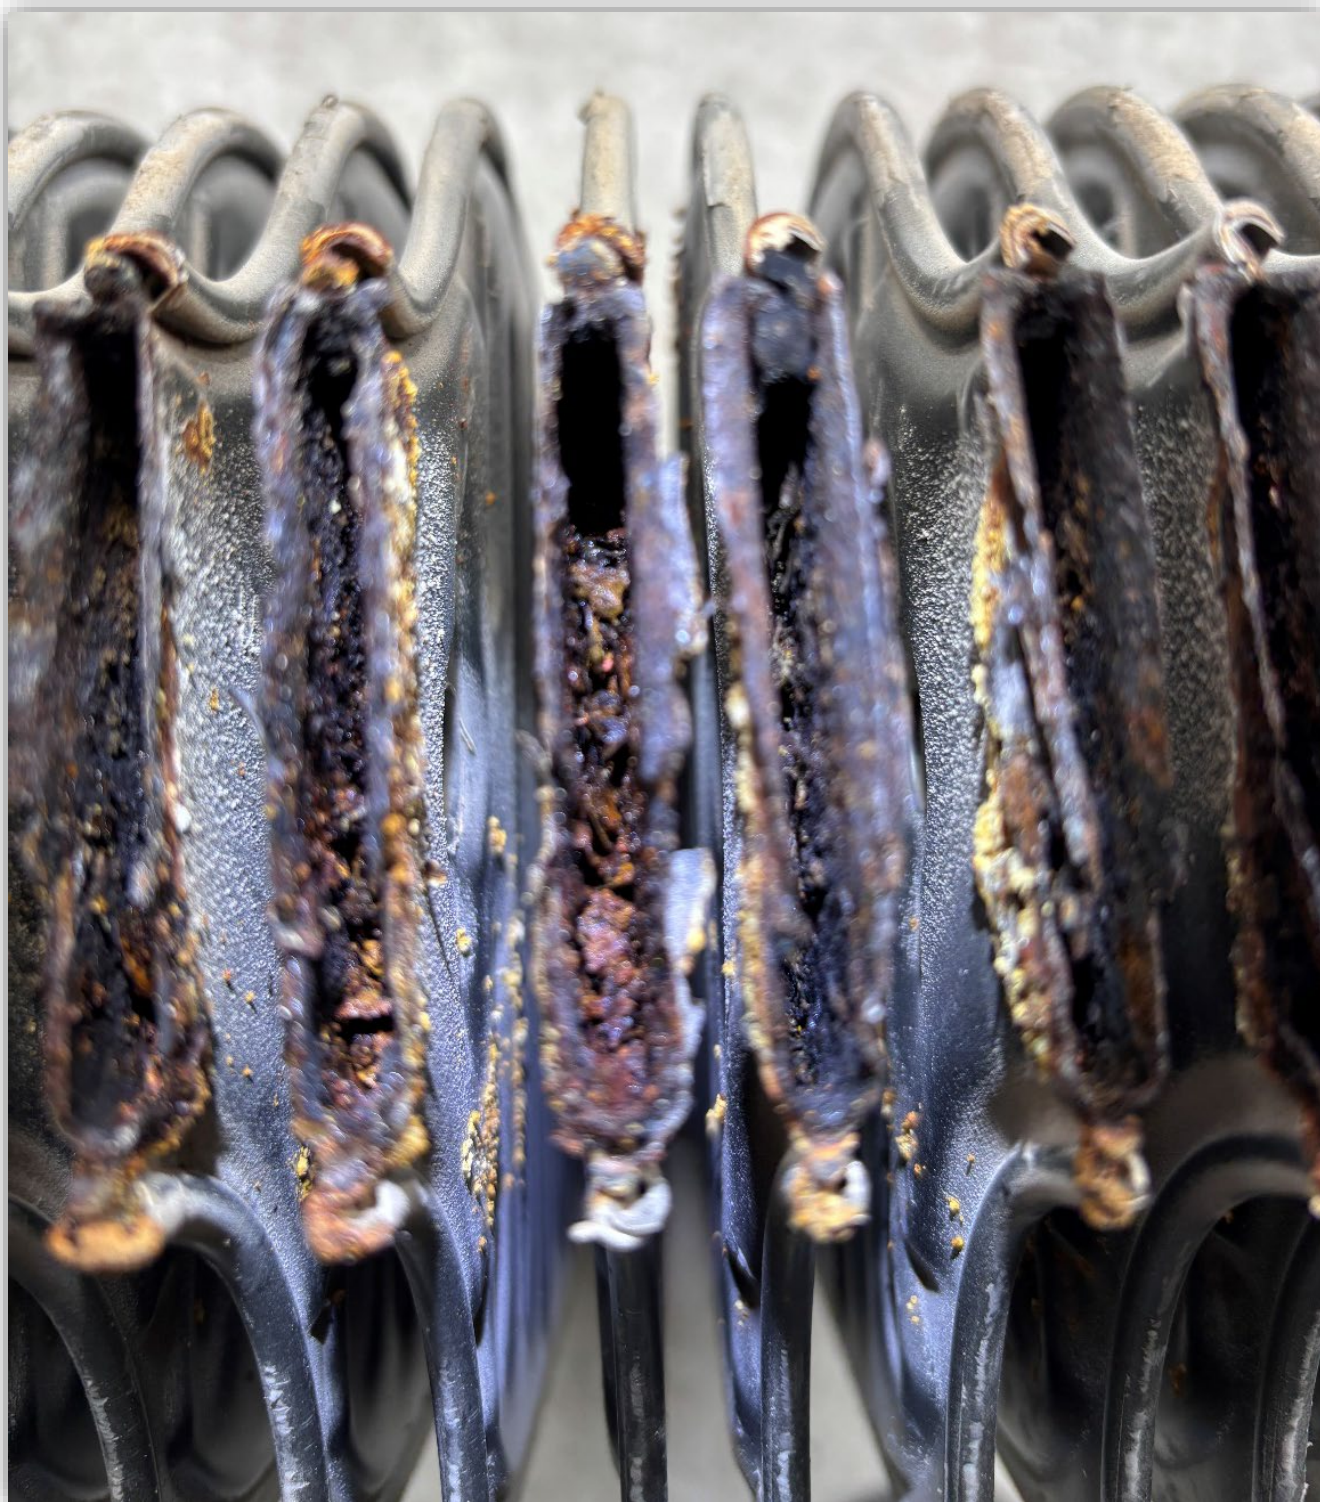
Image 9 – Secondary heat exchanger tube inlets showing corrosion and blockages.

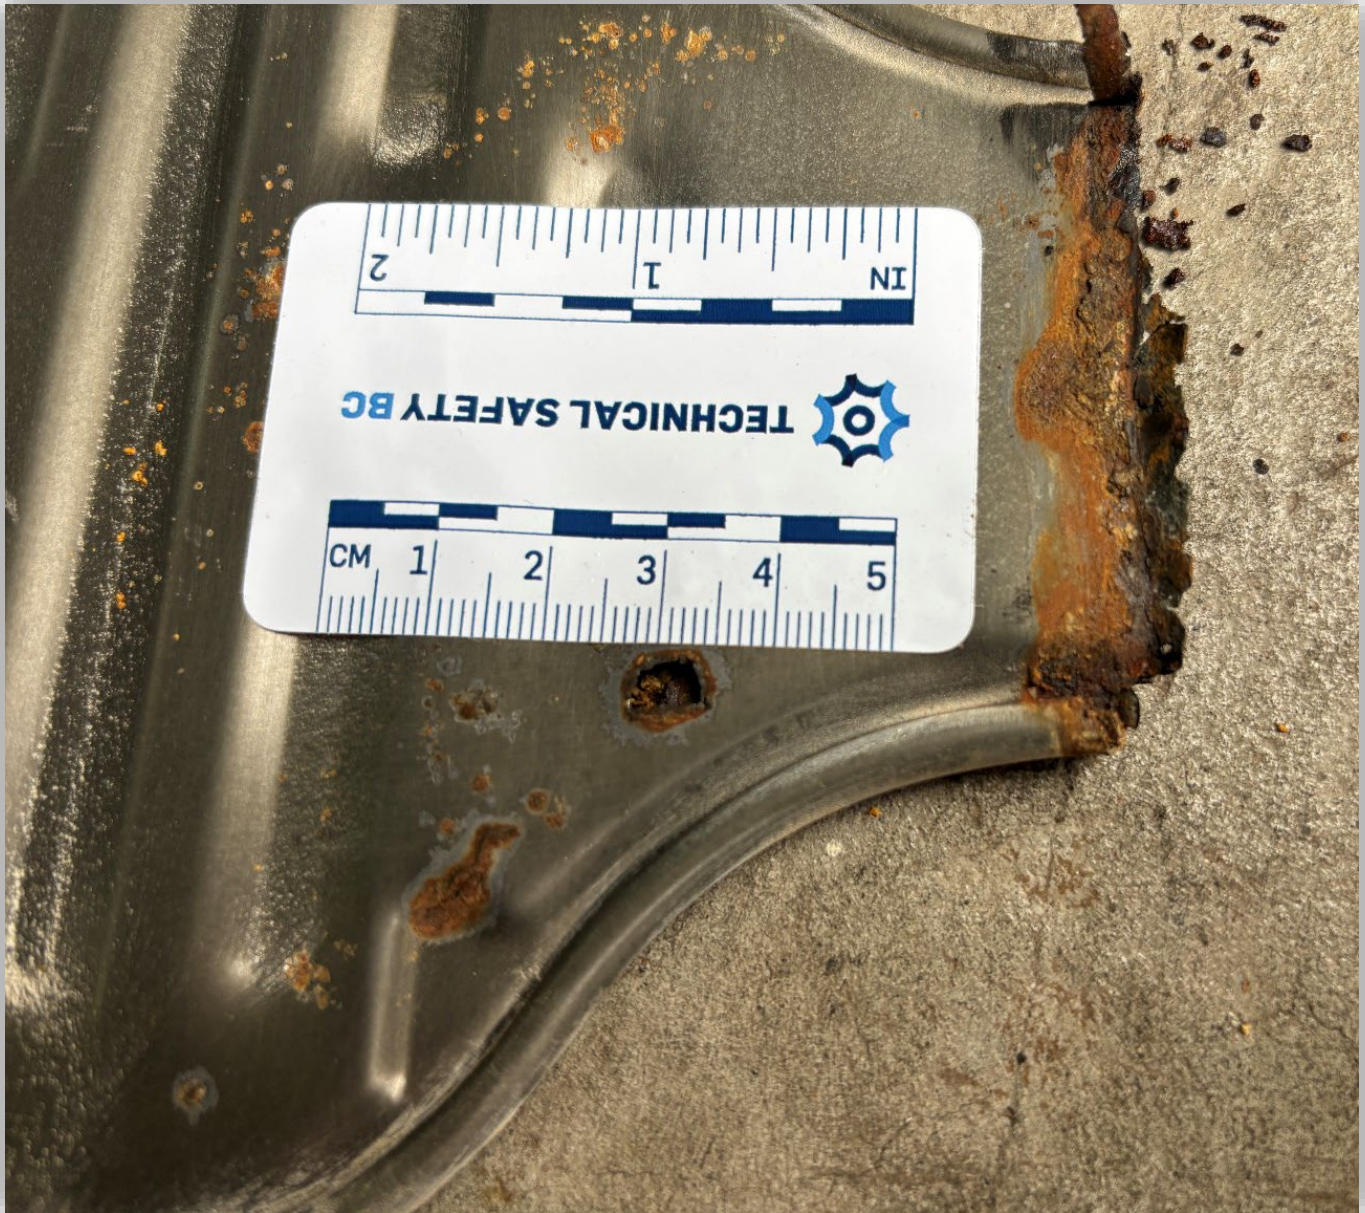
Image 10 – 5-6mm corrosion hole in secondary heat exchanger tube.

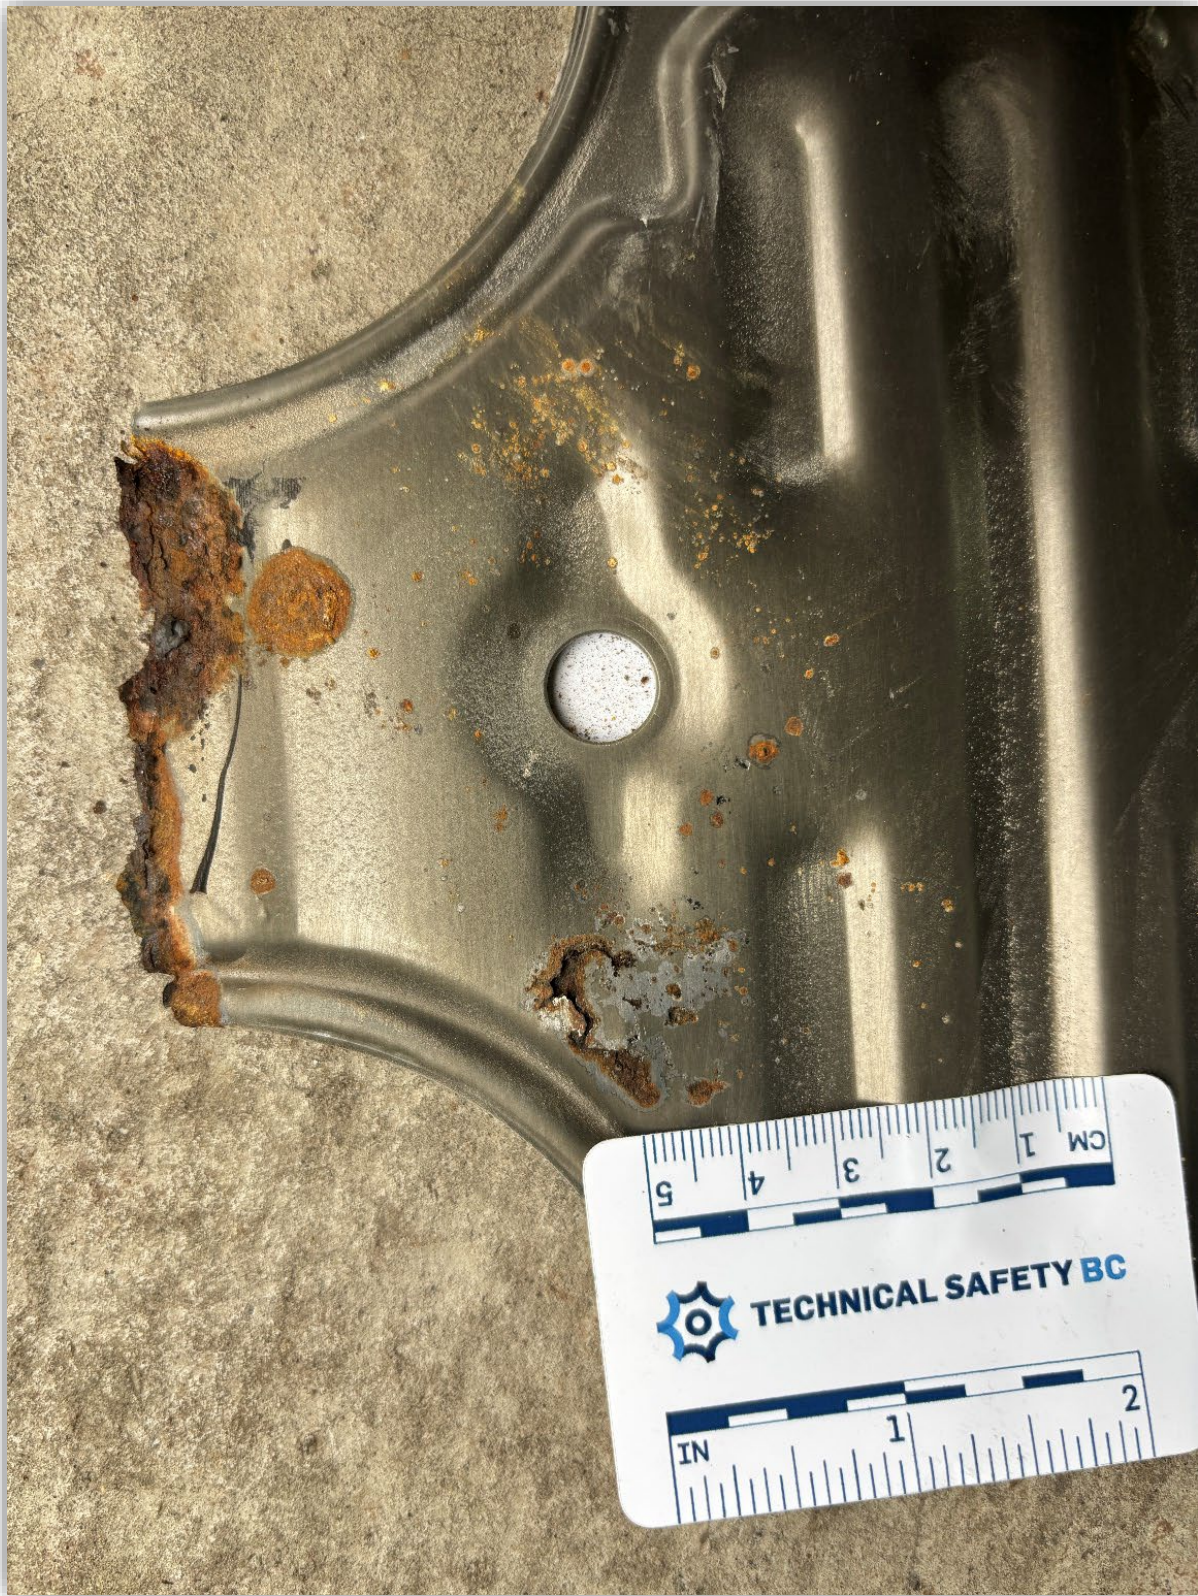
Image 11 – Corrosion hole in secondary heat exchanger tube.

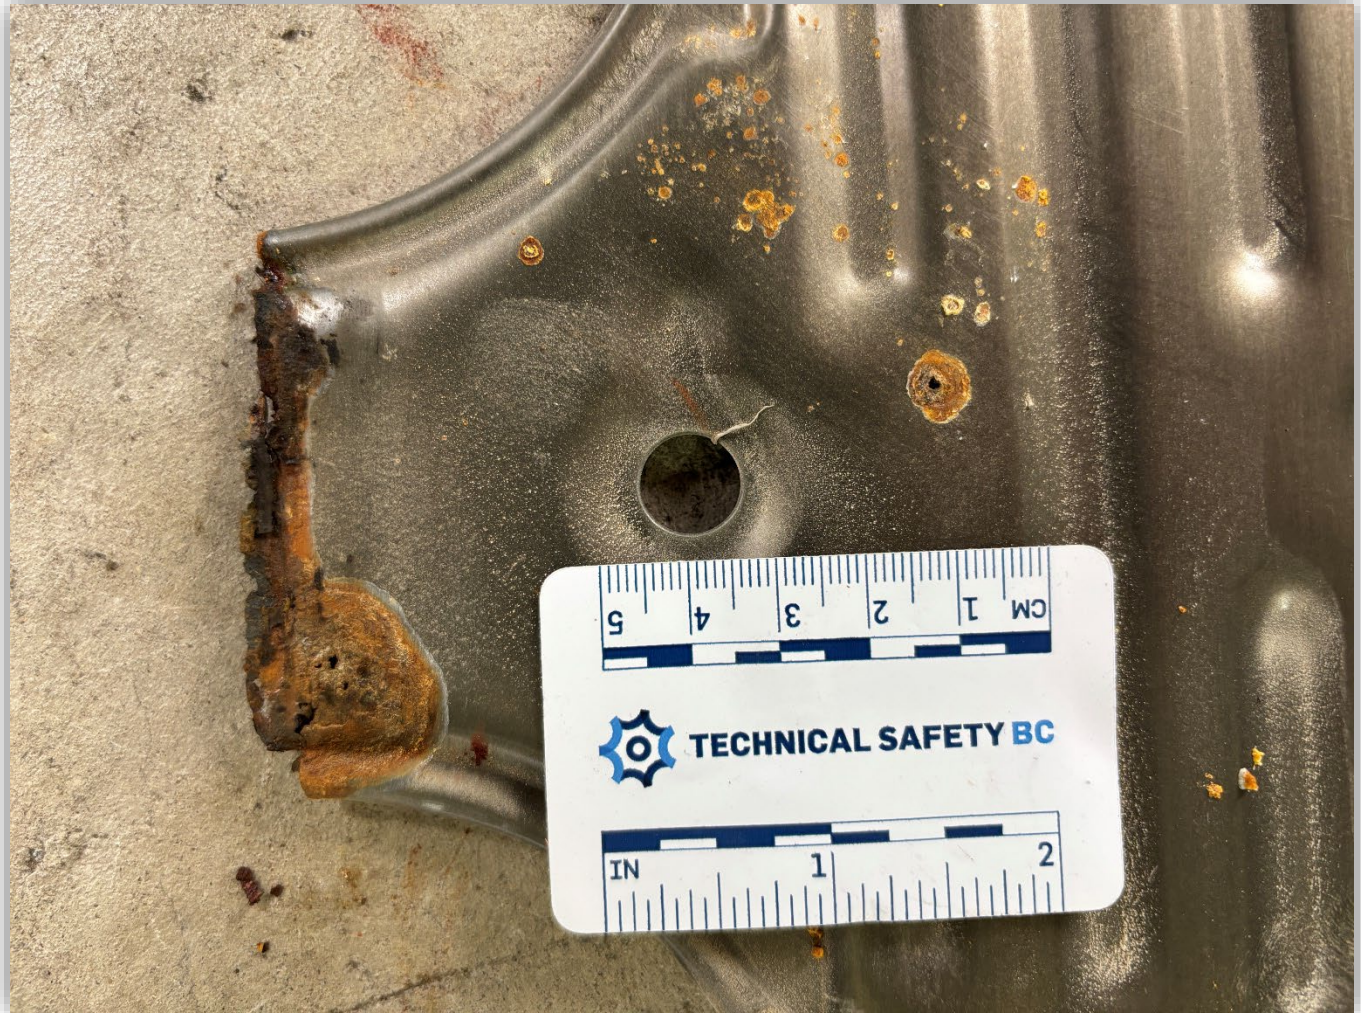
Image 12 – Corrosion hole in secondary heat exchanger tube.
