Incident Summary #II-1977850-2025 (#58852) (FINAL)

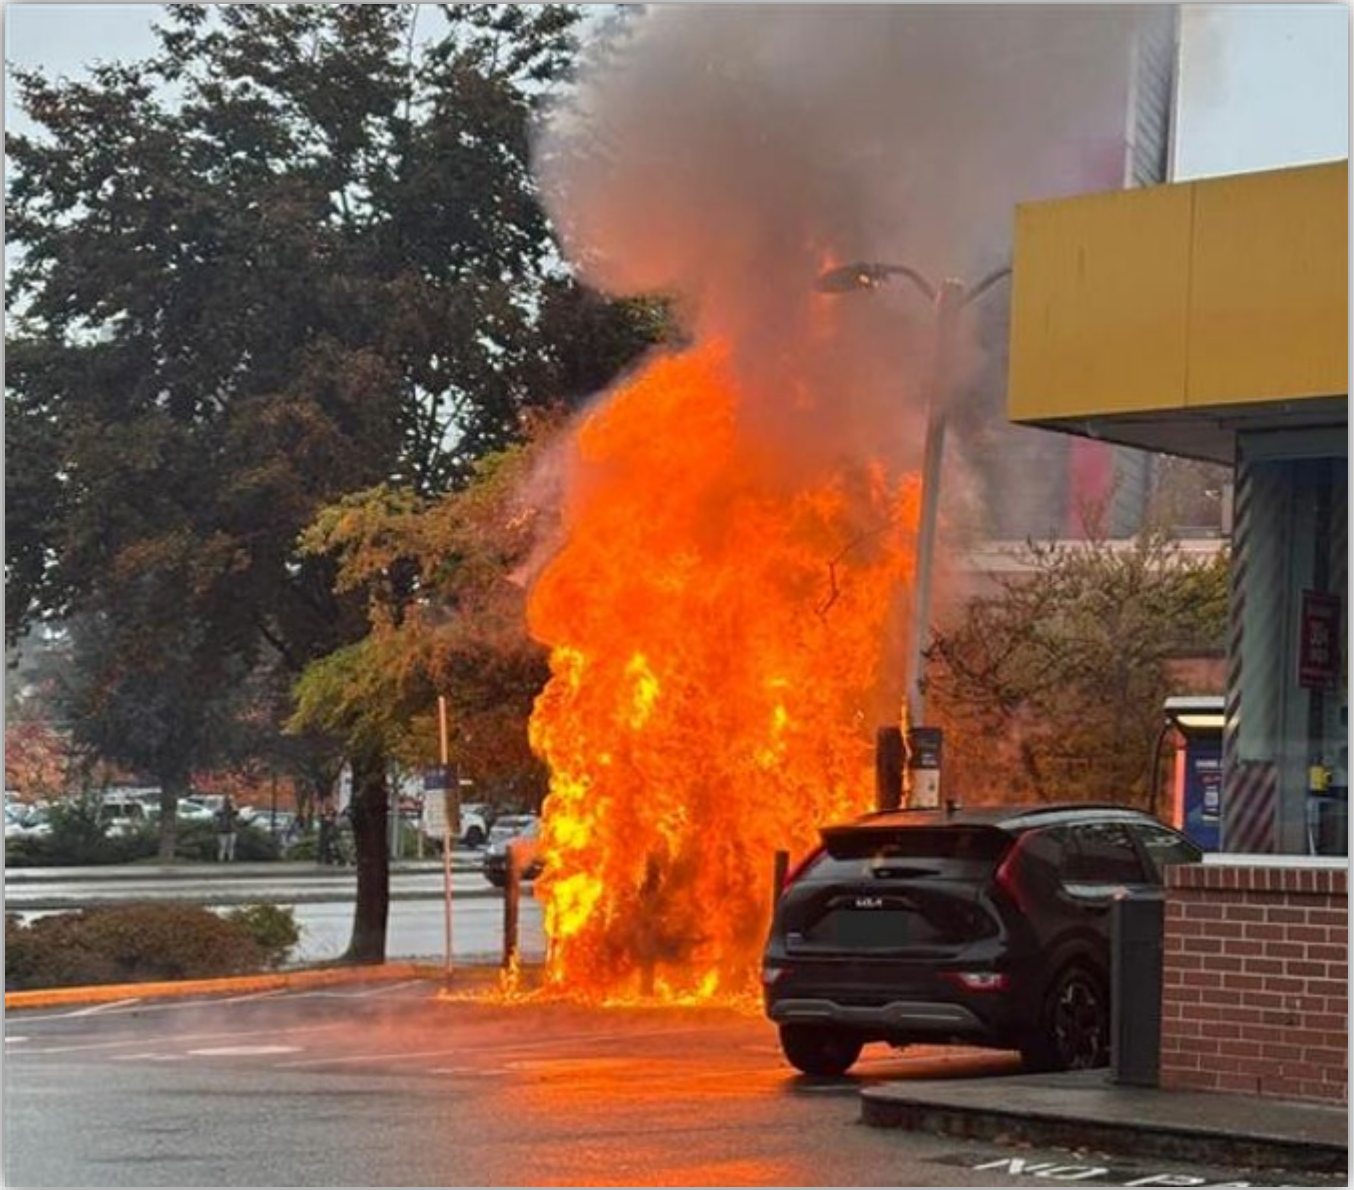
Image 1 – EV charger on fire at retail charging location.

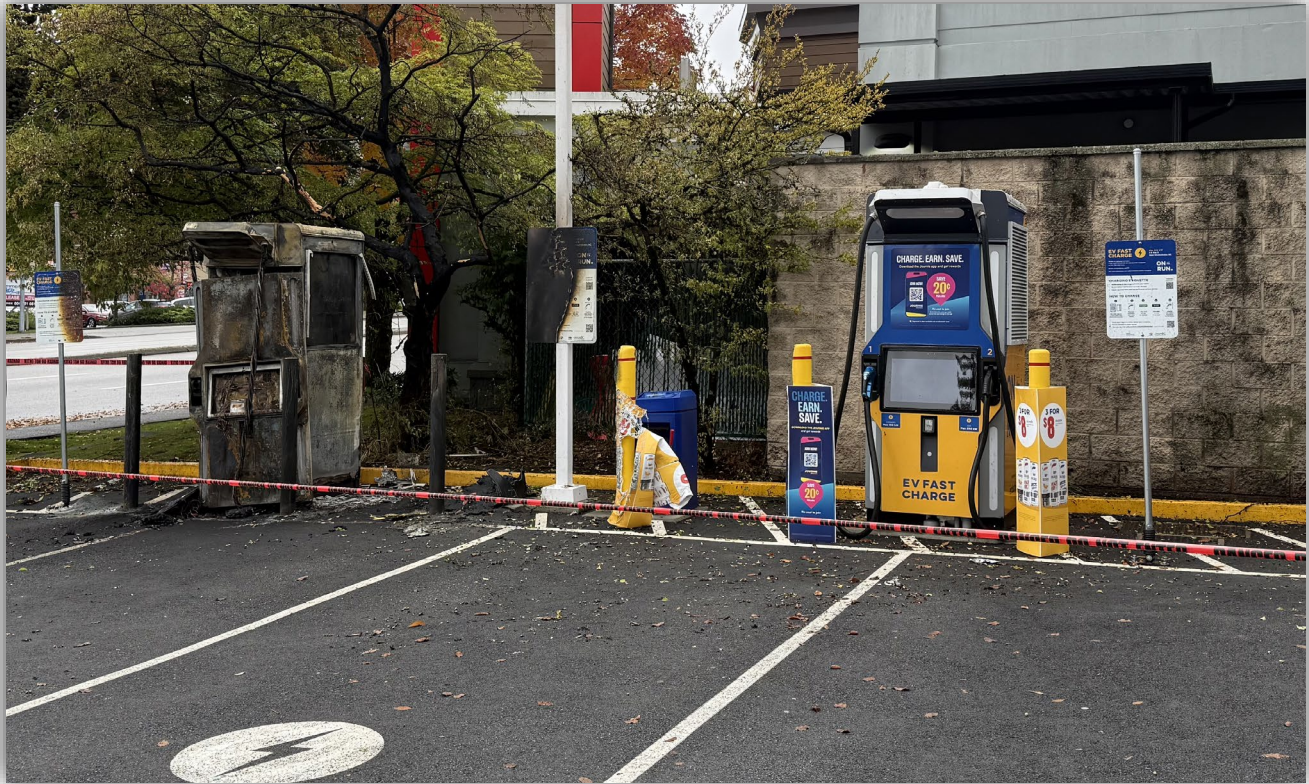
Image 2 – Damaged charger and surrounding area after incident.

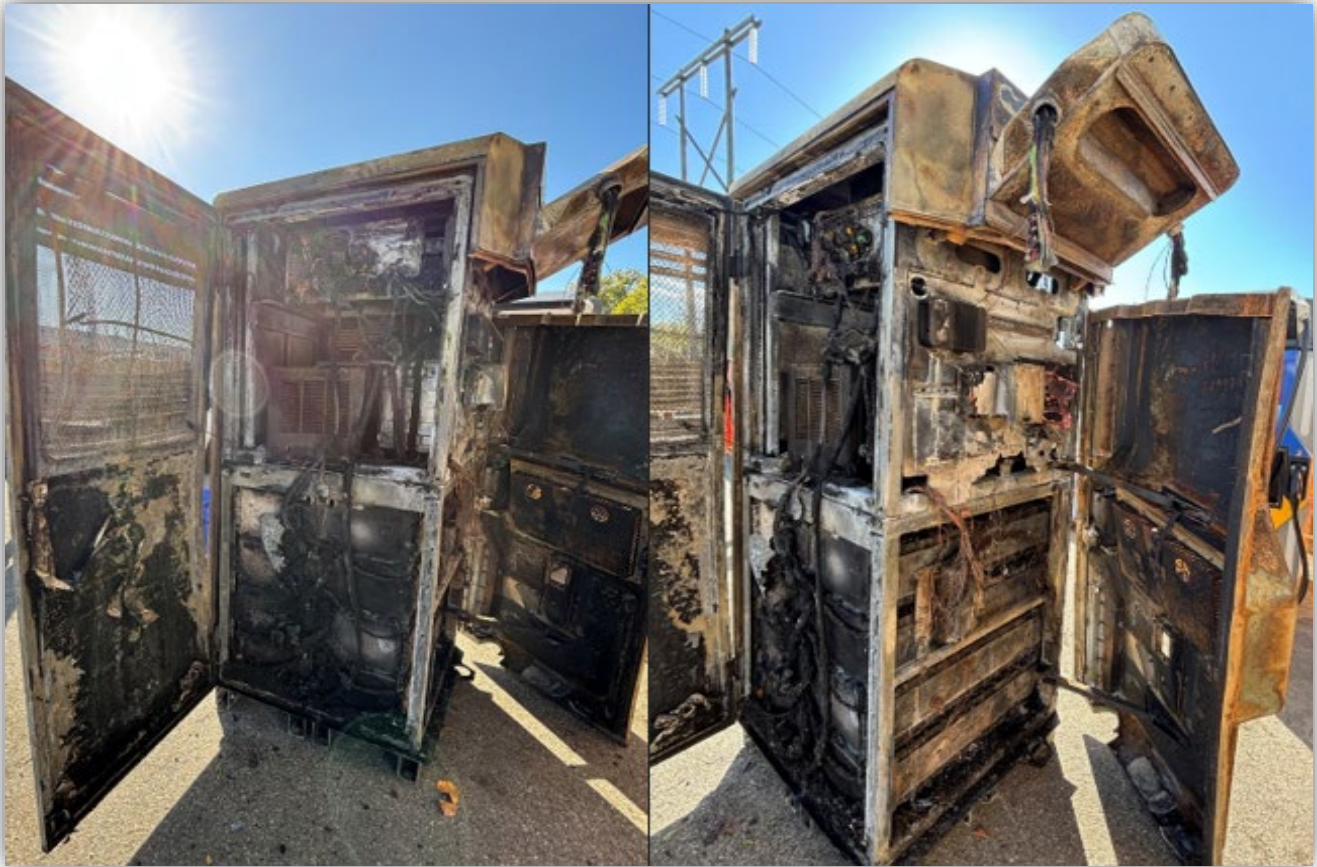
Image 3 – Damaged charger after removal from site.

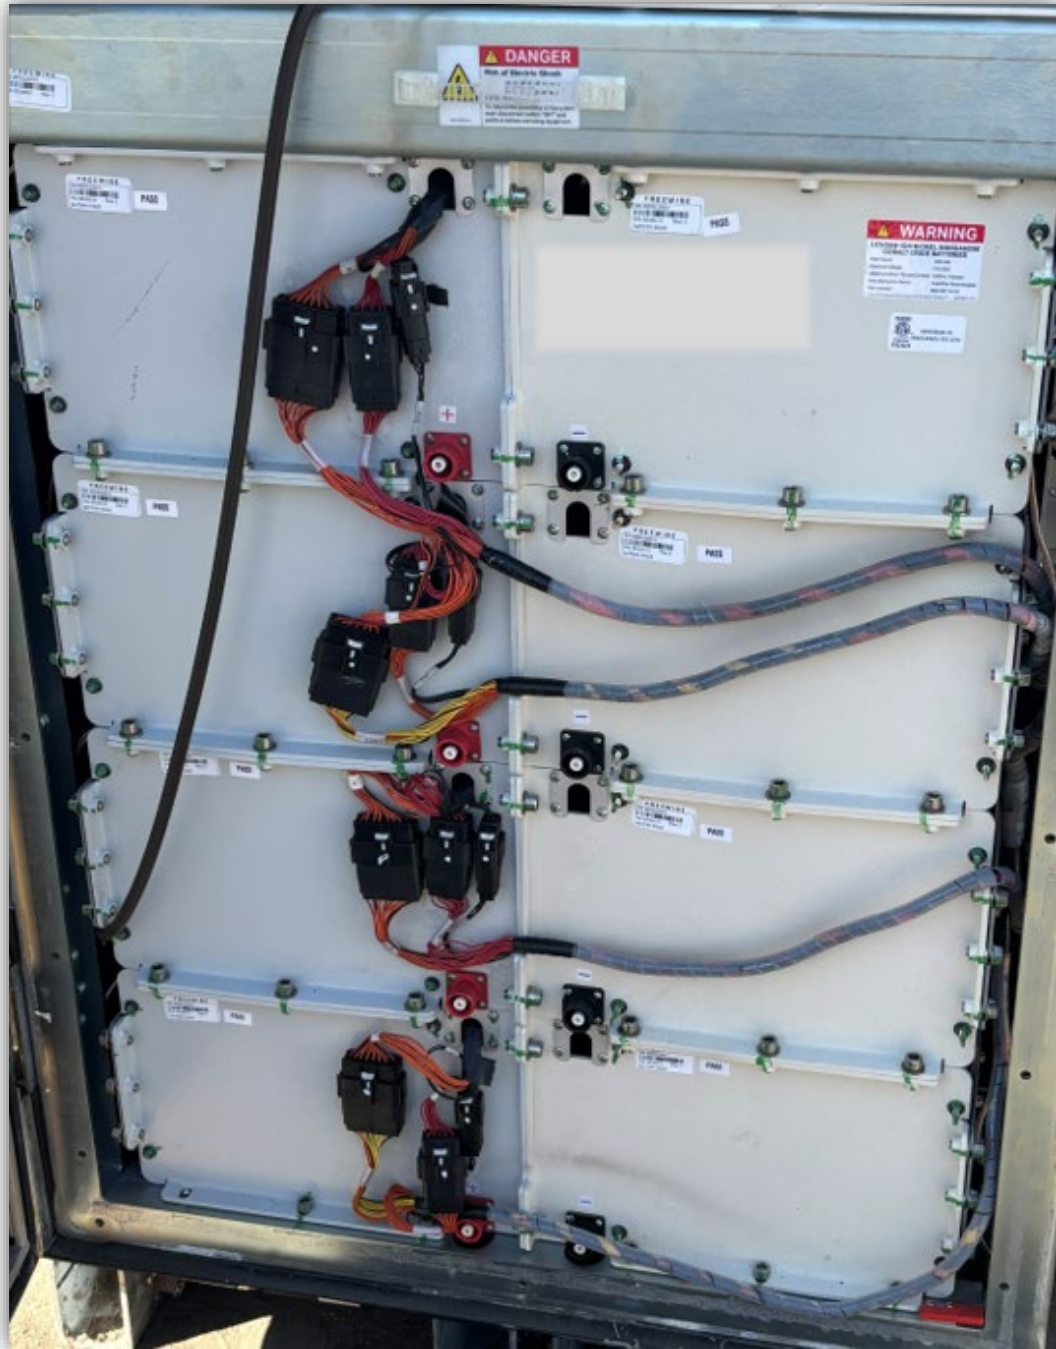
Image 4 – Example of a battery cube assembly inside a Freewire Boost charger showing eight individual module “stacks” bolted together to form one 800V DC lithium-ion battery (Connecting battery jumpers removed).
