Incident Summary (Reference #II-684399-2018) (FINAL)

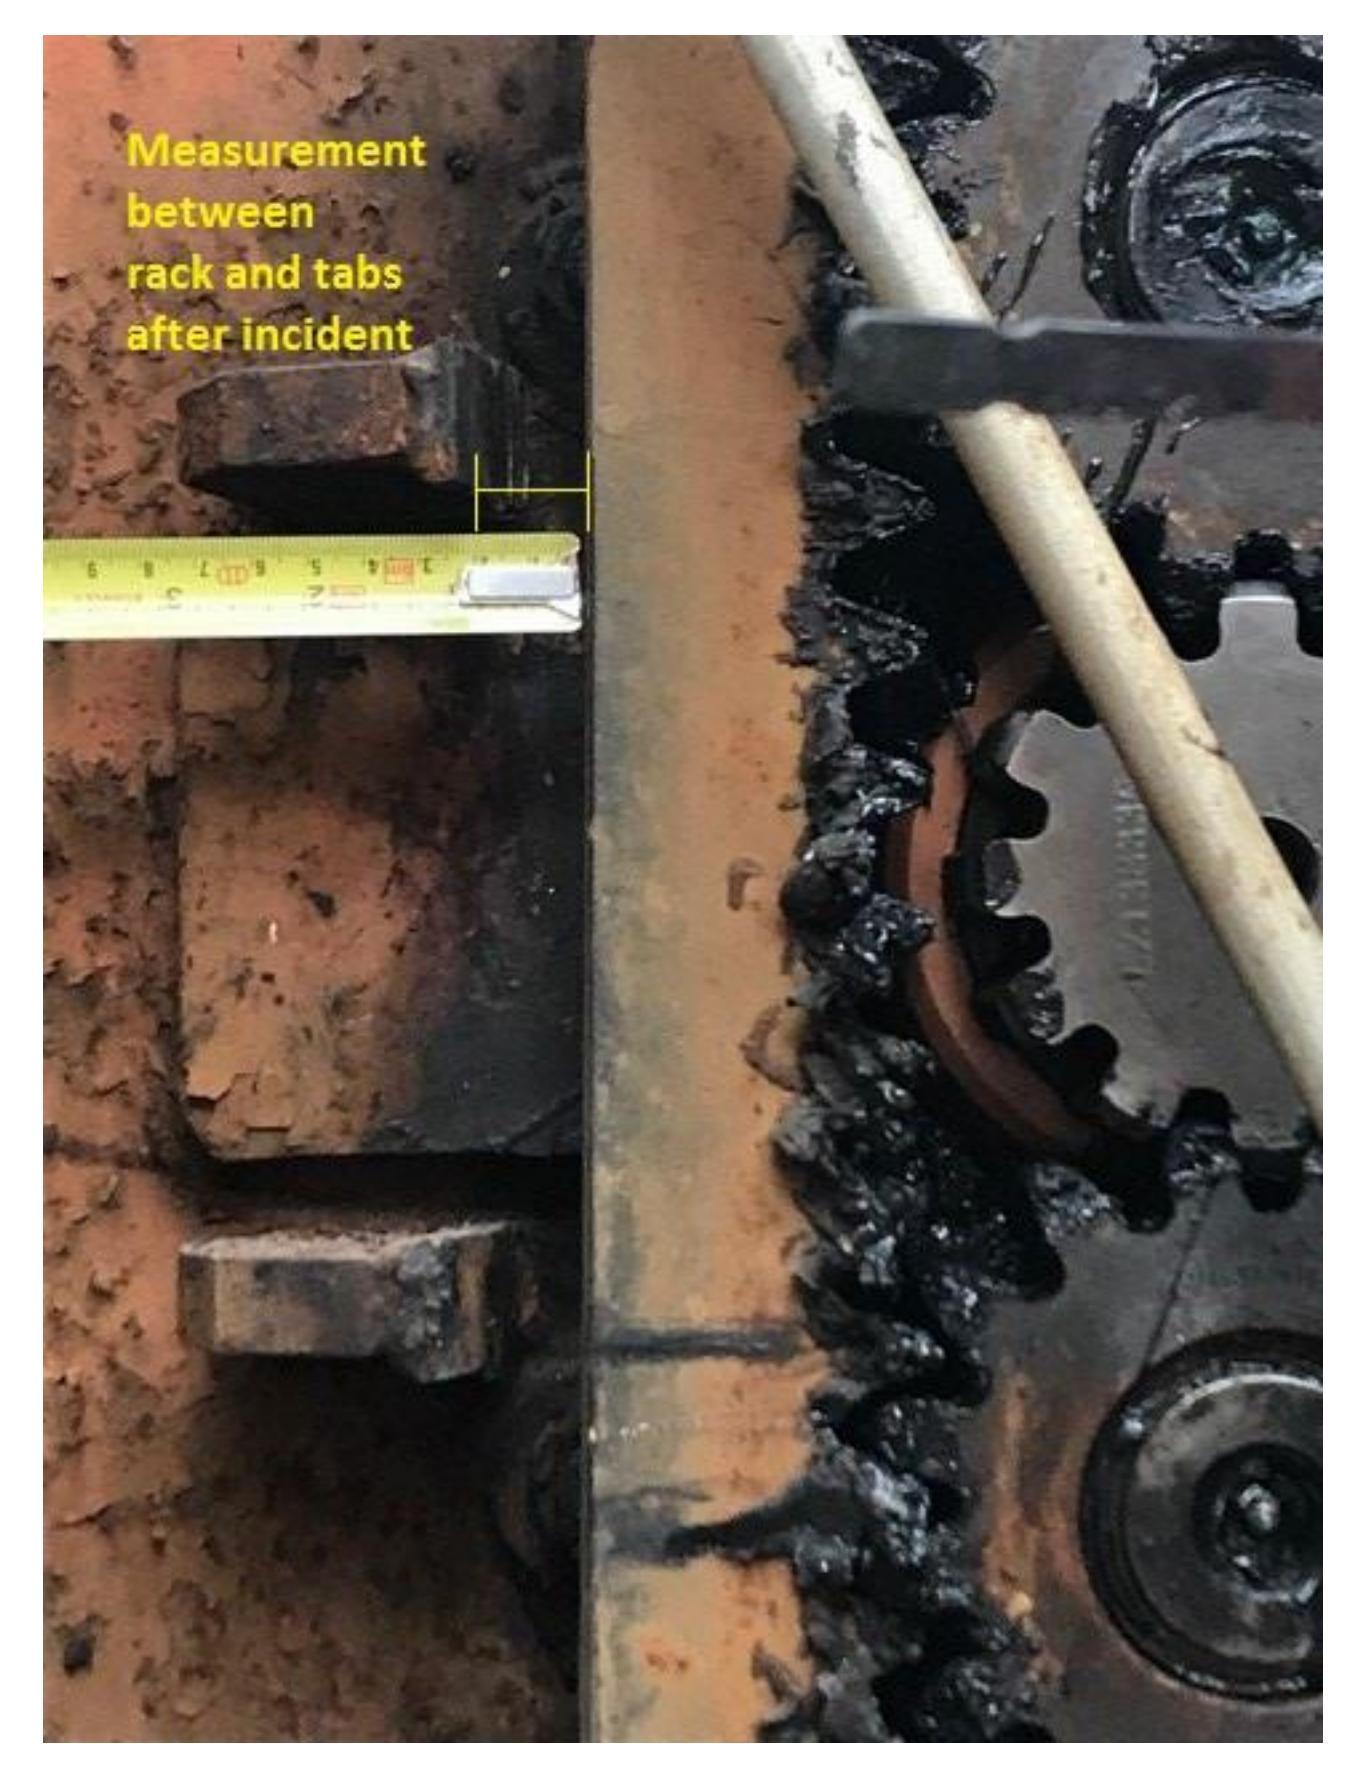
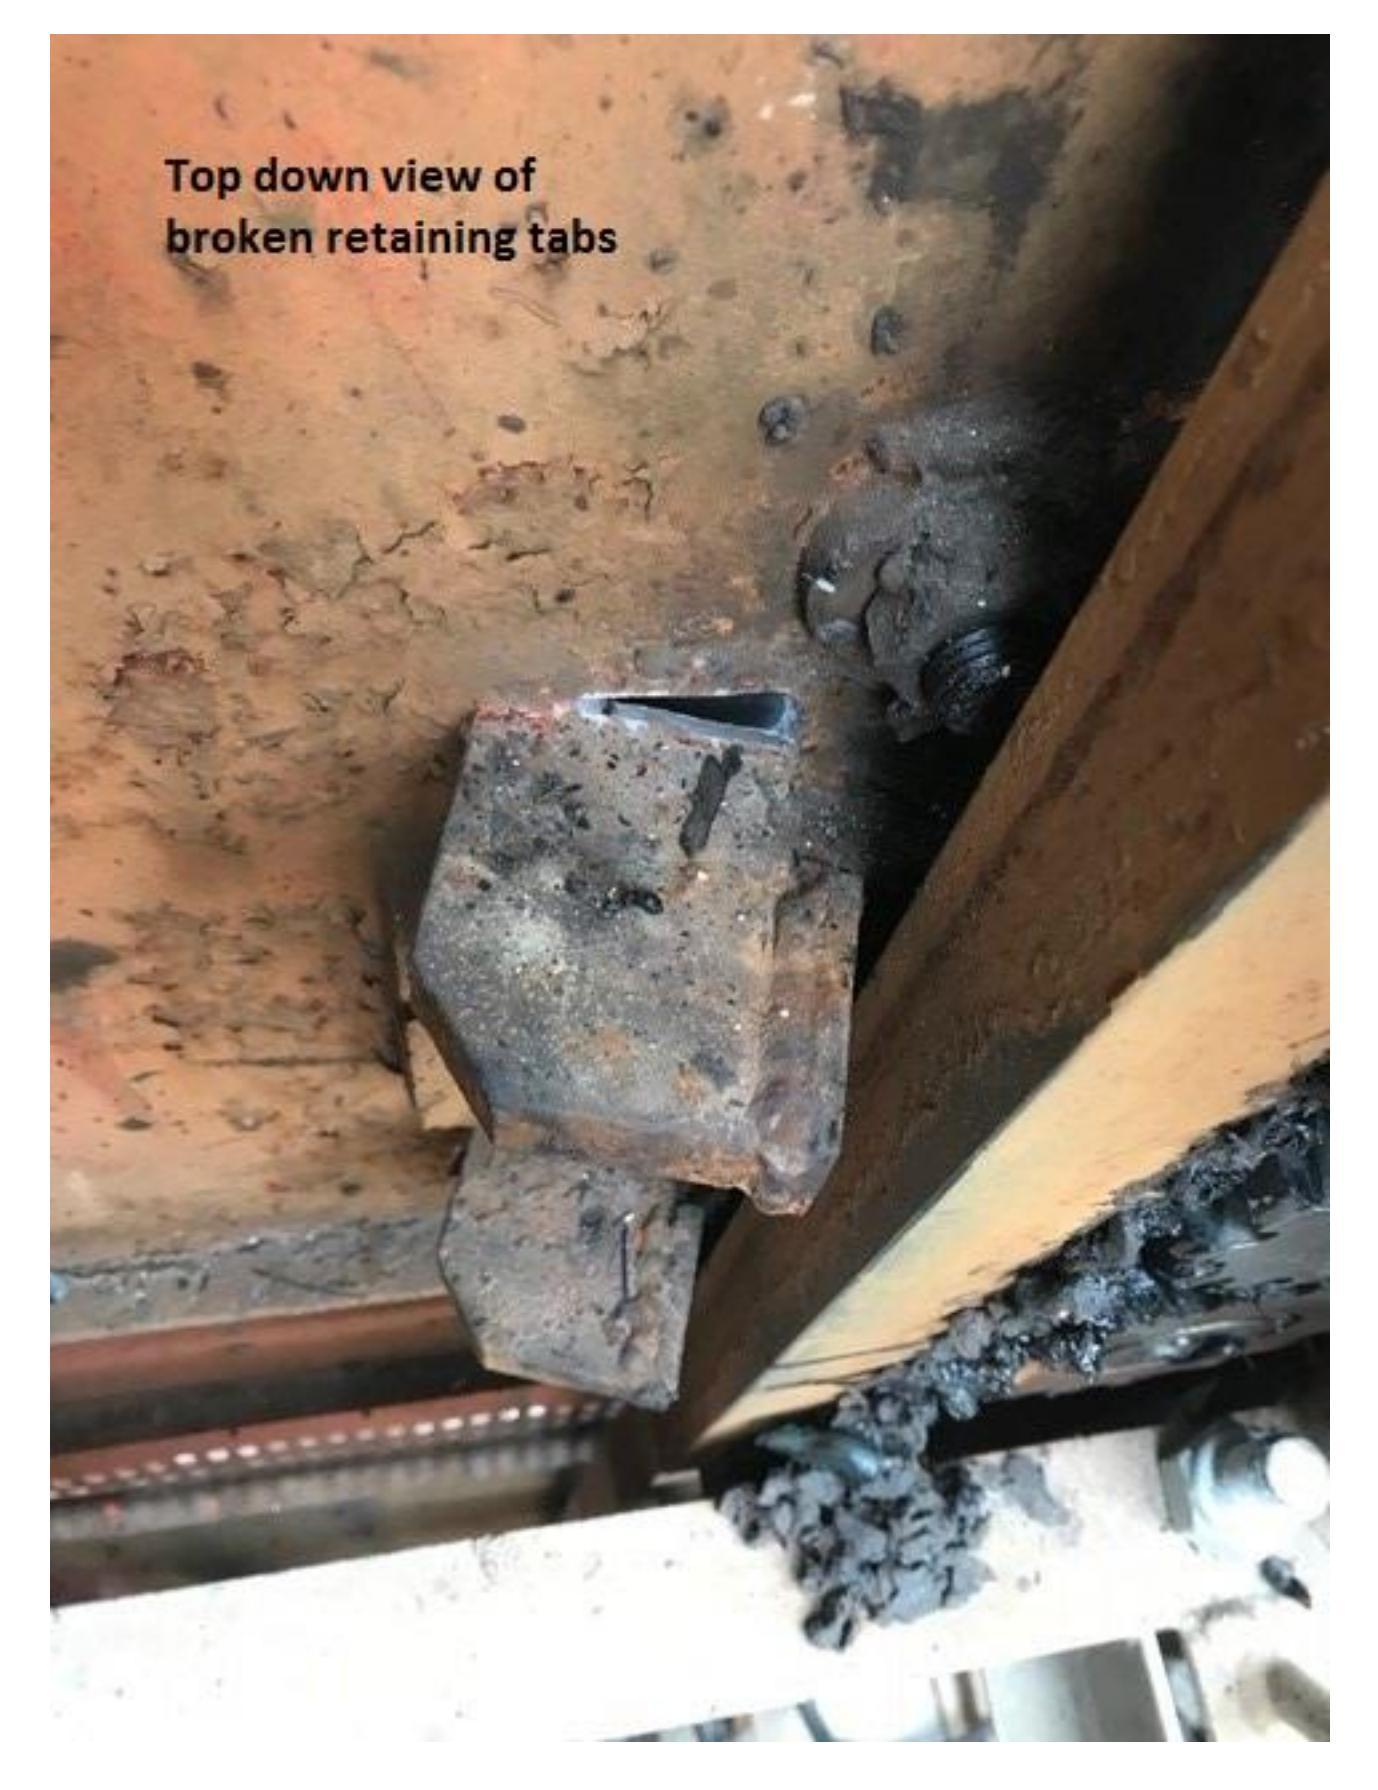
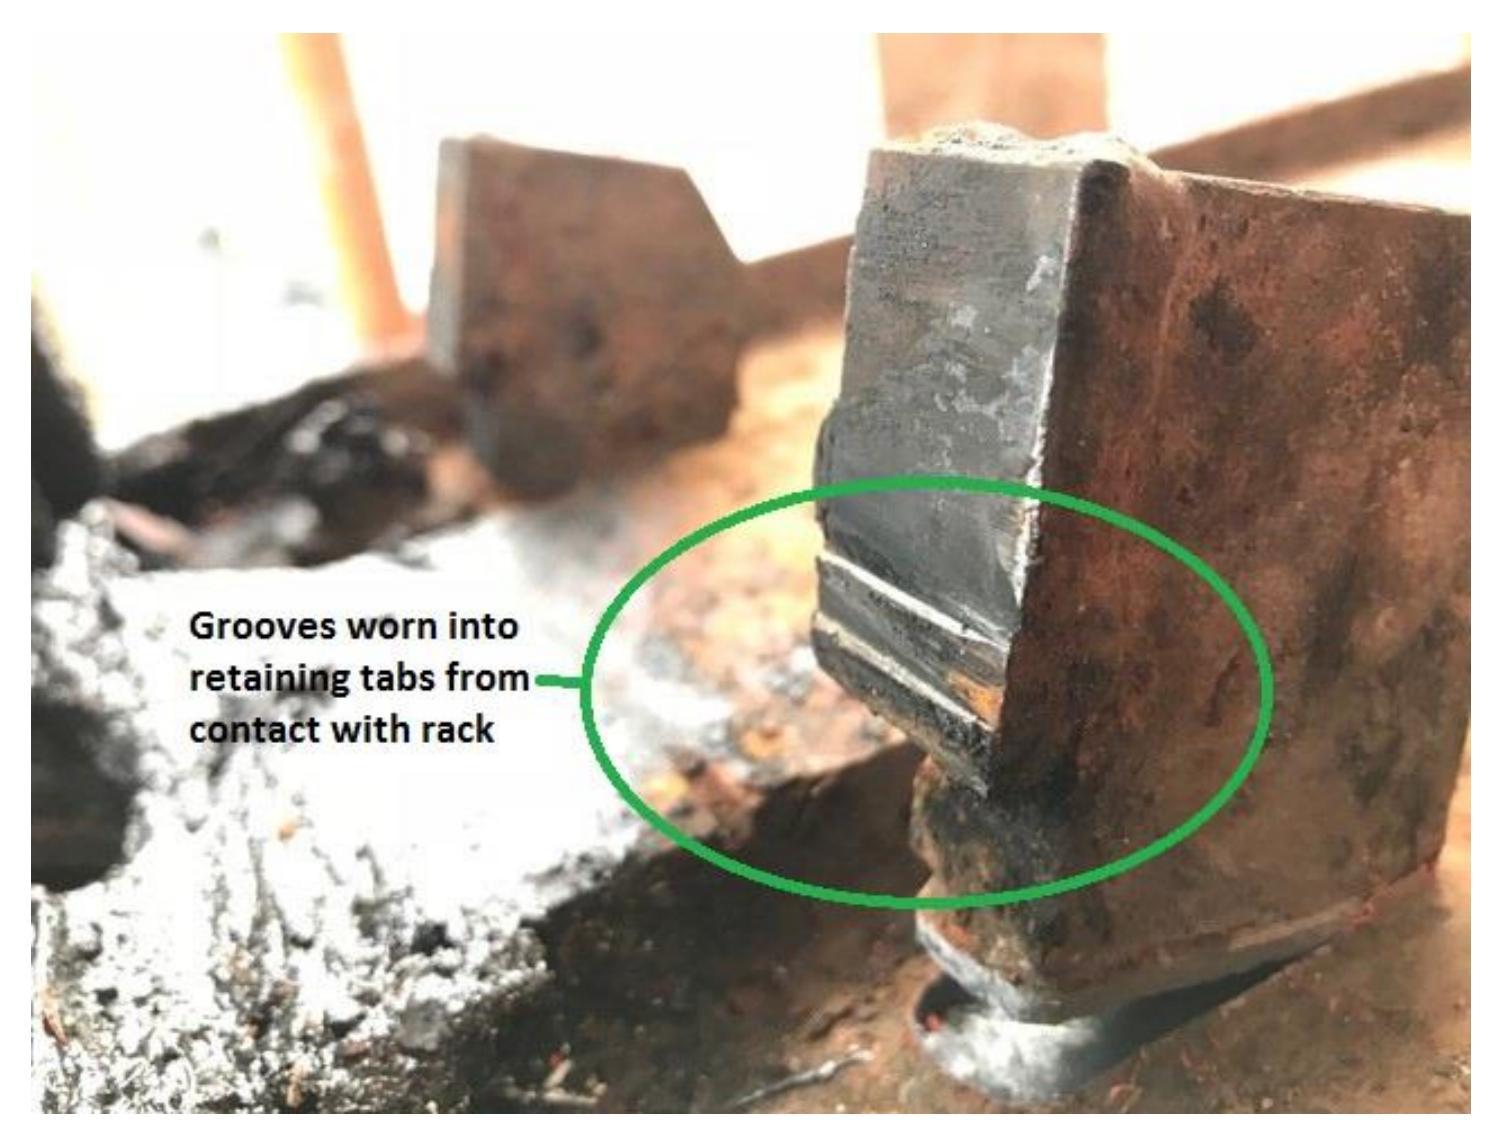
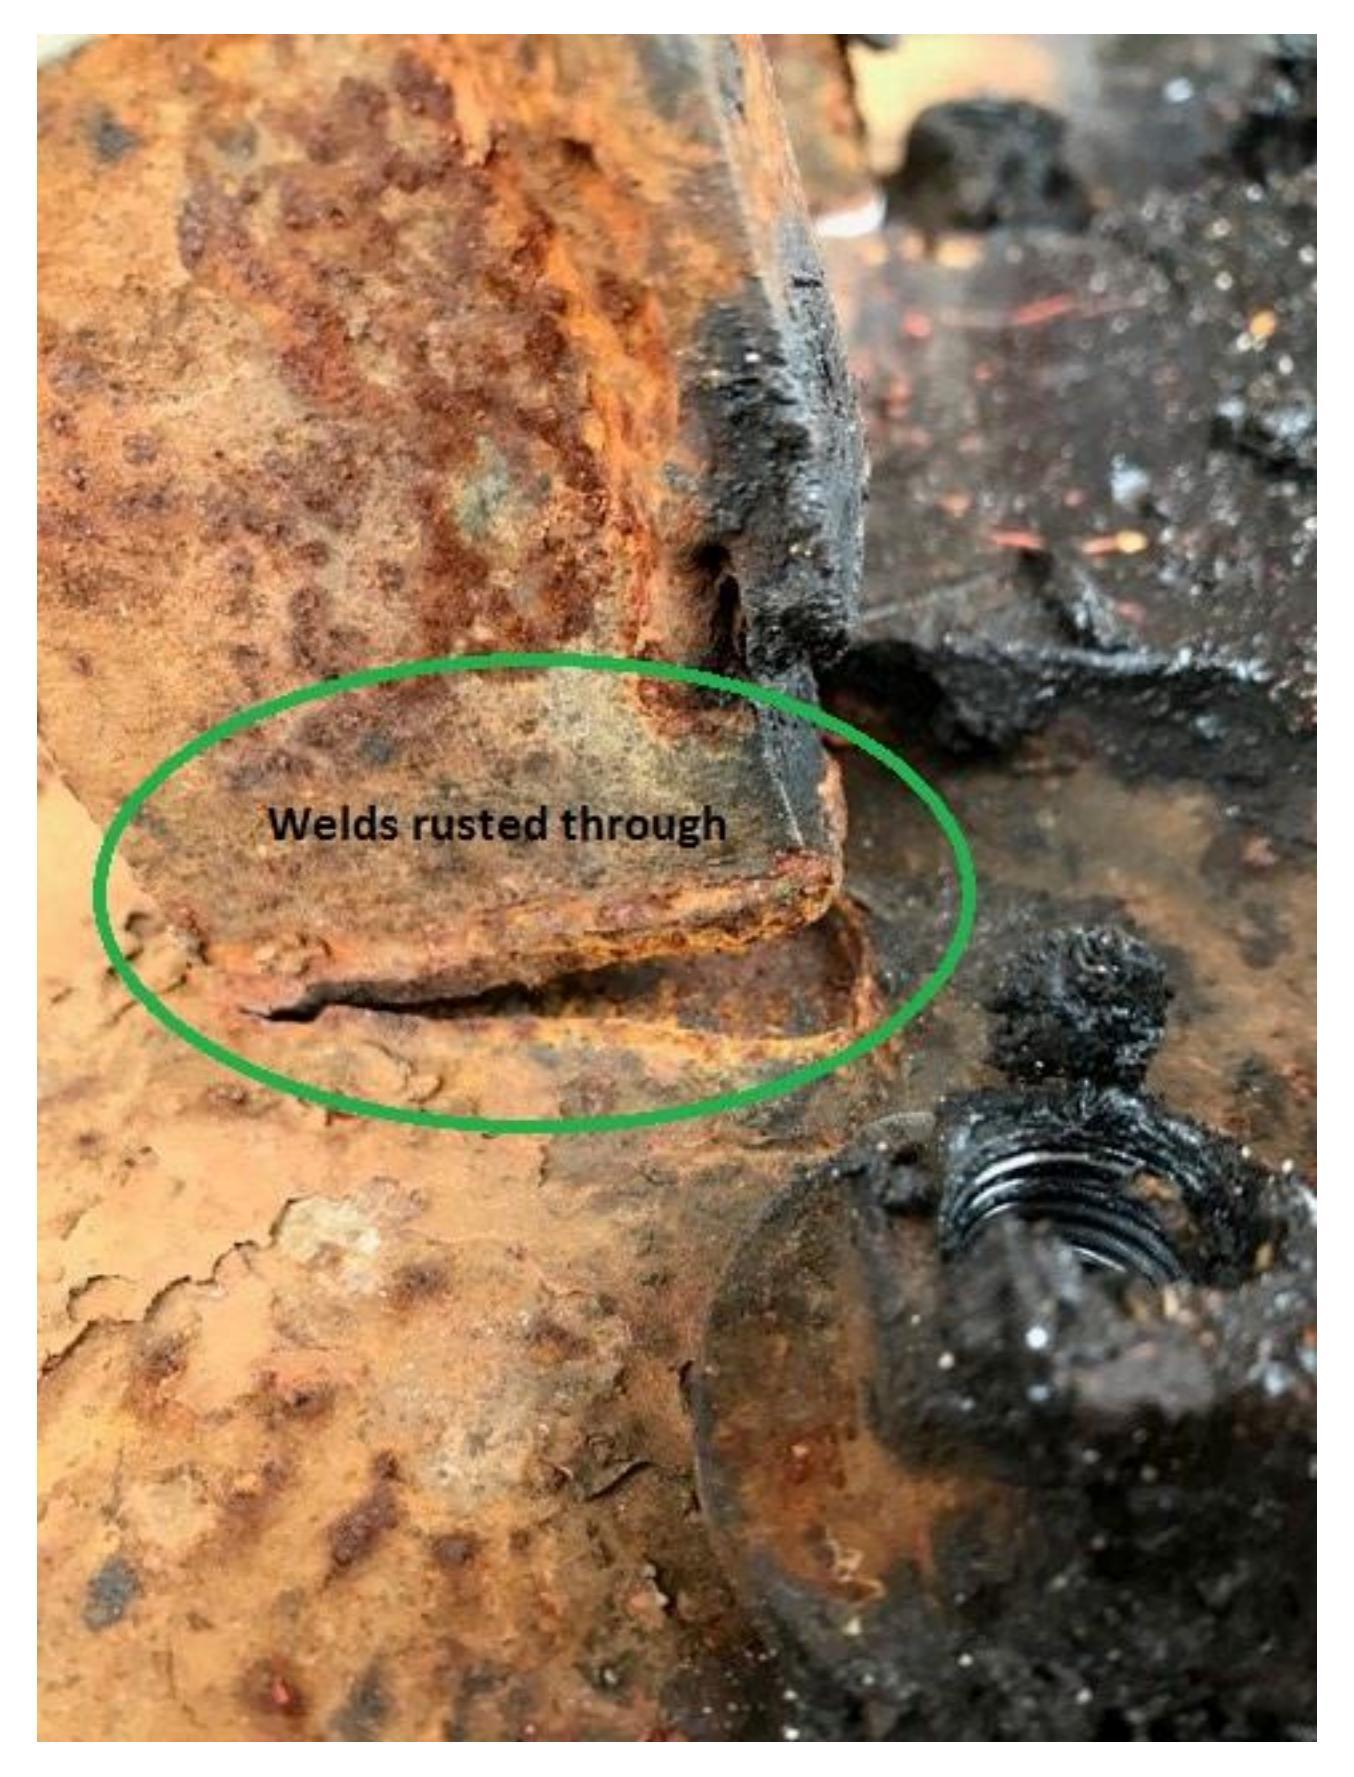
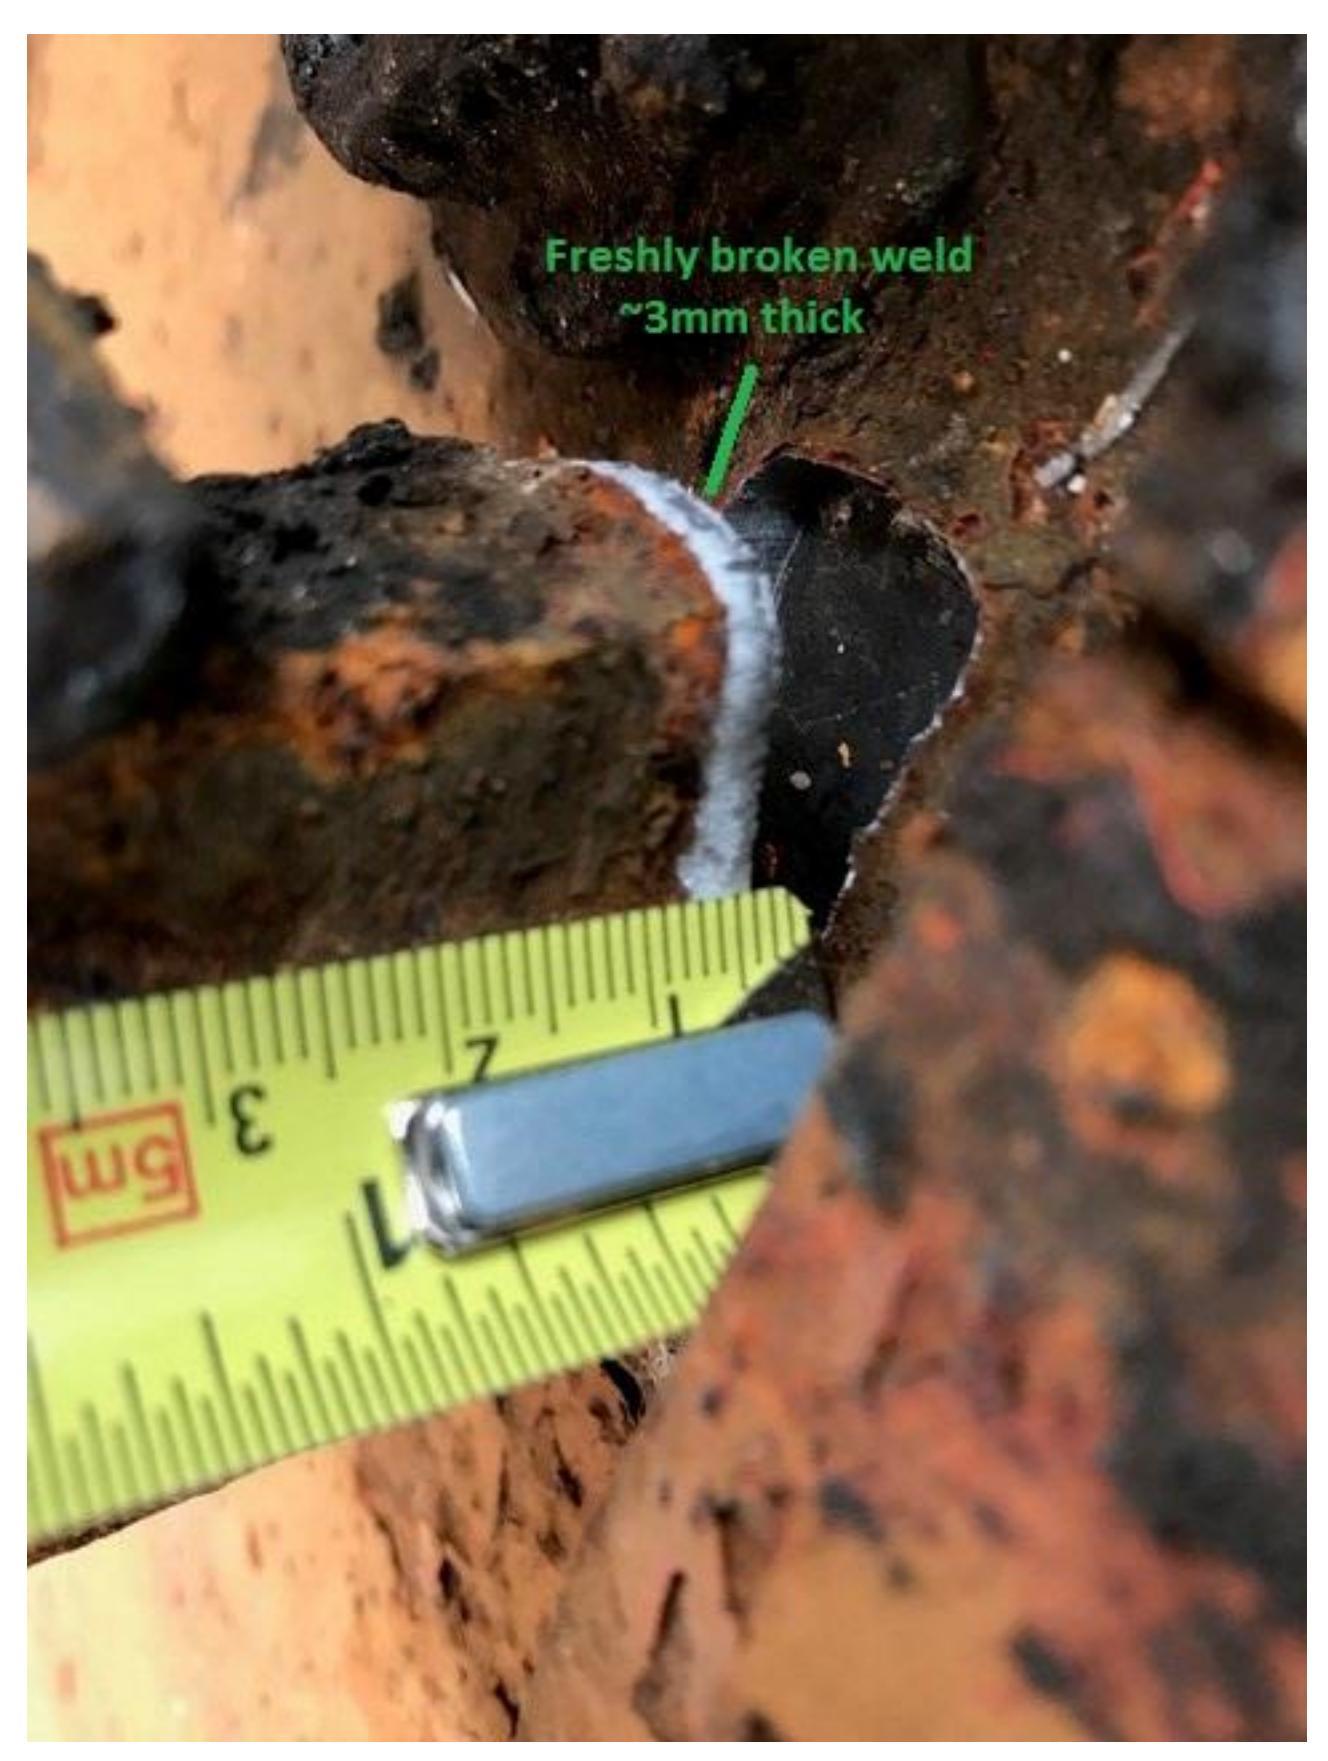
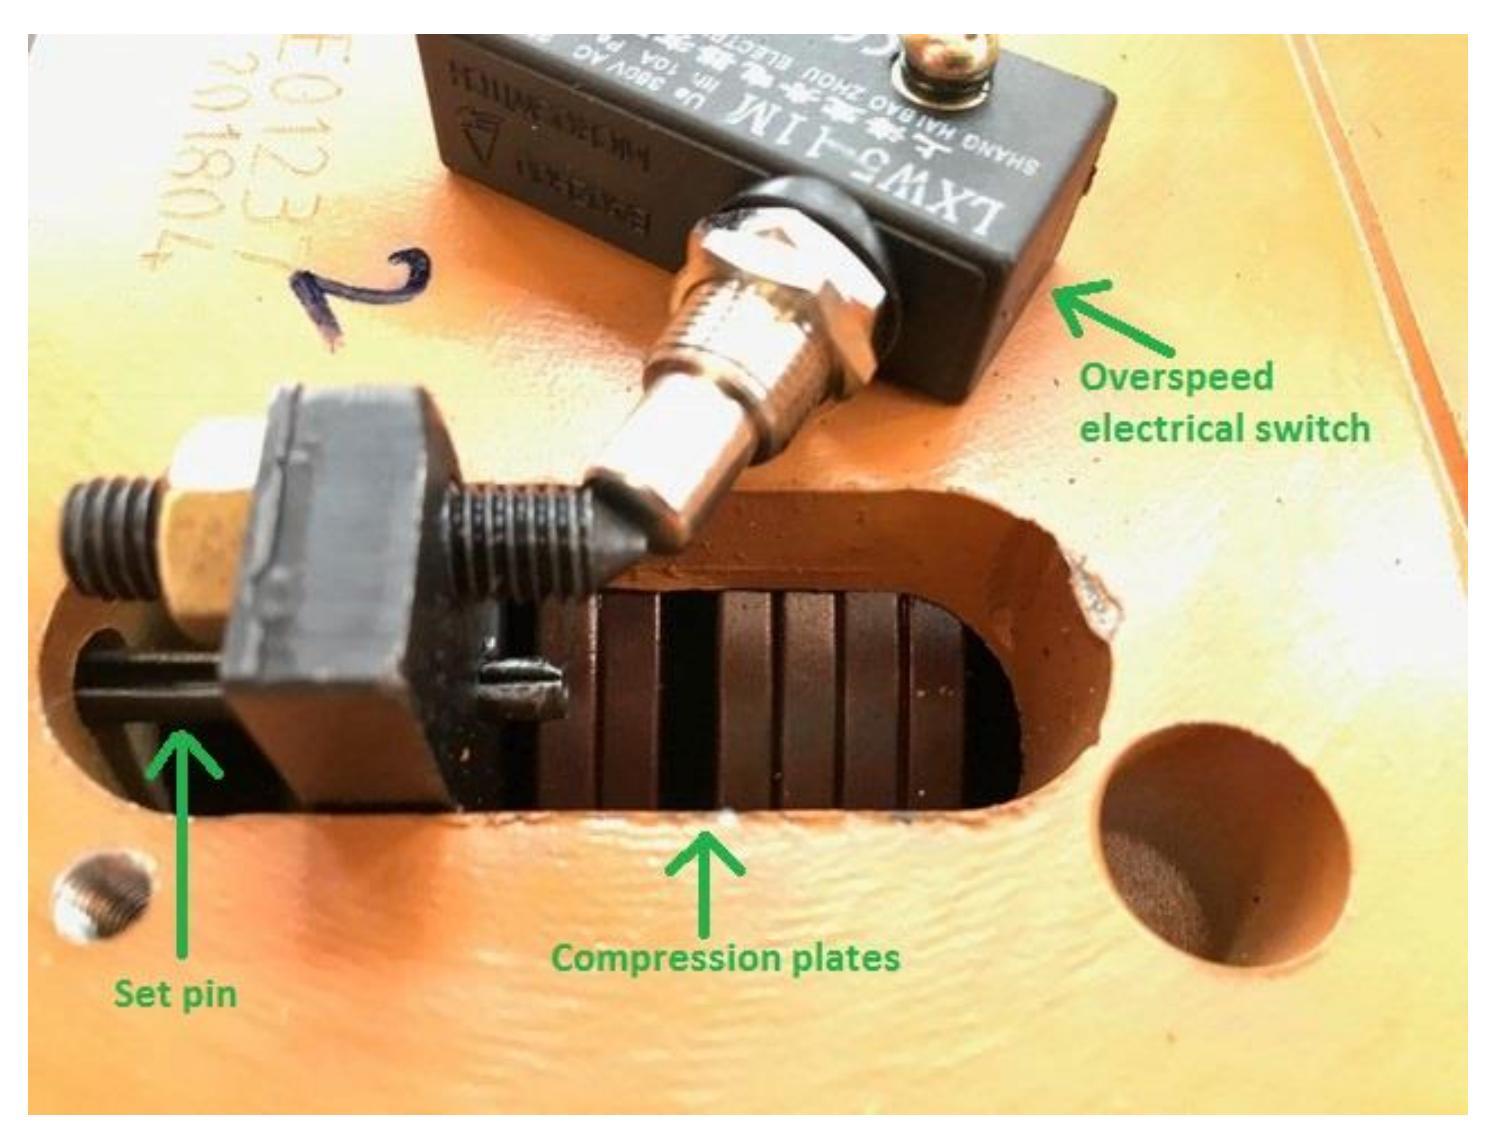
Failure scenario(s)		While performing the over-speed brake test, the hoist was put into test mode and the motor brakes were opened. The hoist car began to descend. When the over-speed brake device actuating speed was reached the device engaged the over-speed pinion brake. The force of the pinion brake actuating caused the pinion to shift away from the rack which engaged the welded retaining lugs. The retaining lug weld, which was already compromised, broke allowing the pinion gear to fully separate from the rack preventing the pinion brake from arresting the hoists decent. The mechanic then manually stopped the decent by activating the motor brakes.			
	Facts and evidence		A physical inspection of the over-speed brake on-site showed that it had only partially engaged. An inspection of the over-speed pinion gears and retaining tabs revealed that the welds on the two retaining tabs had been partially broken off, one of which the welds were rusted through indicating the welds were broken prior to the incident, the second retaining tab had freshly broken welds that measured 3/16" thick. The retaining tabs, which are installed from the factory within 1/4" of the rack were 7/8" from the rack and had over 90% of their welds broken.

Causes contribu	s and uting factors	It is highly probable that previous impact forces on the pinion gear retaining tabs compromised the integrity if the retaining tab welds. The force of the over-speed brake engaging and shifting the rack into the tabs contributed to the retaining tab weld failure. It is probable that the broken tab welds allowed for enough clearance for the pinion gear to disengage from the rack allowing the uncontrolled descent of the

hoist. It is probable that the broken welds went undetected during regular maintenance.
