DRTING INFORMATION	Incident Date			September 10, 2024
	Loc	Location		Langford, BC
	Reg	Regulated industry sector		Electrical - Low voltage electrical system (30V to 1000V)
	Impact	Injury	Qty injuries	4
			Injury description	One (1) contracted labourer experienced electrical burns to face, hands and other skin surfaces and vision impairment. Three (3) other store workers responding to the incident reported minor smoke inhalation.
			Injury rating	Major
		Damage	Damage description	There was a temporary partial power loss during overnight hours when normal restocking and maintenance activities were occurring at a large retail business. Damage to a lighting fixture with arcing and sparks and smoke. A secondary abnormal arc fault caused electrical arcing damage to an electrical panel, relays and conductors in a restricted electrical room.
SUPP(		-	Damage rating	Major
	Inc	iden	t rating	Major
	Incident overview		t overview	During overnight electrical work at a large retail store to upgrade the store lighting from fluorescent to LED fixtures ( <u>Image 1</u> ) an electrical short occurred that tripped an overload, de-energizing a circuit. While attempting to correct the situation, another

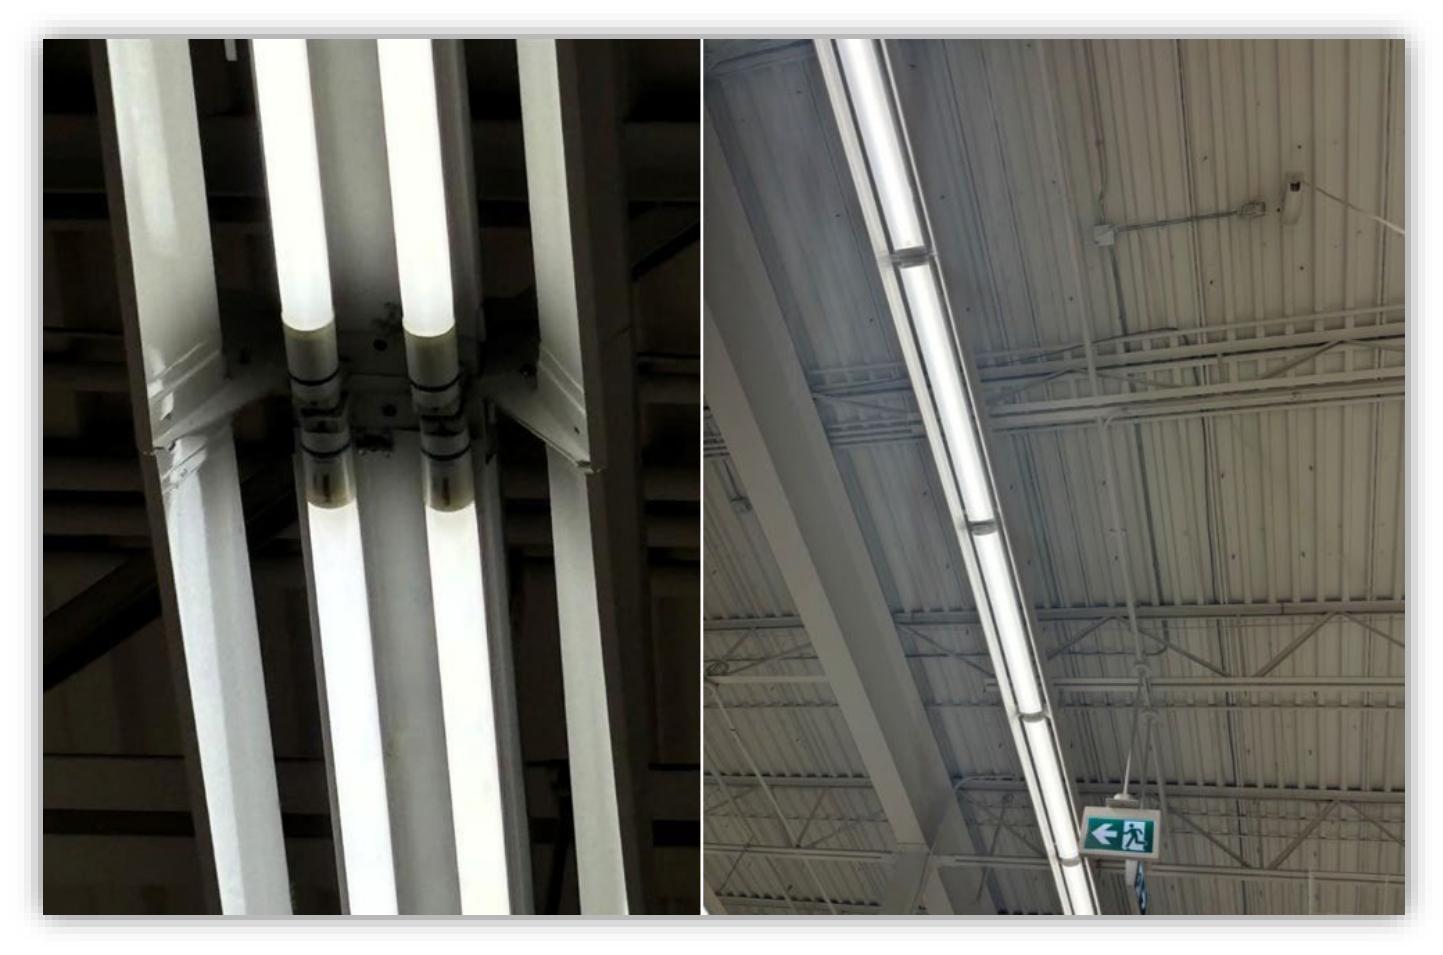
Image 1 – (Left) Old florescent lamps. (Right) New LED lamps being installed.

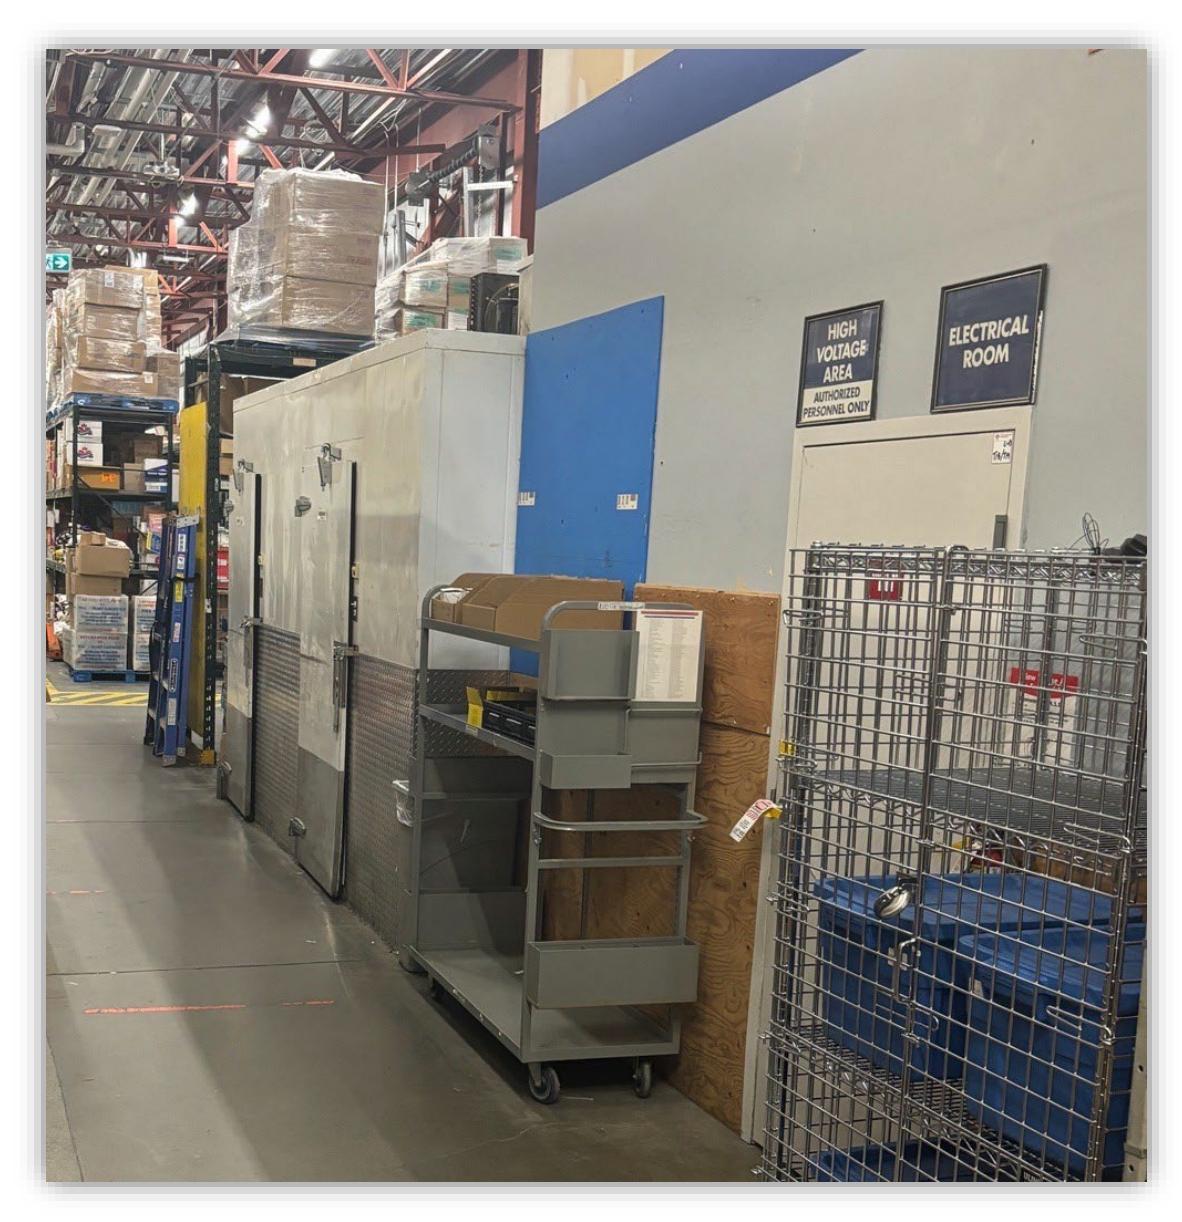
Image 2 - High Voltage electrical room.

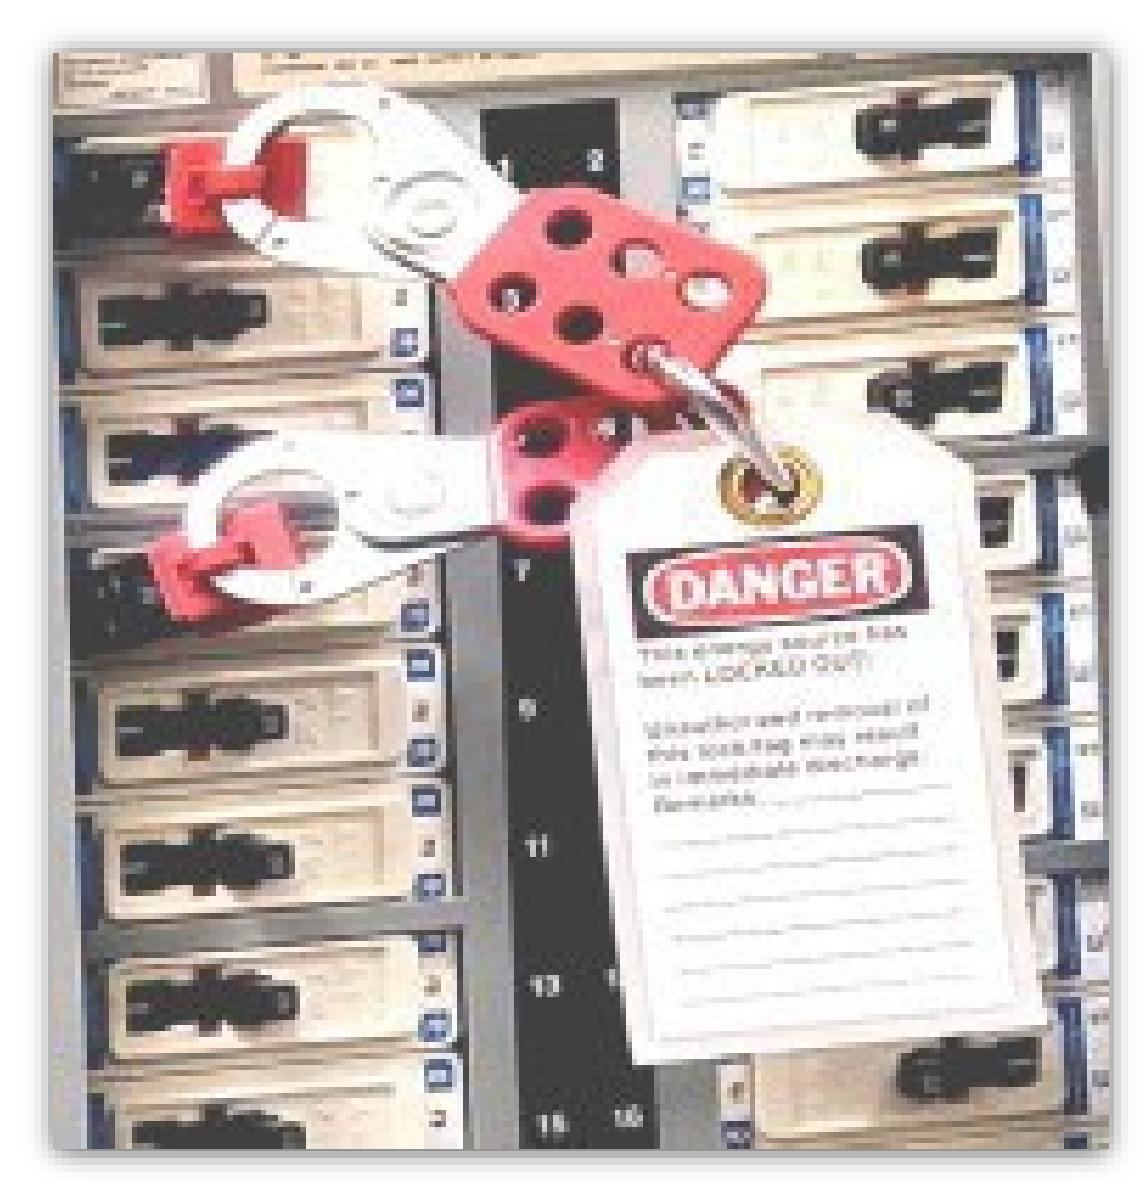
**Lockout** (<u>Image 3</u>) is defined in the Canadian standard CSA Z460-20 "Control of Hazardous Energy - Lockout and Other Methods" as the "placement of a lockout device on an energy-isolating device in accordance with an established procedure." A lockout device is "a mechanical means of locking that uses an individually keyed lock to secure an energy-isolating device in a position that prevents energization of a machine, equipment, or a process." Each worker is required to place a lock on the equipment being de-energized to ensure the equipment is not re-energized while workers are still performing their duties.

Image 3 – Lock out example from individual in the role of onsite supervisor on September 3<sup>rd</sup>, 2024.

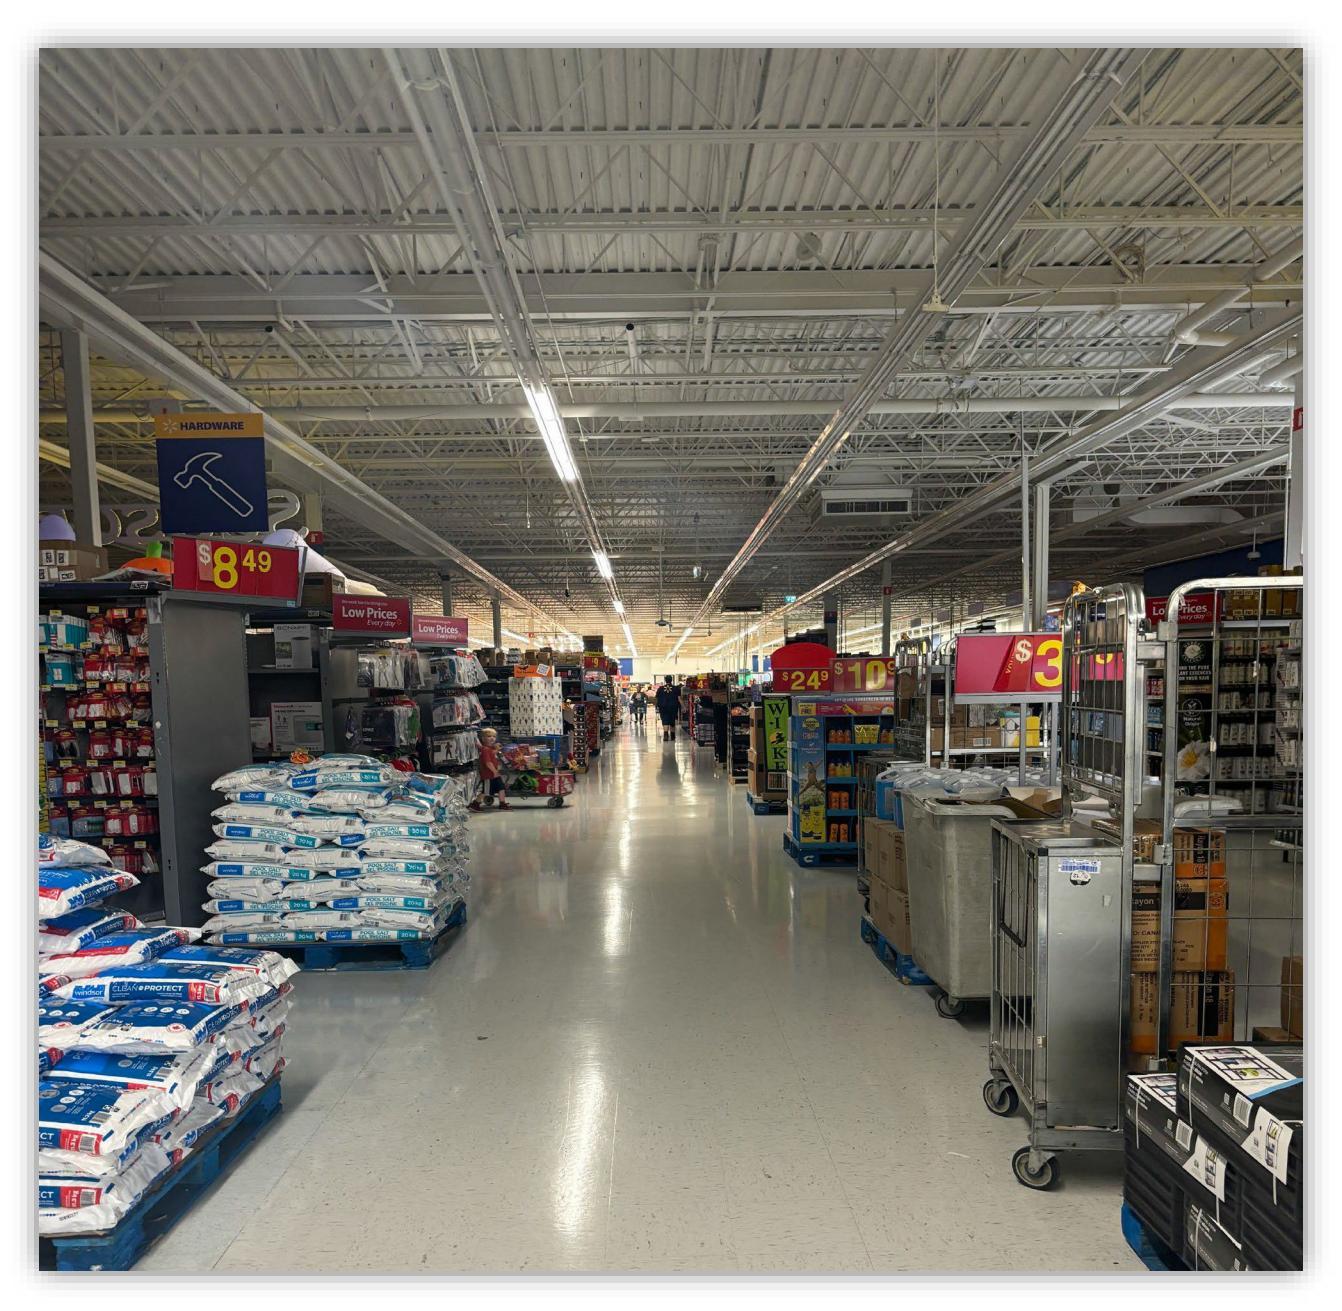
While changing one of the fixtures, an energized conductor contacted bonded material resulting in an active fault condition within the fixture housing. The fault in a fixture activated an overcurrent protection device in a lighting contactor panel in the main electrical room. During this fault condition the branch circuit over current devices for several lighting branch circuits were activated causing a partial blackout in the store (Image 4).
		Following the initial fault, one (1) of the workers reached out to a night-manager of the store. One of the workers later described the manager as being motivated to have the lighting restored which was perceived as pressure by the labourers.
		That manager did understand fully what was happening regarding the blackout and staff described feeling frustrated as communication between staff and labourers was difficult as a result of language barriers.

Image 4 – Partial blackout. During incident footage, sparks are observed at the area of the store where the fault occurs, and image shows sparks and lighting outage.

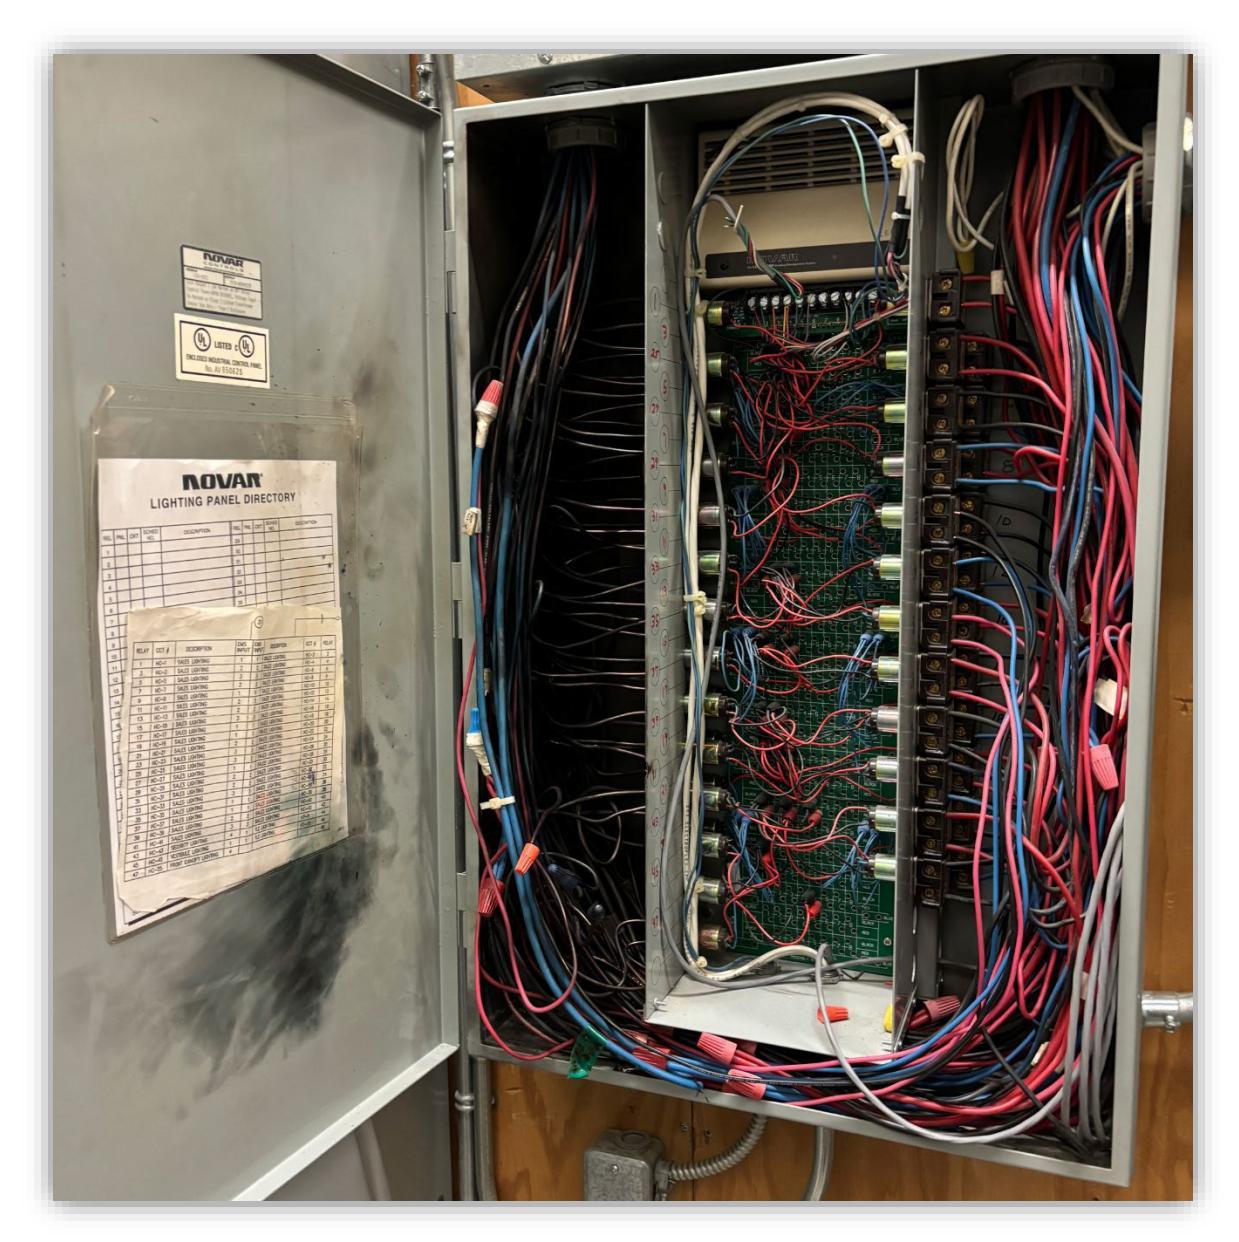
While working inside this energized electrical distribution equipment using conductive tools and without any appropriate personal protective equipment (PPE), a connection was made between an active 347V circuit and the bonded housing of the distribution equipment resulting in abnormal short circuit fault condition causing a thermal flash and injuring the worker (Image 5, Image 6, and Image 7).

Image 5 – Smoke residue on panel after second incident.

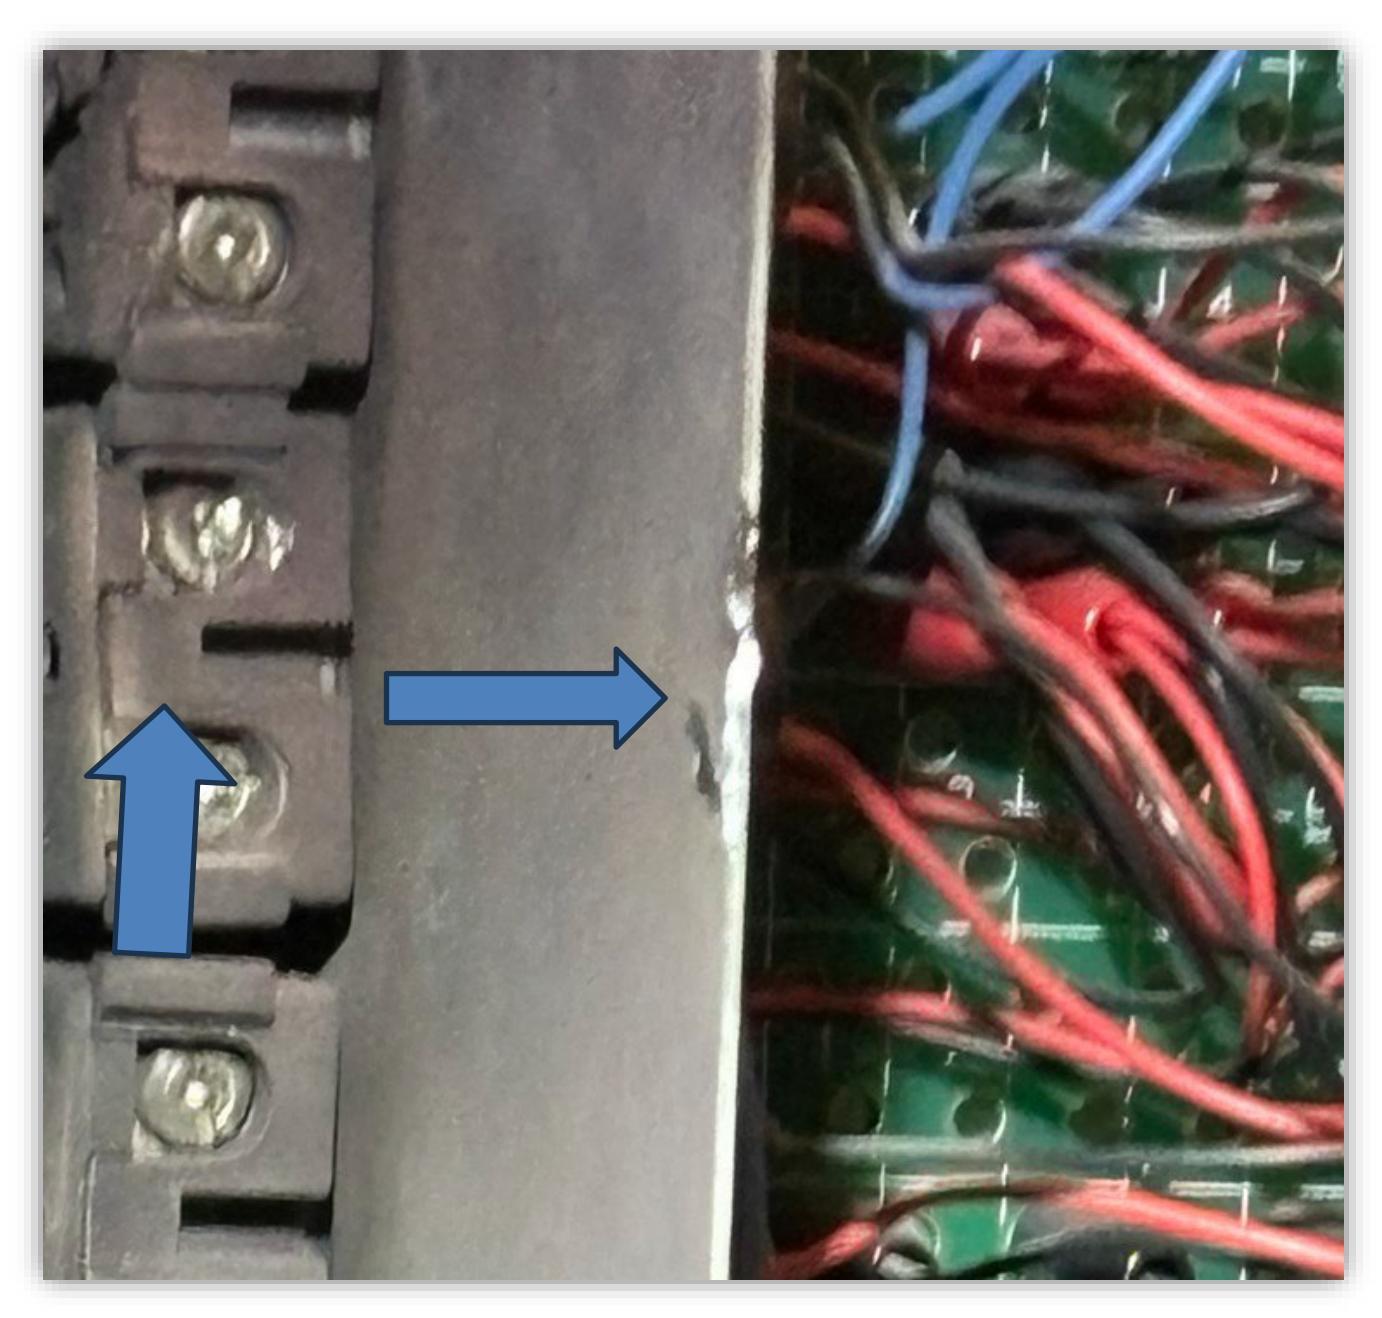
Image 6 - Damage inside panel door. Close up of tool marks at location of incident.

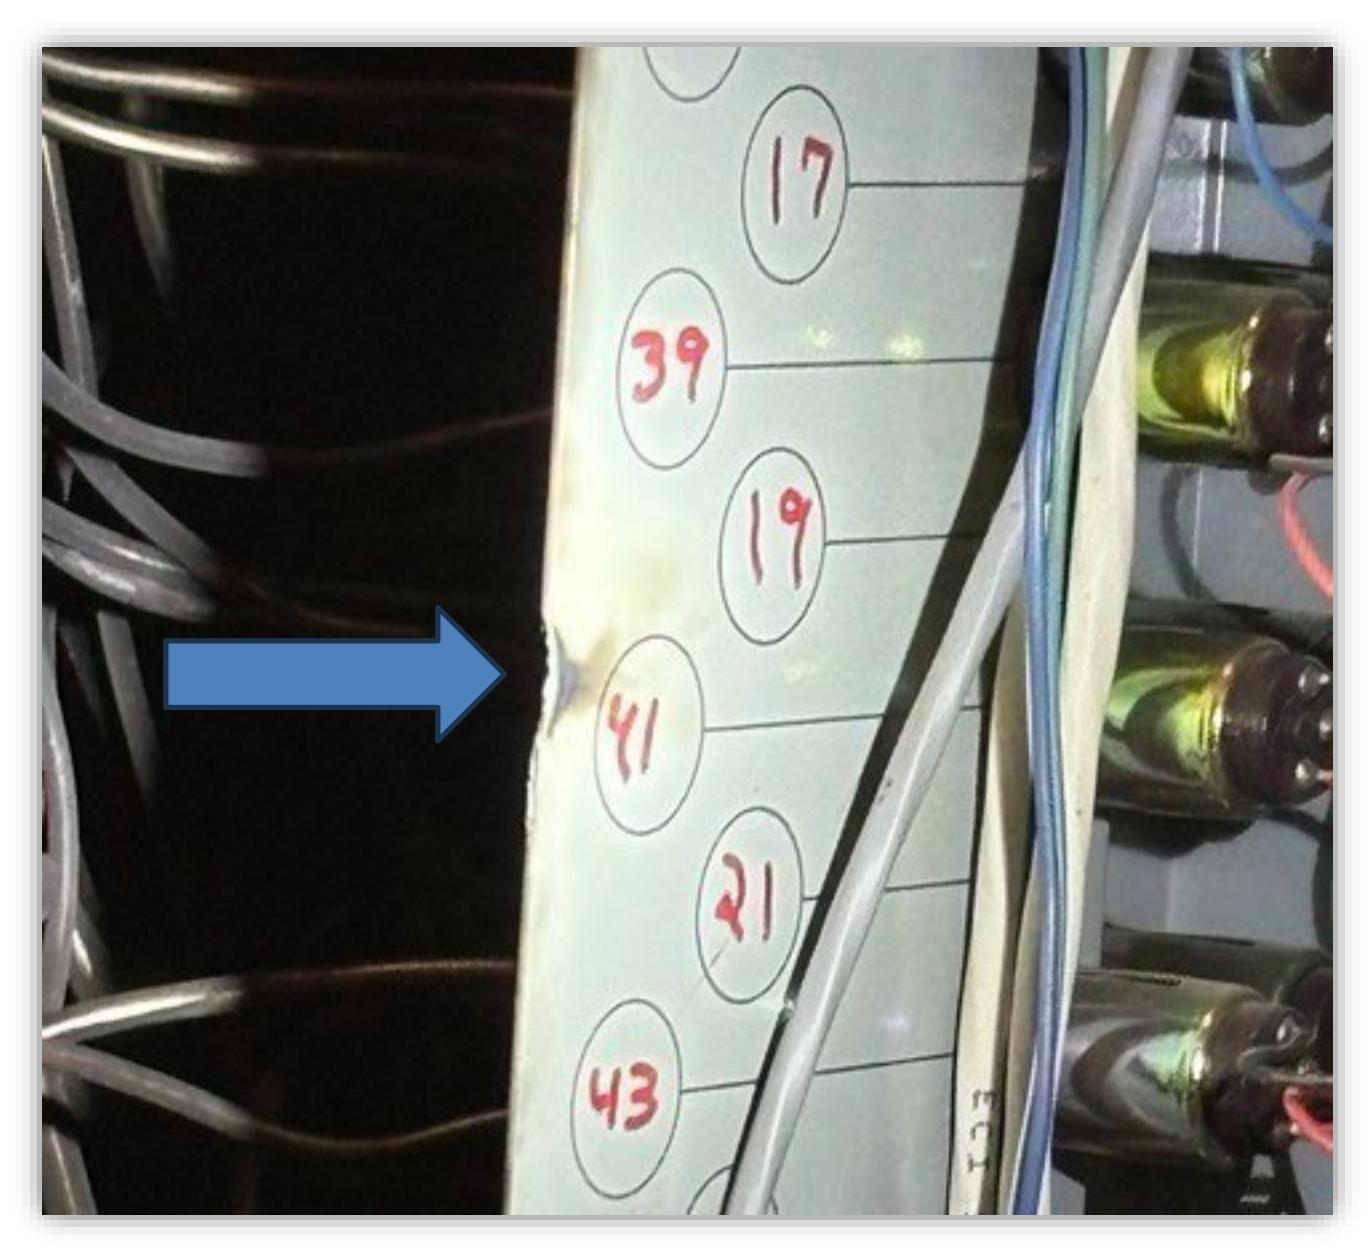
This different worker was also unqualified and the most junior worker of the crew. He was seen in the electrical room working with many tools (<u>Image 7</u>, <u>Image 8</u>, and <u>Image 9</u>) attempting electrical panel repair in front of his supervisor. He used these tools to work inside an open energized electrical panel for the lighting circuits.

Image 7 - Dent from drill tool where incident was initiated.

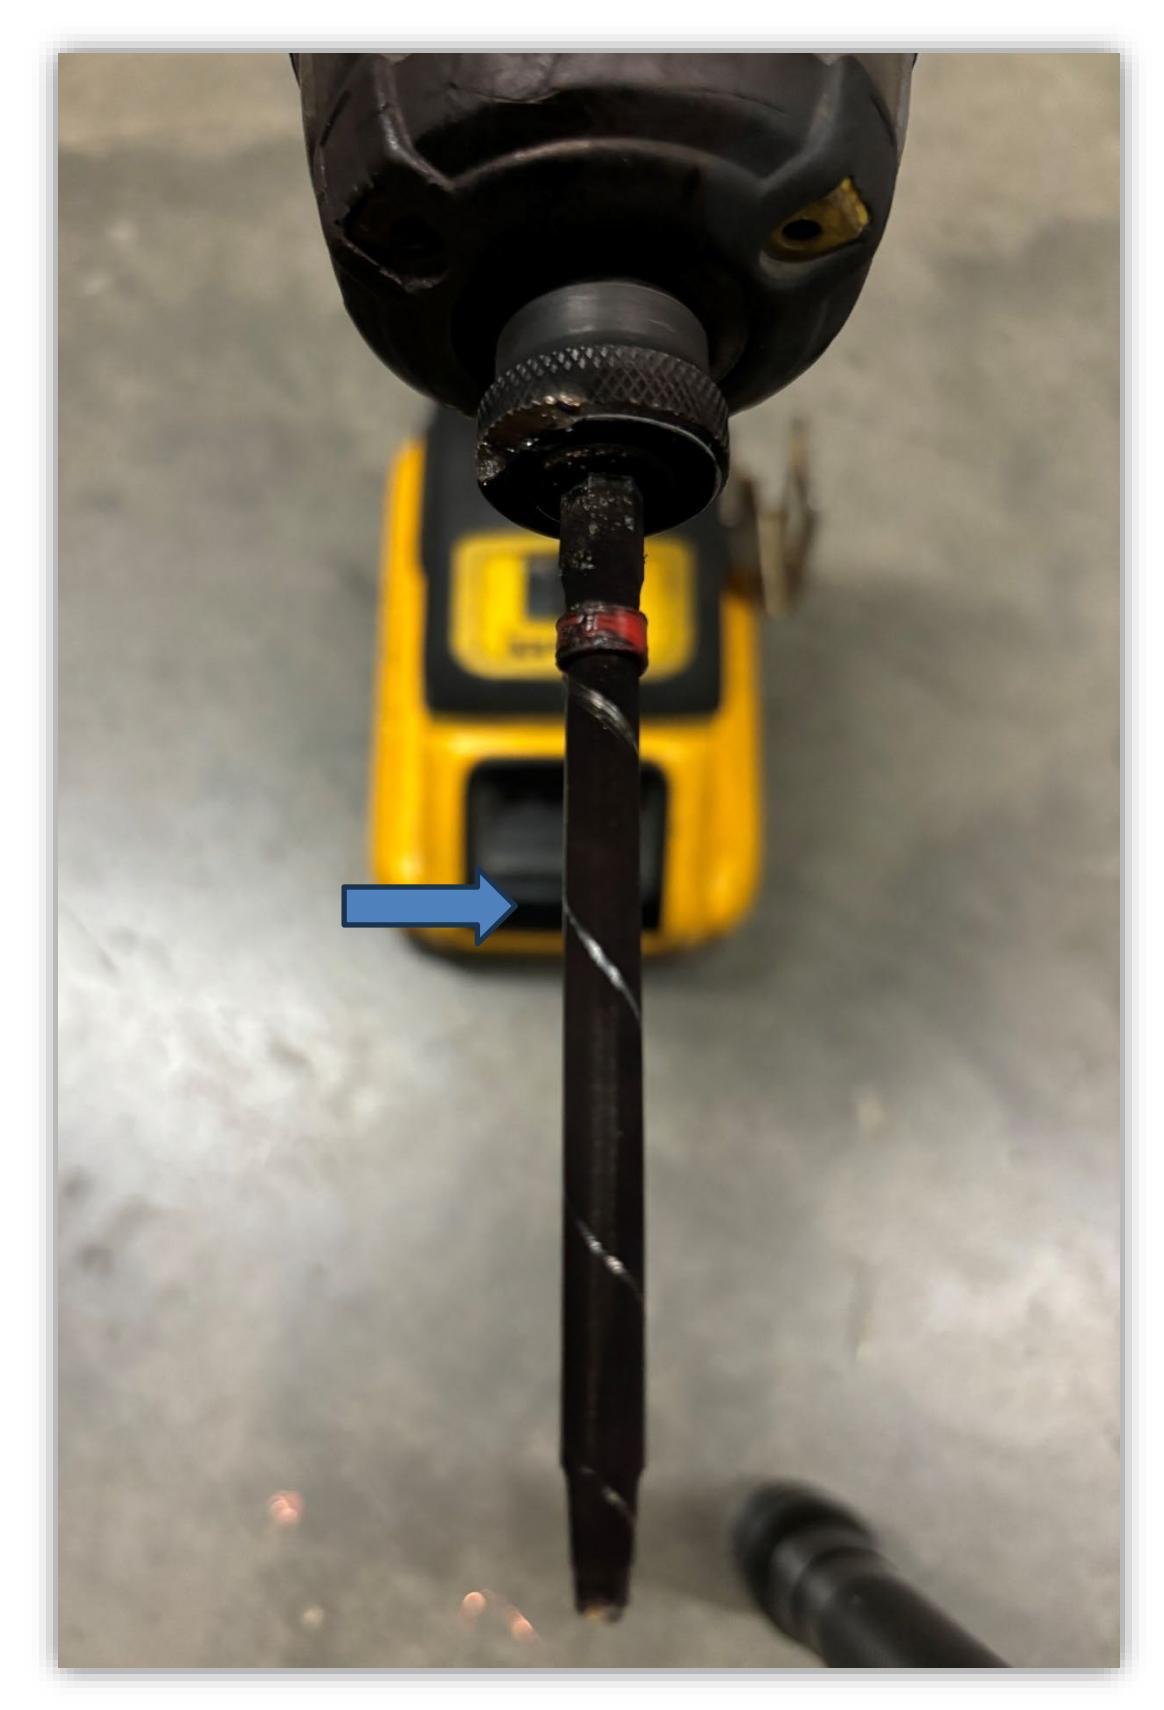
Image 8 - Marks on tool used to attempt a repair by unqualified worker/injured person.

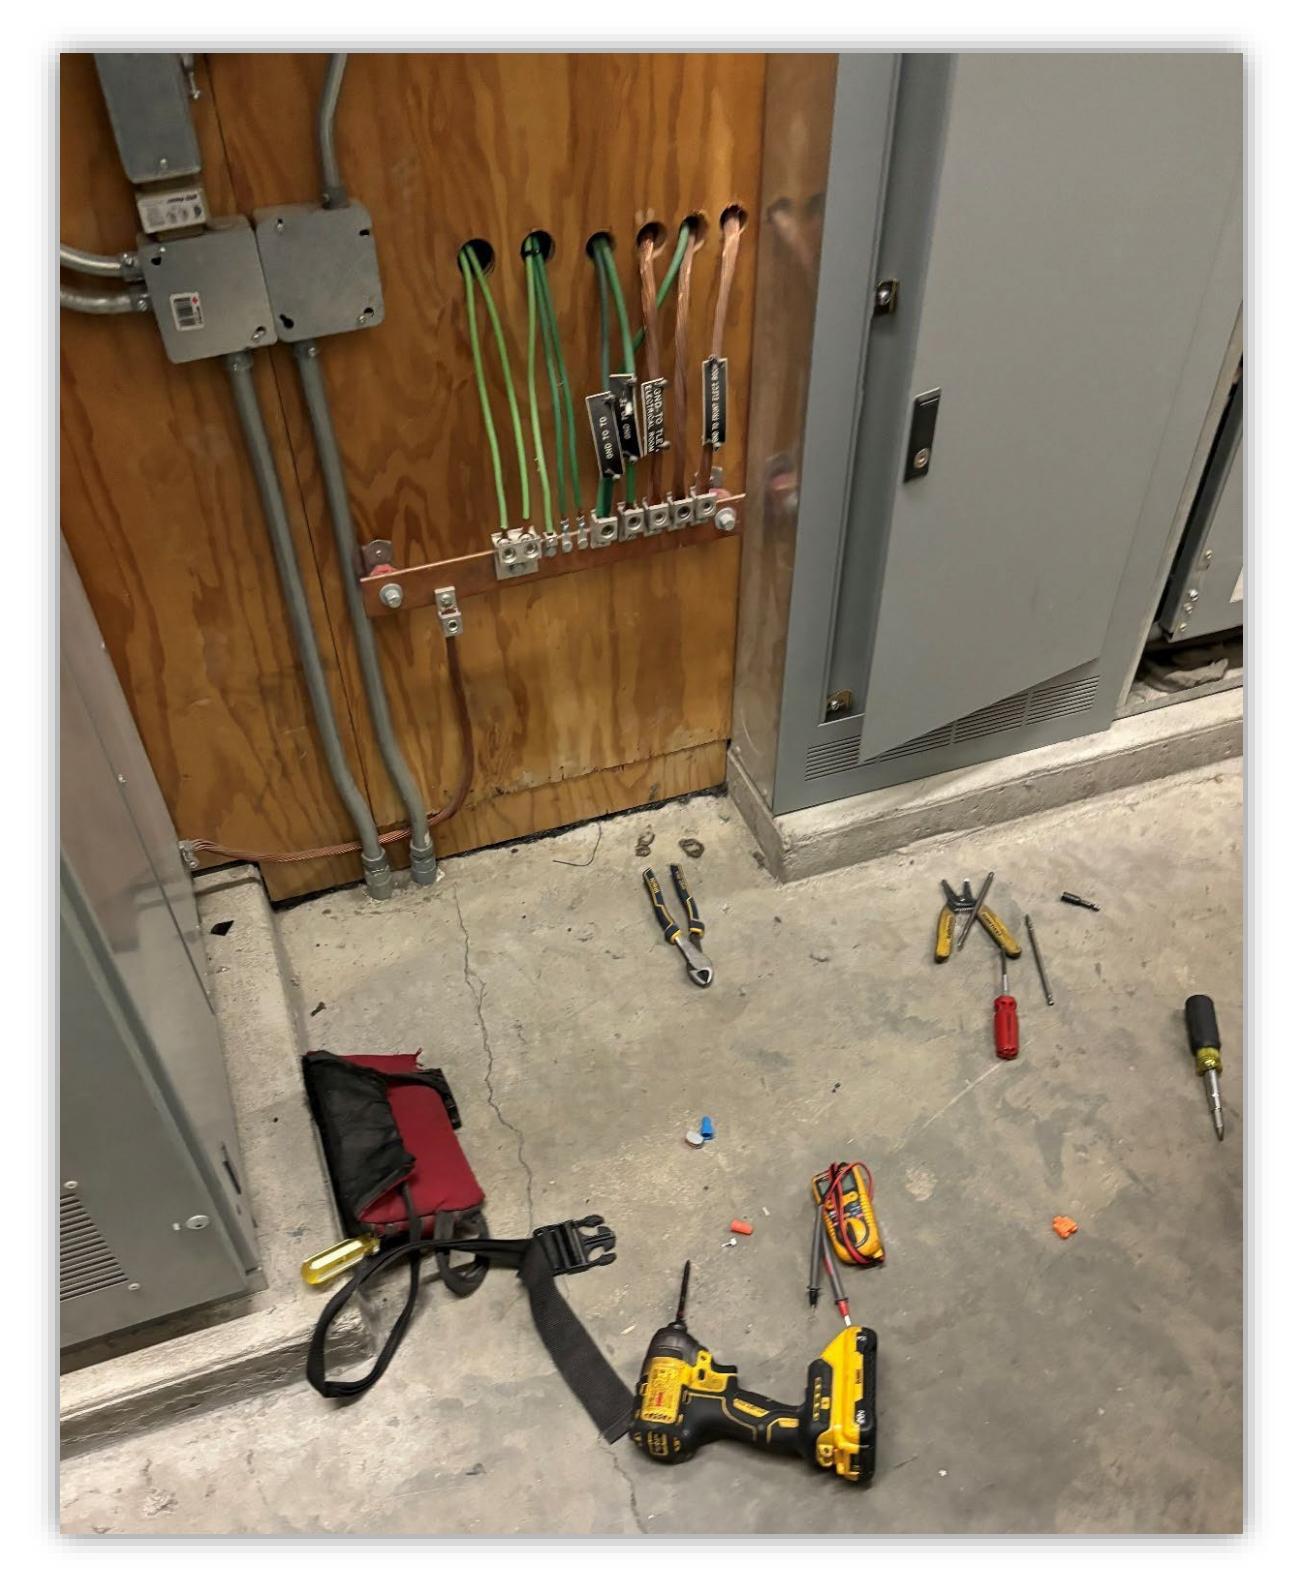
Image 9 - Tools on floor after incident. These were used by unqualified worker/injured person to attempt a repair while individual in the role of onsite supervisor watched.
