SUPPORTING INFORMATION	Incident Date			July 26, 2016
	Location			West Vancouver
	Regulated industry sector			Natural Gas System
	Impact	Injury	Qty injuries	4
			Injury description	One person deceased, one person was found unconscious and was taken to hospital in critical condition and two other individuals were transported to hospital for further treatment.
			Injury rating	Fatal
		Damage	Damage description	N/A
			Damage rating	None
	Incident rating			Severe
	Incident overview			The fire department responded to a 911 call and discovered four individuals who had suffered various degrees of carbon monoxide poisoning. The fire department measured up to 900 parts per million of carbon monoxide in the ambient air within the home. No carbon monoxide detectors were found to be installed within the home so the residents were not alerted to the presence of carbon monoxide.
INVESTIGATION	Site, system and components		em and ents	The mechanical system within the home is comprised of two main components, a low mass fin tube hot water boiler which provides heat for the domestic hot water, fan coil, pool and spa and an air handling unit which moves air throughout the home to be either heated in t

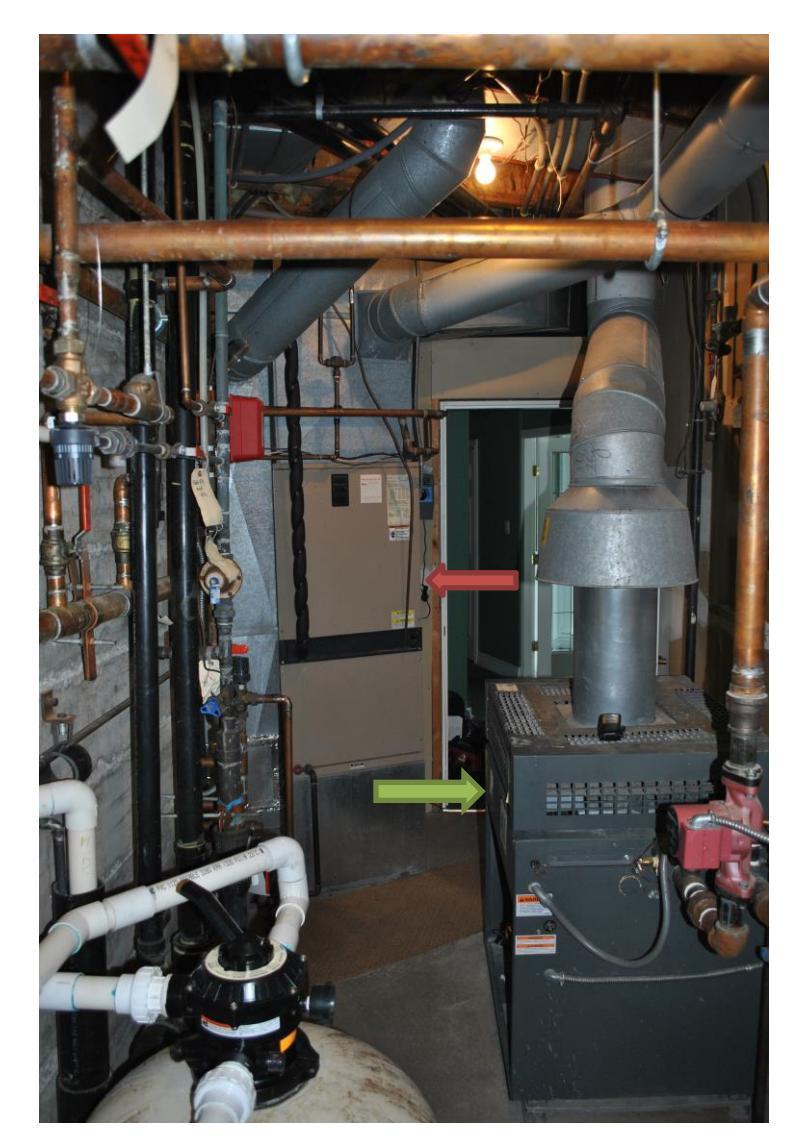
#### Figure 3: Natural gas boiler (green arrow) and Air handling unit (red arrow)

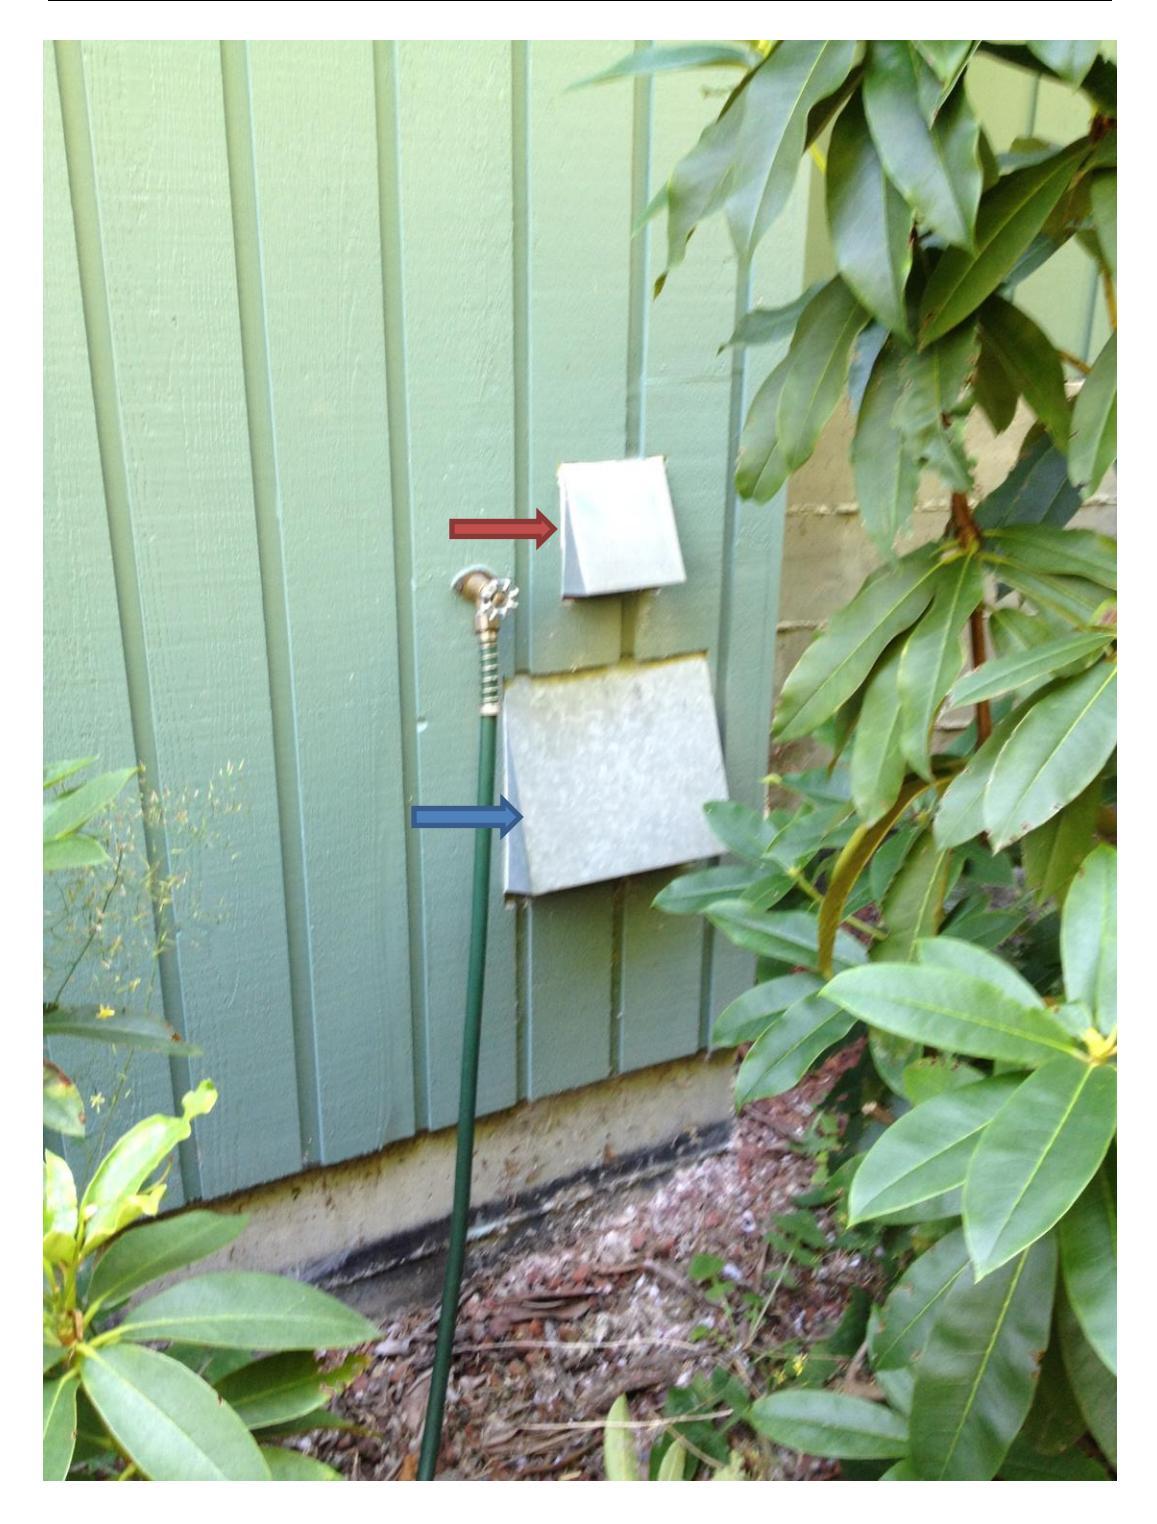
Figure 4: Proximity of dryer vent (red arrow) to combustion air supply intake (blue arrow)

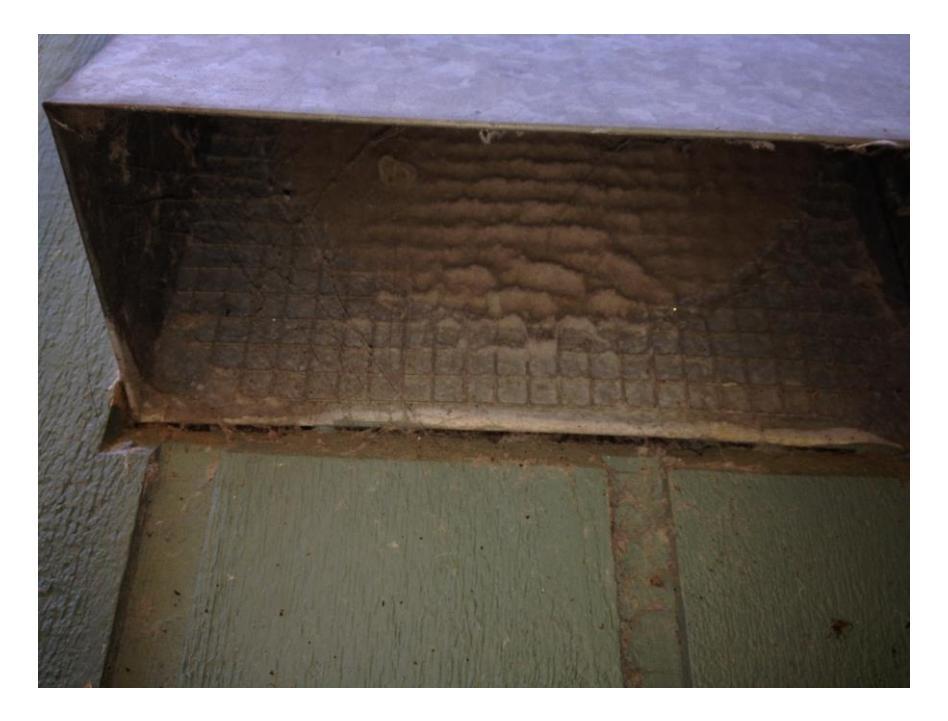
Figure 5: Blocked combustion air supply (outdoor termination)

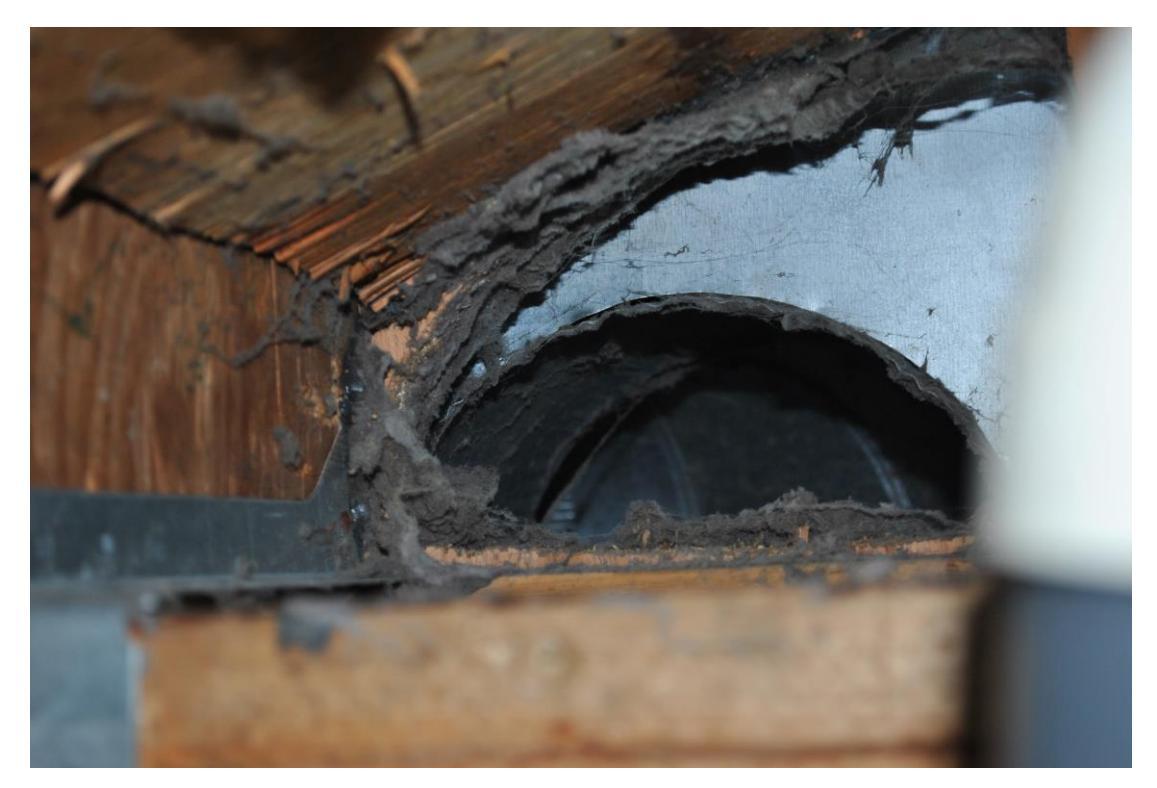
Figure 6: Obstructed combustion air supply ductwork (mechanical room ceiling)

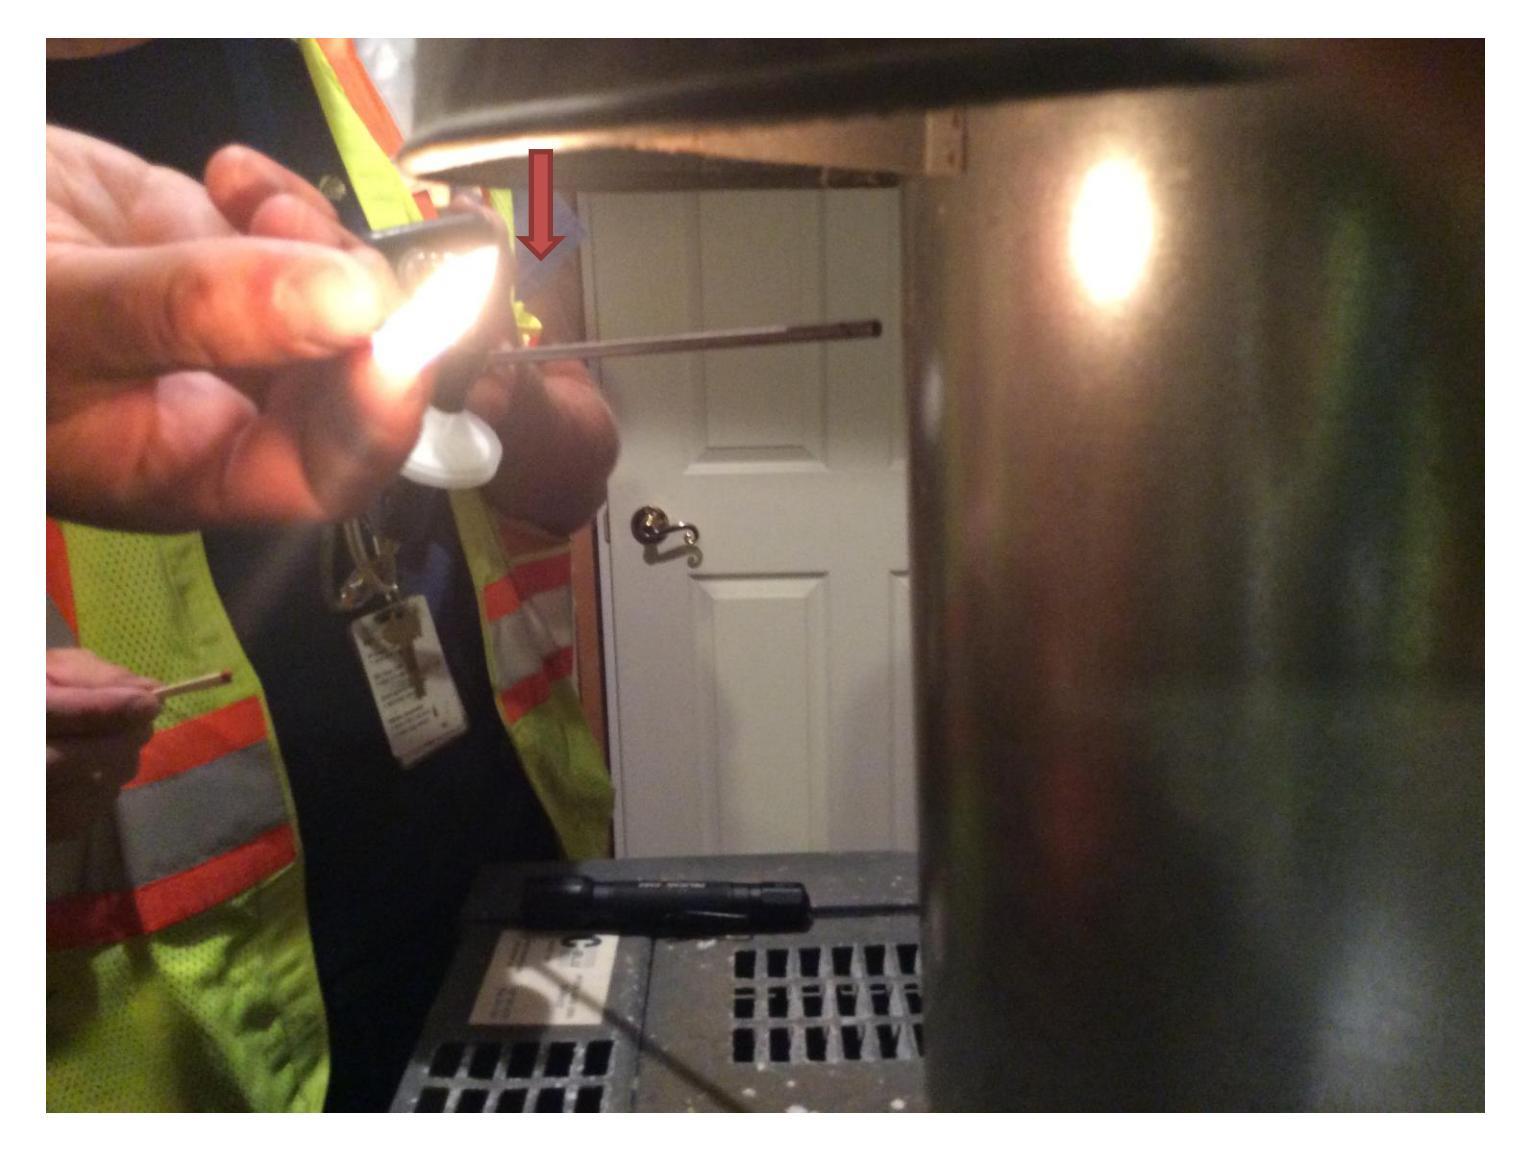
Figure 7: Match flame being forced downward (The red arrow represents the flow of air down and out through the draft hood)

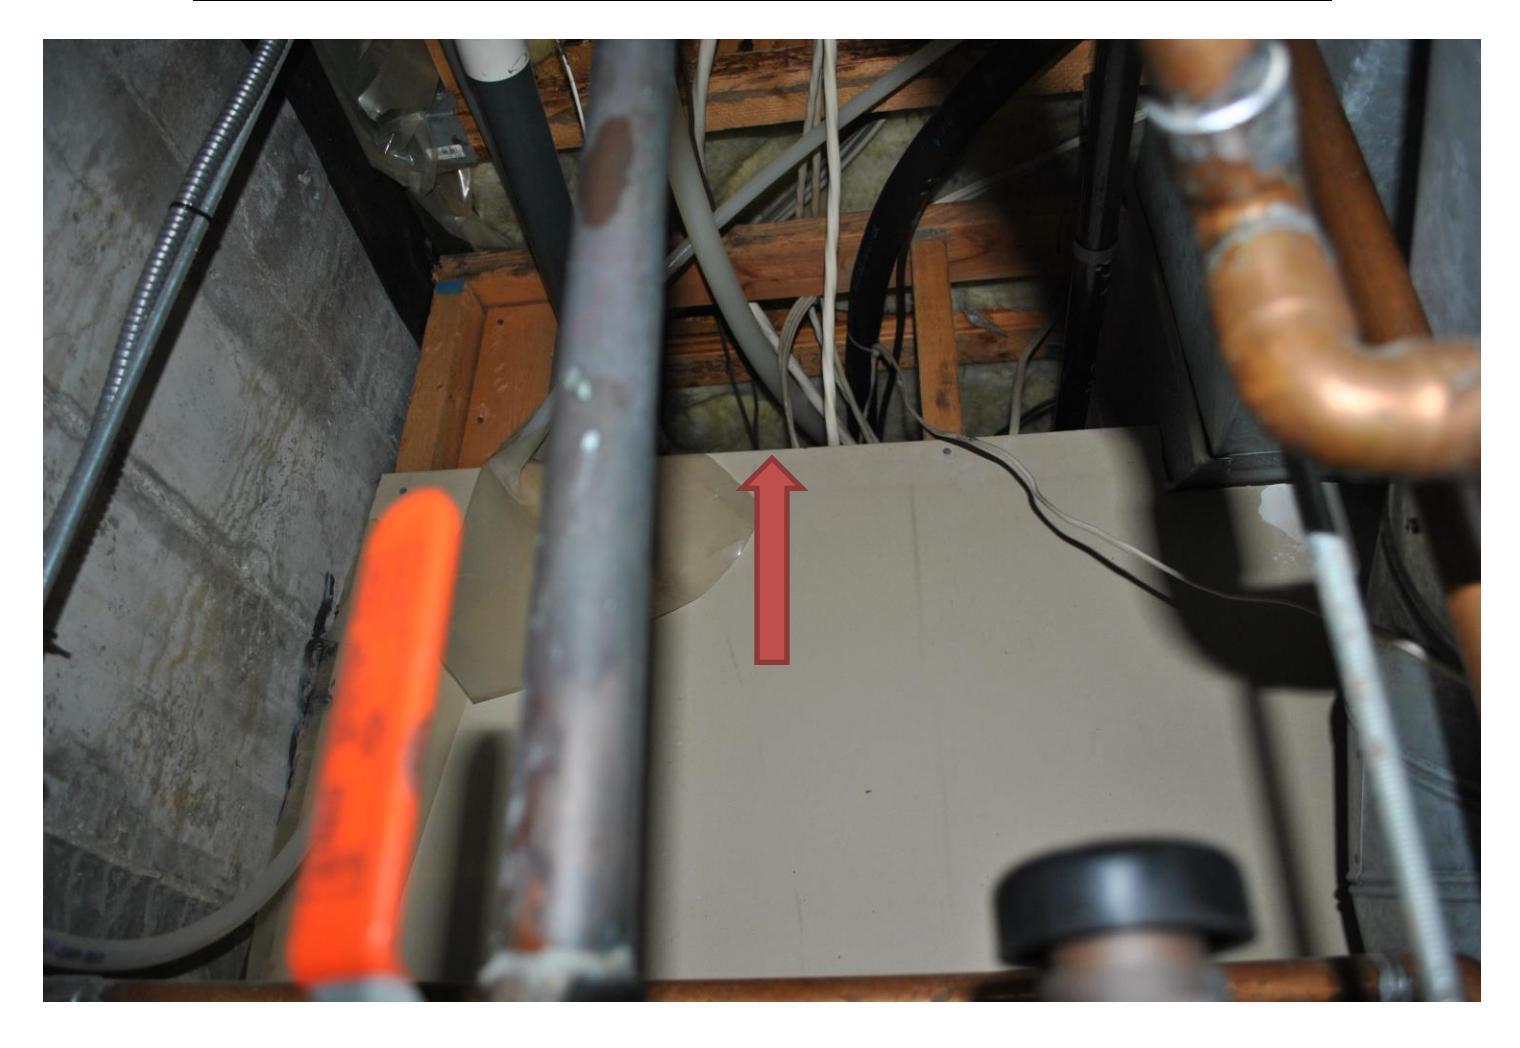
<ul> <li>Multiple smoke tests were performed within the mechanical room which found that the air within the mechanical room was being drawn with force into a large unrestricted opening in the return air ductwork.</li> </ul>
Causes and contributing factors	<ul> <li>It is highly probable that the main cause of the incident can be attributed to the large unrestricted opening in the return air duct work creating a reduced ambient pressure condition in the mechanical room.</li> <li>Multiple contributing factors which were identified were: <ul> <li>A blocked/inadequate combustion air supply into the mechanical room.</li> <li>An elongated boiler run time.</li> <li>A lack of carbon monoxide detectors within the home which would have alerted the residents to the presence of carbon monoxide.</li> </ul> </li> </ul>

#### Figure 8: Open ceiling space housing return air ductwork drawing air from the mechanical room

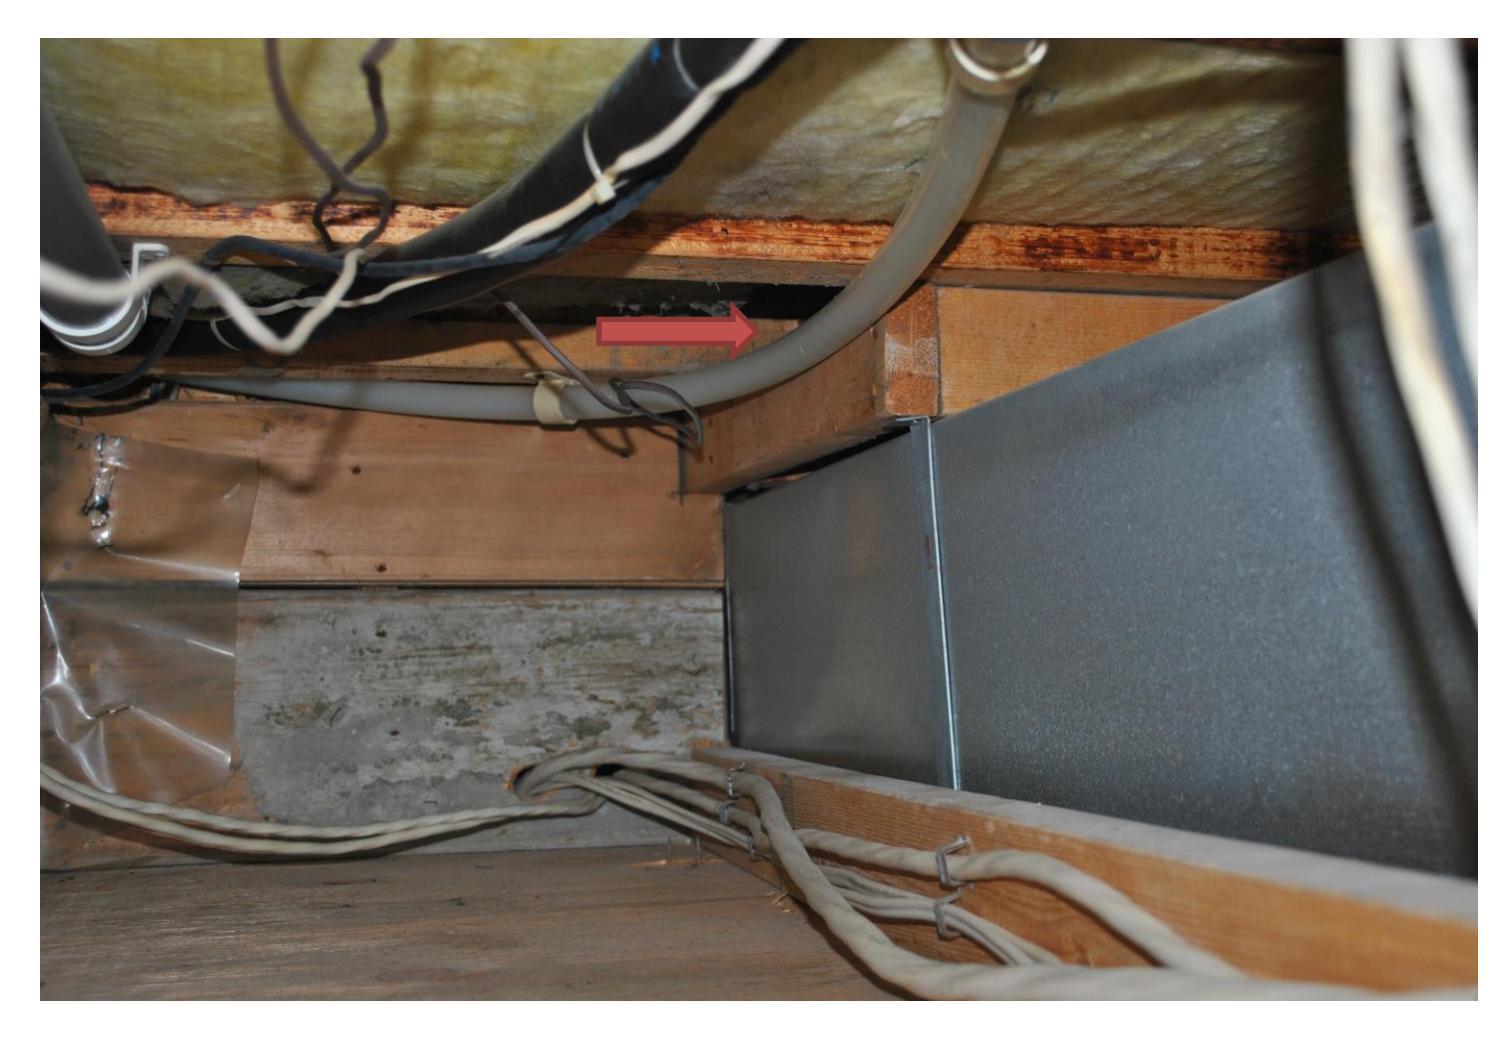
Figure 9: Return air ductwork in ceiling space and large unrestricted opening into ductwork (The red arrow represents the path of airflow into the return air ducting system)
