Incident Summary #II-1578772-2023 (#36933) (FINAL)

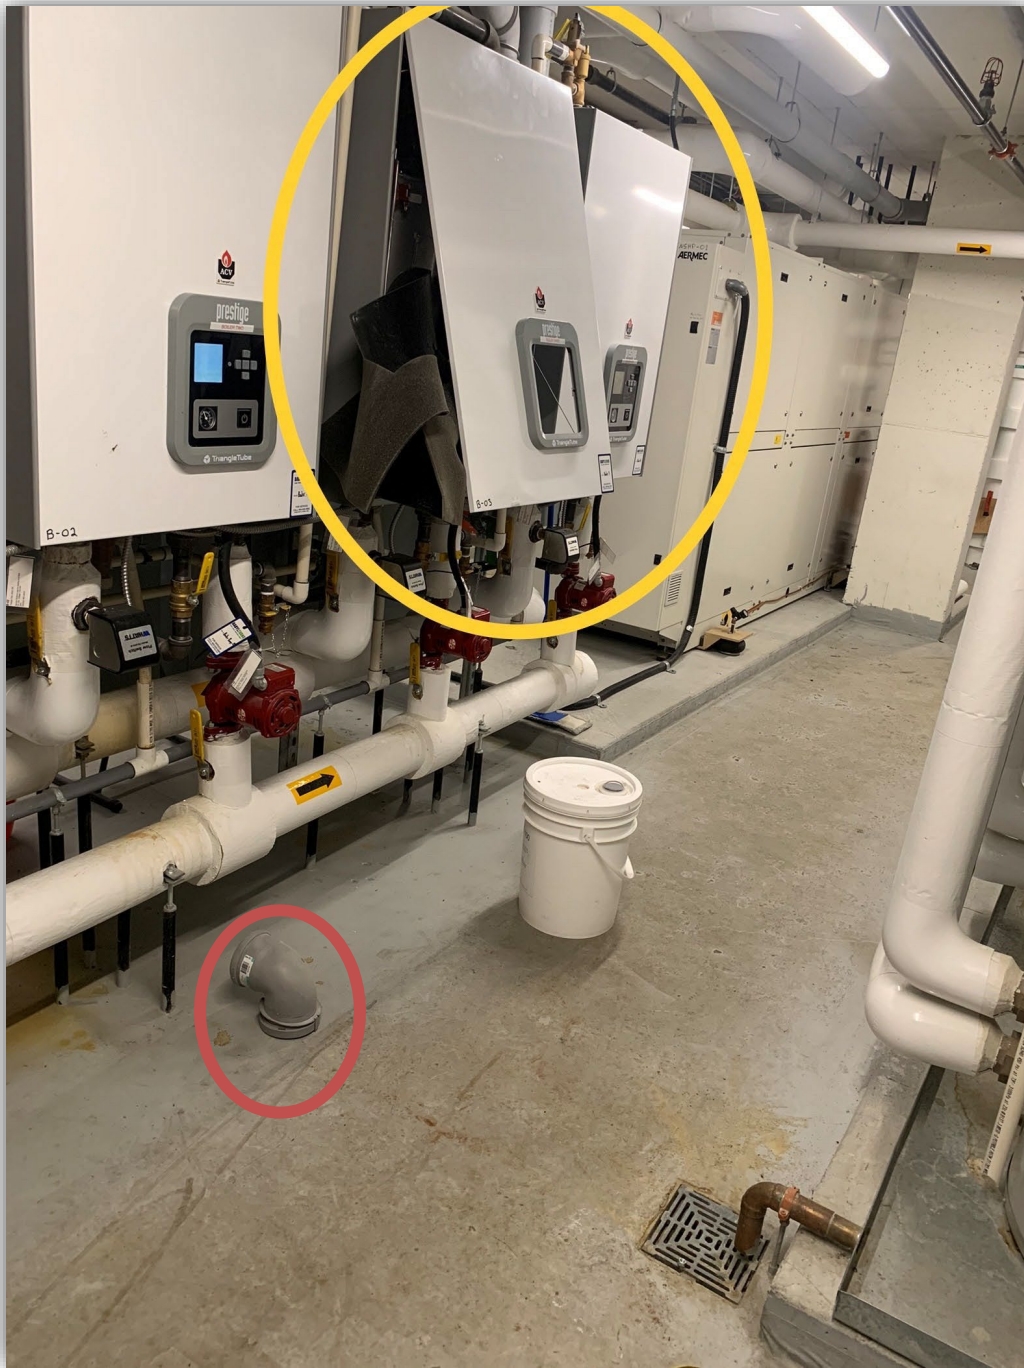
Image 1 - This image was provided by the caretaker and shows what he observed when entering the boiler room during his routine check of the boiler equipment on the day he reported the incident. The orange outline shows boiler #3 that experienced a detonation during a delayed ignition event. The cover was blown open from the force of the incident and the insulation was separated from the interior of the boiler enclosure. The red outline shows the 90-degree polypropylene fitting that was blown off the venting pipe that was terminated on the venting output adapter at the top of the boiler.

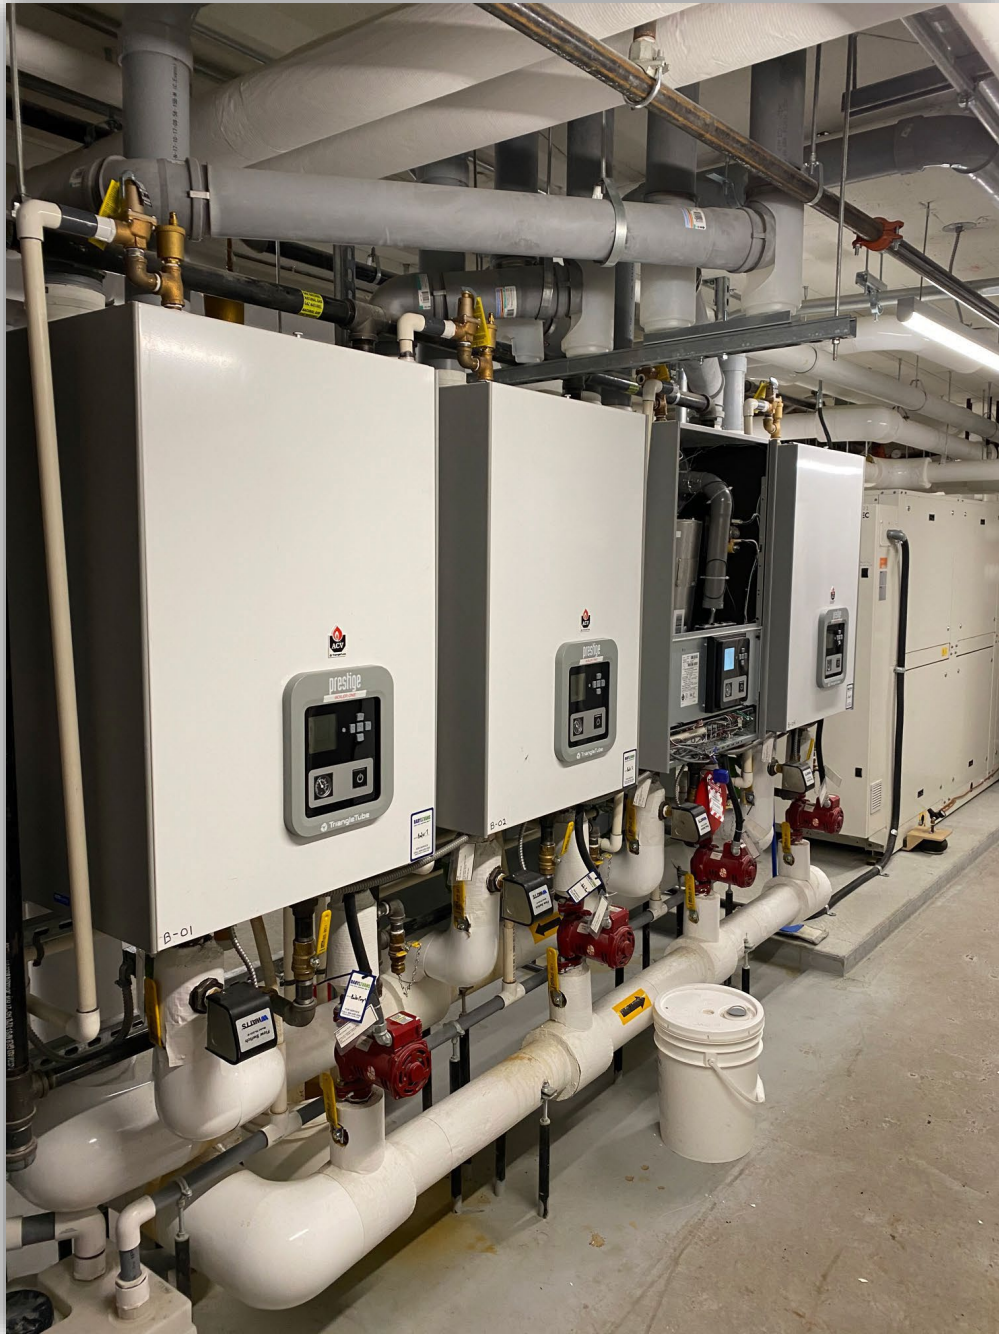
Image 2 - All four boilers that form part of the water heating system. The output venting comes off the top of the boilers with a short piece of polypropylene vent pipe and then transitions to 90-degree bends so the piping can be routed to the location where it enters another 90-degree bend and rises through the building structure to the roof.

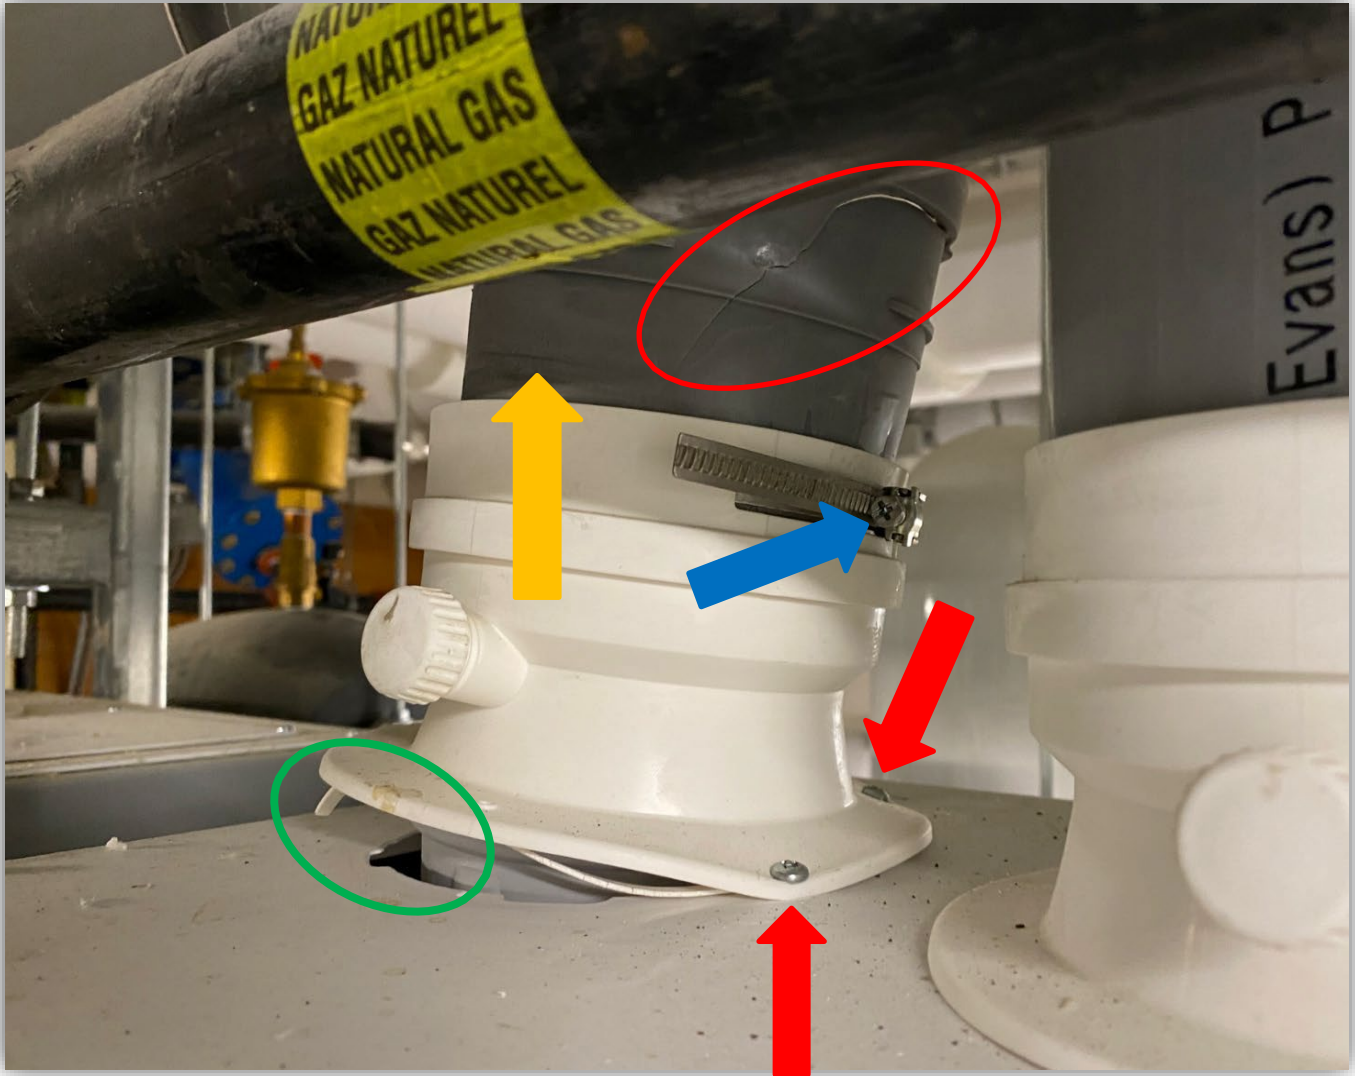
Image 5 - The venting outlet adapter pulled away from the boiler enclosure. The red arrows show screw #2 and screw #3. The red outline shows the venting pipe cracked above the adapter. The blue arrow shows the vent outlet adapter tightening screw used to secure the venting in place once installed. The orange arrow shows marks around the pipe where the vent adapter securing clamp was tightened on to the pipe prior to the detonation. The green outline shows the area where the fourth screw should have been installed as per the manufacturer's recall for the venting output adapter.

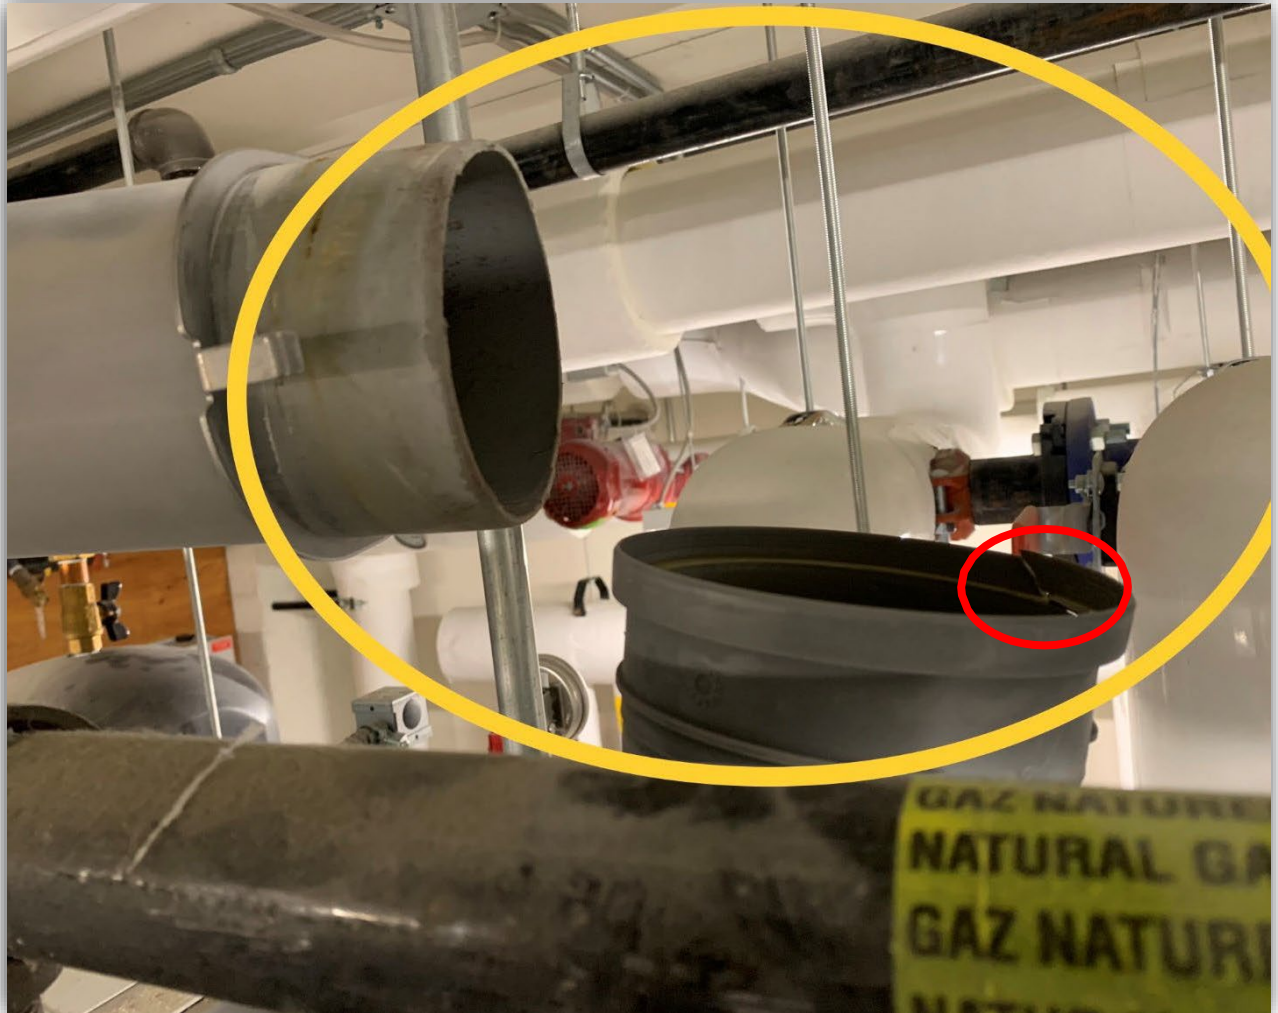
Image 6 - This image was provided by the caretaker and shows the 90-degree polypropylene venting fitting missing from the venting system at the top of the boiler. The fitting was blown off the venting system from the force of the detonation caused by the delayed ignition event. The red outline shows the venting pipe cracked from the force of the detonation.

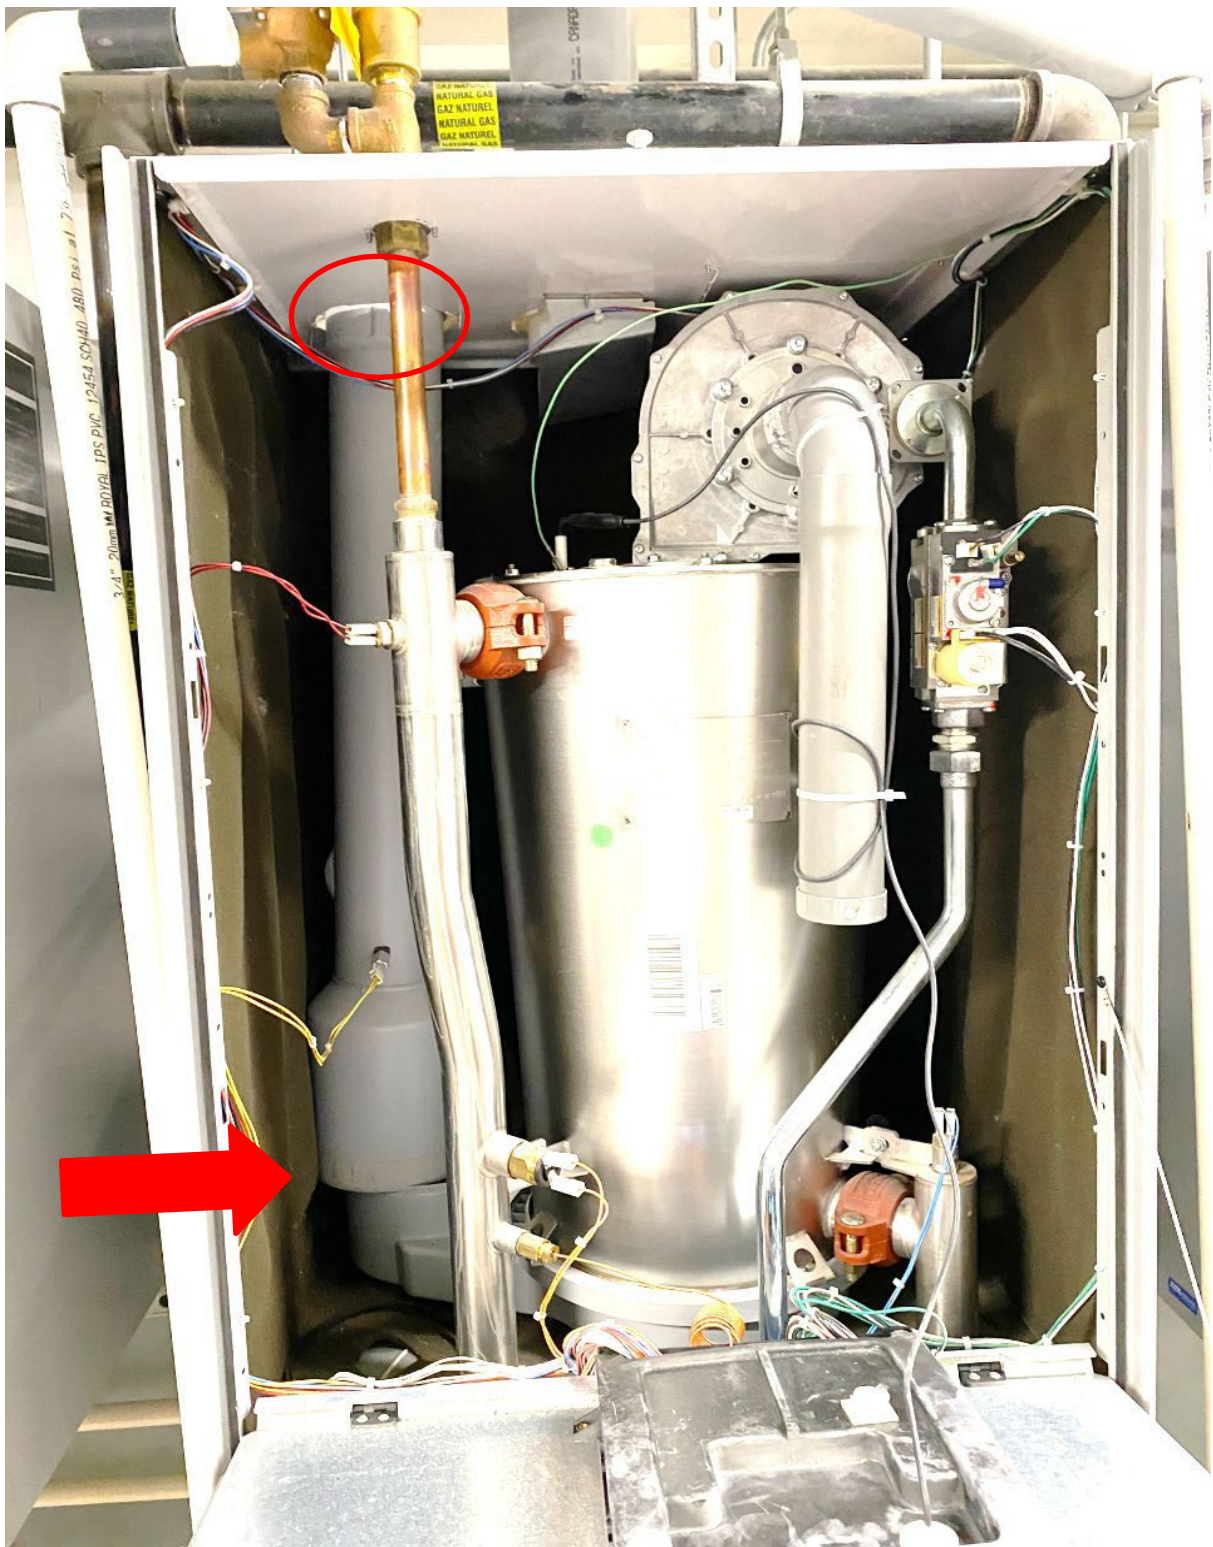
Image 7 – The interior of the boiler #3 enclosure after the incident. The red outline shows where the internal venting piping connects to the boiler's venting output adapter at the top of the boiler. Light coming from outside of the boiler at the top is visible where the adapter was pulled away from the boiler enclosure and the red arrow shows where the internal venting pipe was dislodged from the condensate pan at the bottom of the boiler. Both conditions were caused by the detonation during the delayed ignition event.

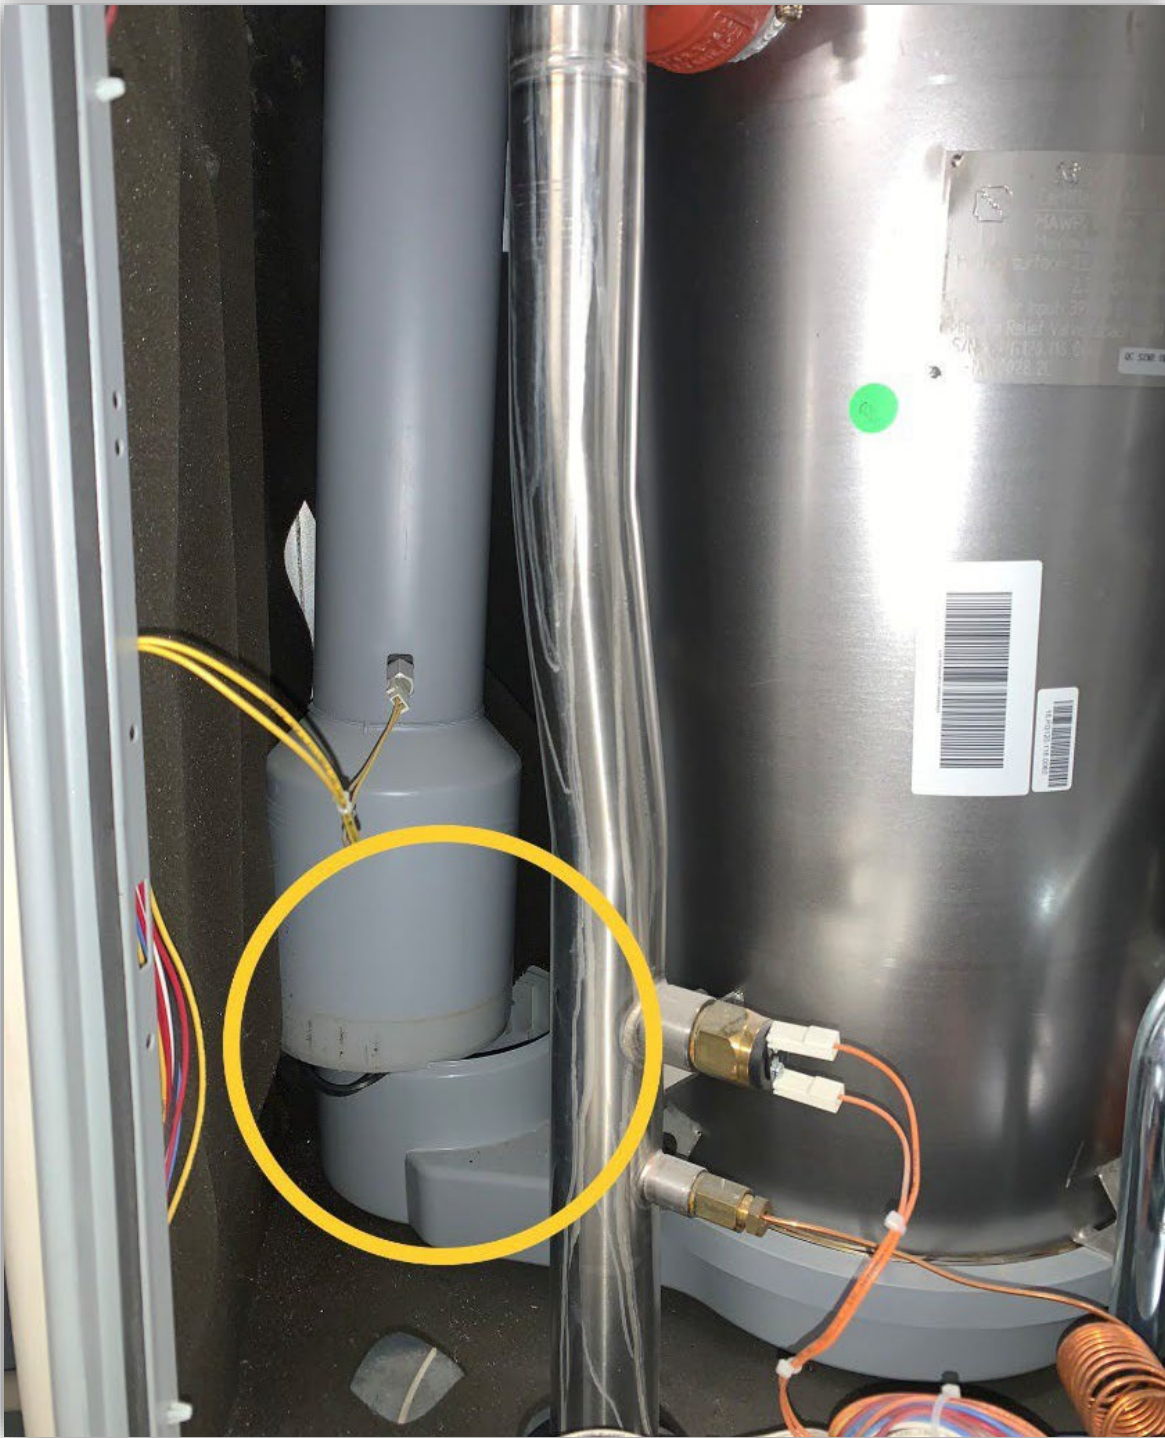
Image 8 - This image was provided by the caretaker. The orange outline shows the internal venting output pipe dislodged from the condensate pan. The condensate pan fitting gasket is intended to make a seal around the venting pipe. The photo also shows the gasket dislodged.

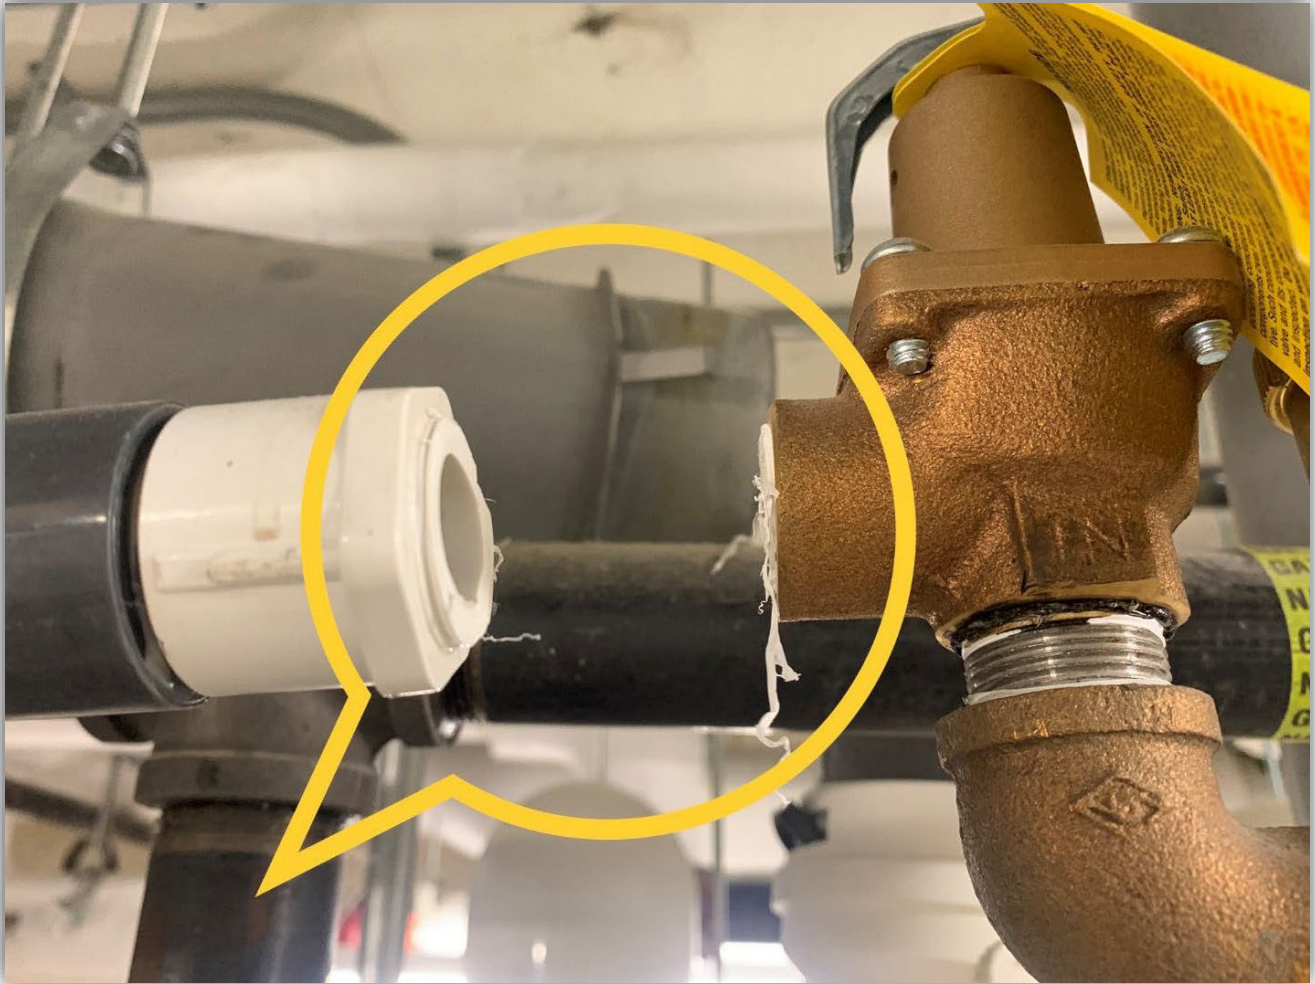
Image 11 - This image was provided by the caretaker and shows the pressure relief draining piping broken and dislodged after the incident.

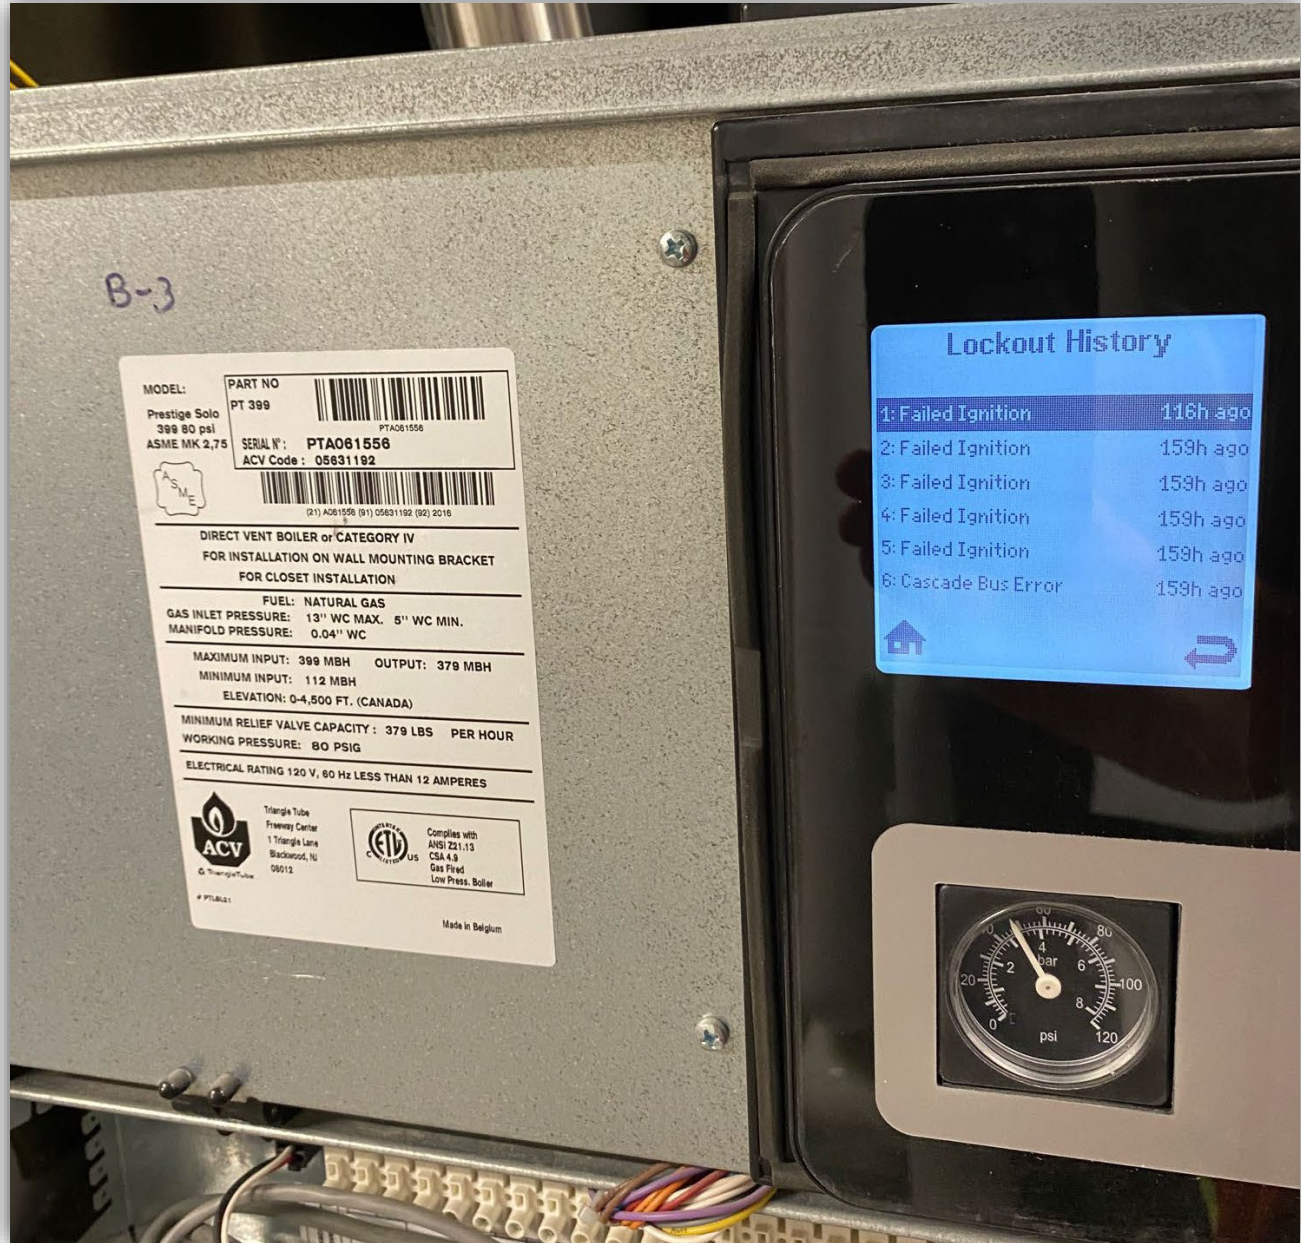
Image 12 - The display on the front of Boiler #3 involved with the incident. At the time of the incident the lockout history displayed five failed ignition errors.

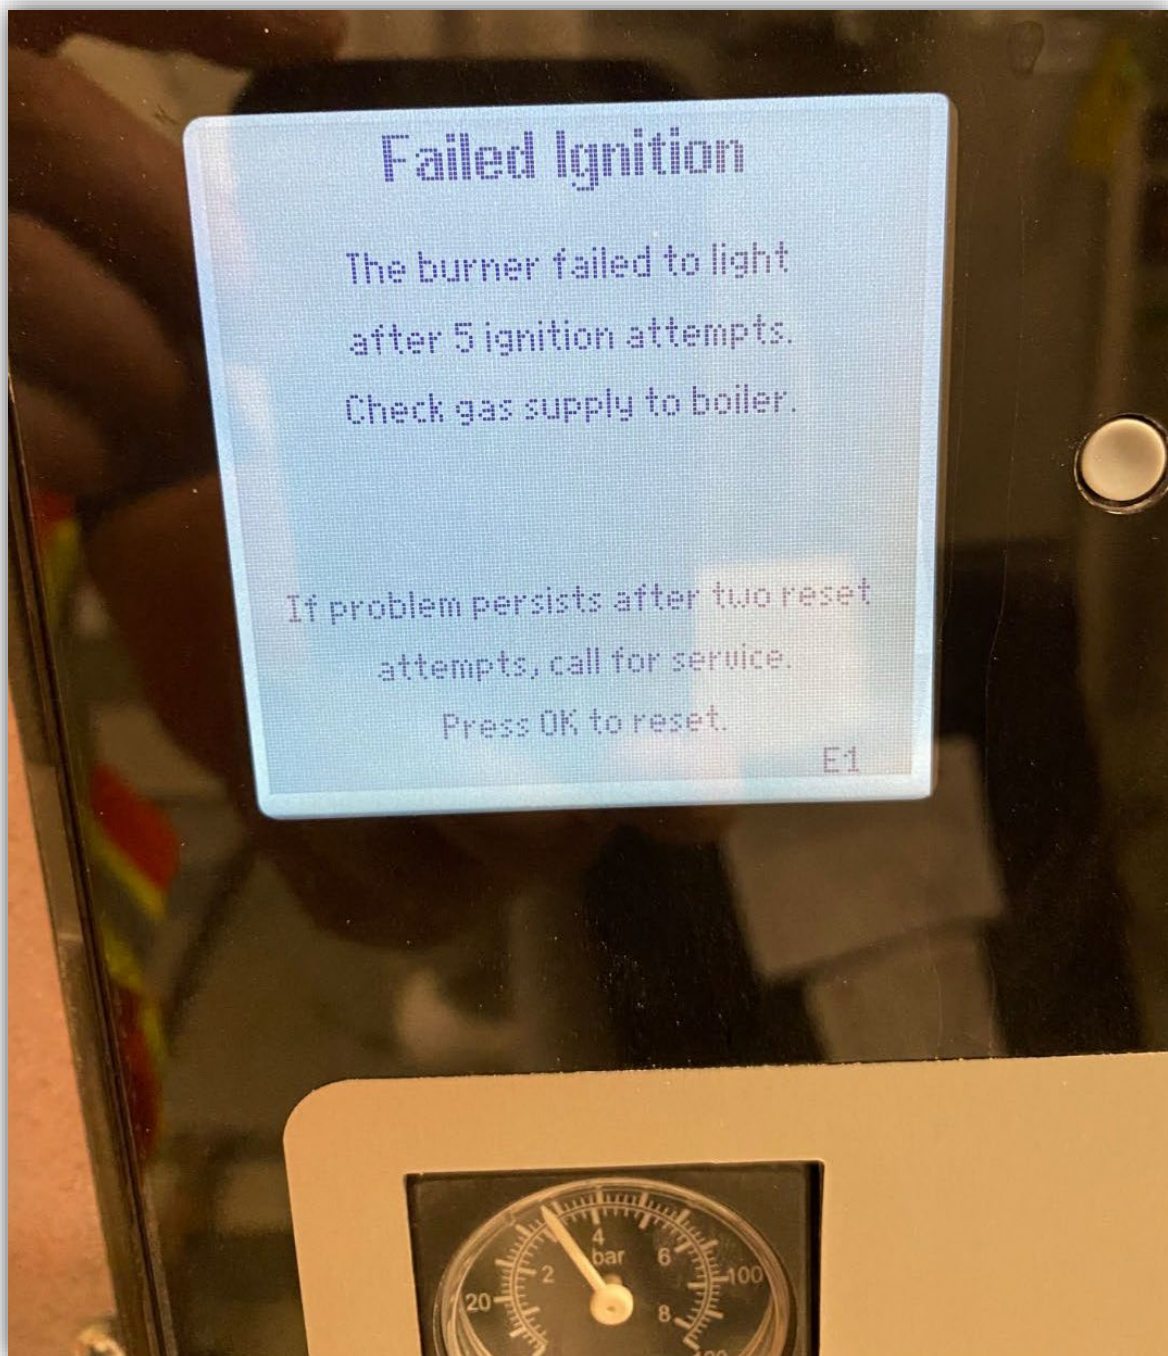
Image 13 – A failed ignition warning and instructions to call for service.

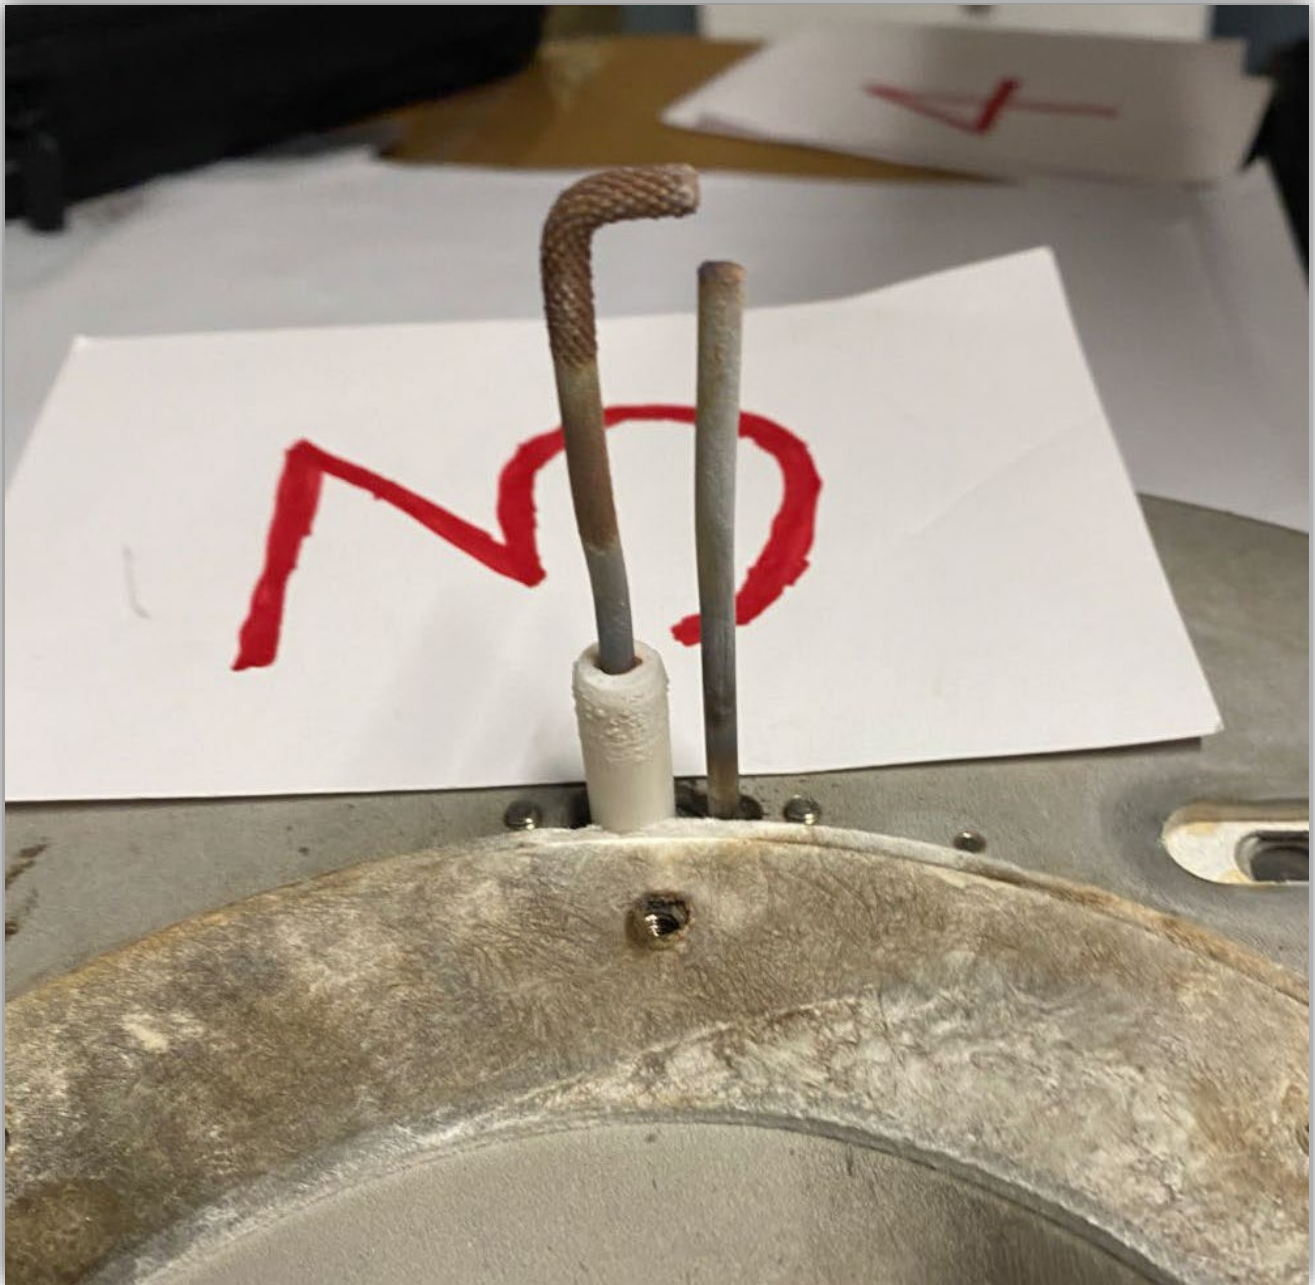
Image 14 - The ignitor from boiler #3 that was involved in the incident.

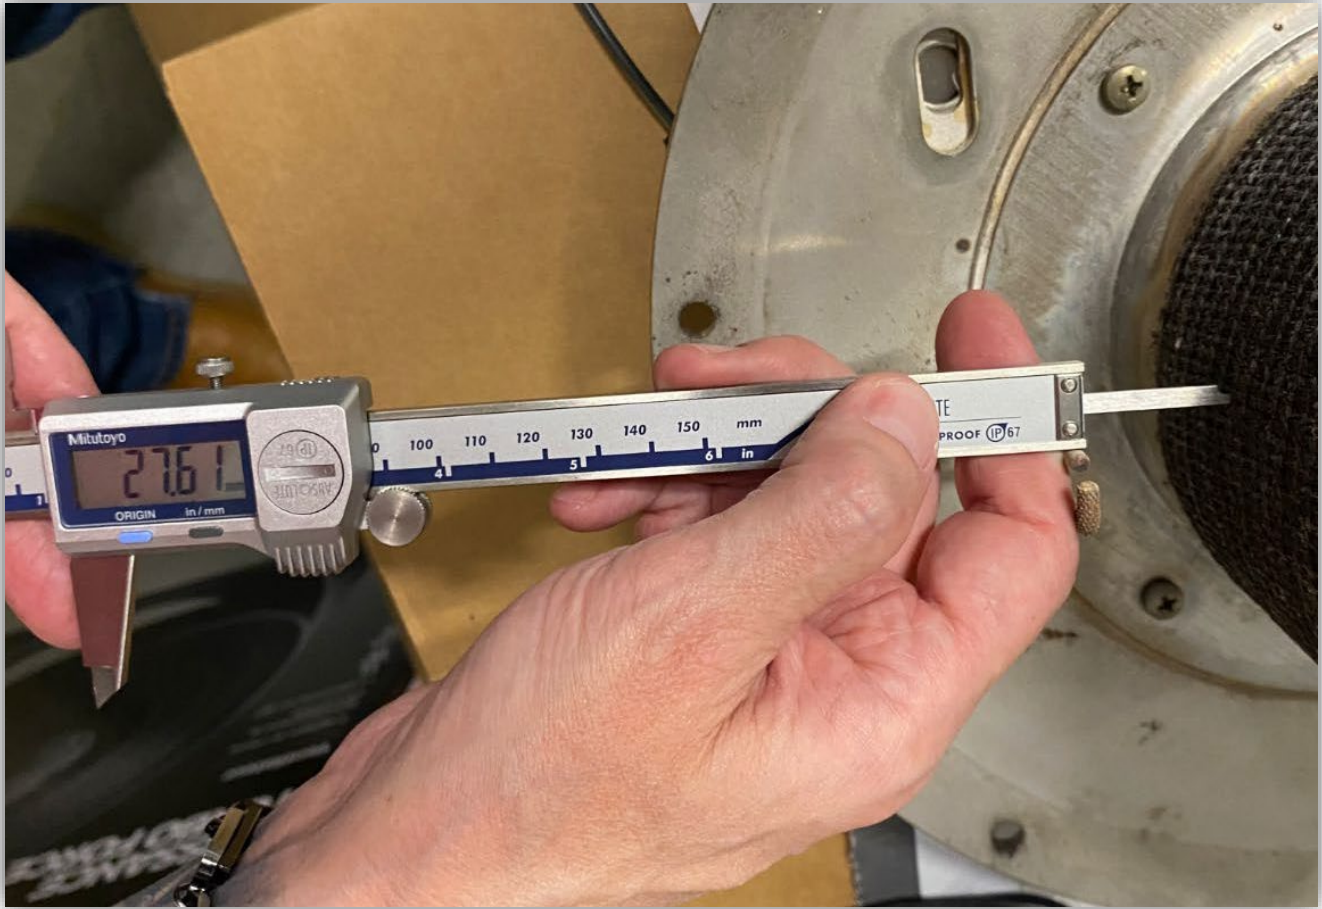
Image 18 - This image shows the distance from the ignitor to the boiler burner for boiler #3. The distance was 27.61mm which is close to the manufacturer's specification of 28mm. The manufacturer's replacement ignitor outlined in the manufacturer's technical bulletin specifies a much closer distance of 7.2mm between the ignitor legs (prongs) and the burner ([Image 19](#)).
