Incident Summary #II-1672647-2024 (#44259) (FINAL)

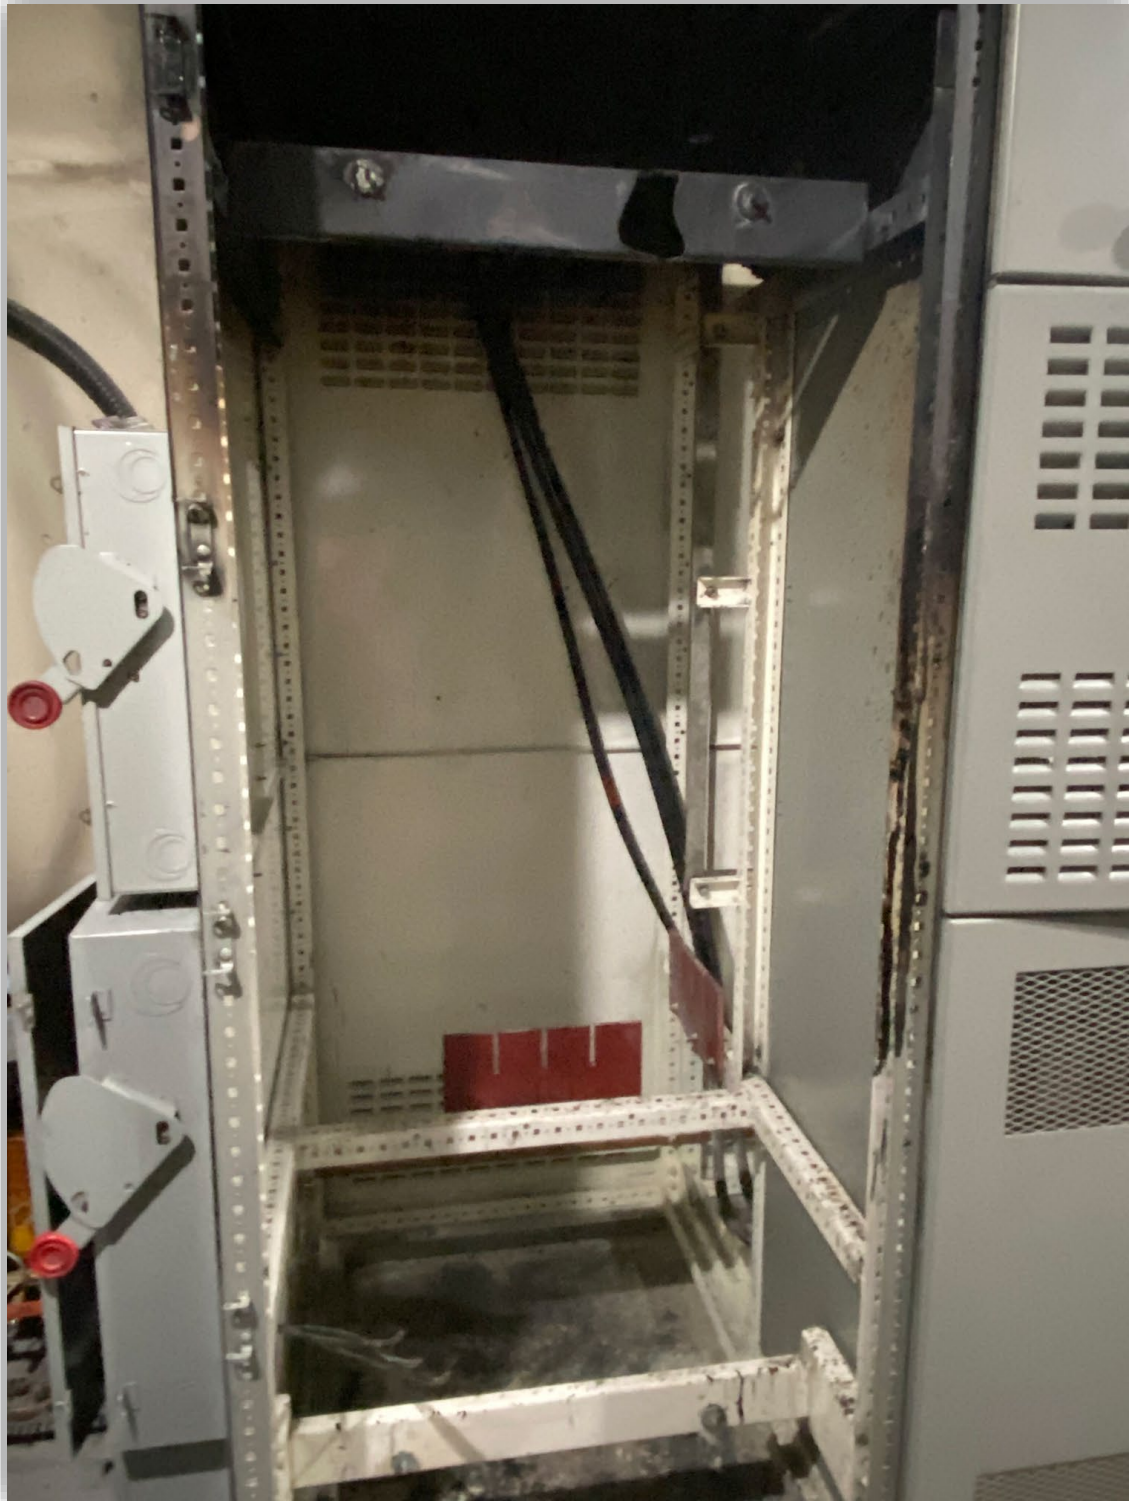
Image 1 – Distribution board enclosure.
