Incident Summary #II-1639122-2023 (#41742) (FINAL)

SUPPORTING INFORMATION	Incident Date			November 21, 2023
	Location			Chilliwack
	Reg	Regulated industry sector		Gas - Natural gas system
		Injury	Qty injuries	0
			Injury description	NA
	Impact		Injury rating	None
		Jamage	Damage description	An electrical connection just below the plastic air filter overheated, burning off approximately three (3) inches of insulation from the wire and then igniting the plastic air filter.
		Δ -	Damage rating	Moderate
	Inci	cident rating		Moderate
	Incident overview			There was a fire inside an approximately 30-year-old furnace.
				A "push on" electrical terminal connection that is part of the electrical power circuit for the furnace fan became resistive over time, resulting in the wire becoming hot enough to burn away approximately four (4) inches of the wire insulation jacket and then ignite the plastic air filter mounted above the wire on fire. The resulting smoke and fumes from the burning filter entered the living space of residence and was detected by a carbon monoxide alarm which alerted the single resident of a hazardous situation.

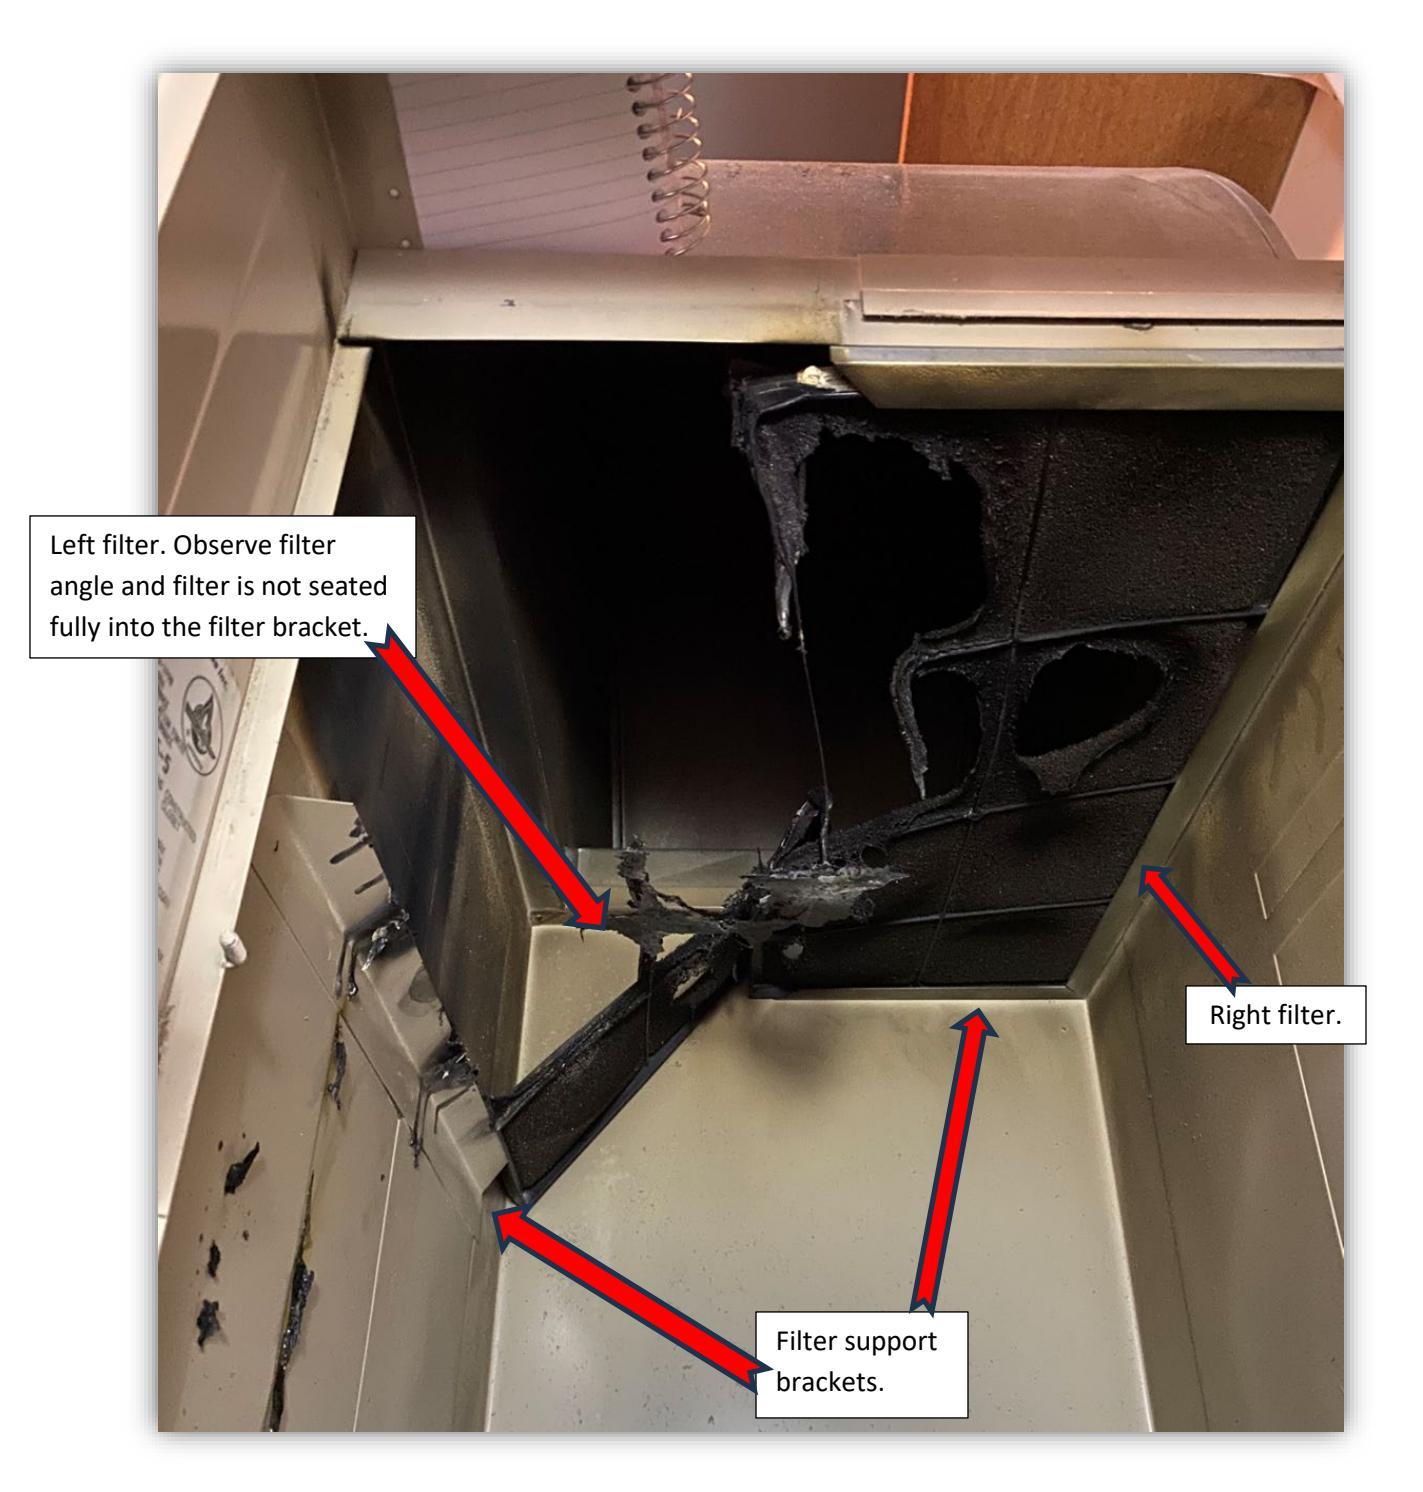
Causes and contributing factors	The resulting fire appears to be a combination of an existing electrical component ongoing failure and a possibility that the left side filter was not placed fully into the lower filter bracket resulting in the plastic filter being drawn down with the airflow to make contact with the heated electrical wire. The design of the filter brackets and fan assembly places the filter in close proximity to the electrical connections of the fan capacitor. An error in properly installing the filters, or poor maintenance resulting in plugged filters can result in the filters being drawn down toward the fan assembly with the airflow and making contact with the energized terminals of the capacitor.

Image 4 - The furnace filters after the fire with the fan assembly removed. The area with the most damage is located above where the capacitor and associated wiring would be located. The filter does not appear to be fully seated inside the lower filter bracket which may have resulted in the filter making contact with the damaged wire as shown in <u>Image 5</u>.

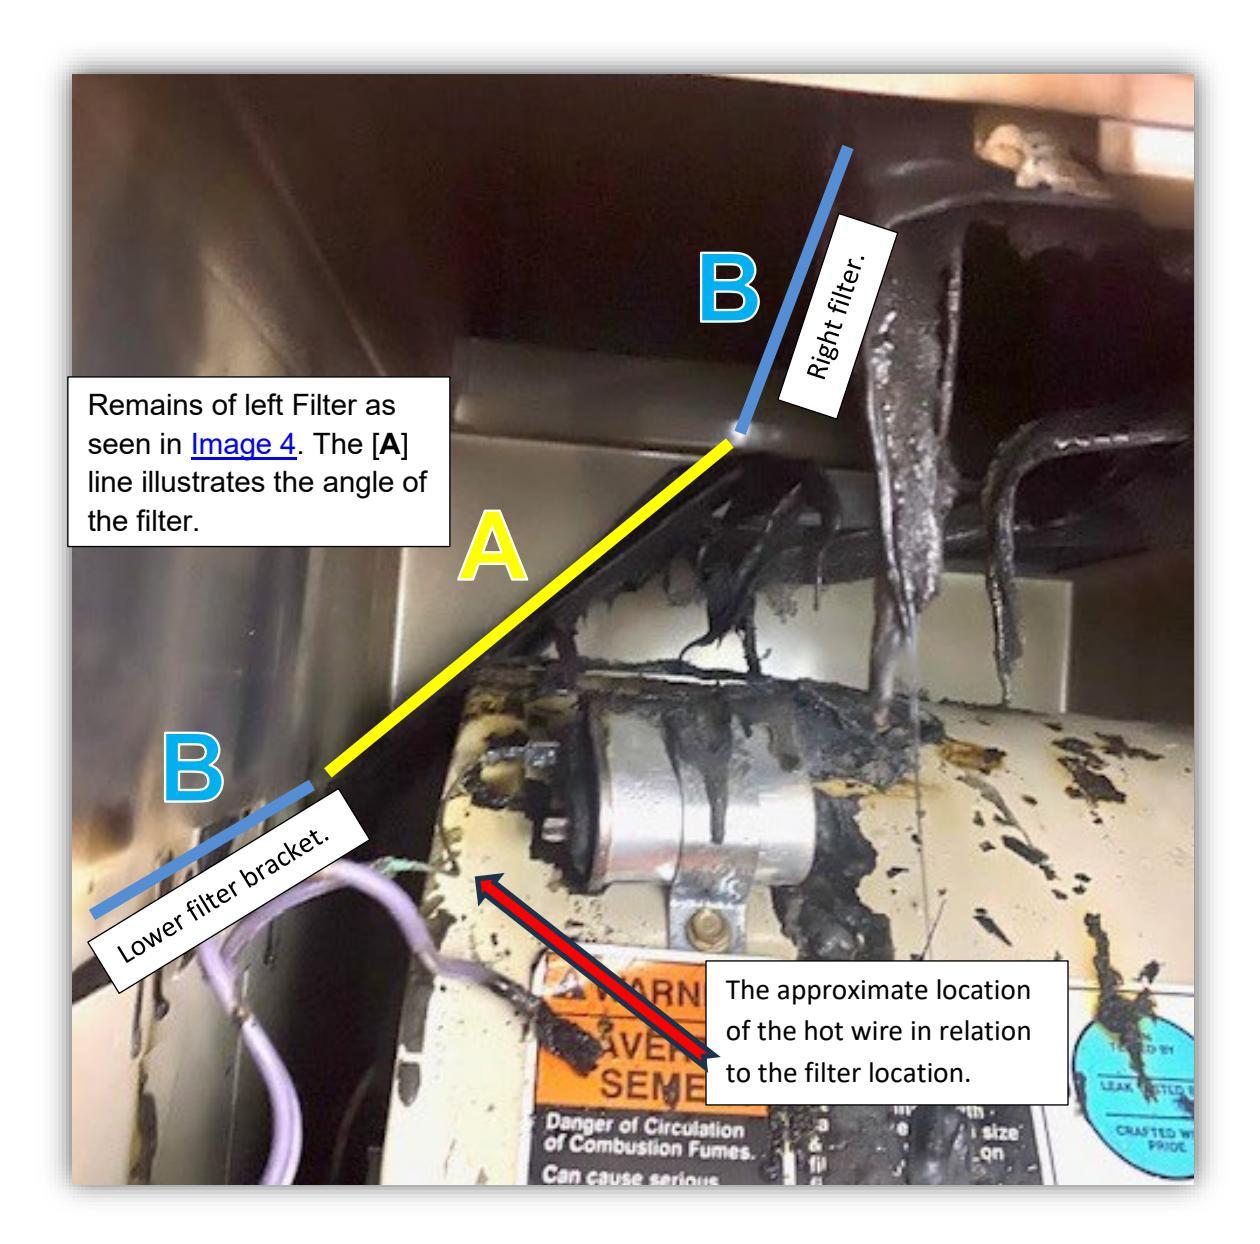
Image 5 - The angle of the left filter is illustrated in [**A**] to show how it sits in relation to the fan assembly. The complete filter would sit in the lower filter bracket and lean against the upper right-side filter as shown by [**B**] lines. The filter normally sits close to the fan assembly and the capacitor wiring, but if the filter is not seated into the lower filter bracket properly it is possible the filter could sag and make contact with the live electrical connections and wiring of the capacitor.

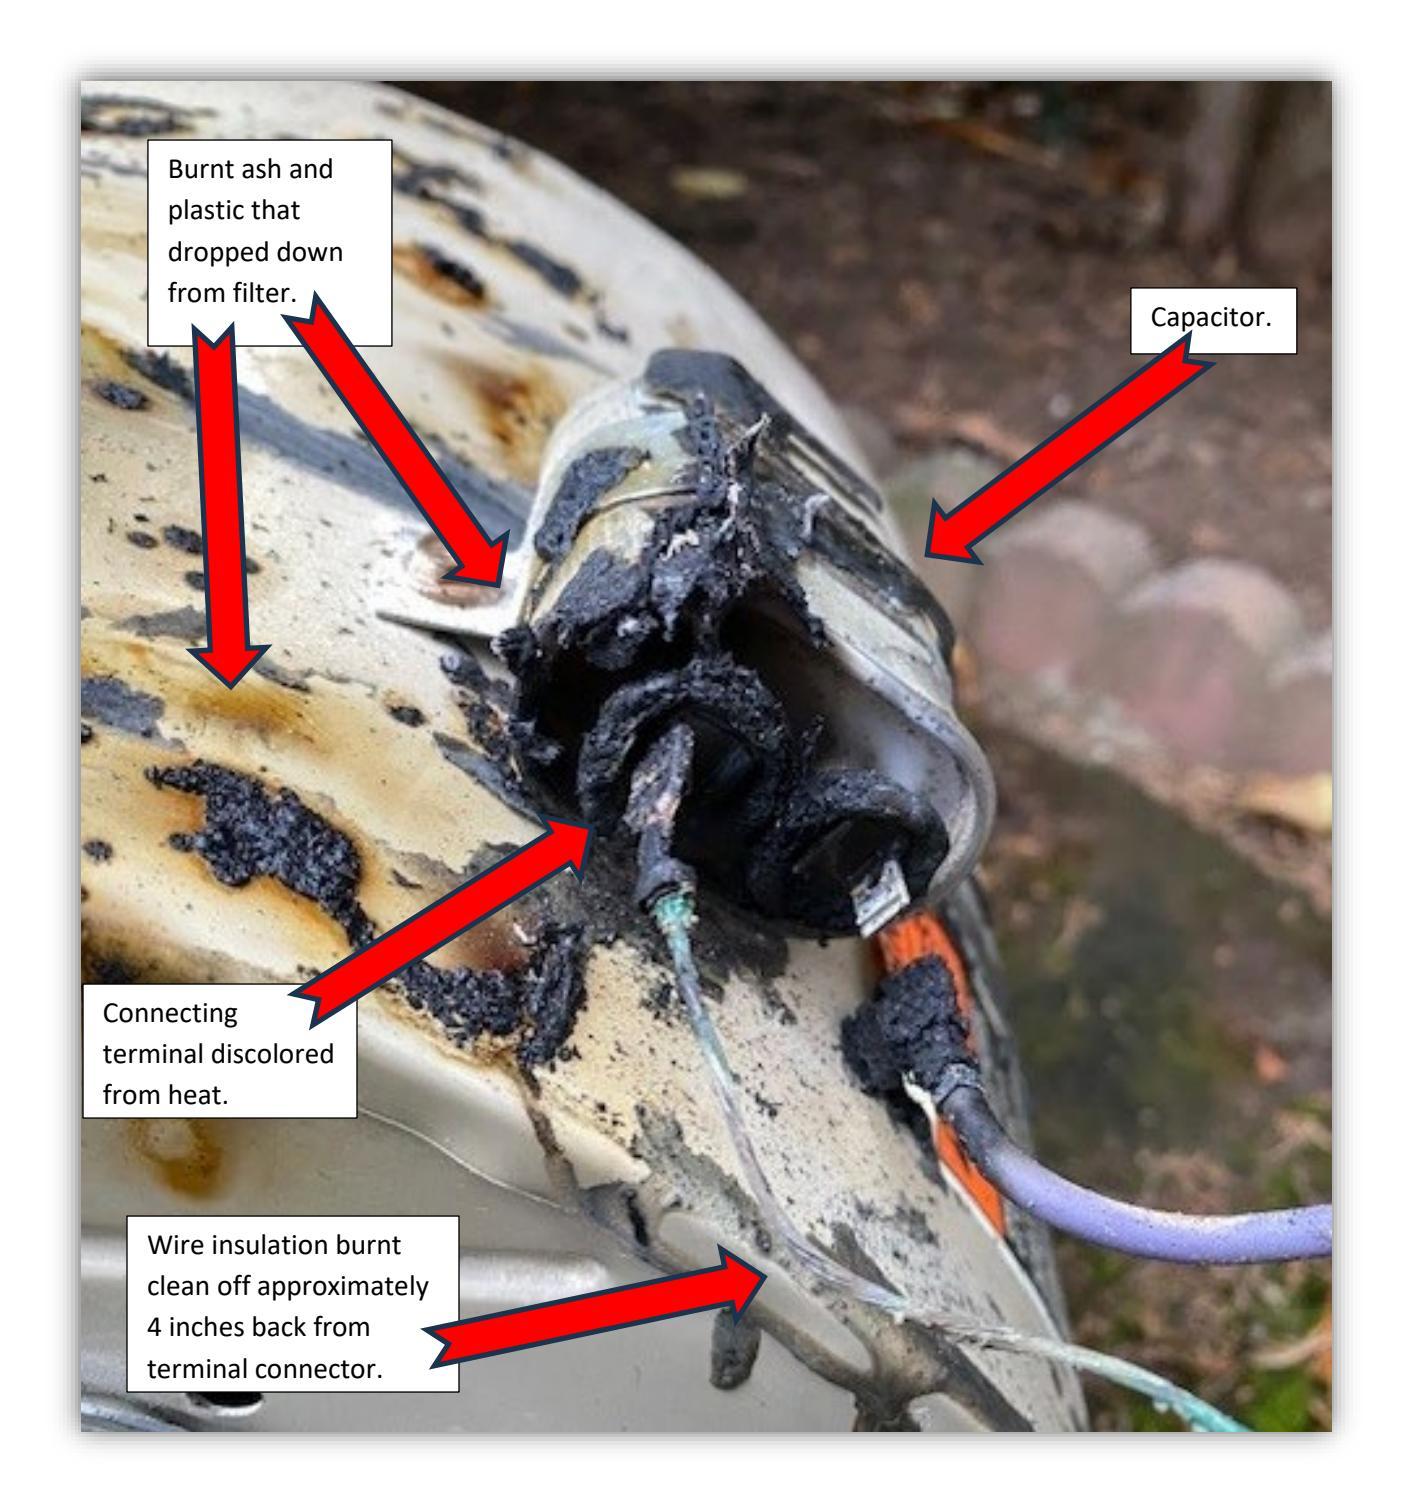
generate heat that may further compromise the connector and the associated wire or component (<u>Image 6</u>).
	The furnace was approximately 30 years old. The homeowner described that he had performed the maintenance for the furnace annually since 1990. The furnace filters the homeowner installed were reuseable aftermarket plastic foam furnace filters. The homeowner said he had just vacuumed the reusable plastic furnace filters to remove any dust or debris collected. The homeowner re-installed the filters, then turned the power to the furnace on to restore normal operation.
Failure scenario(s)	A short time after the furnace was turned back on, a carbon monoxide detector inside the home went into alarm. The homeowner saw smoke coming from the furnace, shut the furnace off, and called the contractor who had recently repaired an unrelated ignition problem with the furnace. The contractor instructed the homeowner to exit the building and open doors to ventilate. The contractor was nearby and immediately went to the residence. Upon arrival the contractor opened the fan compartment, found the furnace filters to be on fire and extinguished the flames. The contractor then immediately contacted the Gas Safety Officer for the area to report the incident.

Facts and evidence	 Site observations: A wire connecting to the fan motor capacitor shows evidence that it had become hot. The insulation has burnt off the wire completely for approximately 4 inches back from the "push on" terminal connection to the capacitor (Image 6). The left side filter appears to not have been fully seated into the channel that holds the filter in position away from the fan housing and capacitor. It is possible the filter may have sagged as it was not properly installed in the lower filter bracket and was pulled down to the capacitor by the airflow and contacted the hot wire, resulting in the plastic filter catching on fire (Image 5). The furnace filters may not have been properly placed into the filter mounting bracket that holds the filter in place. A photo of the remaining portion of the left-hand filter shows it is not completely seated into the filter bracket (Image 4). This could have resulted in the plastic air filter coming into contact with an overheating electrical wire, causing it to melt and ignite. Homeowner statements: The homeowner has been maintaining the air filters in the fan compartment for approximately 30 years and declared he had removed and cleaned the filters. The homeowner said the incident occurred just after cleaning the filters.

Image 6 - The wire without insulation. The insulation is completely removed without any fragments or residue which is an indication that the wire was hot enough to burn the insulation away completely from the wire. There is also a discoloration of the "push on" terminal connector where you can see the brown coloured metal underneath the burnt filter material that dropped onto the capacitor. Normally a terminal connector will have a shiny silver colour as shown in <u>Image 3</u>.
