Incident Summary #II-1880563-2025 (#56884) (FINAL)

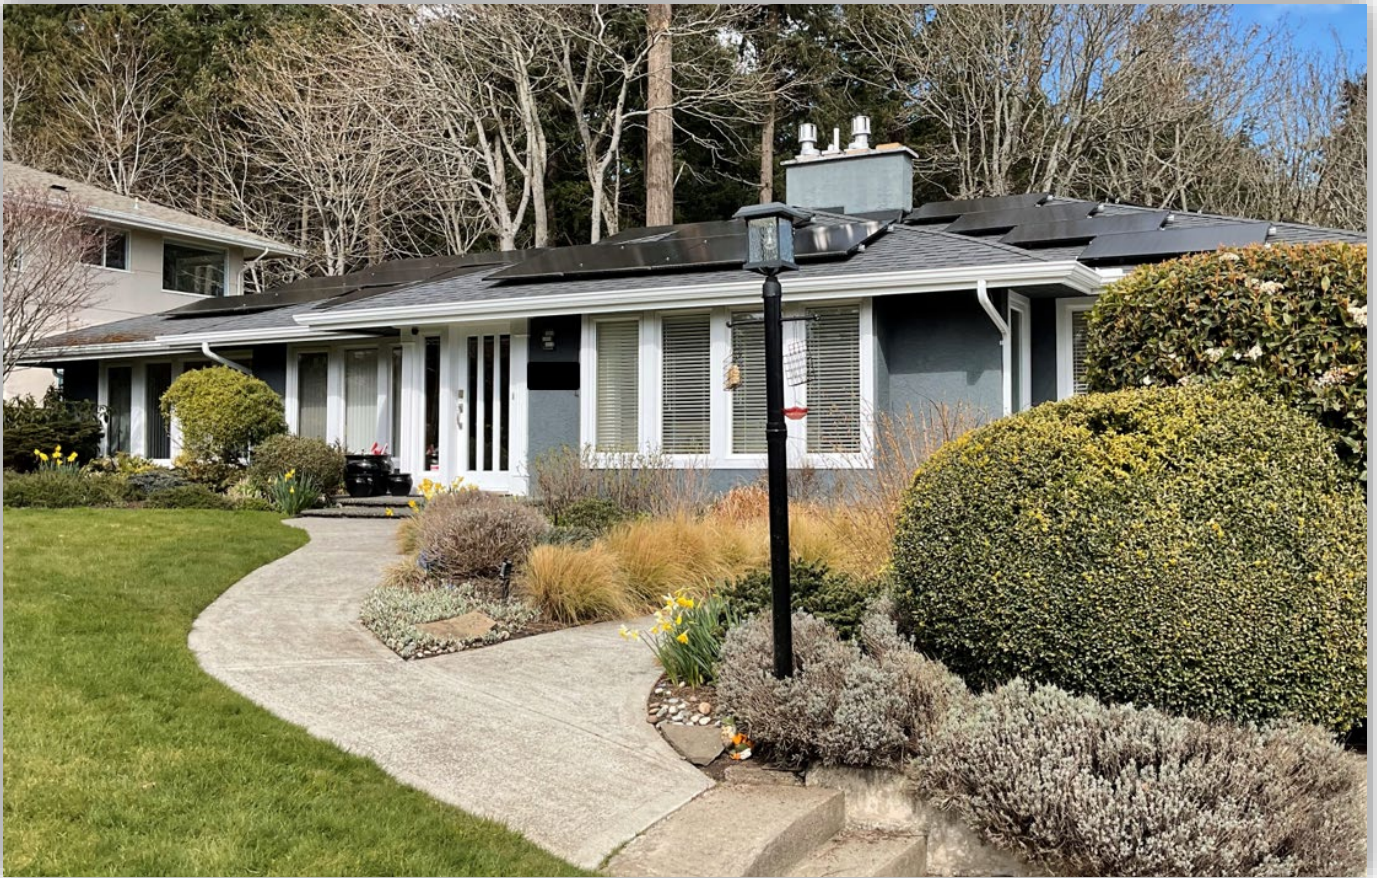
Image 1 – Exterior of home.

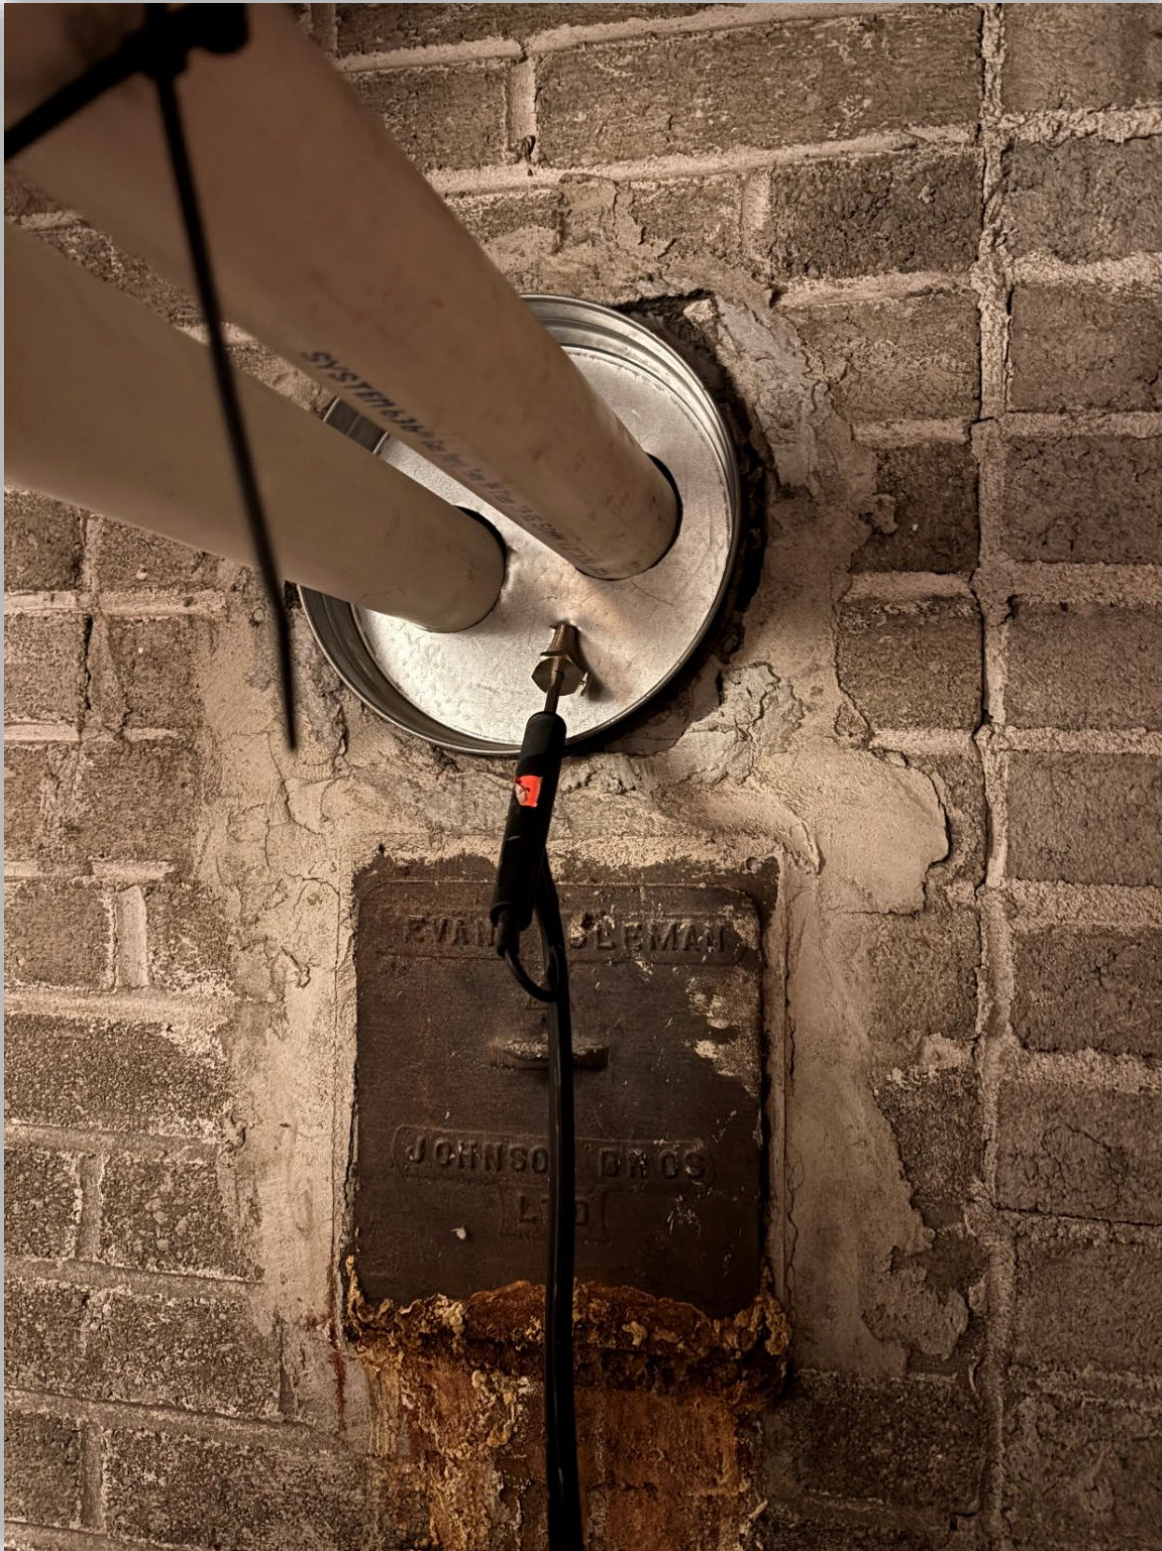
Image 7 – Furnace air and vent pipes entering masonry chimney with combustion analyser probe for investigation testing. Original metal chimney cleanout door with corrosive staining coming from the bottom.

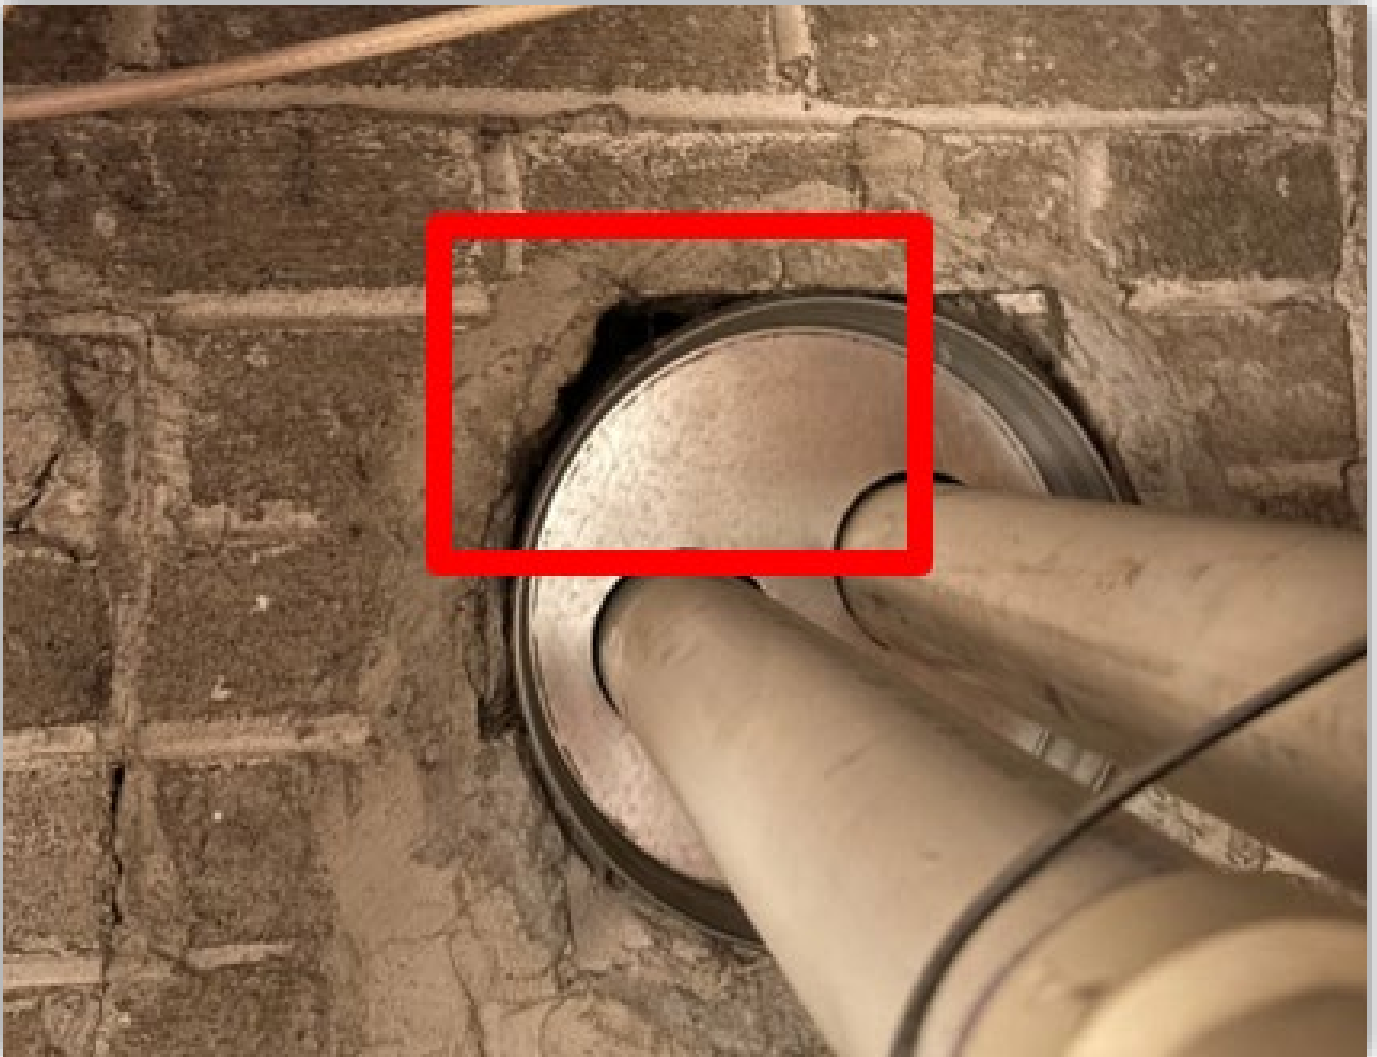
Image 8 – The opening into masonry chimney that the spilling flue gases were measured entering the home during testing.
