Incident Summary (Reference #BPVII-947434-2017)

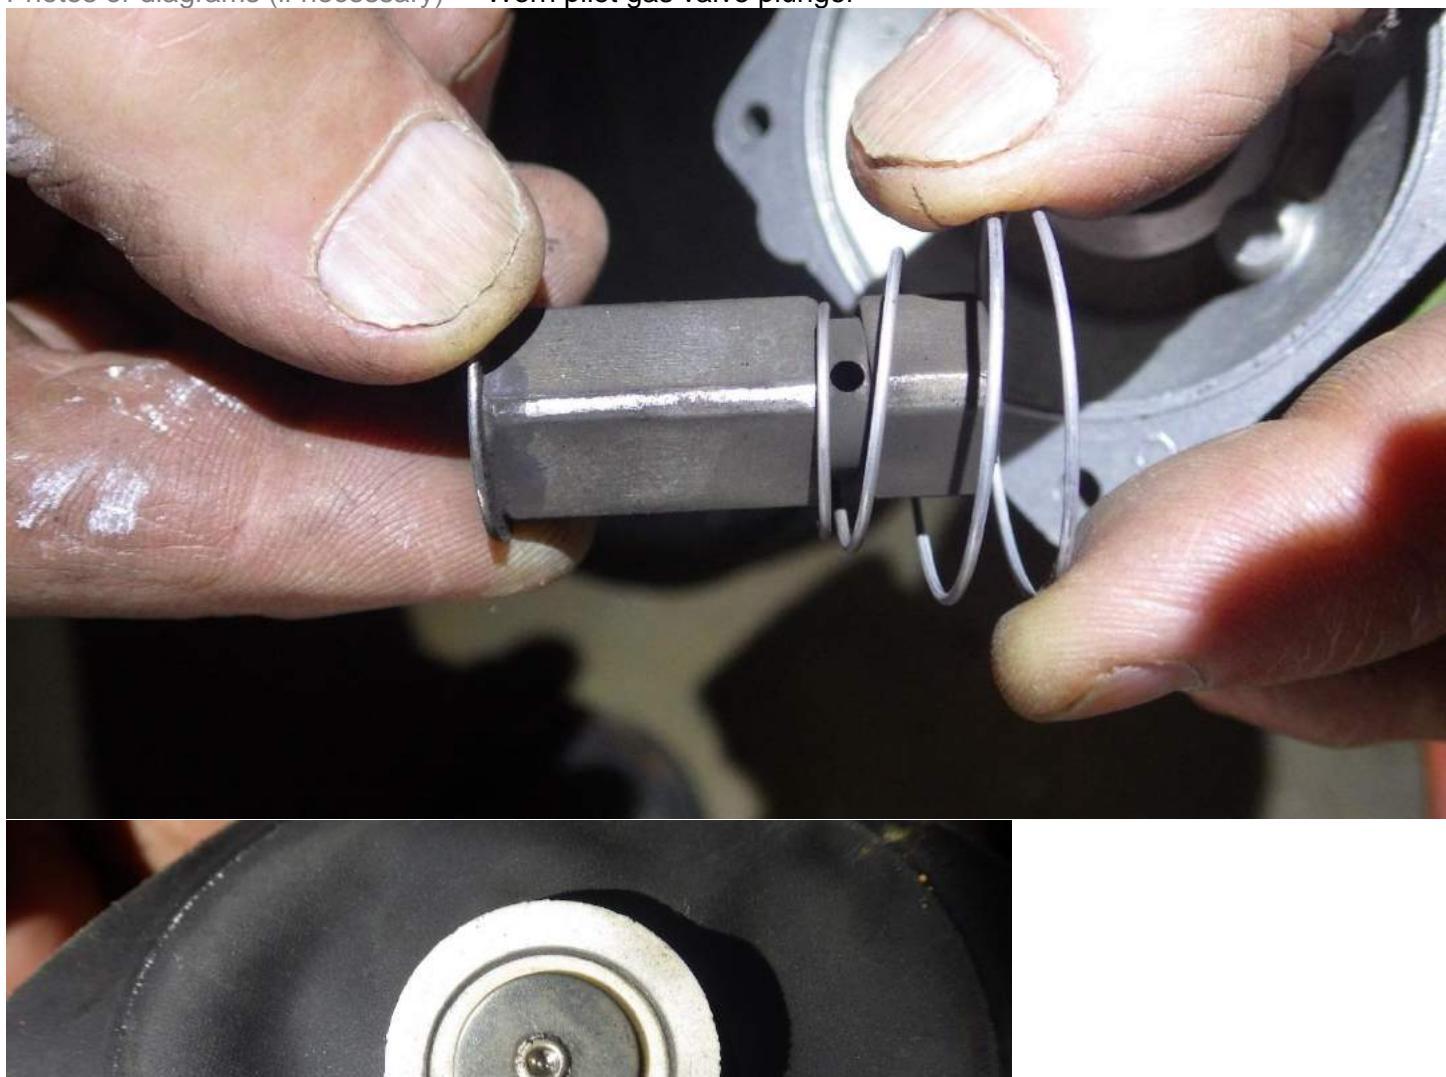
Causes and contributing factors		This solenoid pilot valve plunger guide surfaces have worn significantly ,easily seen on inspection. This valve has been in service for many years, if an internal inspection occurred on a regular basis this wear may have revealed this problem developing. Proper boiler shutdown procedures and checklist may have prevented the continued un-noticed pilot operation.

Pilot Gas Valve seat - Blemish

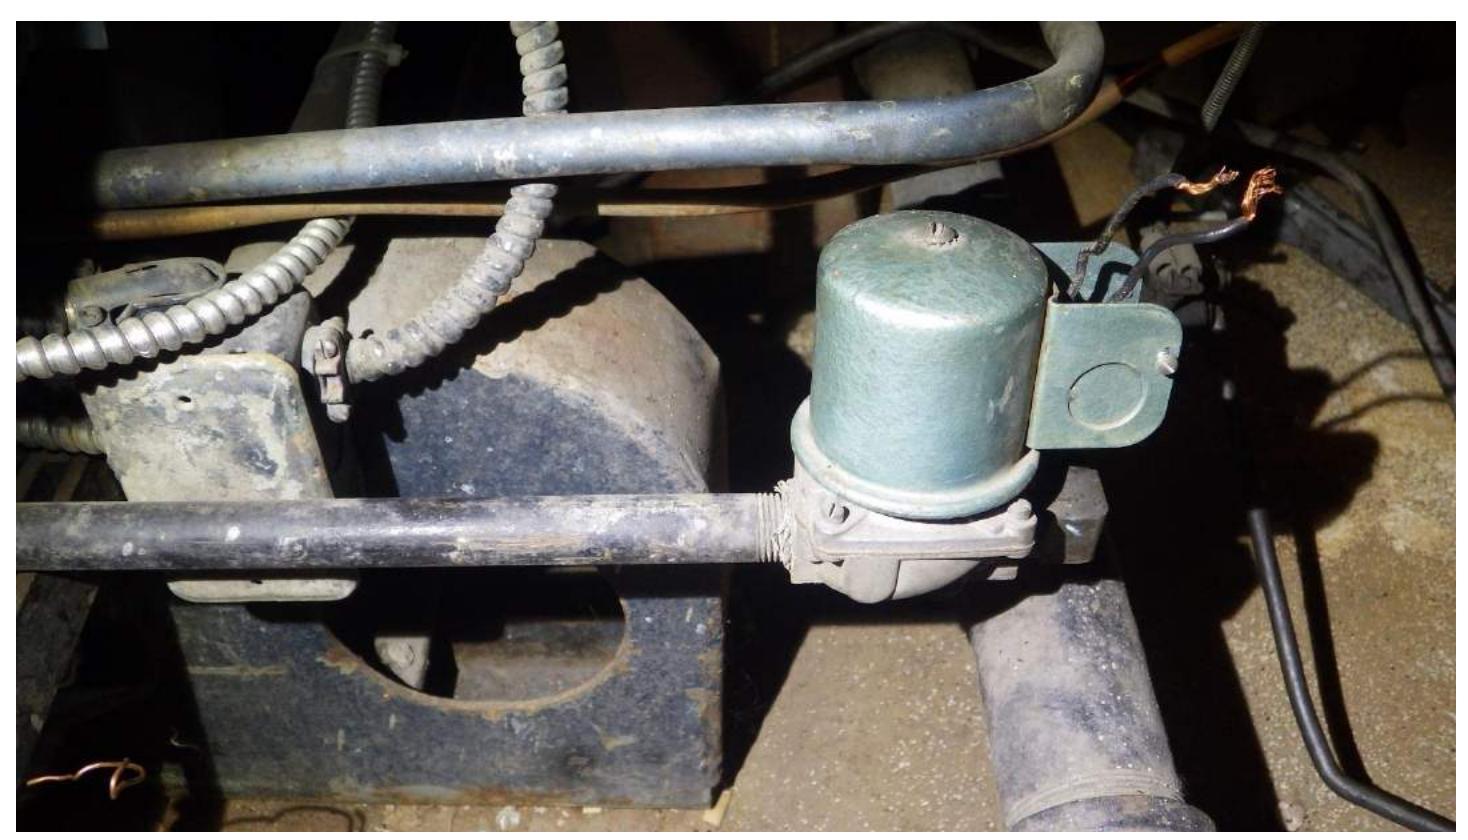
Failure scenario(s)		When the boiler receives a shutdown signal, both the main burner and the pilot gas igniter safety shutoff valves close stopping the flow of gas to the main and pilot burners. The pilot safety shutoff gas valve failed to positively shut off the flow of gas to the ignitor and the pilot flame continued to burn.
	Facts and evidence		The boiler was shut down by switching off the power panel control switch by maintenance personnel. Boiler fires were not visually checked to be out. The pilot gas valve did not close, gas was allowed to flow to the pilot system The gas valve was disassembled on site by the contractor, the plunger guide contact points show wear and could be felt to bind when the plunger was moved through its total travel in its guide. Furnace and fire tubes were heavily carbon coated. The pilot and air diffuser were also heavily carbon coated and the diffuser metal appearance shows it had overheated by insufficient air flow .

Solenoid operated pilot gas valve, still attached to supply line.
