SUPPORTING INFORMATION	Incident Date			January 1, 2021
	Location			Chilliwack, BC
	Regulated industry sector			Electrical - Low voltage electrical system (30V to 750V)
	Impact	Injury	Qty injuries	0
			Injury description	N/A
			Injury rating	None
		Damage	Damage description	Damage consisted of blown potential transformers (PT's) used for instrument transformer metering in 600-volt services (See figure 2), a destroyed 100-amp main switch and 100-amp 600-volt utility meter (see figure 7 and 8), a destroyed 200-amp 600-volt utility meter (see figure 4), damage to several 347-volt high bay lights, ahand dryer, an overhead door operator, a main fire alarm panel, and a surge suppressor.

-	Damage rating	Major
0,	Incident rating			Major
	Incident overview			A utility pole steel guy wire swung up after being cut free from a motor vehicle accident and shorted out high voltage overhead power lines. This created a massive voltage surge because of a phenomenon called ferroresonance. The massive voltage surge caused significant electrical damage to an event centre / fair ground facility, a golf course irrigation shed, and an operations / maintenance office building.
INVESTIGATION CONCLUSIONS	Sit

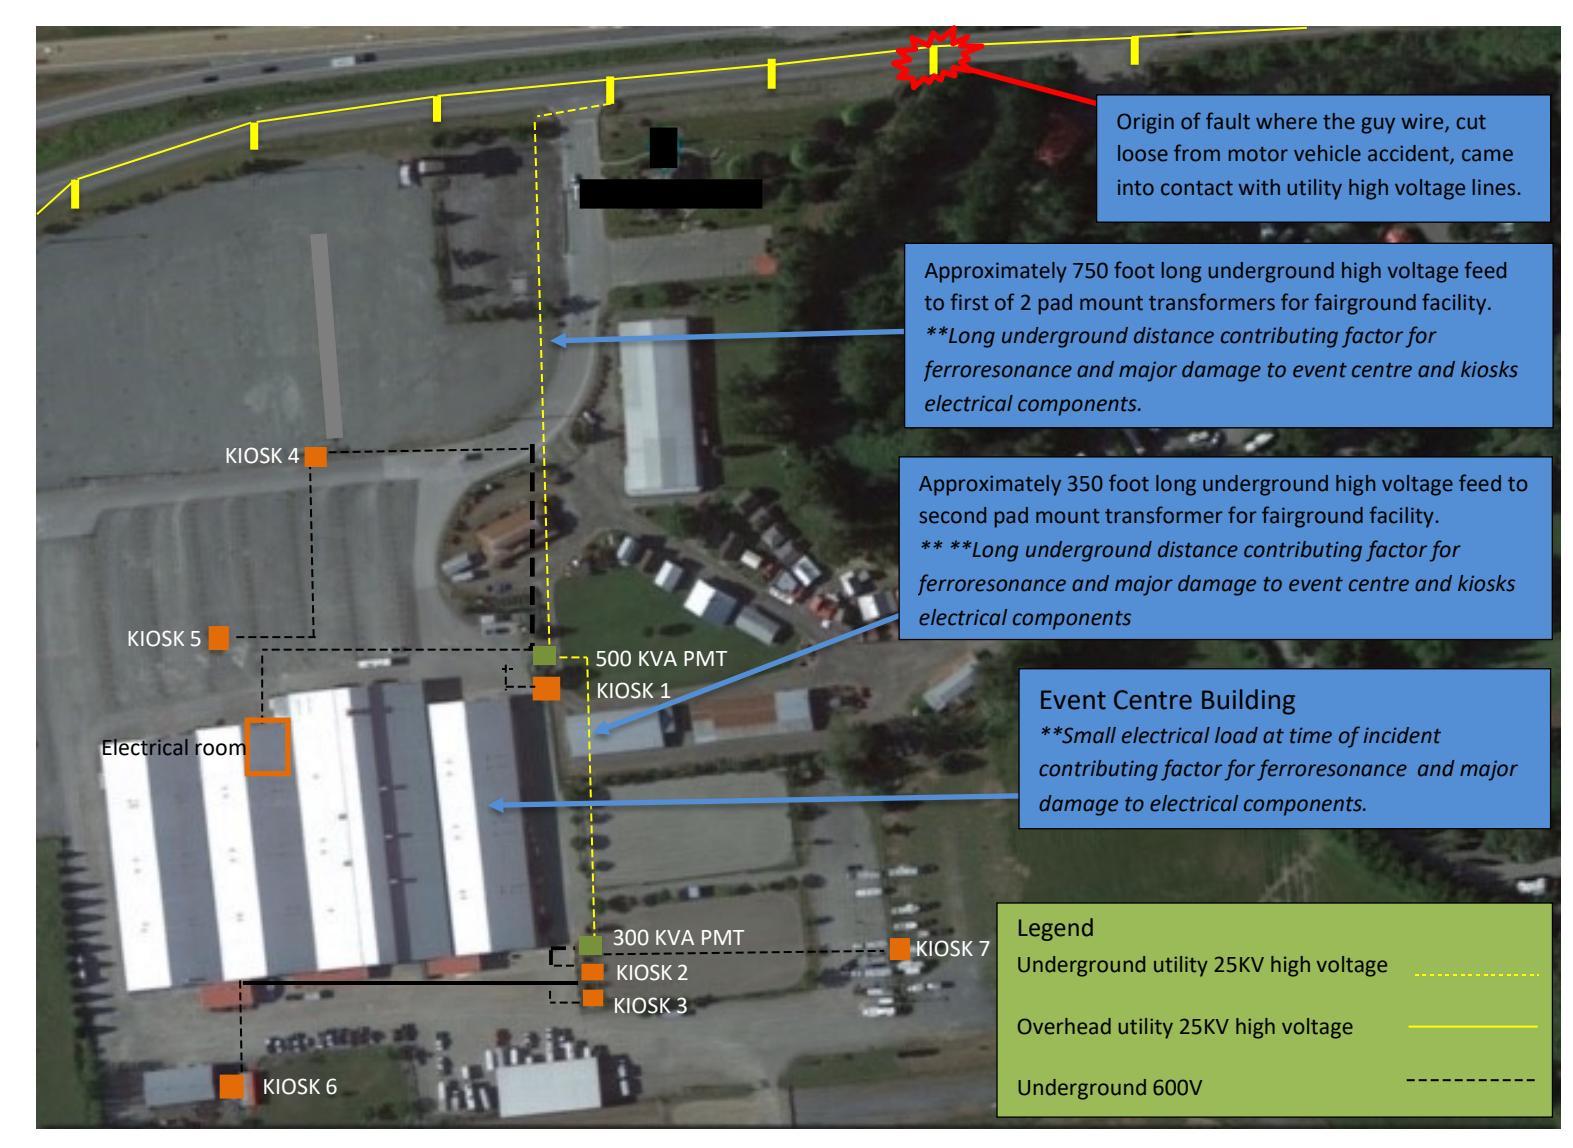
The incident was very likely caused by ferroresonance.
Causes and contributing factors	Contributing factors to the occurrence of ferroresonance include: -Underground runs of capacitive high voltage cables, with greater damage where these runs are long distances. -Very little or no electrical loads on the pad mount, and pole mount transformers that feed the electrical services to all of the buildings / kiosks that sustained electrical damage.

Figure 1 – Overhead view of Event centre building and fair ground facility showing contributing factors to ferroresonance

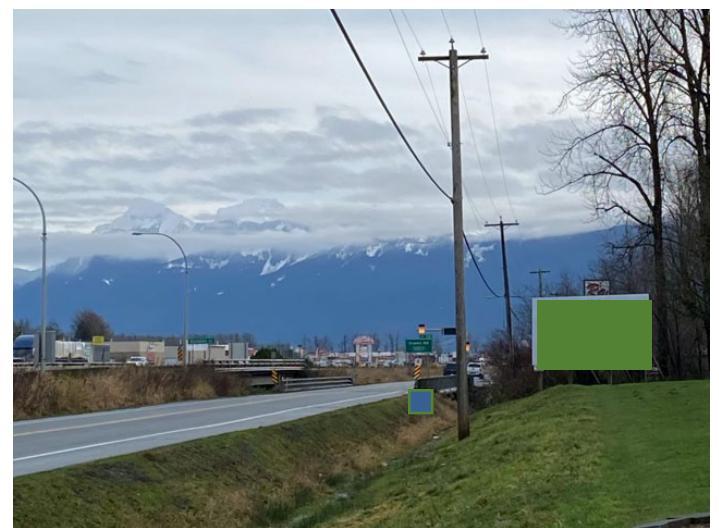
Overhead utility high voltage lines where the motor vehicle accident occurred.

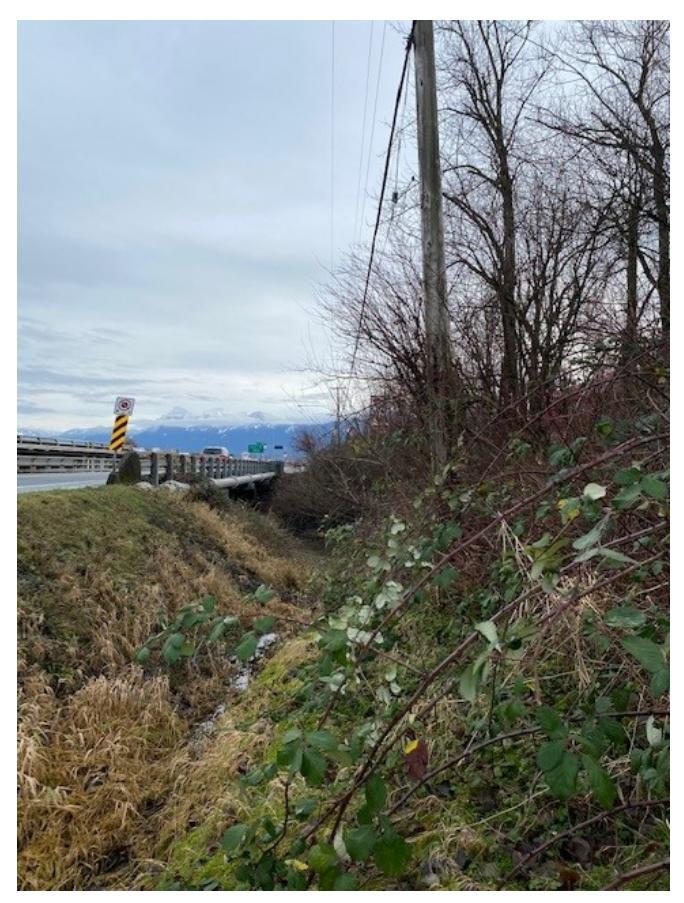
Motor vehicle left road and entered this ditch cutting the steel guy wire loose.

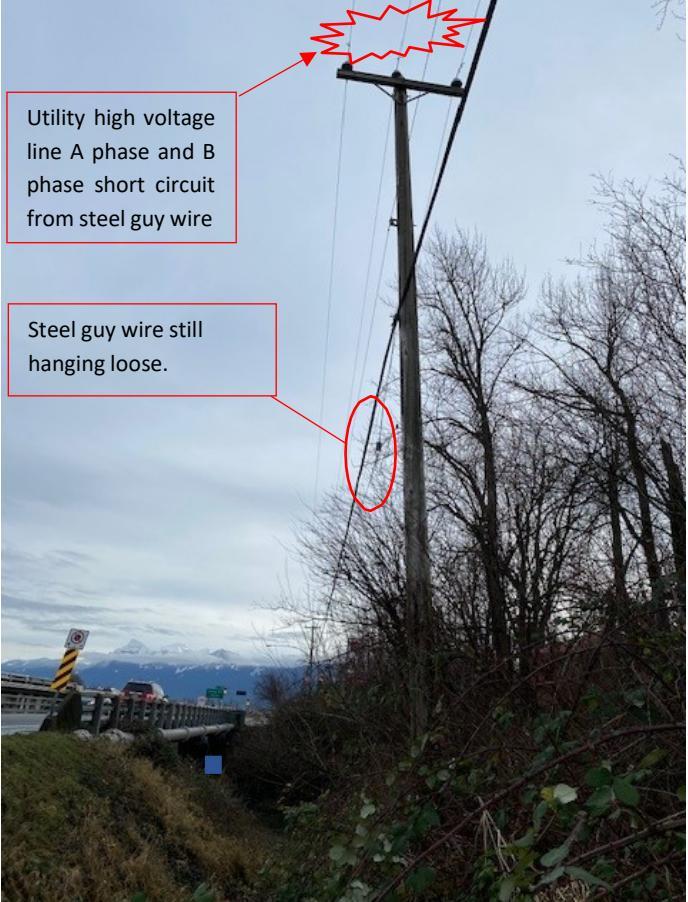
Failure scenario(s)	When the steel guy wire swung up from being hit by the car, it crossed the A and B phase conductors of the overhead utility high voltage lines. This caused a dead short across two phases that blew the A phase fuse. What happened next was an extreme voltage surge, or over voltage, due to ferroresonance. All the electrical services involved were being fed from an overhead 3 phase high voltage system with a portion of the system being underground. With the A phase disconnected, the services were only being fed from two phases, B phase and C phase. The B and C phase energized the disconnected A phase through induction with all three phases wound around the same core. The A phase circuit of the transformer then became a purely resistive and resonant circuit due to the capacitance of the underground cable coming into series with and cancelling out the inductance of core in the transformer. With little or no electrical load on the secondary side of the transformers, a voltage of up to 5 times the normal value most likely occurred on the de-energized leg of the 3-phase secondary system. This is what is referred to as ferroresonance. This over voltage caused major damage to the electrical systems in each of the facilities involved.

Close up of utility pole guy wire where it shorted out A phase and B phase of the overhead lines.

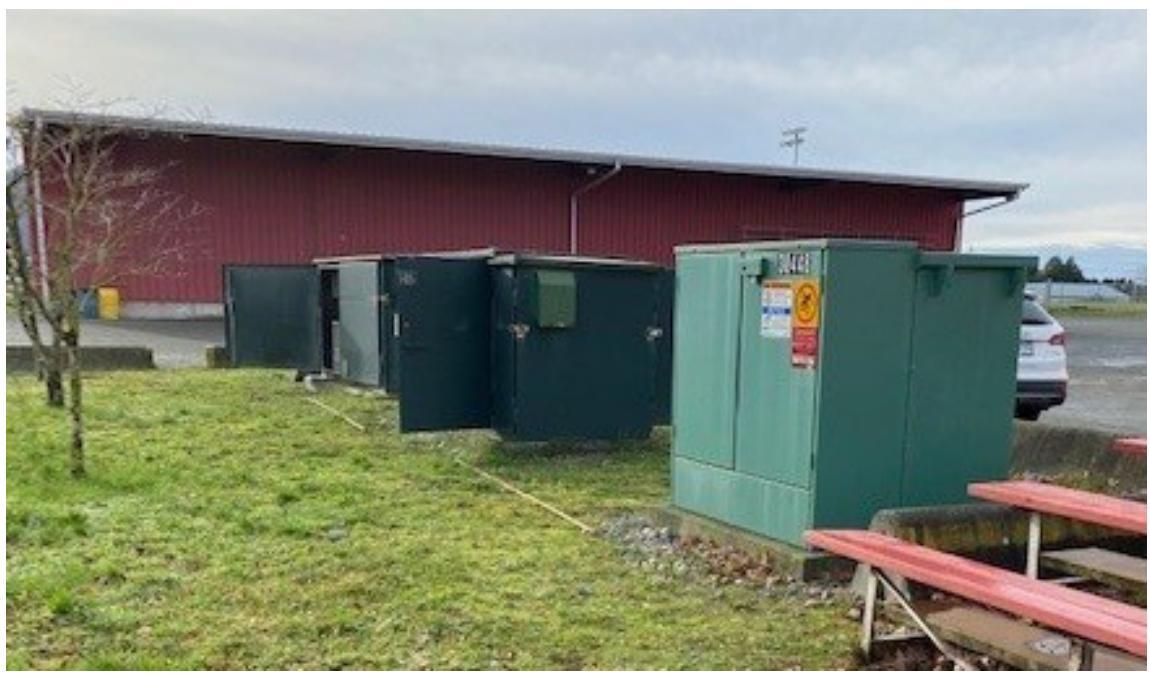
300 KVA Pad mount transformer (PMT 2) and kiosks 2 and 3 at fair ground facility

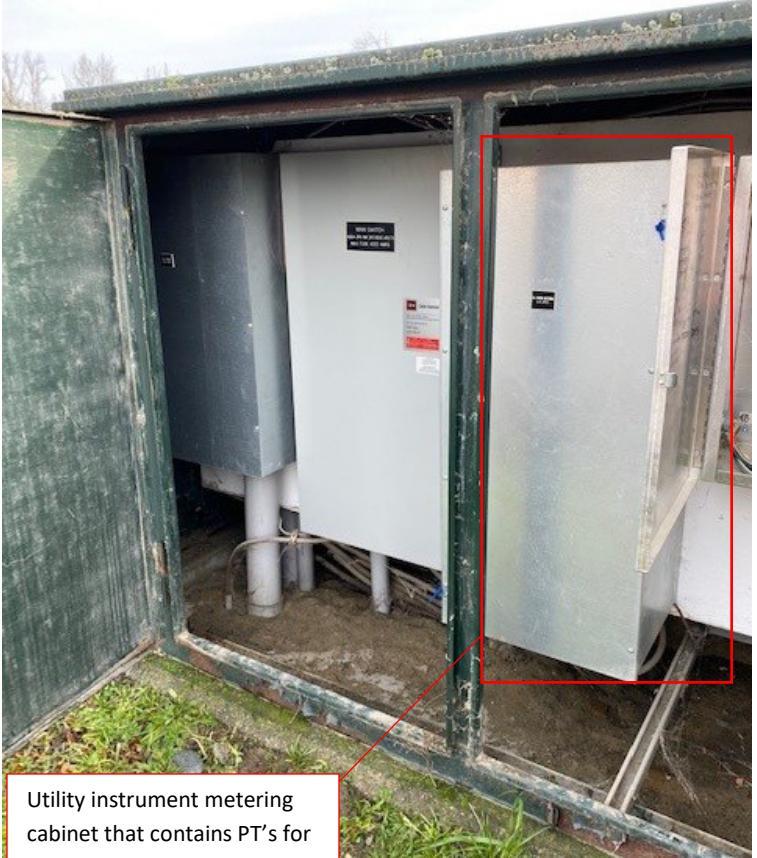
A phase damaged PT inside utility instrument metering cabinet

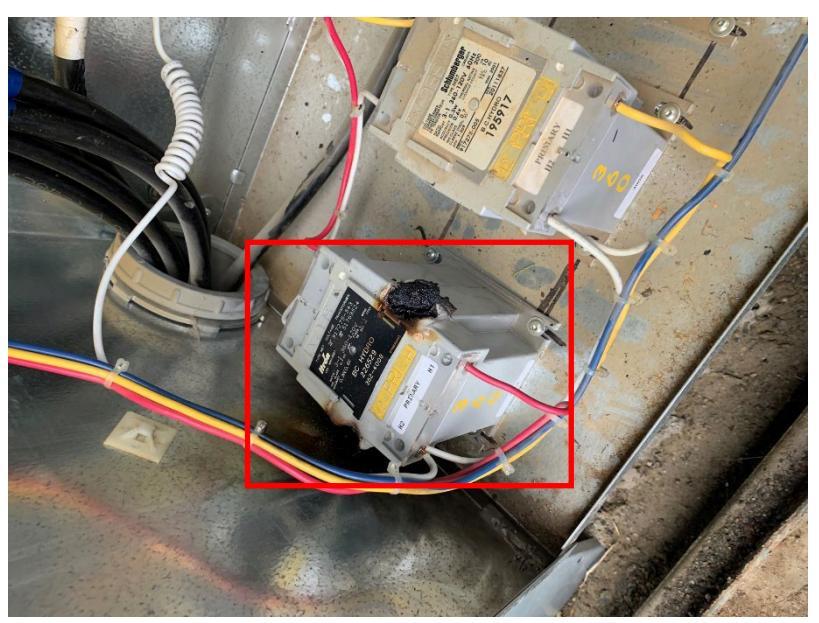
Inside of one of the kiosks at fair ground facility

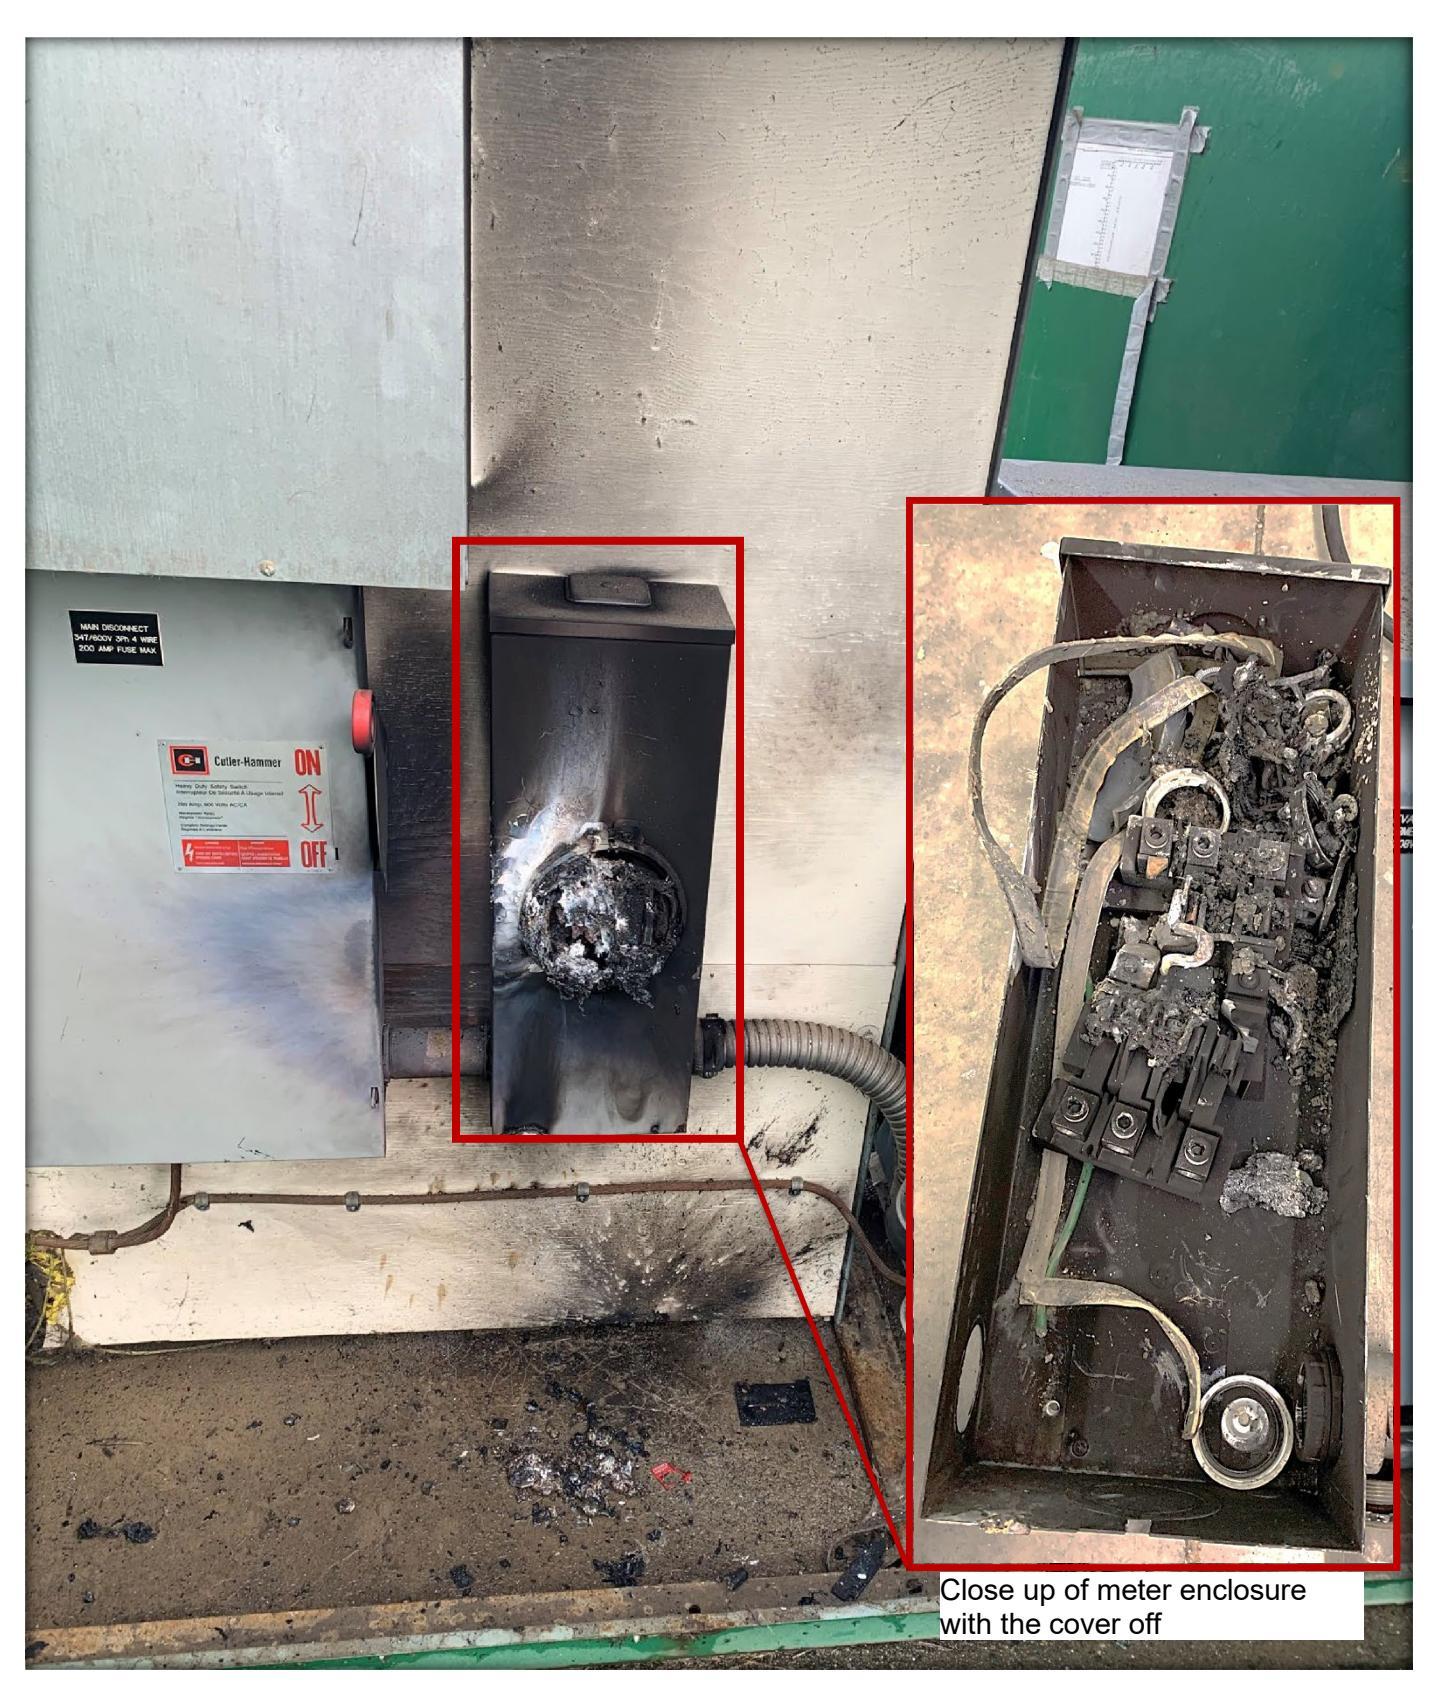
Figure 4 – Damage to 200 amp 600 volt meter enclosure inside Kiosk 7 at fair ground facility

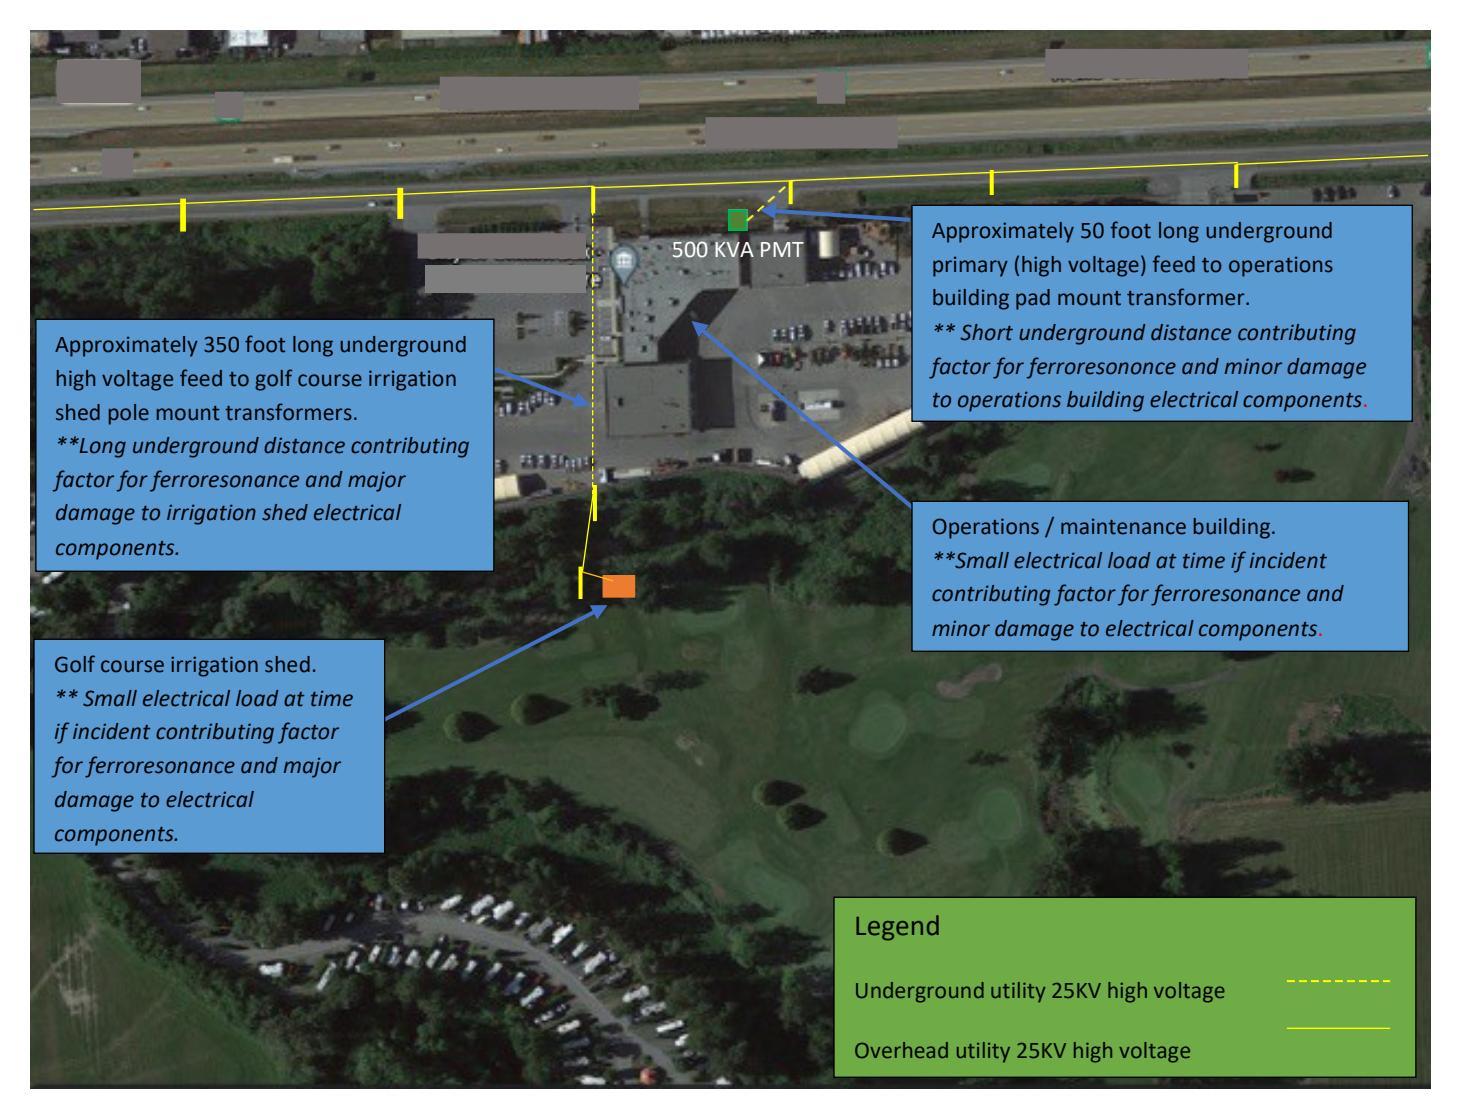
Figure 5 – Overhead view of operations / maintenance building and golf course showing contributing factors to ferroresonance.

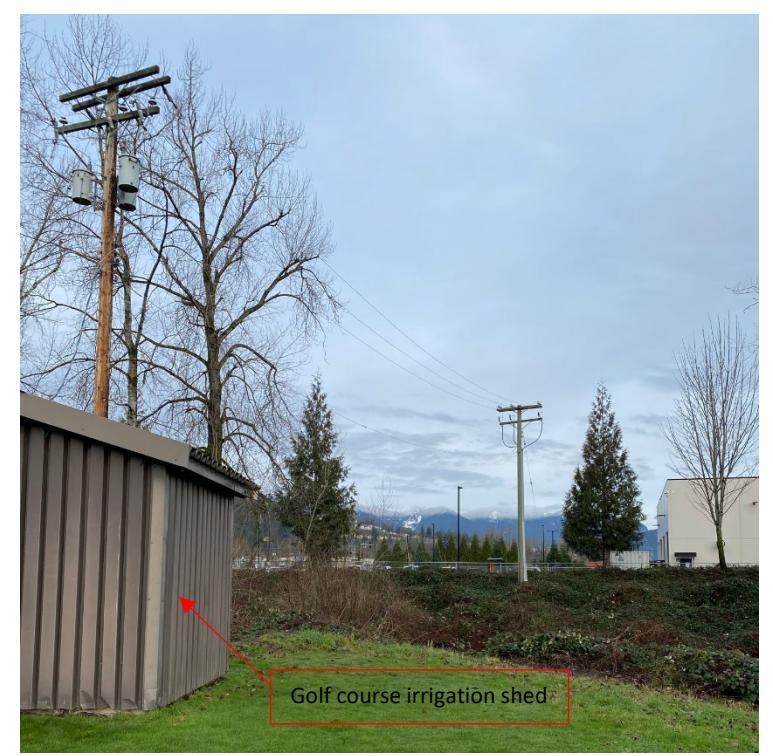
Utility high voltage lines to golf course irrigation shed service

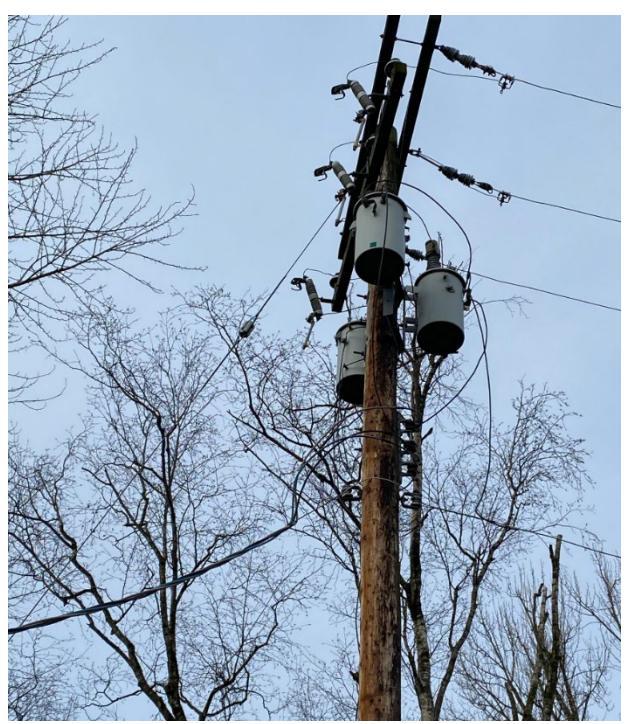
Utility 3 phase transformer bank mounted to pole for golf course irrigation shed service

Figure 6 – Golf course irrigation shed 3 phase transformer bank fed from underground section of cable.

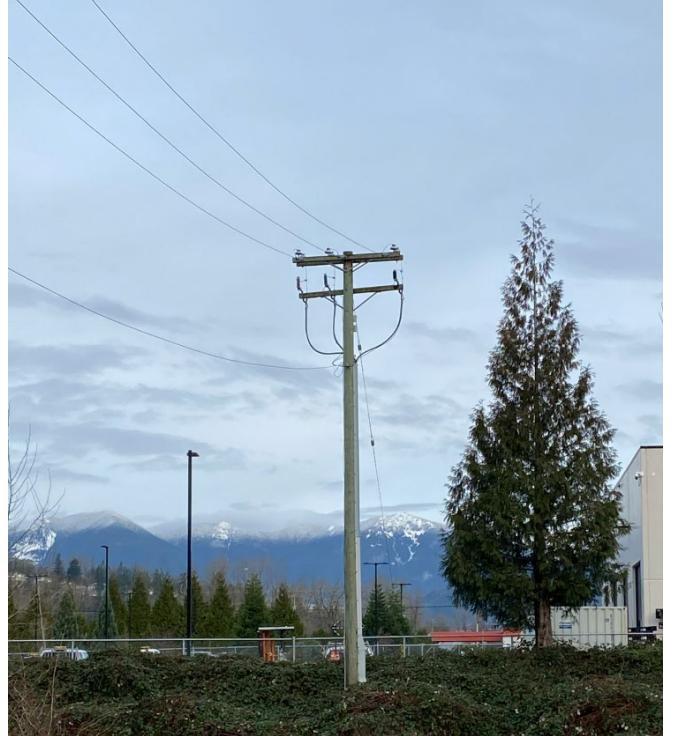
High voltage lines go underground for approximately 350 feet across the operations center parking lot and come overhead to the irrigation shed.

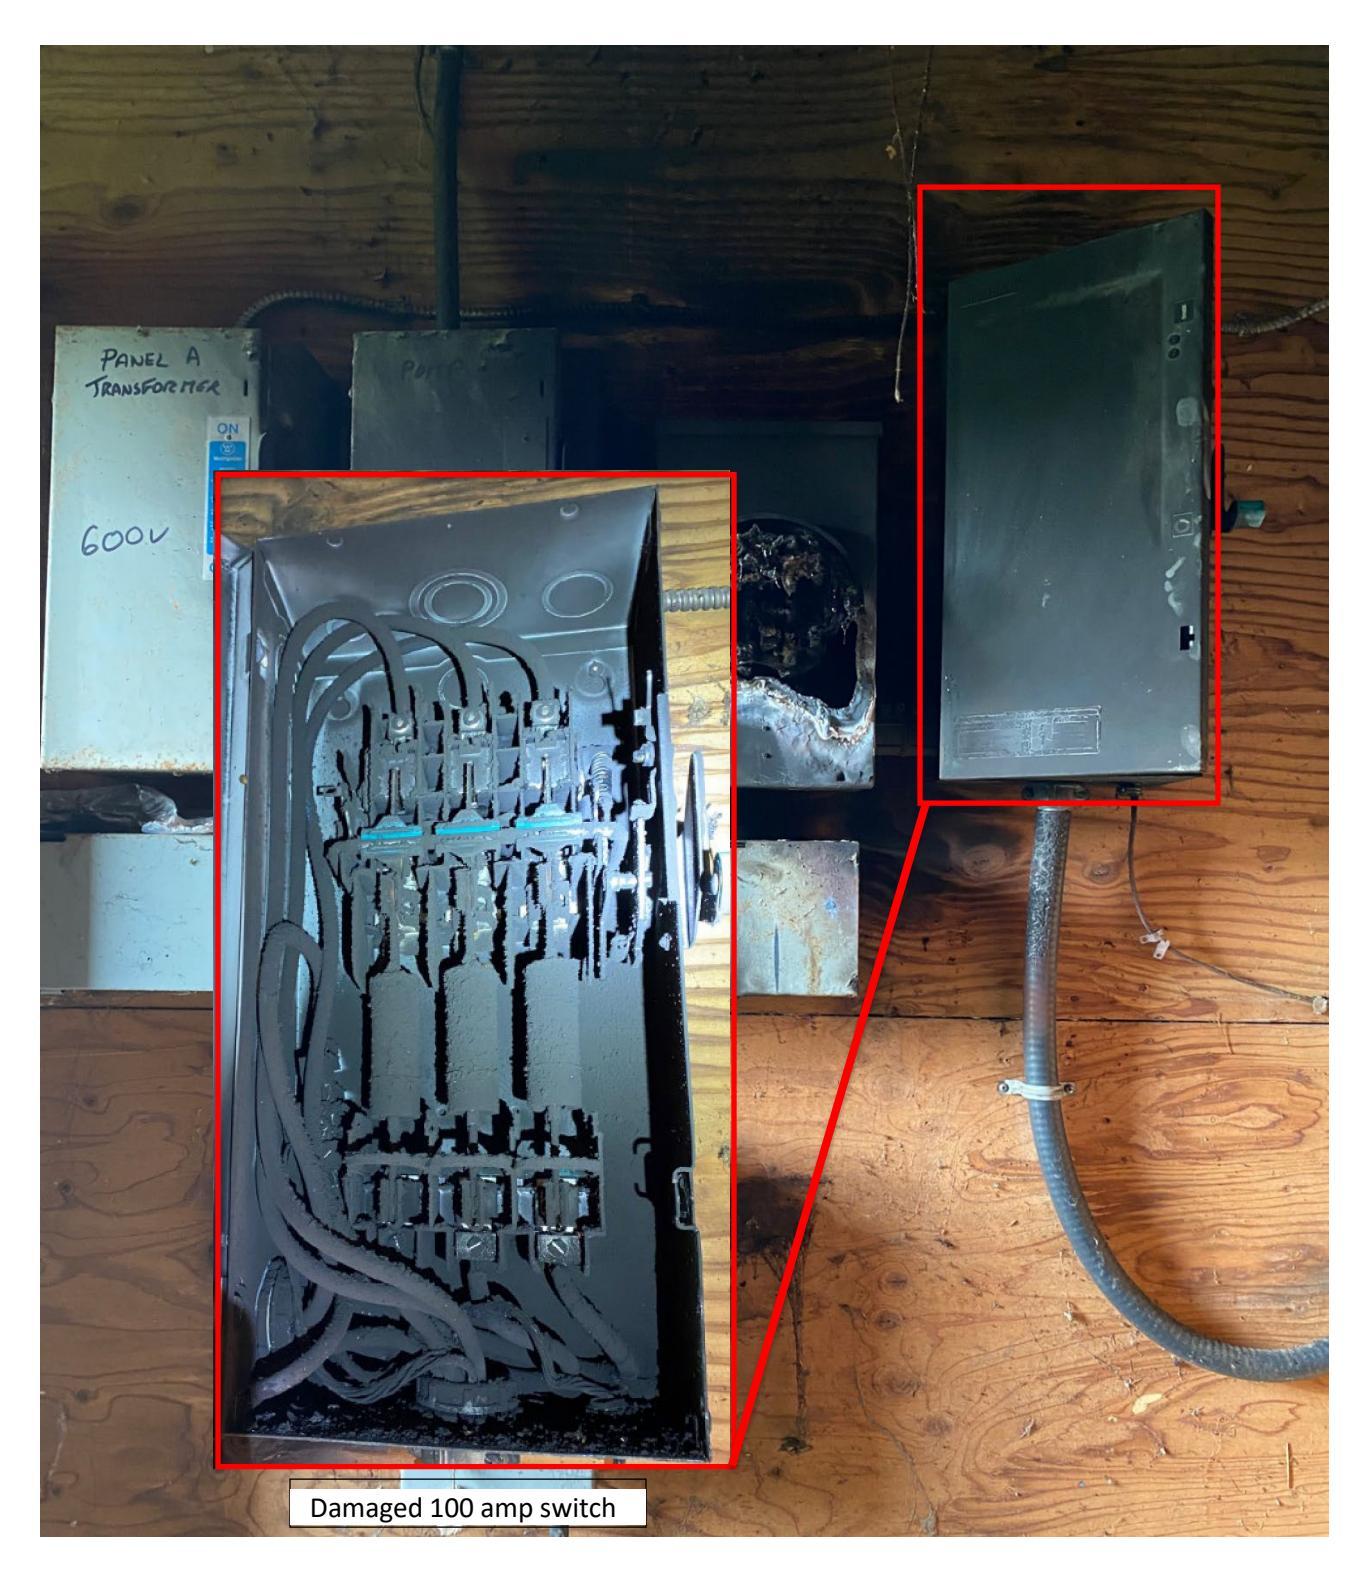
Figure 7 – Damage to golf course irrigation shed electrical equipment

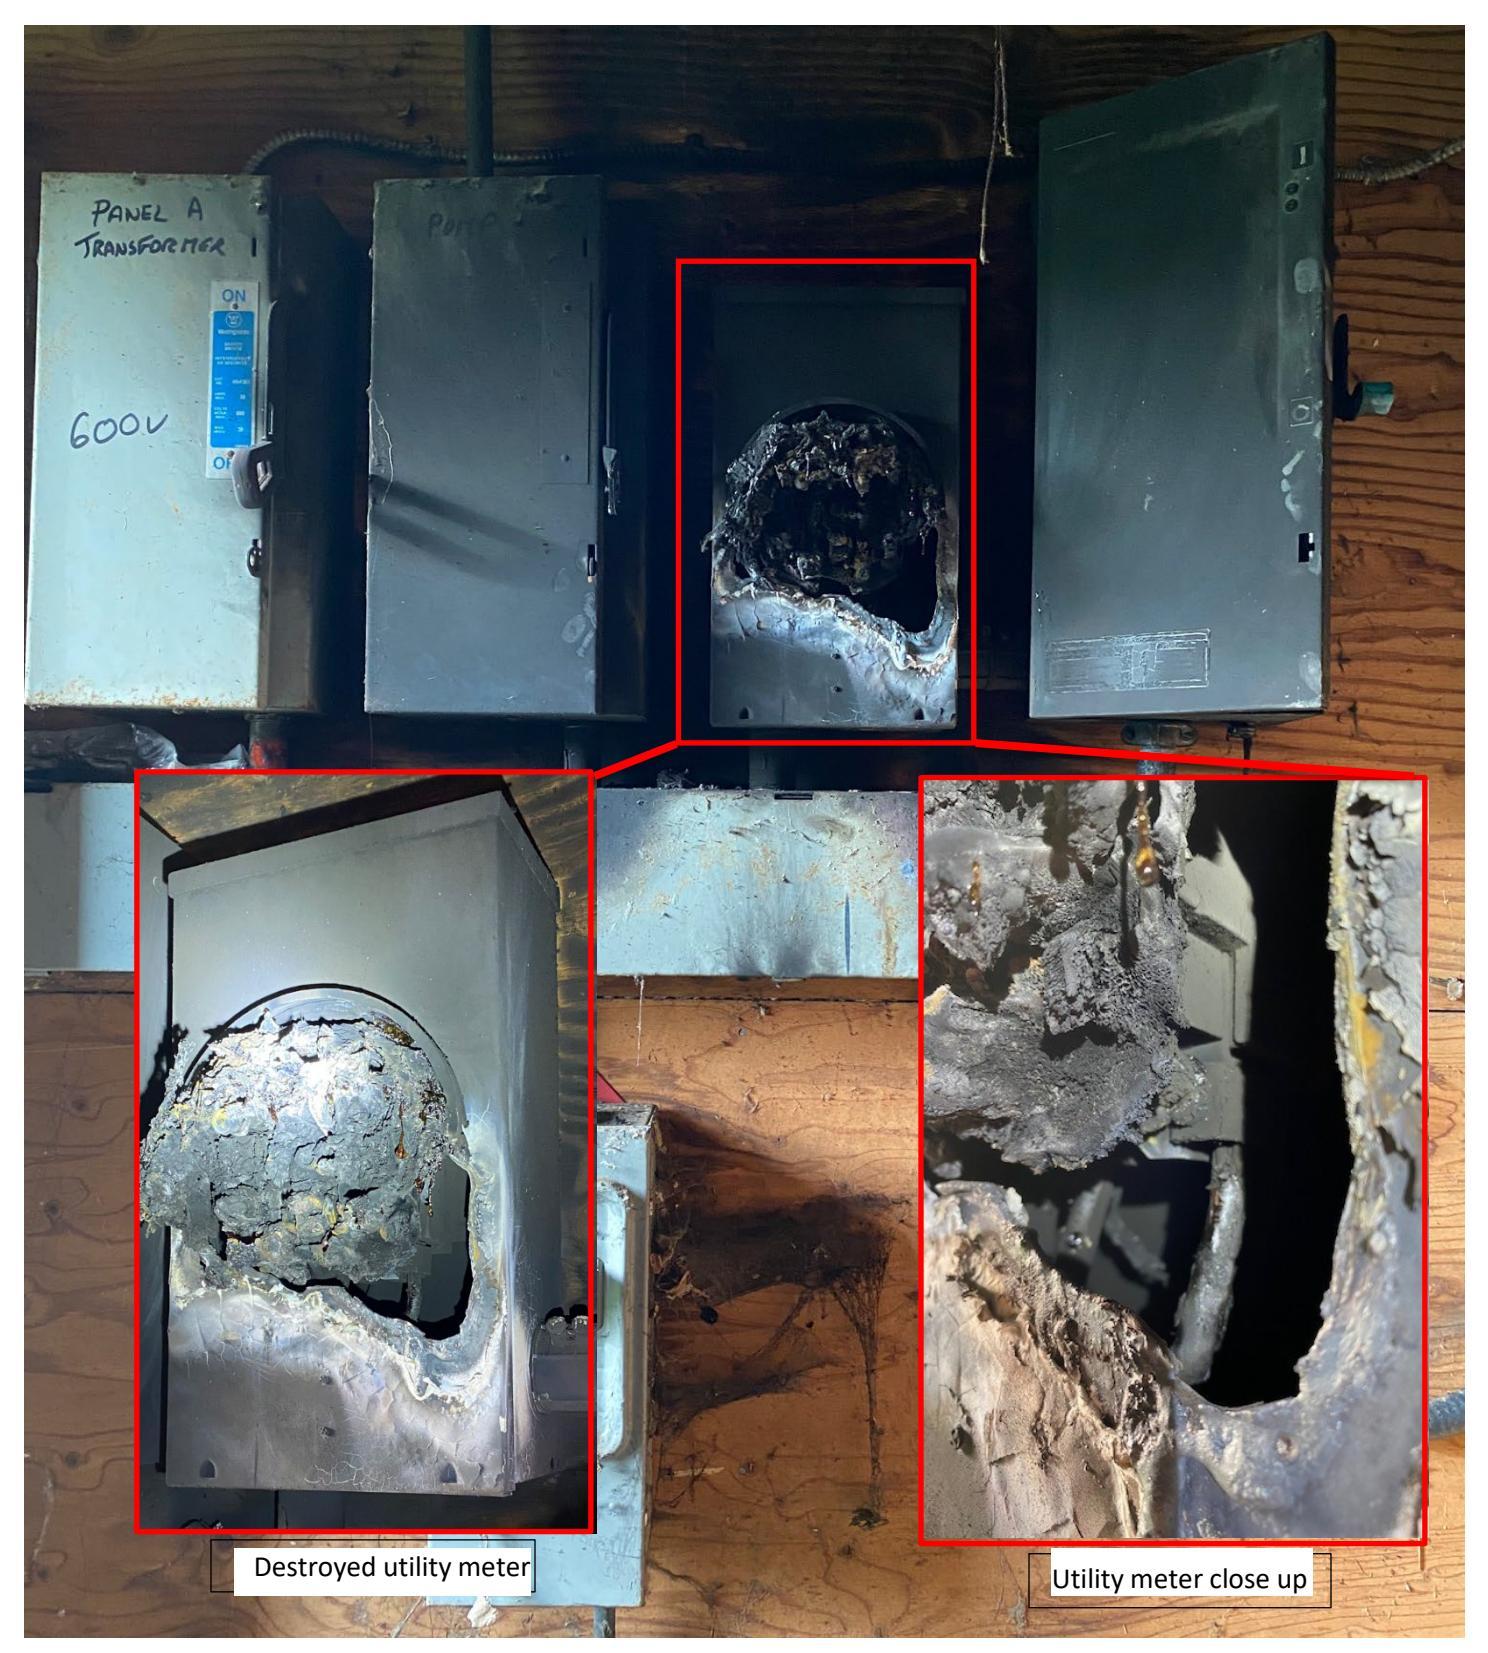
Figure 8 – Damage to golf course irrigation shed electrical equipment

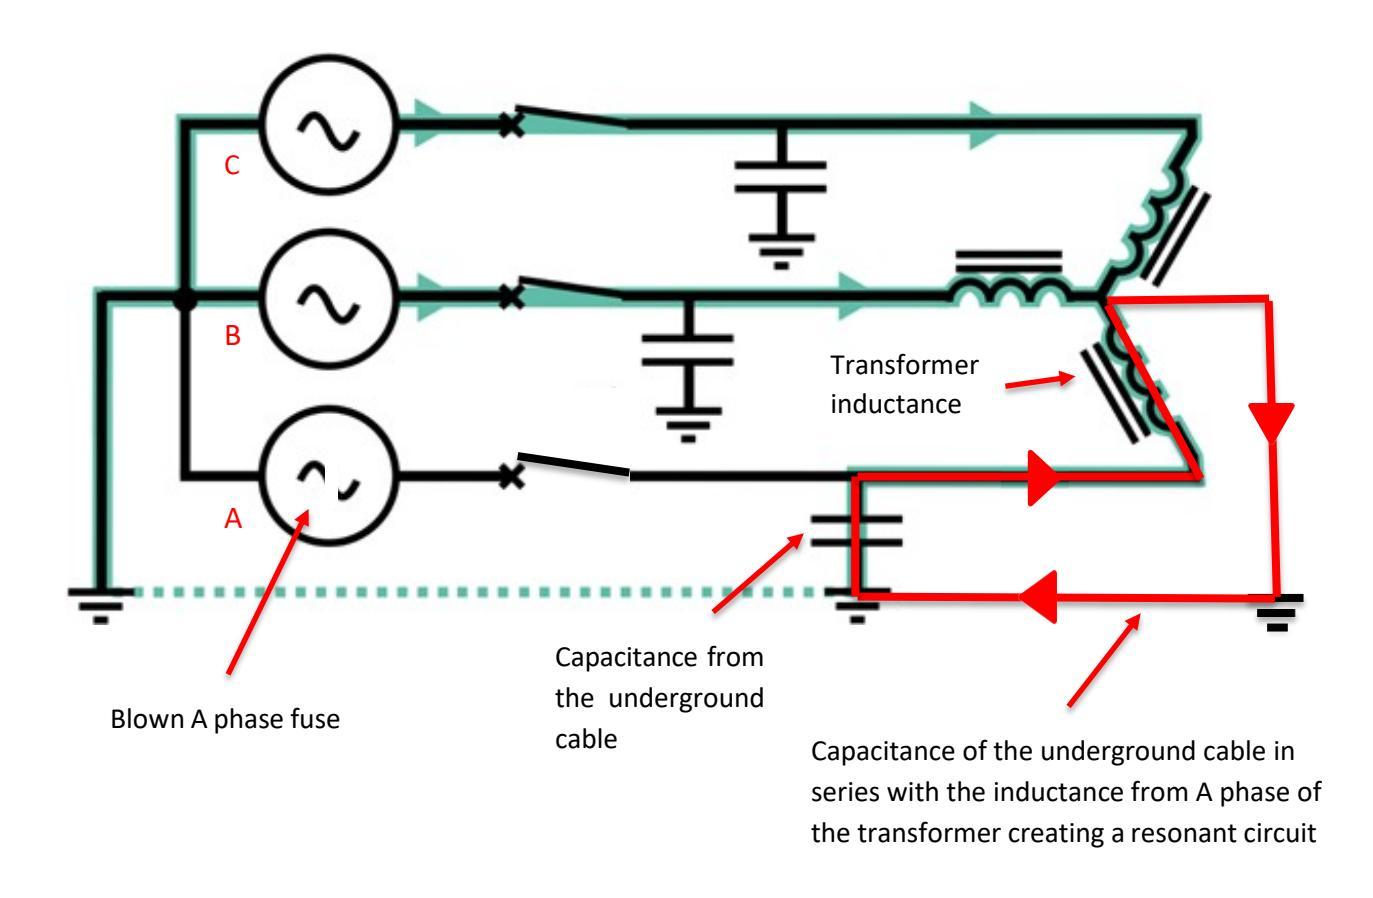
Figure 9 - 3 phase wye grounded transformer showing the ferroresonant circuit that was created in this incident. The A phase winding in the transformer became energized due to all three phases being wound around the same core and current being induced to the A phase from the. The capacitance of the underground cable and the inductance of the transformer cancelled each other out on the A phase. This left only a resistive circuit and the ferroresonace condition which can create voltages up to 5 times the normal value on the A phase secondary circuits of fed transformers.

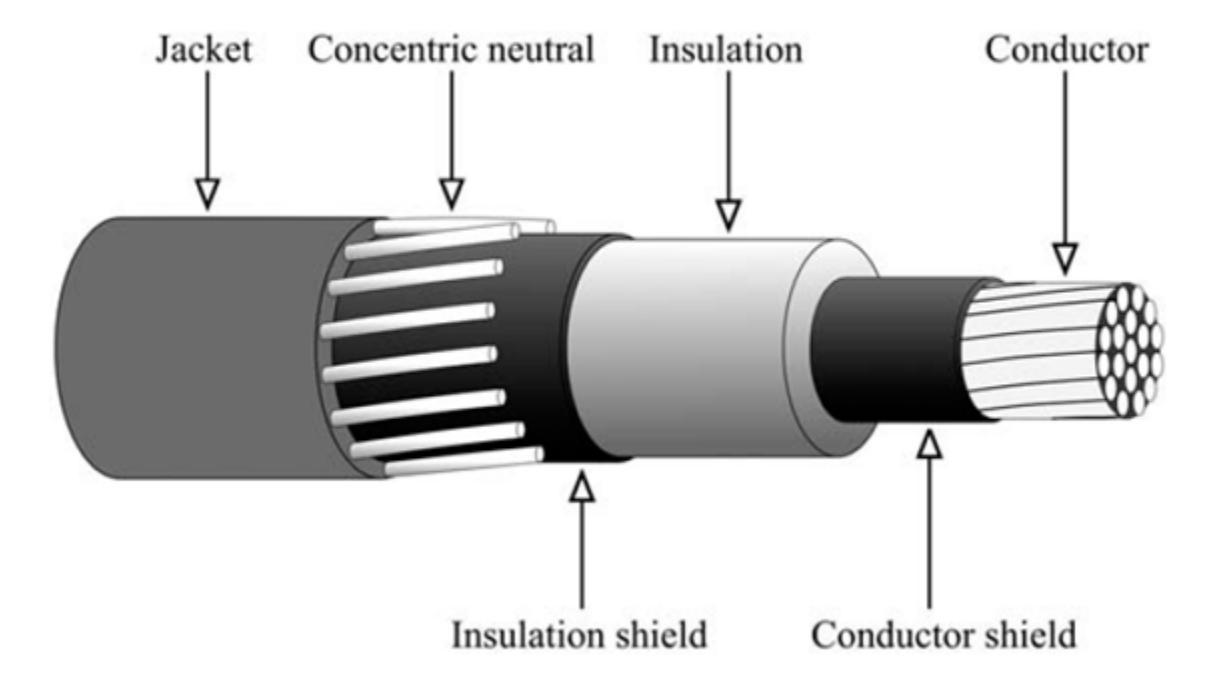
Figure 10 – The construction of a high voltage underground cable. Capacitance is built up between the outer concentric neutral and the inner conductor under normal operation.
