Incident Summary #II-1447428-2022 (#30045) (FINAL)

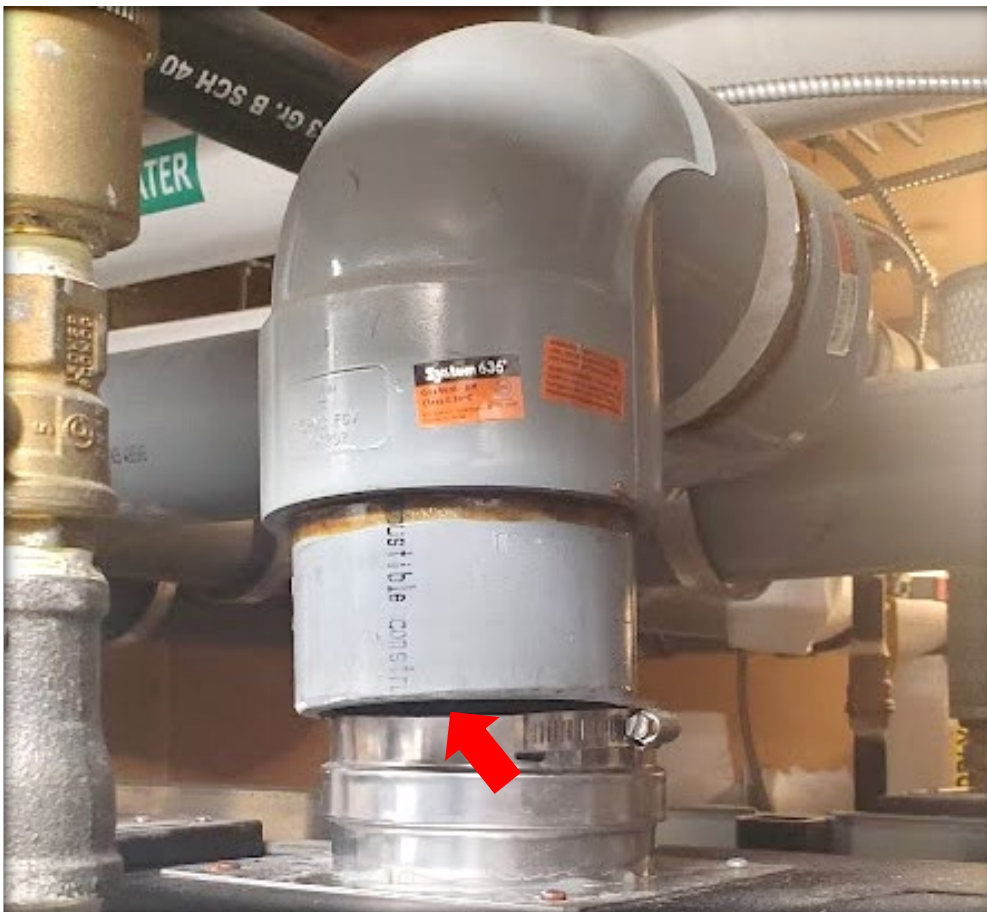
Image 1 – Vent for boiler #1 found dislodged from the boiler exhaust connector.

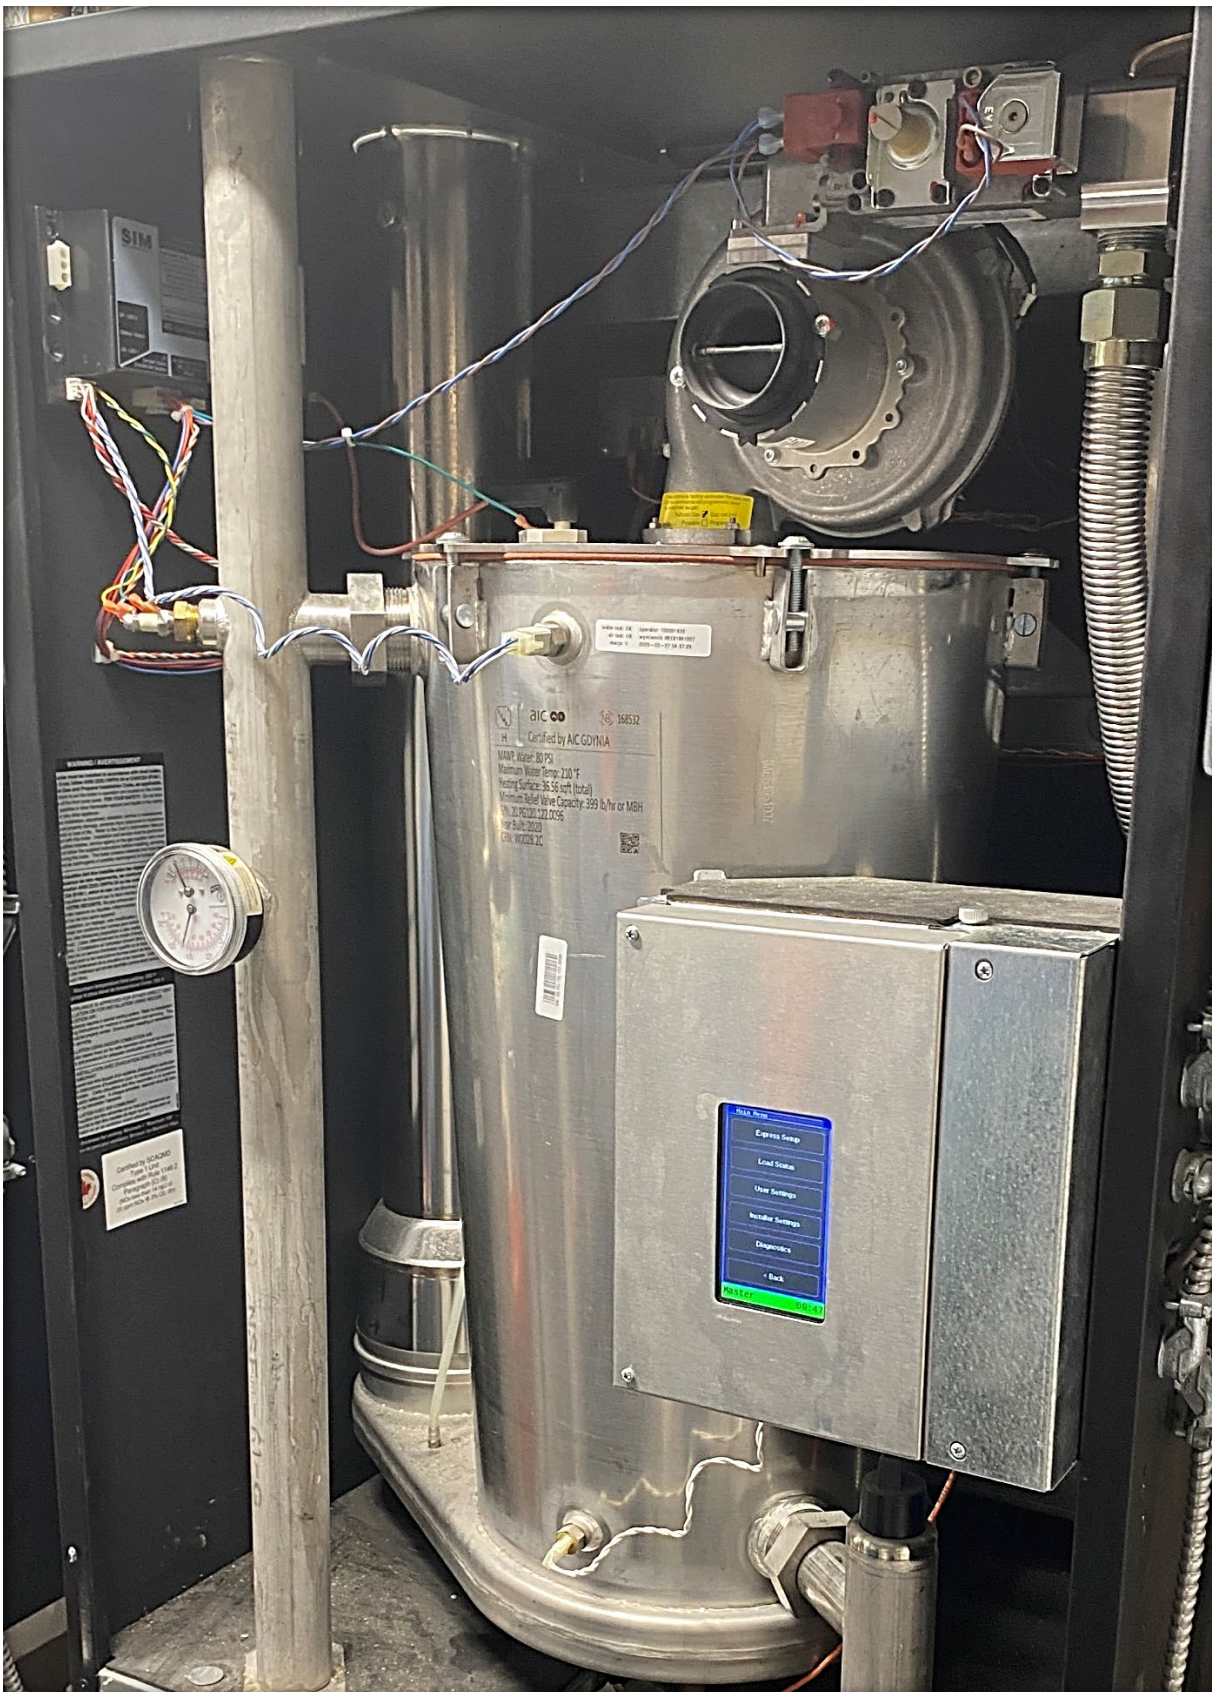
Image 2 – Boiler # 1 with stainless steel cover off.

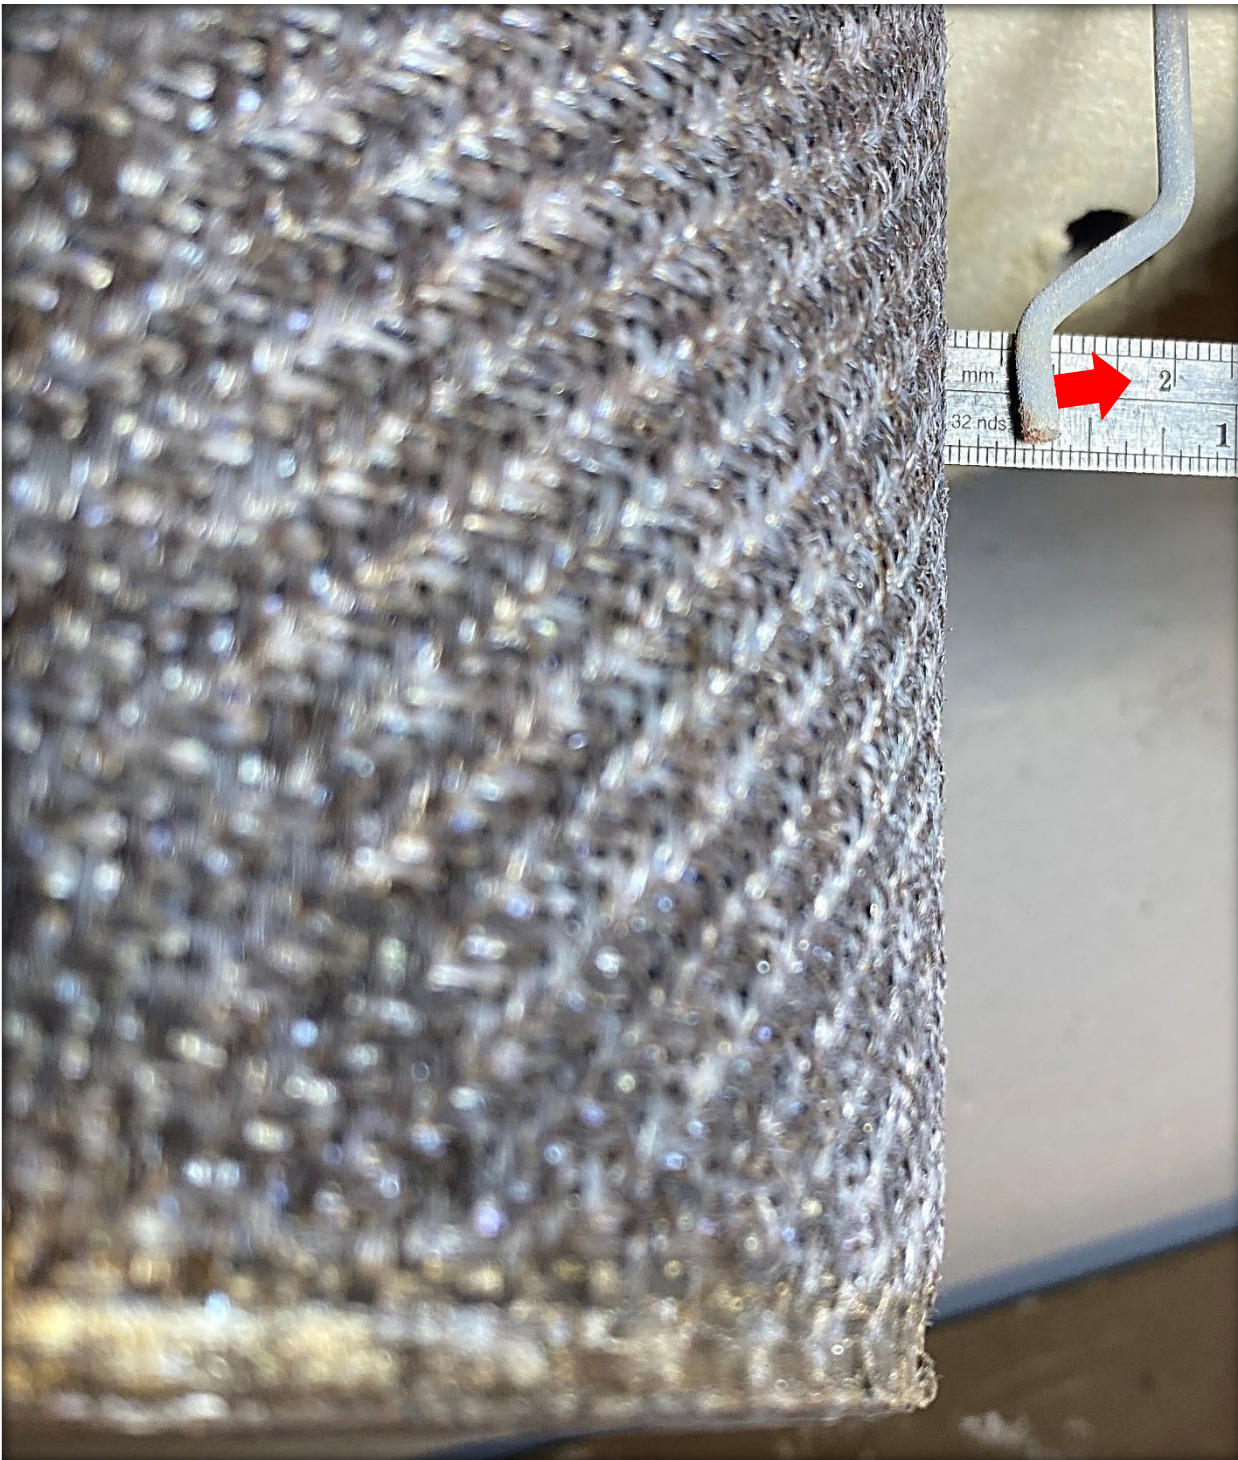
Image 3 – Boiler #1 single prong ignitor gap at 6.5-7mm from burner mesh.

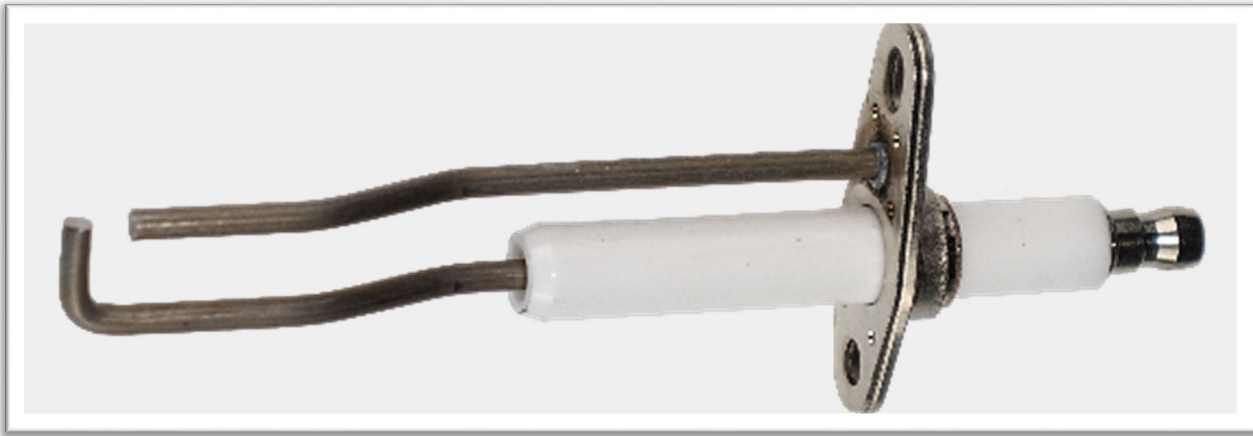
Image 4 - Dual prong type ignitor indicated in boiler manufacturers January 2021 product change.

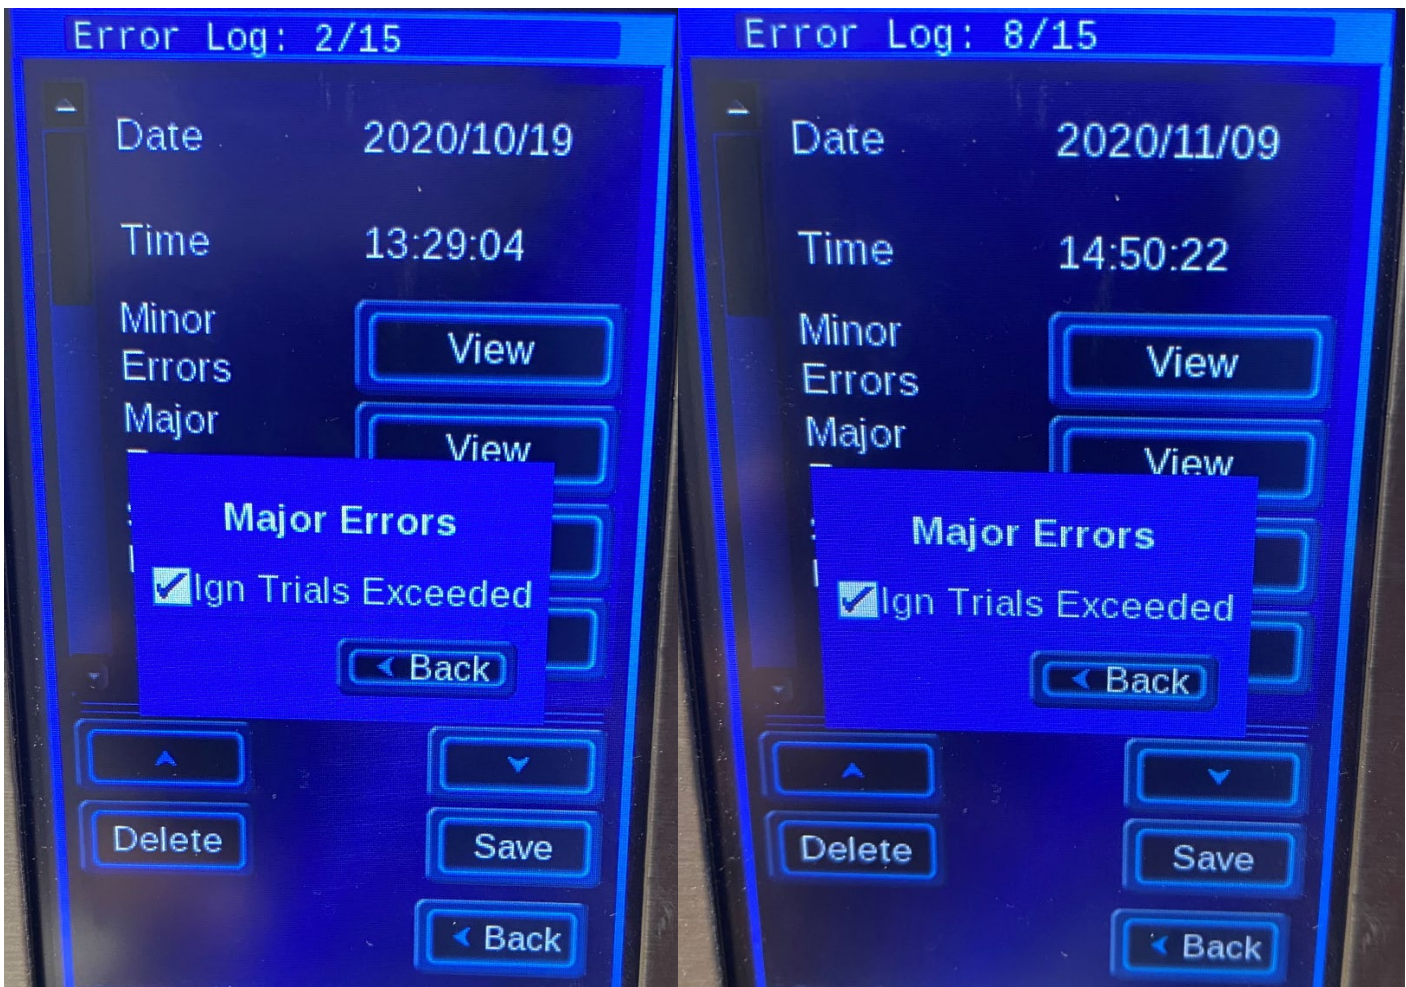
Image 6 - Major ignition trials exceeded errors (2 examples of 7) prior to the incident.
