Incident Summary #II-1090177-2020 (#19554) (FINAL)

SUPPORTING INFORMATION	Incident Date		October 28, 2020
	Location		Terrace
	Regulated industry sector		Gas - Natural gas system
		Qty injuries	1
	Injury	Injury description	Driver of Vehicle was taken to hospital by ambulance after sustaining burns in lungs and on body.
	t	Injury rating	Major
	Jamage	Damage description	Black iron natural gas riser located in open area was damaged at ground level causing an uncontrollable leak of 60PSI natural gas which caused an explosion engulfing vehicle in flames, glass and shrapnel was found 10m away from the explosion site. Vehicle was left to burn until natural gas distribution line was shut off by the utility.
	_	Damage rating	Major
	Incident rating		Major
	Incident overview		A black iron natural gas riser from the distribution line of a natural gas system at a modular park was hit by a vehicle causing a gas leak, explosion, and fire.
INVESTIGATION CONCLUSIONS	Site, system and components		A black iron natural gas riser connected to an underground piping system was left capped and secured to an iron post at a vacant modular lot without vehicle protection. Natural gas code requires protection p

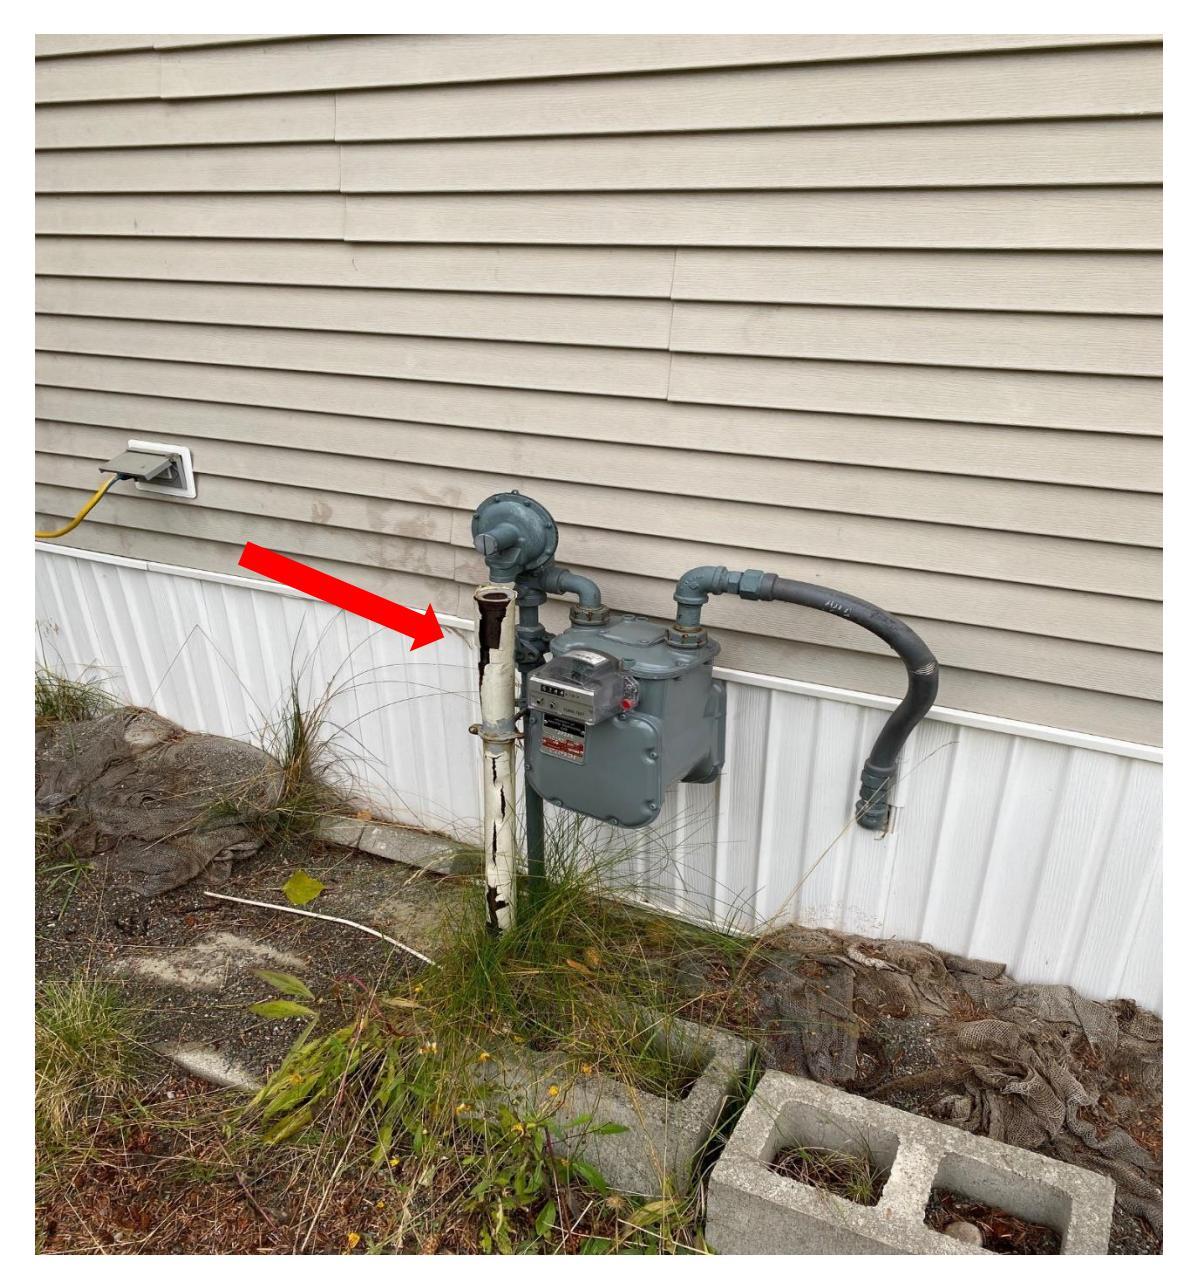
Typical natural gas meter install at modular home park showing post used to support meter (red arrow) Gas Meter and Riser are 4 feet from laneway without any means to protect from possible vehicle damage.

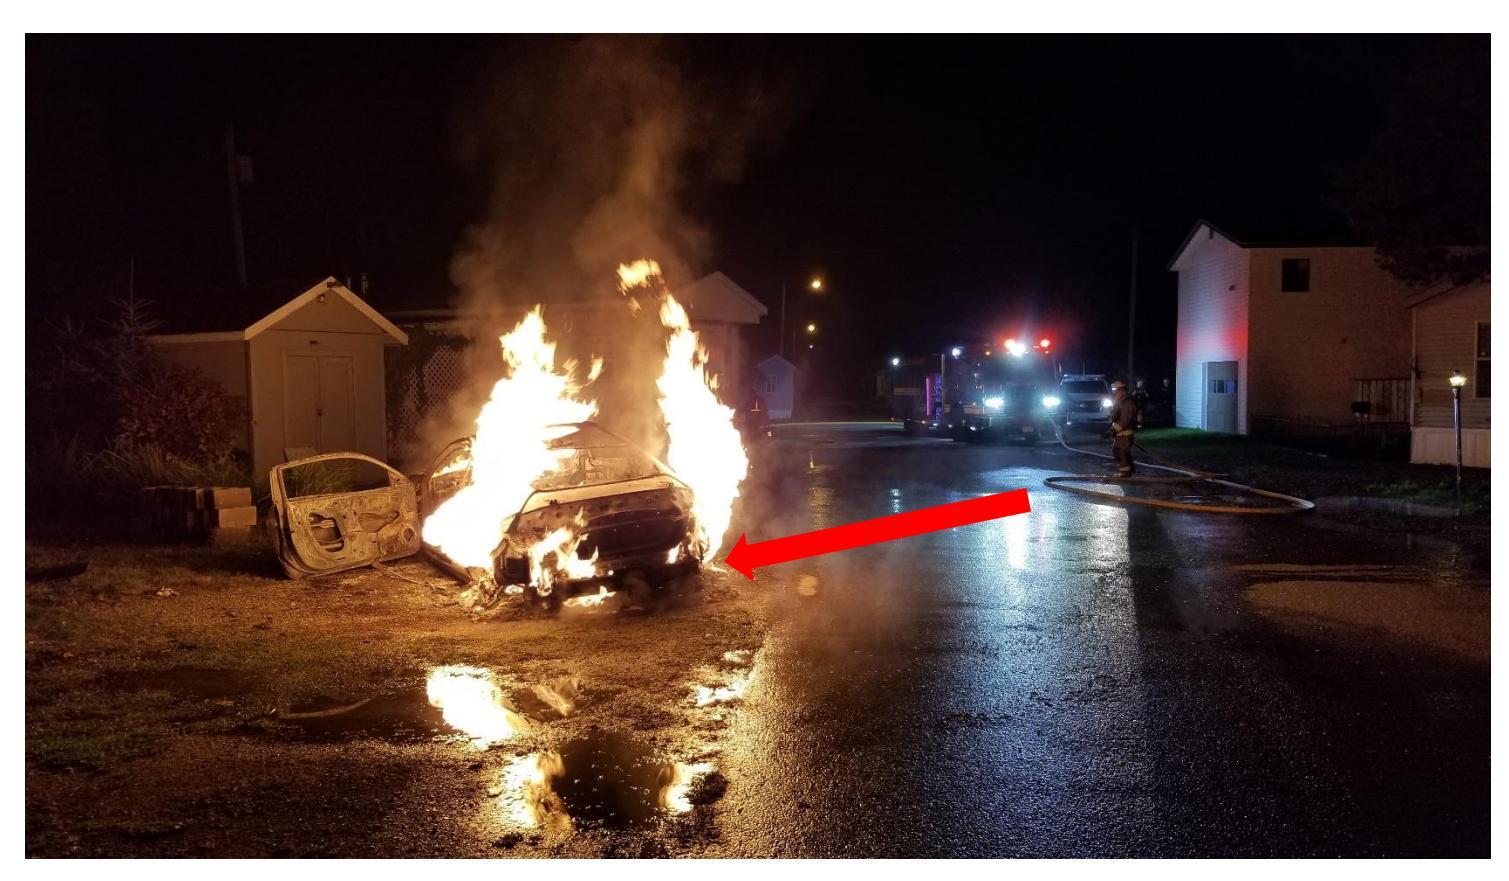
Car engulfed in flames from Natural Gas Riser beneath car at red arrow.

At time of photo, occupant has been removed and is safe in hospital. It is best practice during a natural gas leak which has caught fire to turn off the gas at shutoff valve and let the residual gas burn to minimise any other fires or pockets of gas after shutdown of a piping system.

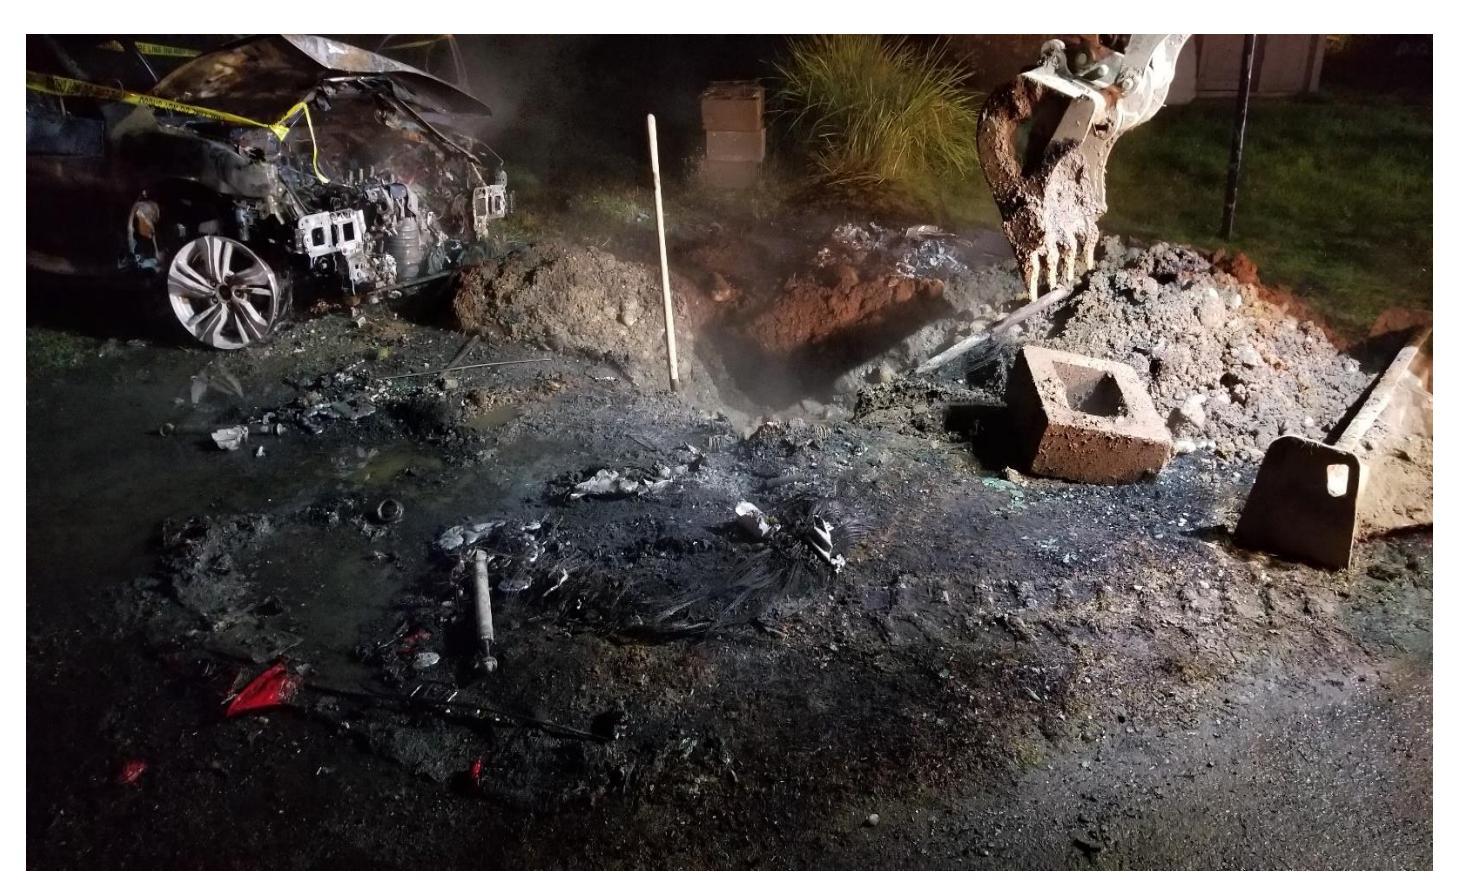
Car has been removed and dragged north for utility company to access and cap the underground natural gas line

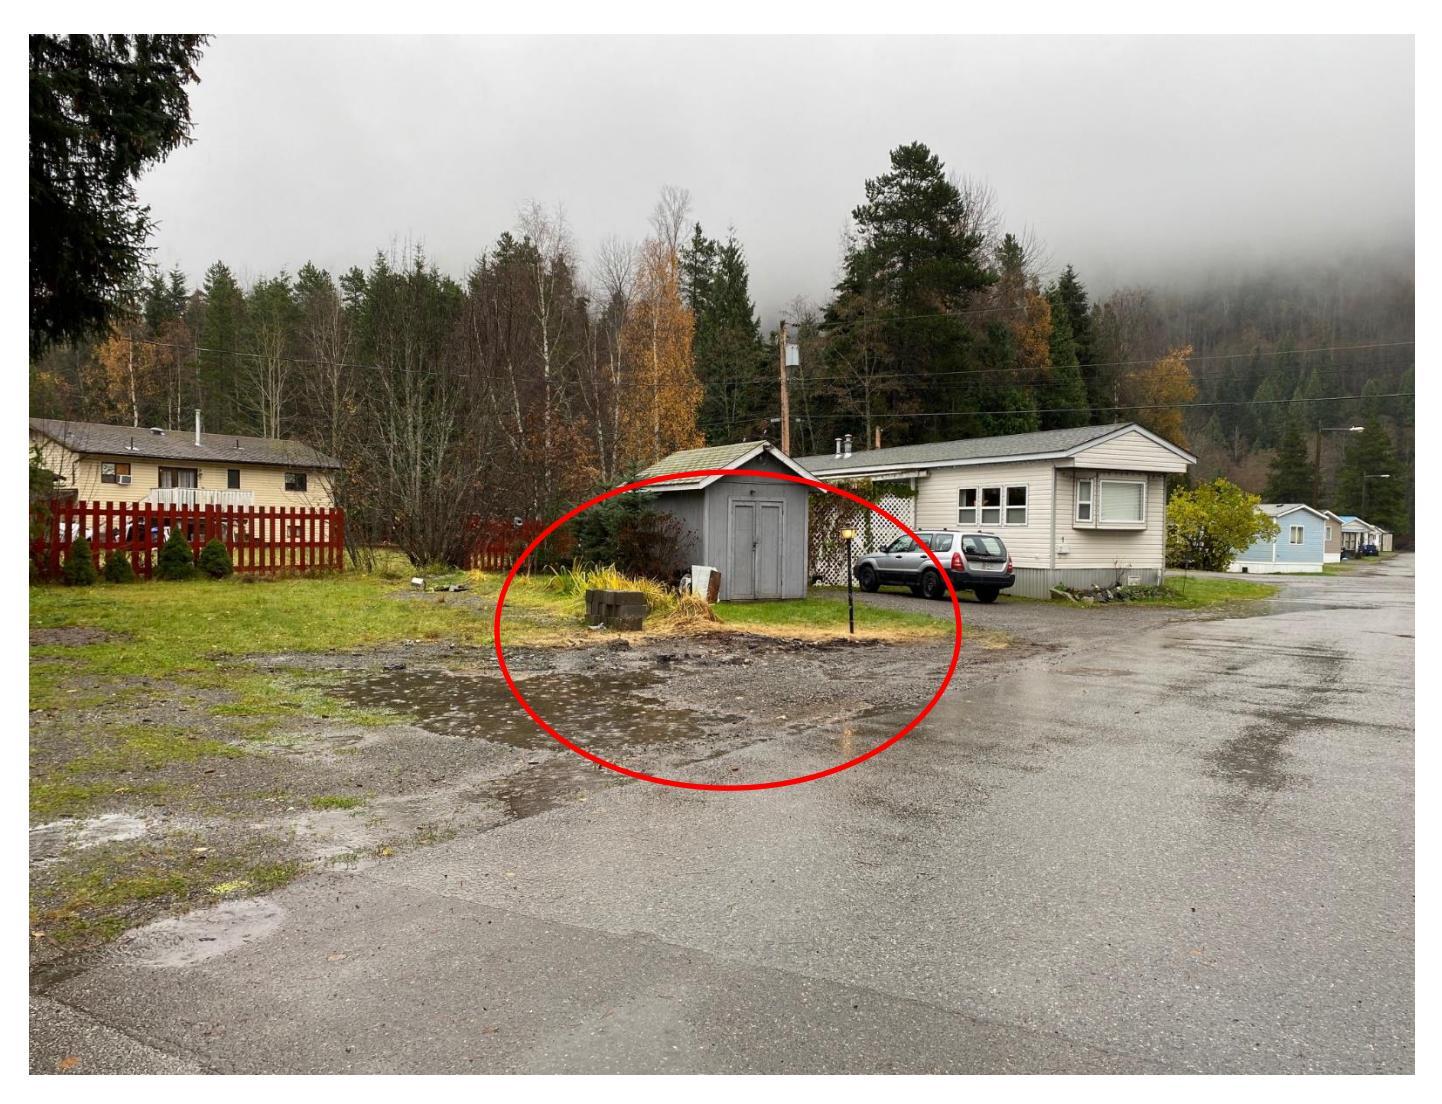
Location of incident looking south. Car and gas riser located in red circle. Riser was approximately 4Ft from laneway.

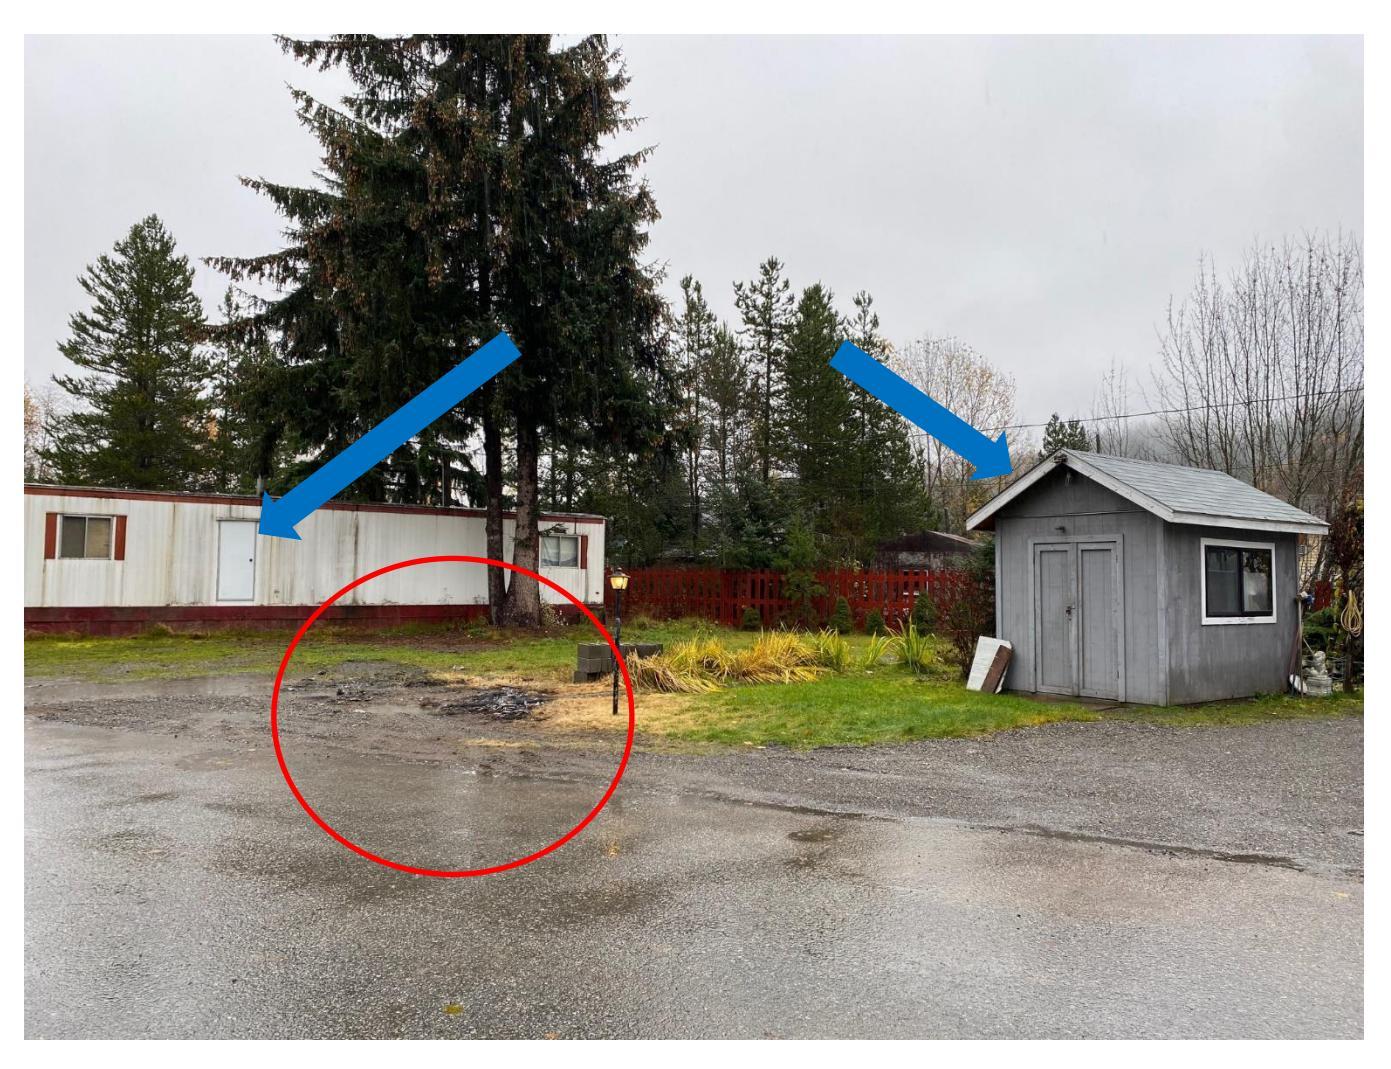
Location of incident looking north. Car and riser located in red circle.

Neighbours Shed and Neighbours Modular located with blue arrows.

Space between shed is a vacant lot in which the Natural Gas Riser was left for future modular install
