Incident Summary #II-928694-2019 (#15744) (FINAL)

SUPPORTING INFORMATION	Incident Date		October 25, 2019		
	Location		Abbotsford		
	Regulated industry sector		Boilers, PV & refrigeration - Refrigeration system		
		Qty injuries	0		
	Injury	Injury description	No injury reported		
	act	Injury rating	None		
	lmp amage	Damage description	A shaft seal failure on a compressor in a refrigeration system released approximately 5 lbs of ammonia intended to be contained.		
	Ő	Damage rating	Minor		
	Incident rating		Minor		
	Incident overview		An ammonia release resulted in the temporary shutdown of an ammonia plant in an industrial food processing facility.		
INVESTIGATION CONCLUSIONS	Site, system and components		Ammonia refrigeration systems are designed to operate at 250 pounds per square inch gauge (Psig). The major components of the system like compressors, evaporators, liquid receivers, piping, and fittings etc. are installed in a machinery room. The compressor sucks refrigerant gas into a cavity, gradually reduces the volume of the cavity, and discharges the refrigerant as a high-pressure gas. Lubricating oil is very significant to keep the compressor in a good operating condition. To p

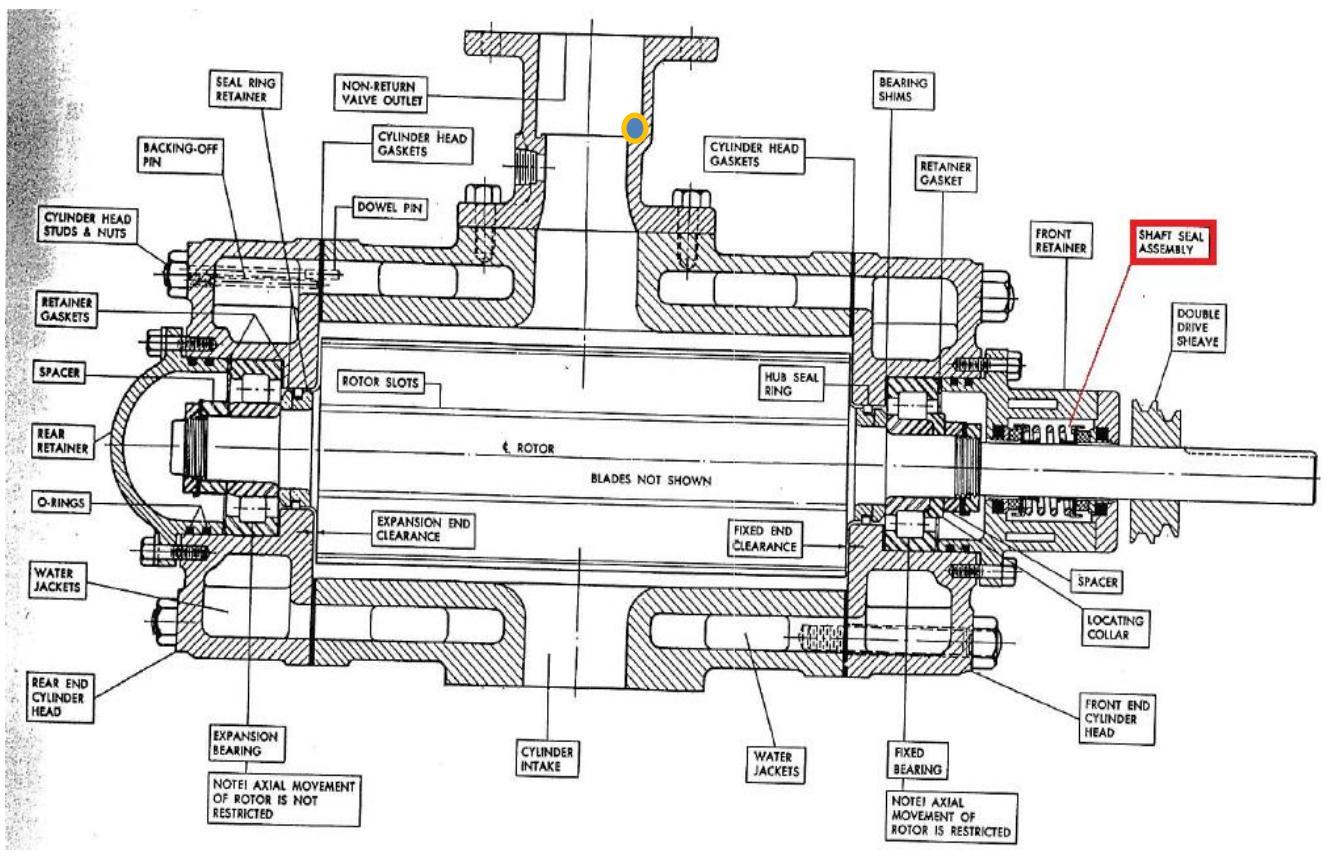
Compressor (sectional view – shaft seal assembly location)

Causes and contributing factors	The cause of the ammonia release was very likely due to a lack of lubrication between the compressor shaft seal faces. This caused the seal to fail allowing ammonia to be released through the micron class gap between the seal faces. The lack of seal lubrication was due to a low oil level condition within the compressor seal reservoir. A contributing factor was that there was no monitoring system in place for the seal reservoir oil level.
