Incident Summary #II-1786583-2024 (#54049) (FINAL)

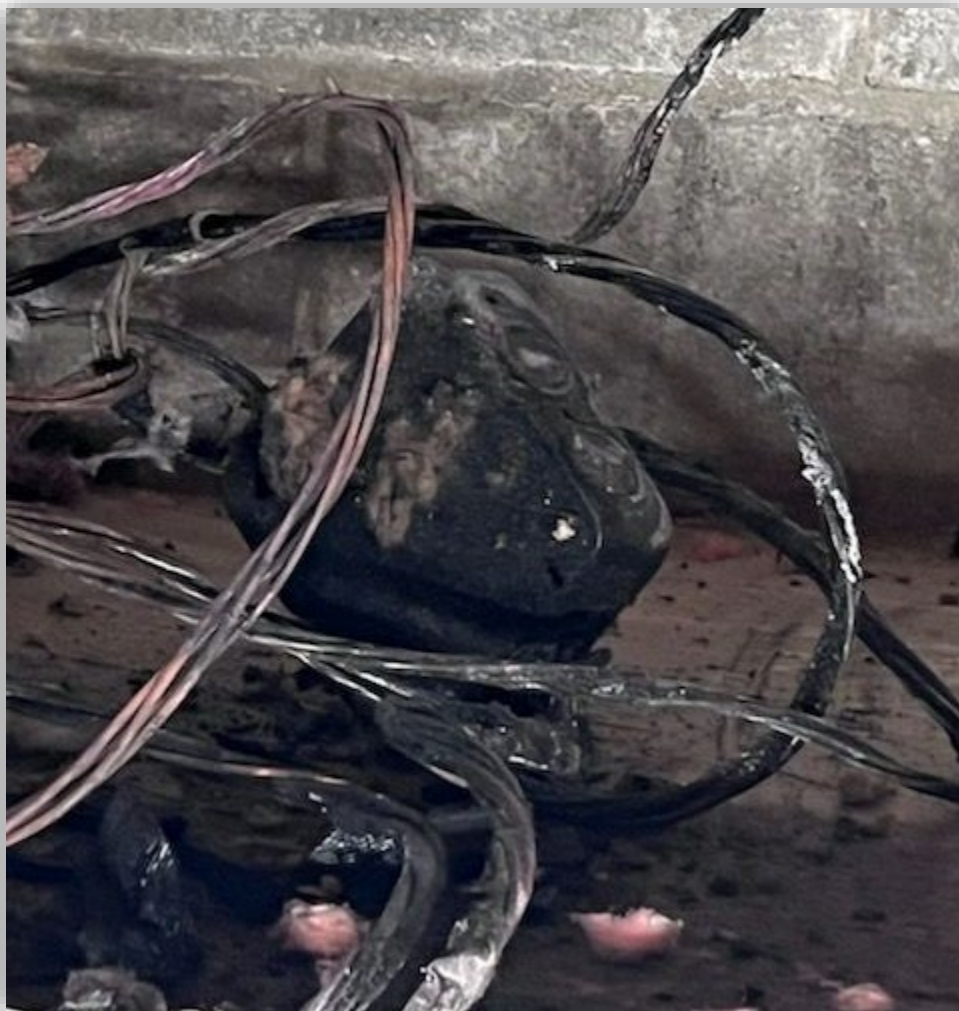
Image 1 – Burnt wiring.

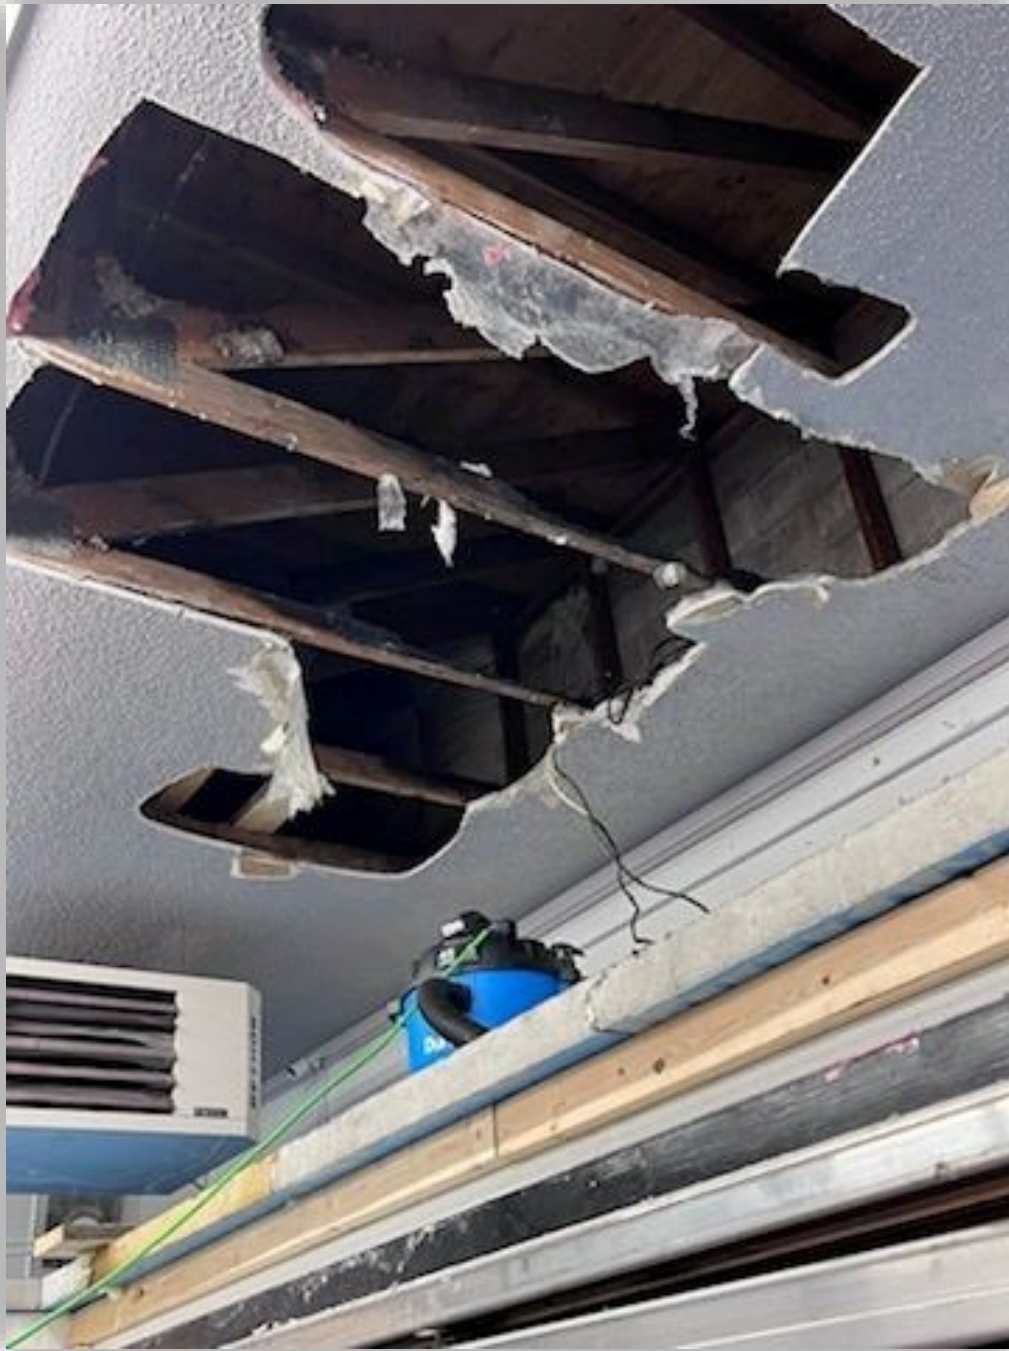
Image 2 – Damage to ceiling.

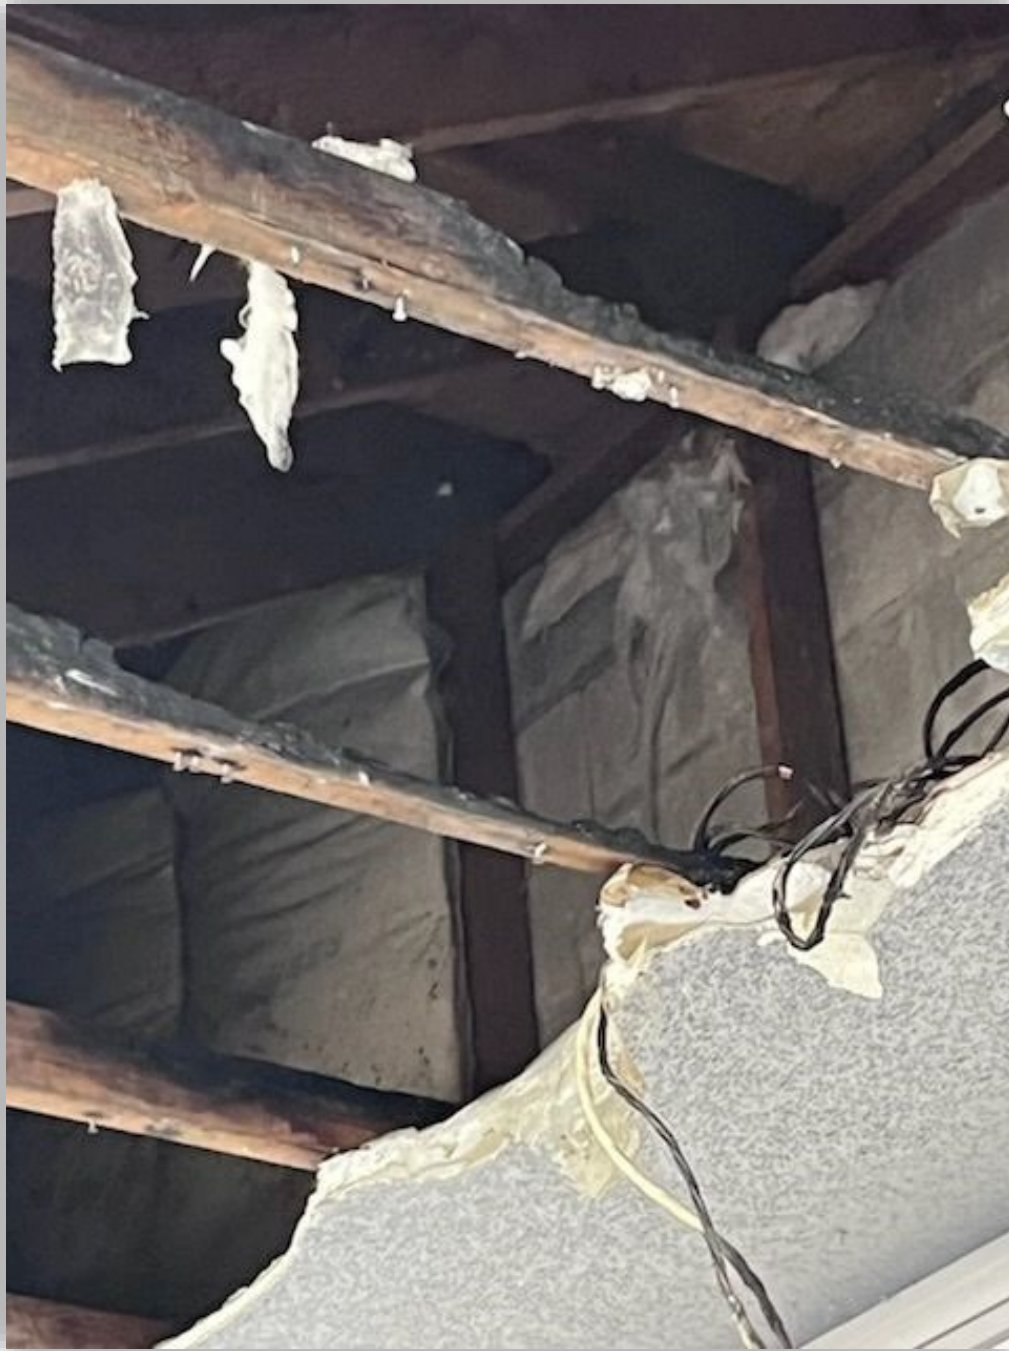
Image 3 – More damage.
