Incident Summary #II-1139526-2021 (#20647) (FINAL)

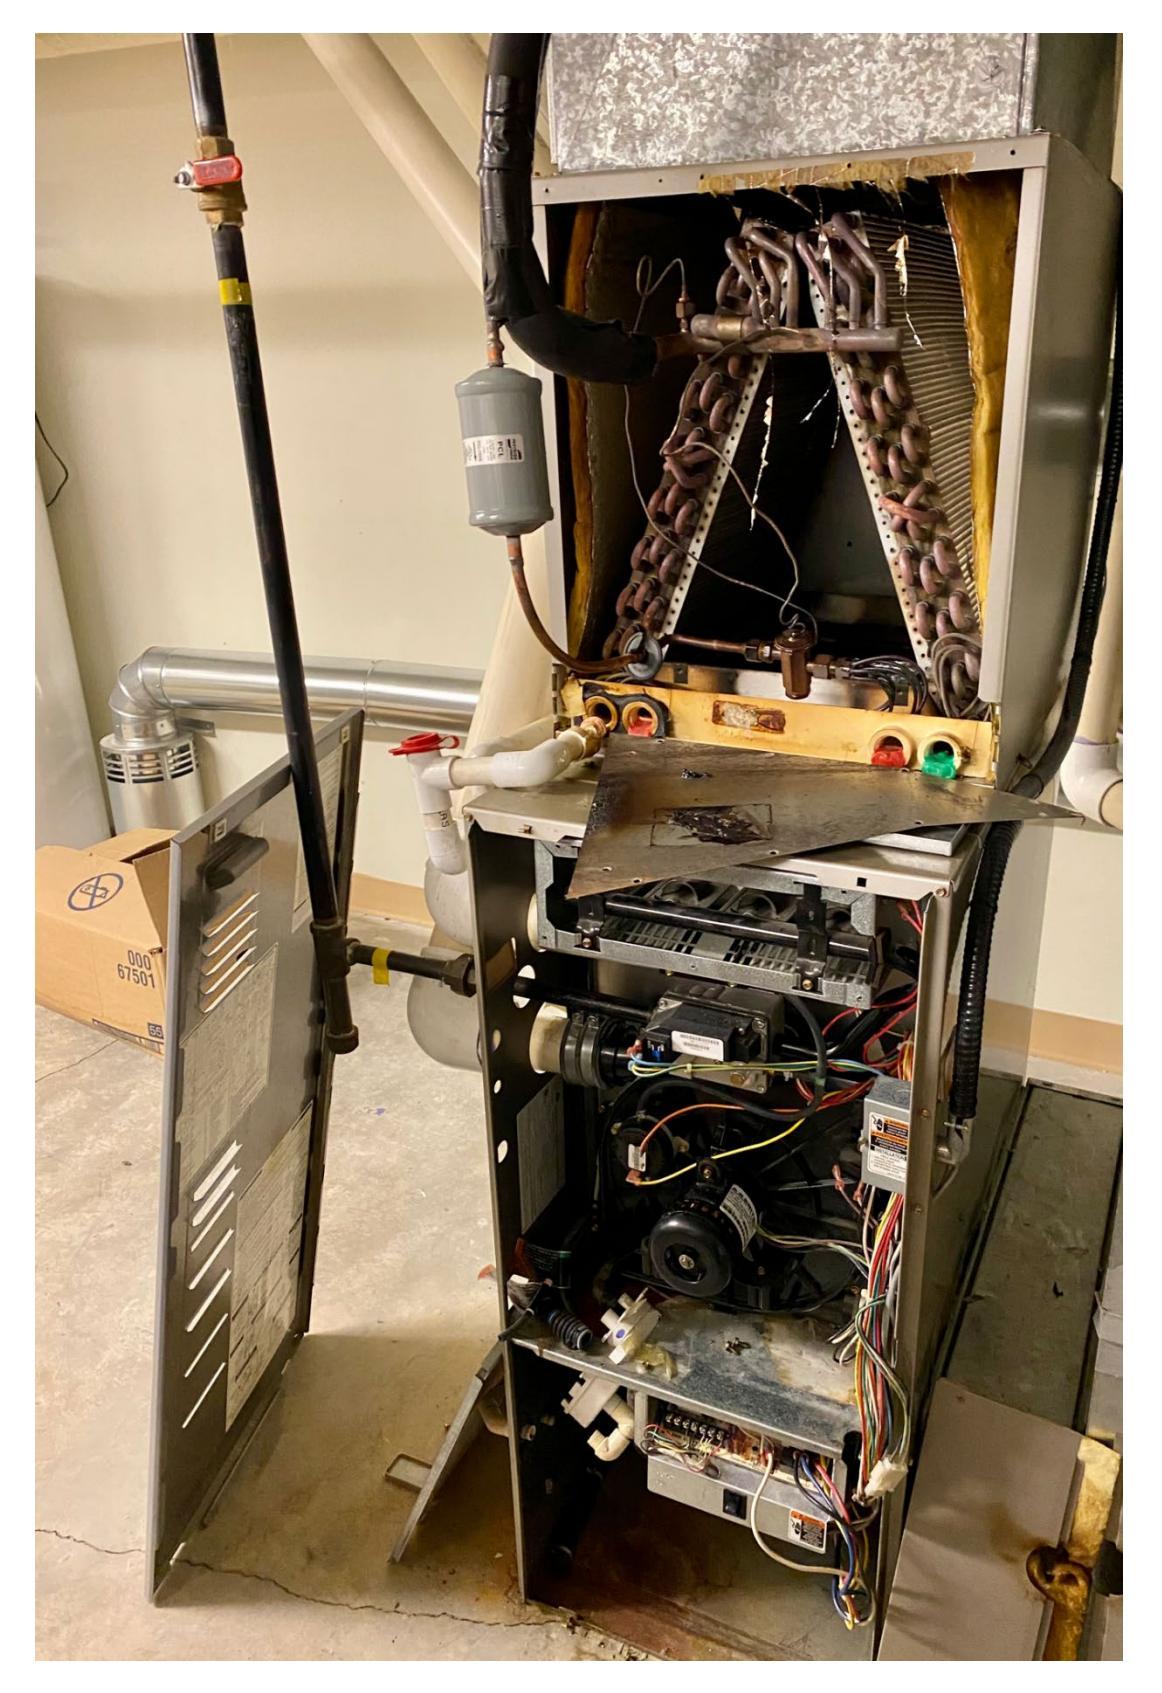
Image 1: Photo of the furnace as found by the safety officer at time of investigation

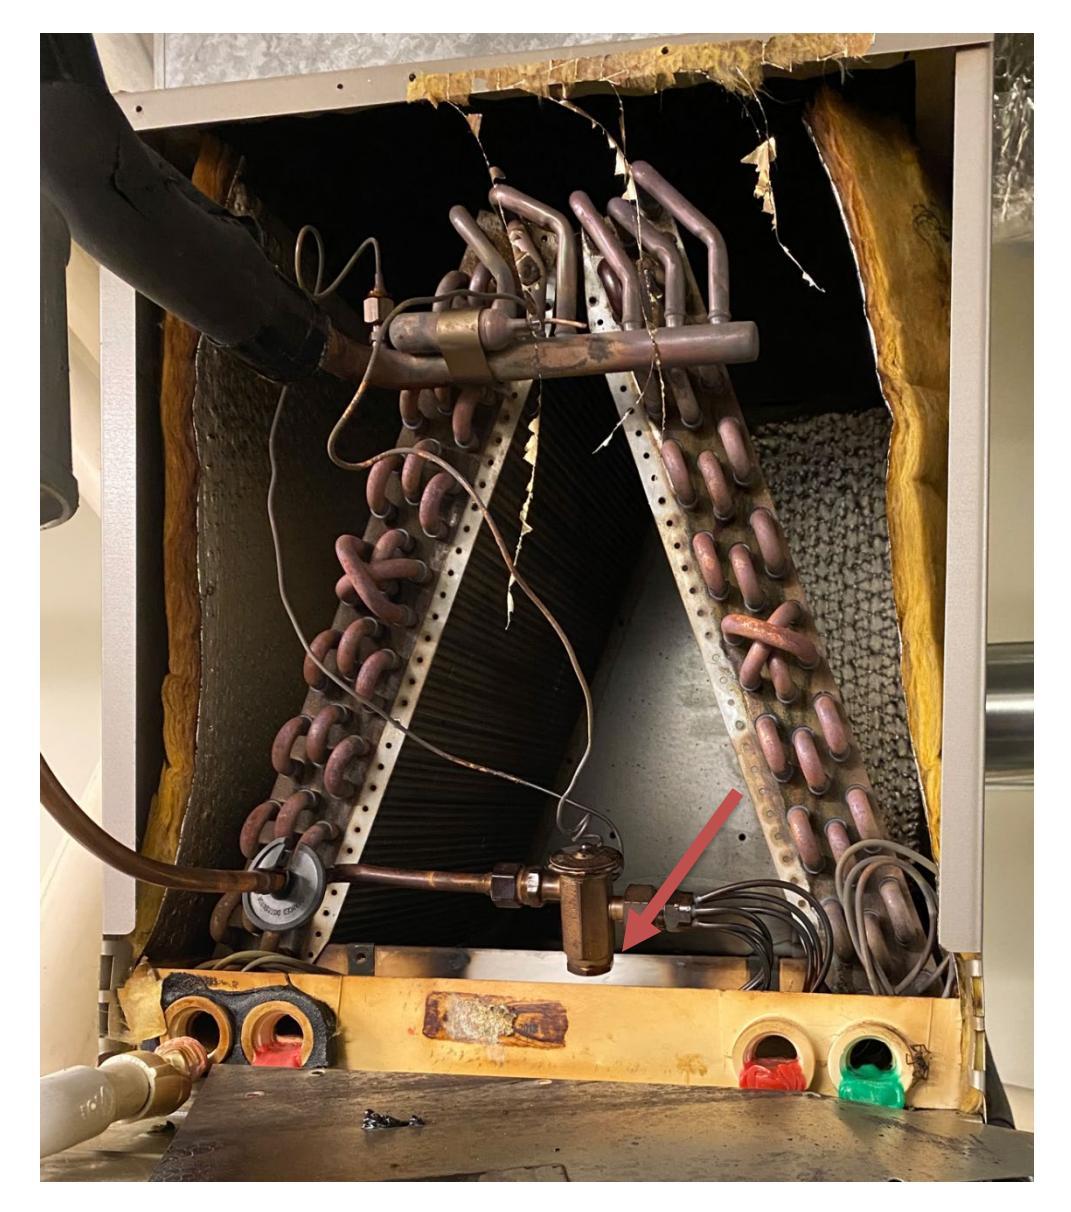
Image 2: Photo of the air conditioning coil, the red arrow shows the area of the drain pan which ignited.

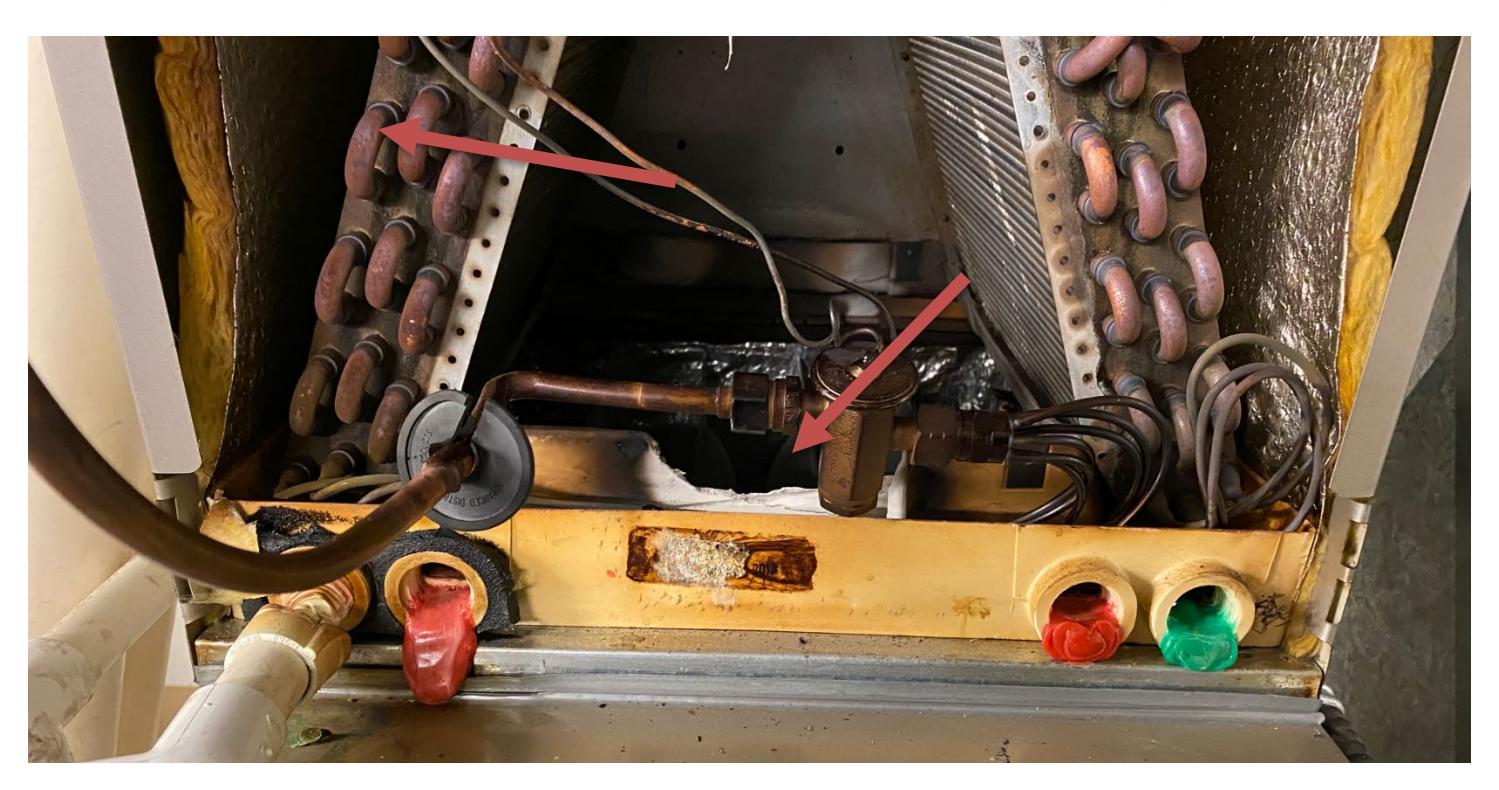
Image 3: Close up of air conditioning coil after it was touched by the safety officer. The area indicated by the red arrow had been reduced to white ash in the incident.

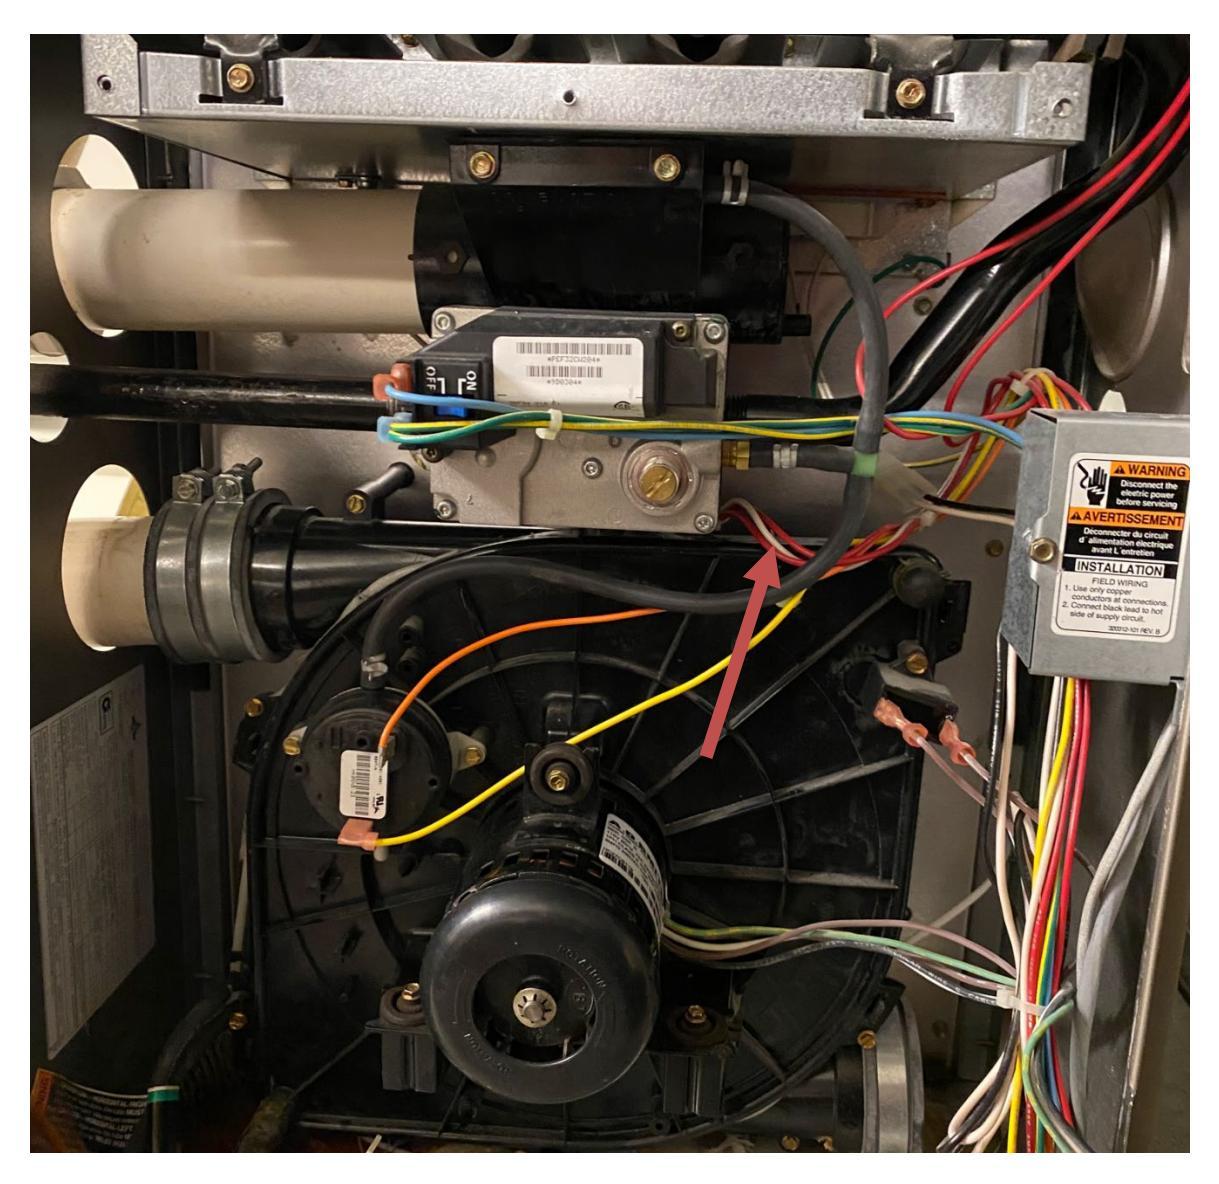
Image 4: Close up photo of the furnace venter assembly, the red arrow indicates the location of the wires for the high limit safety.

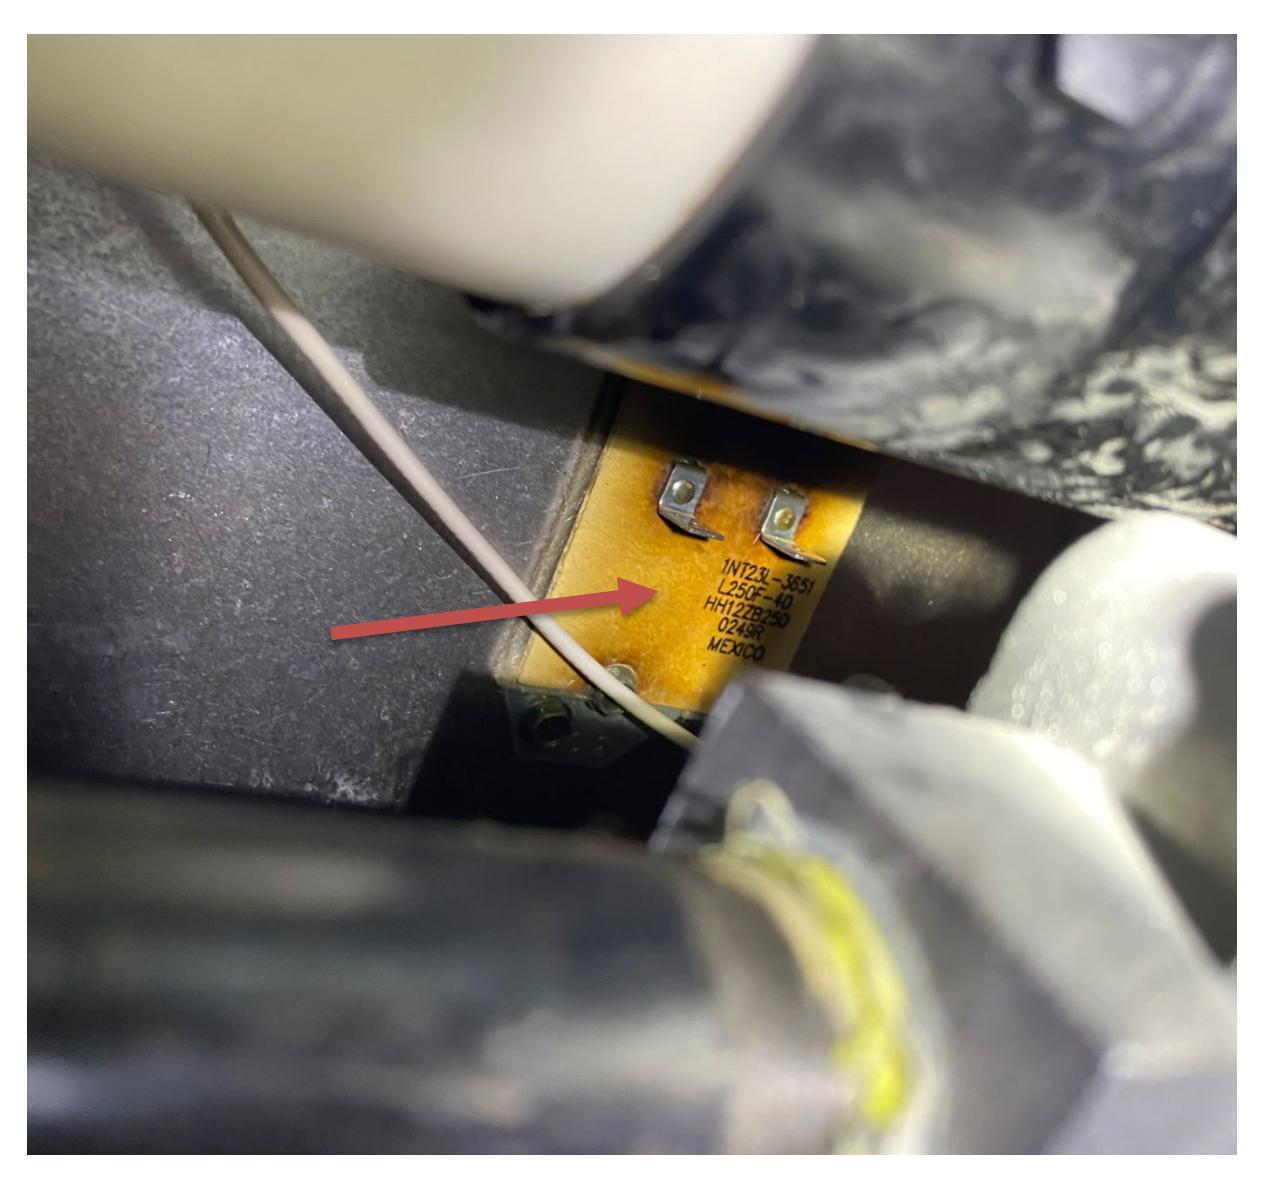
-An interview with a service tech who replaced the furnace after the incident confirmed that the duct work was clear, and the new furnace is operating within parameters.
Causes and contributing factors	It is highly probable that the high limit safety being bypassed from the system, coupled with an unknown issue in the furnace caused the furnace to overheat while in operation, causing the air conditioning components to melt and ignite.

Image 5: Close up of the high limit safety. The wires had been removed, and the discoloration of the safety indicates that it was subjected to high temperatures.

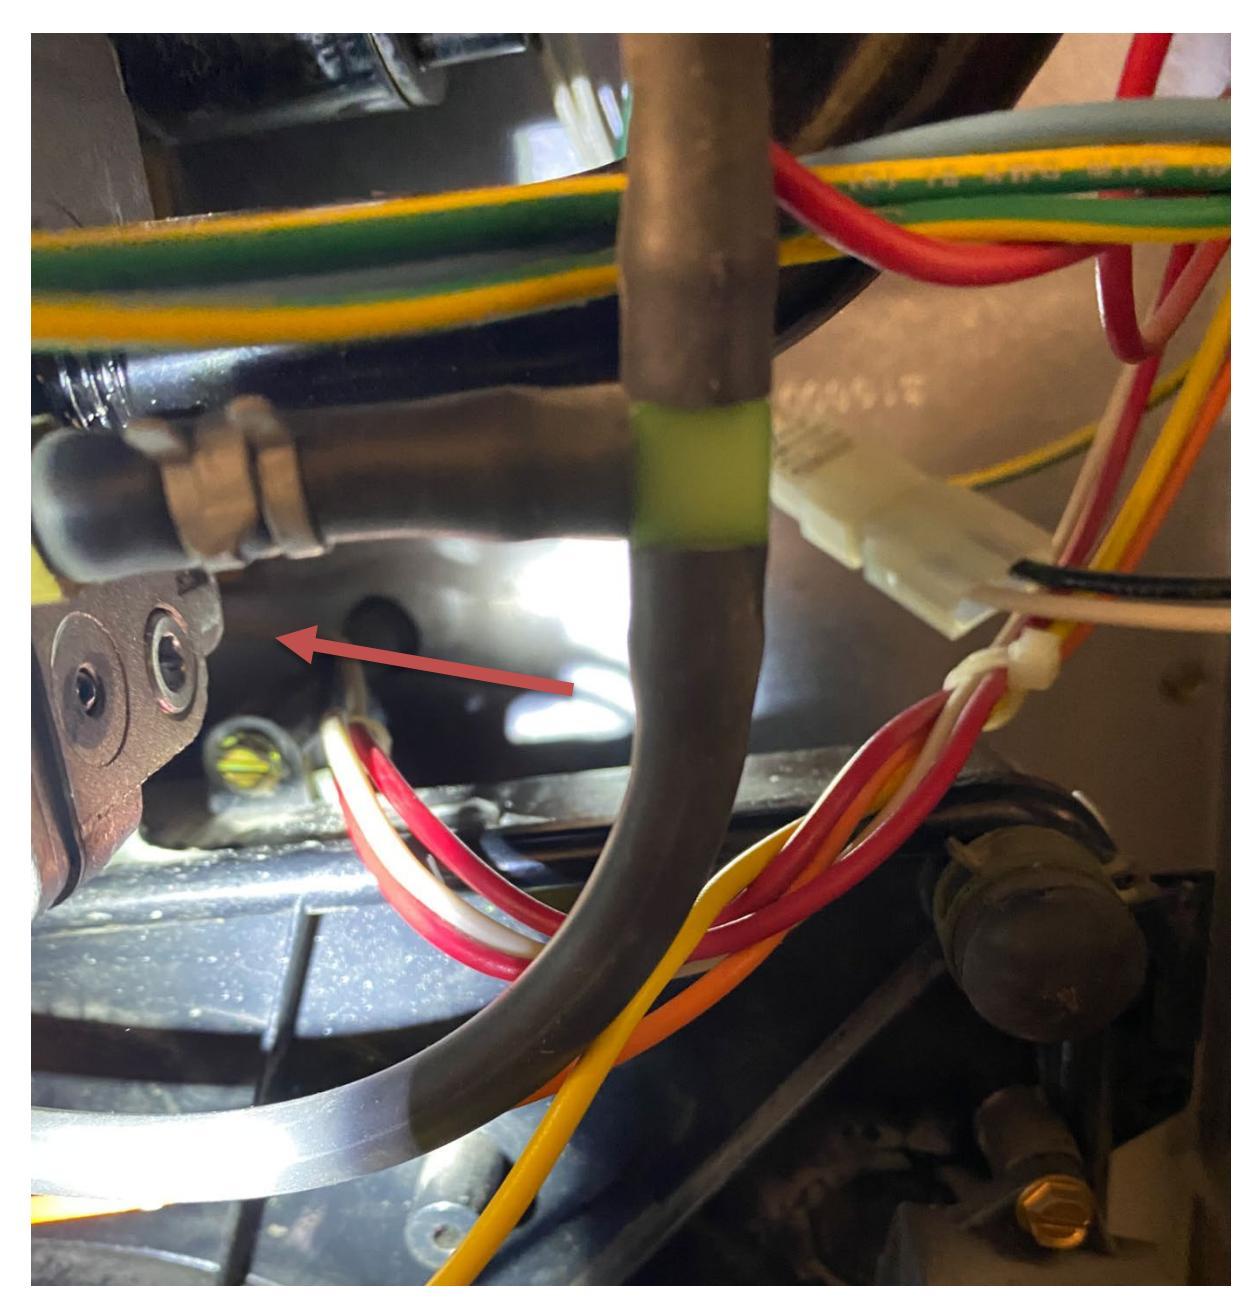
Image 6: Close up of the high limit safety wiring. The red arrow indicates where the bypassed high limit wiring was found.

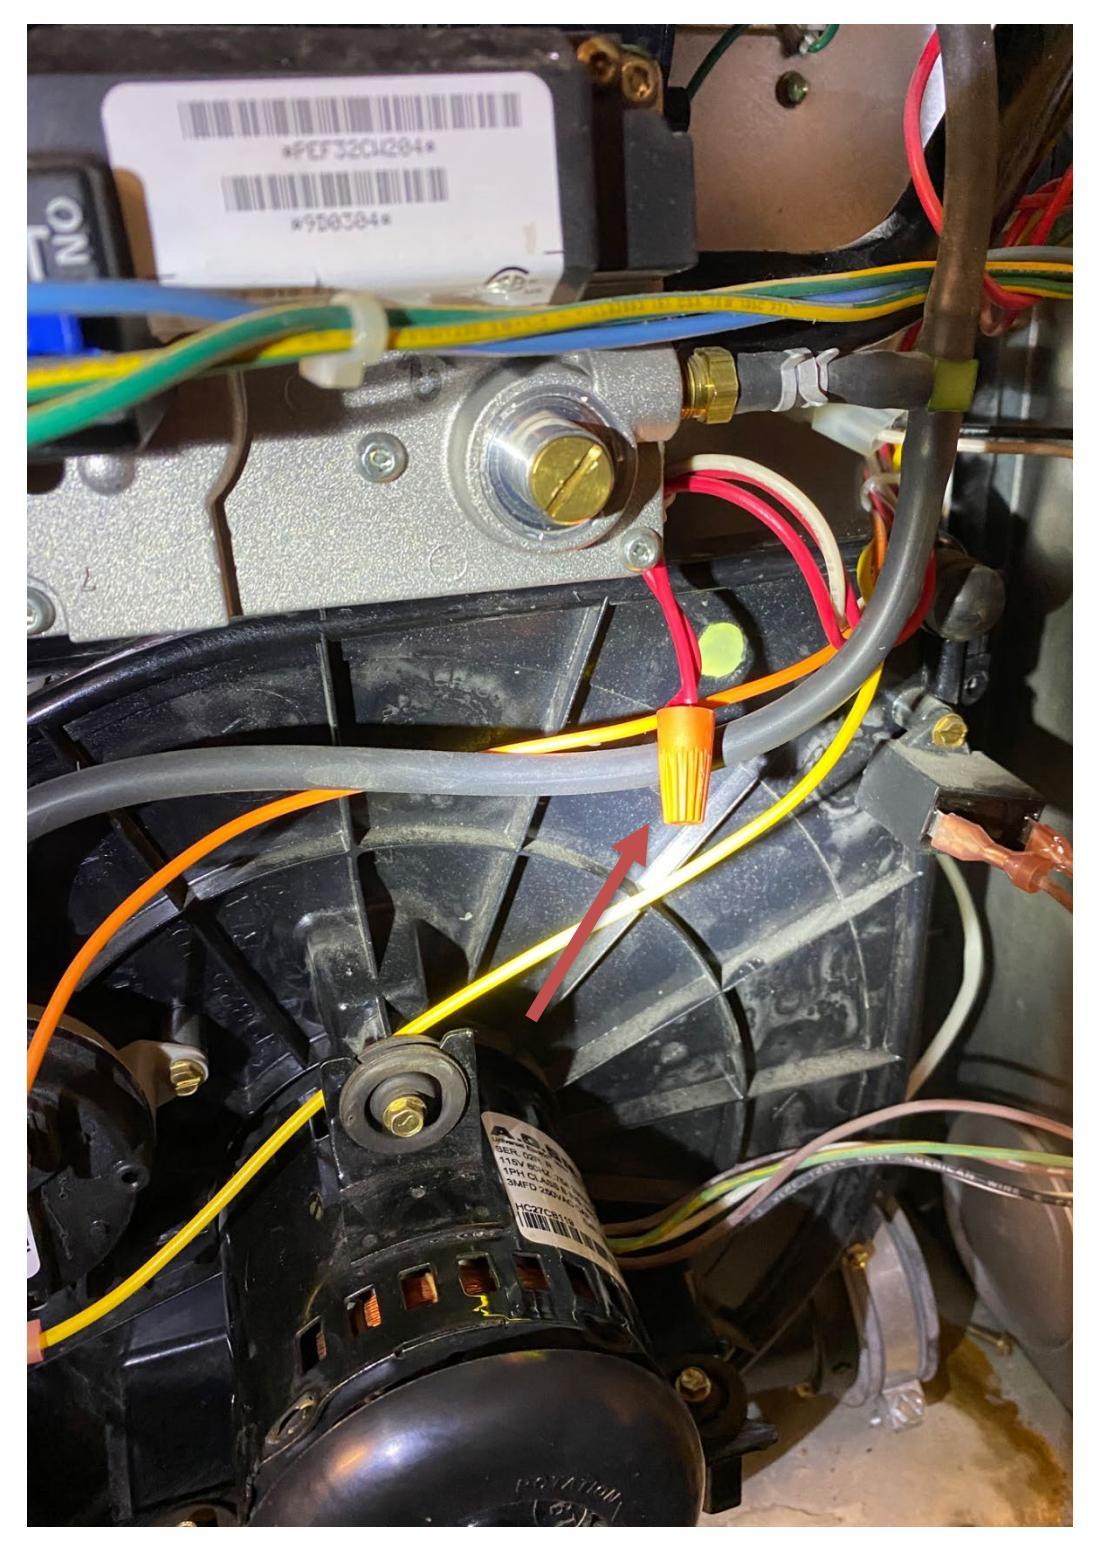
Image 7: The bypassed high limit safety wiring.
