## Incident Summary #II-1286980-2021 (#25031) (FINAL)

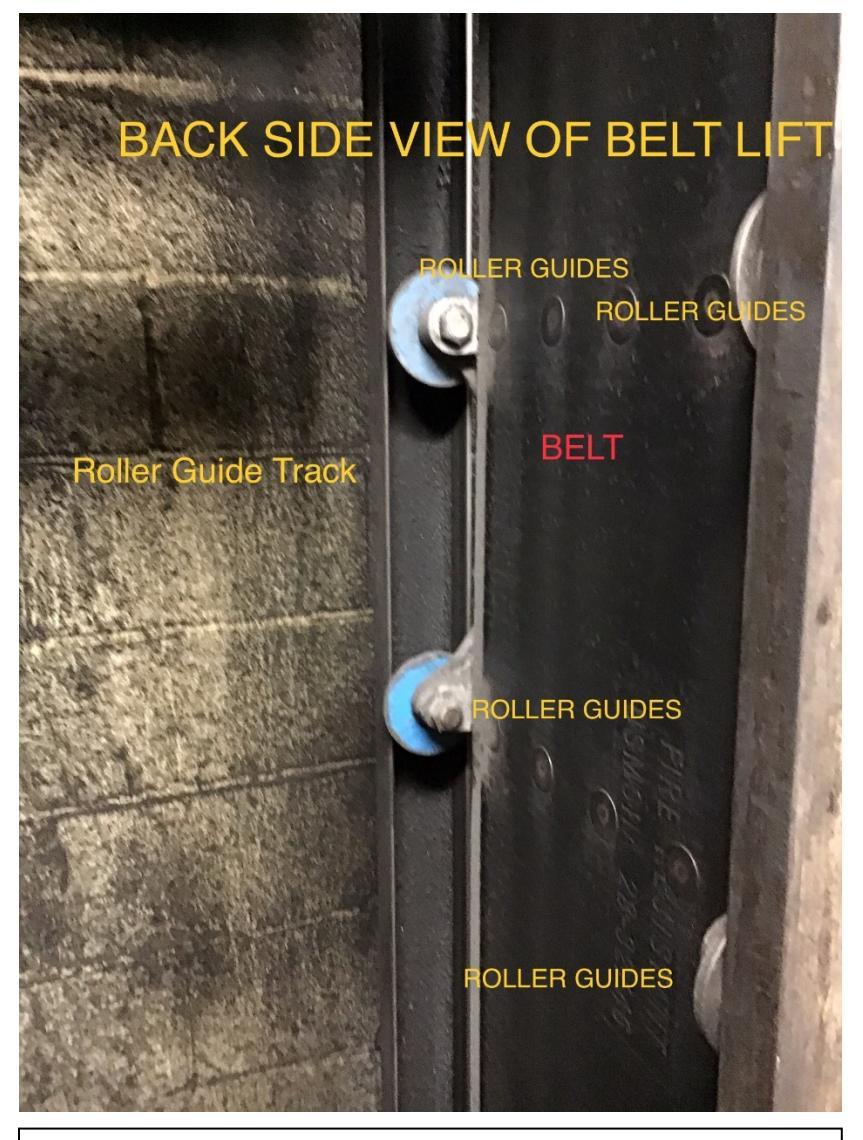
**Photo 1** - Roller guides are connected to the steps and tracks. The rollers run on the inside a track know as the guide rail.

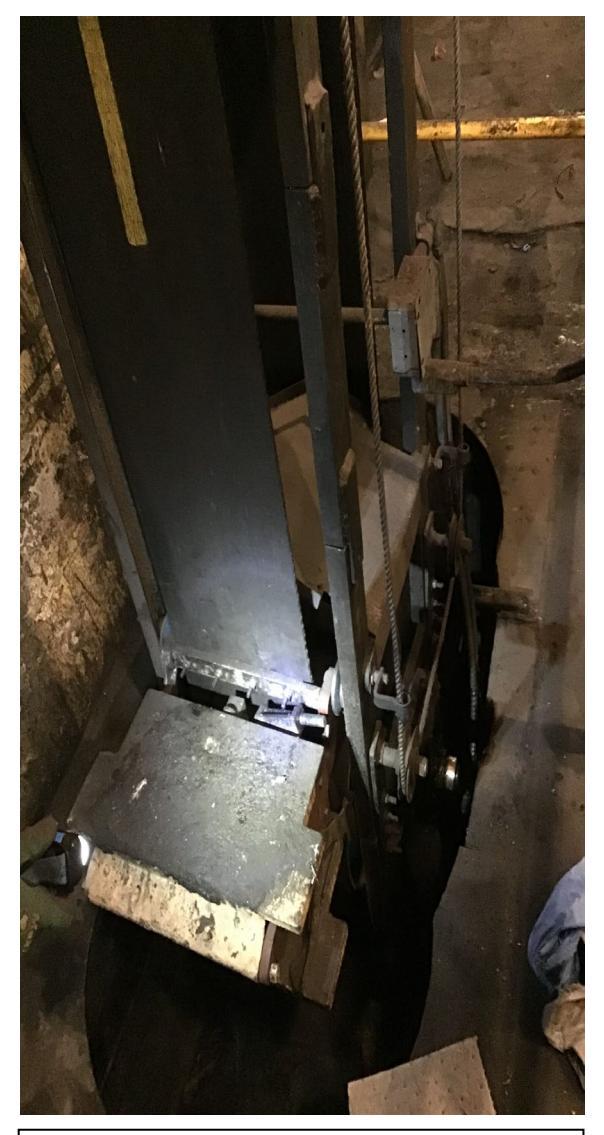
**Photo 2** - Front view of the belt and a step assembly just as it's about to loop under the bottom pulley. The rollers are secured in place by fasteners of the bolt and nut type.

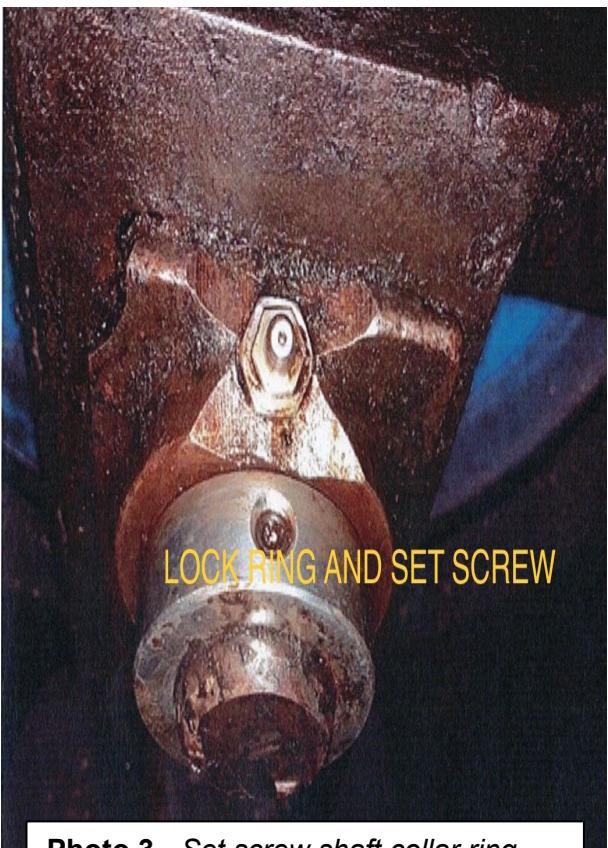
It is very likely that the bottom end pulley rolled out of alignment because of the failure of the shaft collar ring. It is highly likely that the fasteners on the roller guides were coming into contact with the edges of the pulley as the steps looped around. It is also likely that the fastener's structural integrity was compromised as a result. It is certain that the damaged hardware is what led to the roller guide falling off while under load. It is unknown what caused the set screw shaft collar ring to fail. It is possible that the set pins installed at the time of the failure were not torqued adequately to withstand the forces exerted on them or were not adequate for the installation. The set pins for the top and bottom drums were upgraded to prevent the drums from moving laterally in the future.

**Photo 3** - Set screw shaft collar ring installed on one end of the pulley shaft.

May 13, 2022 – Engineering documentation submitted for the replacement of the lock pins to the upper pulley.
<ul> <li>Engineering letter was submitted to Safety Officer confirming a replacement of the existing set pins. Set pins to be upsized to prevent upper traction pulley from vibrating and moving laterally along the shaft. Documents attached to file.</li> </ul>

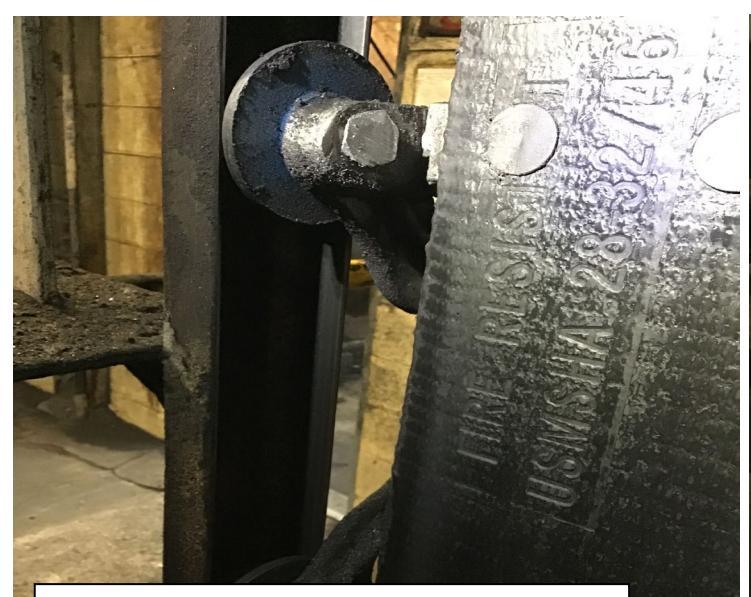
Failure scenario(s)		A set screw shaft collar ring installed on one side of the pulley failed to keep the pulley from rotating out of alignment. The clearance between the roller guides and pulley was reduced as a result. The hex fasteners that keep the roller guides from falling off the track, wore off from the continuous contact with the edge of the pulley. (Photos $5$ , $6$ and $7$ )

**Photo 5** - One of the many roller guide fasteners that were damaged by coming into contact with the side of the pulley.

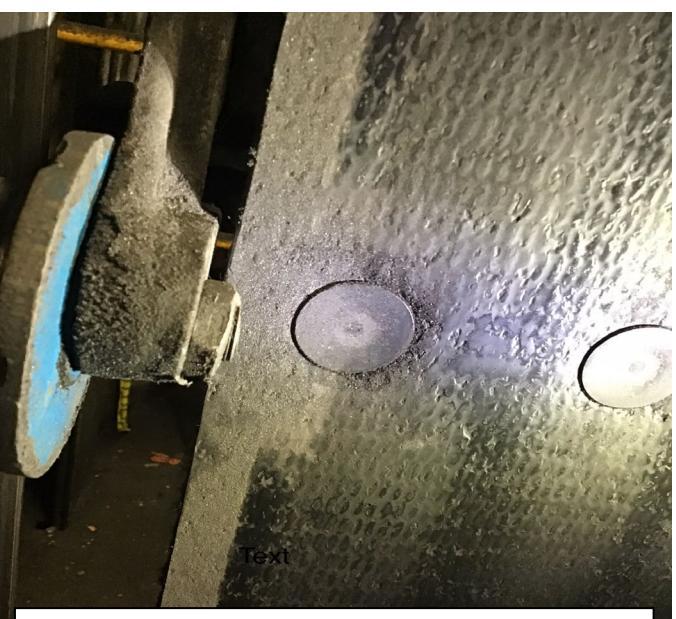
**Photo 6** - Hex nut that normally threads on to the end of the roller guide bolt has worn off.

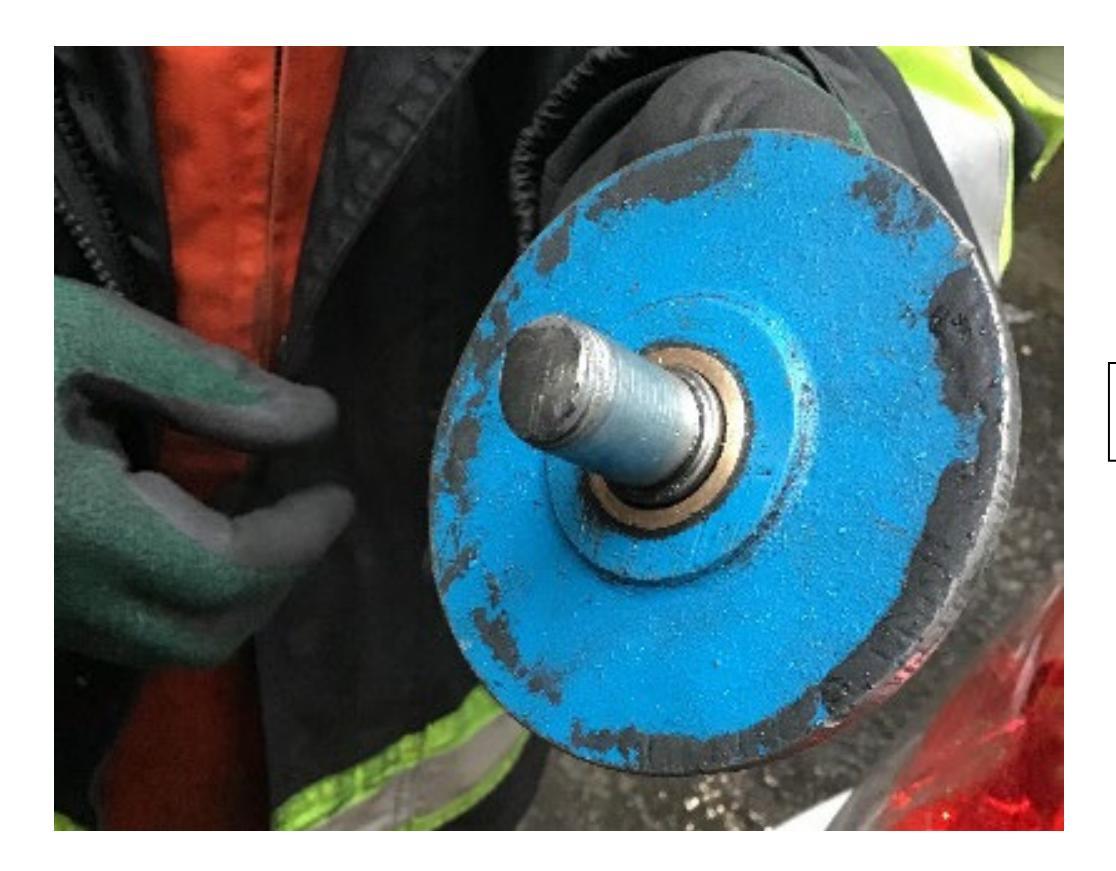
**Photo 7** - *Roller guide that fell off the step assembly*
