Incident Summary (# 5612651)

| | Incident Date | | | February 8, 2017 |

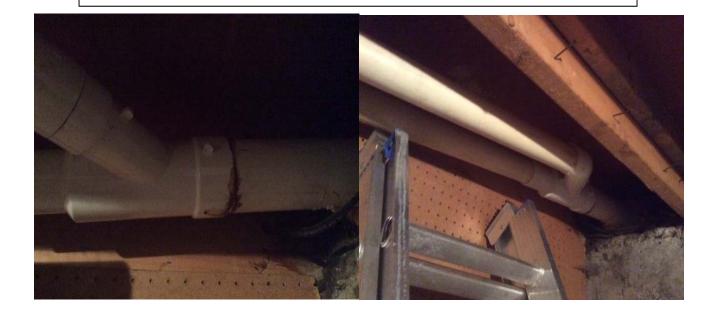
The two pictures show the vent piping going into the concentric vent kit before exiting the side wall. The piping was no longer glued securely to the concentric vent kit and was leaking into the basement of the home.
