Remote Incident Summary #II-1008803-2020 (17051 #) (Final)

SUPPORTING INFORMATION	Incident Date			January 30, 2020
	Location			Delta, British Columbia
	Reg	Regulated industry sector		Electrical - Low Voltage Electrical System (30V to 750V)

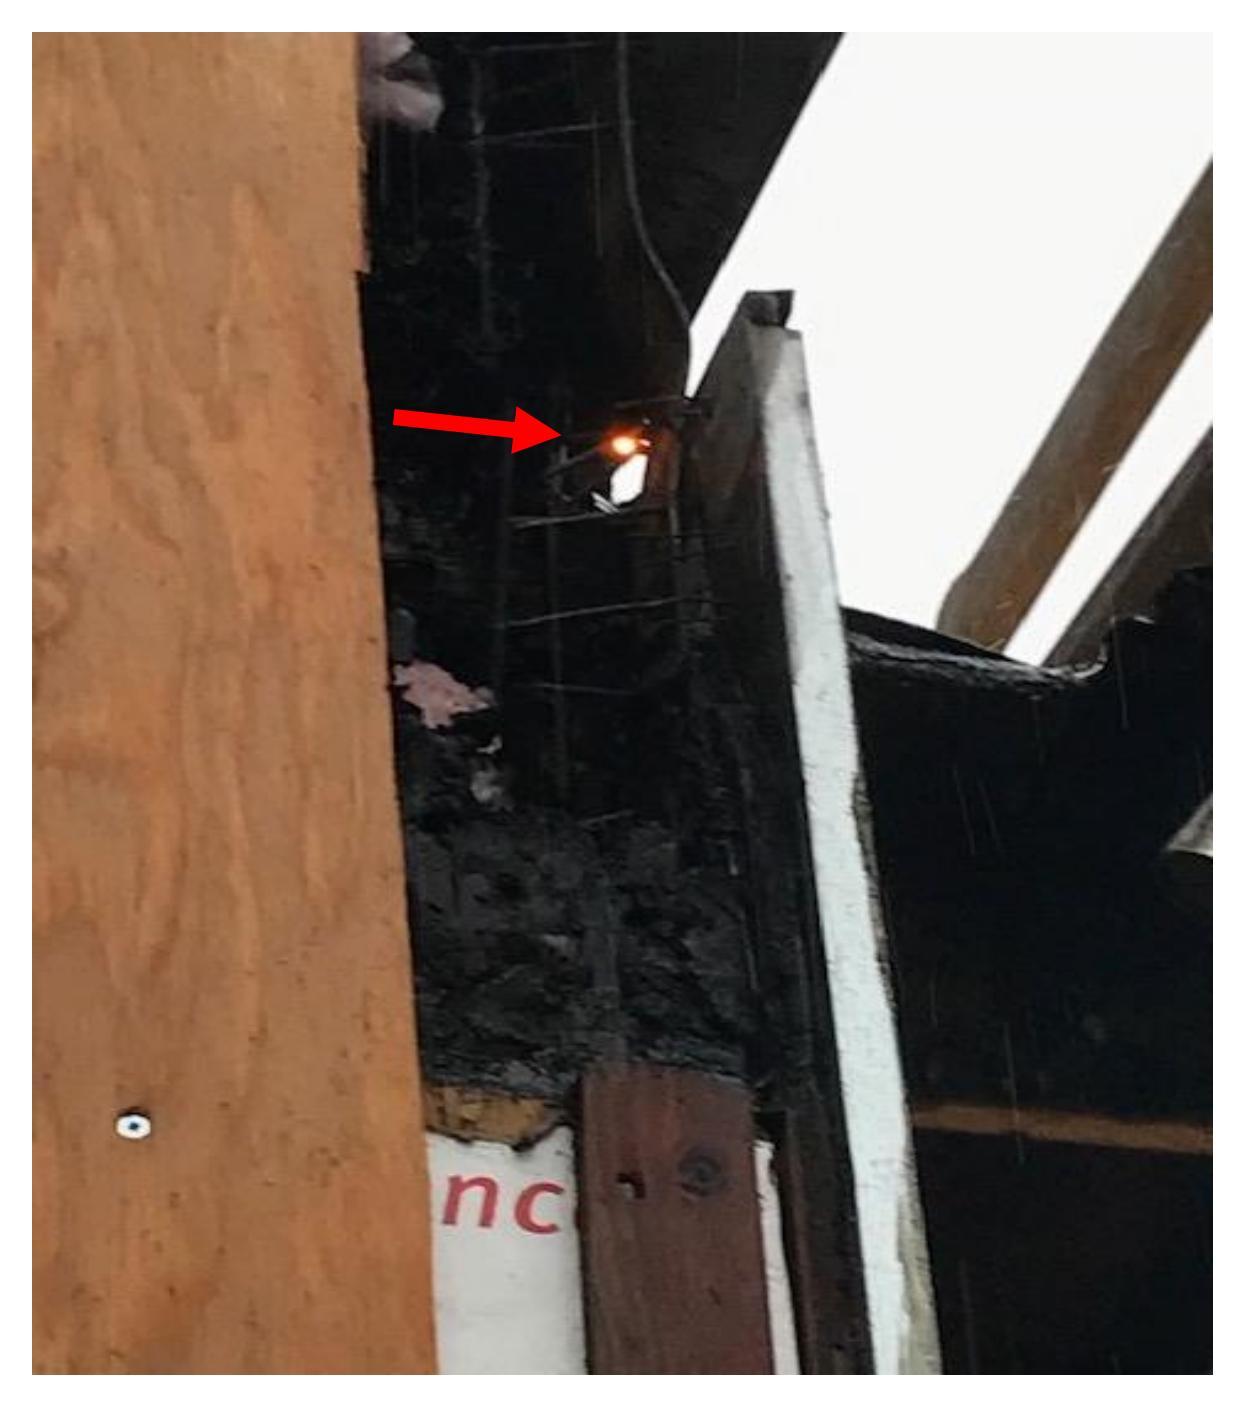
Photo #1 – Red hot nail observed in the area of the fire, after the fire was extinguished.

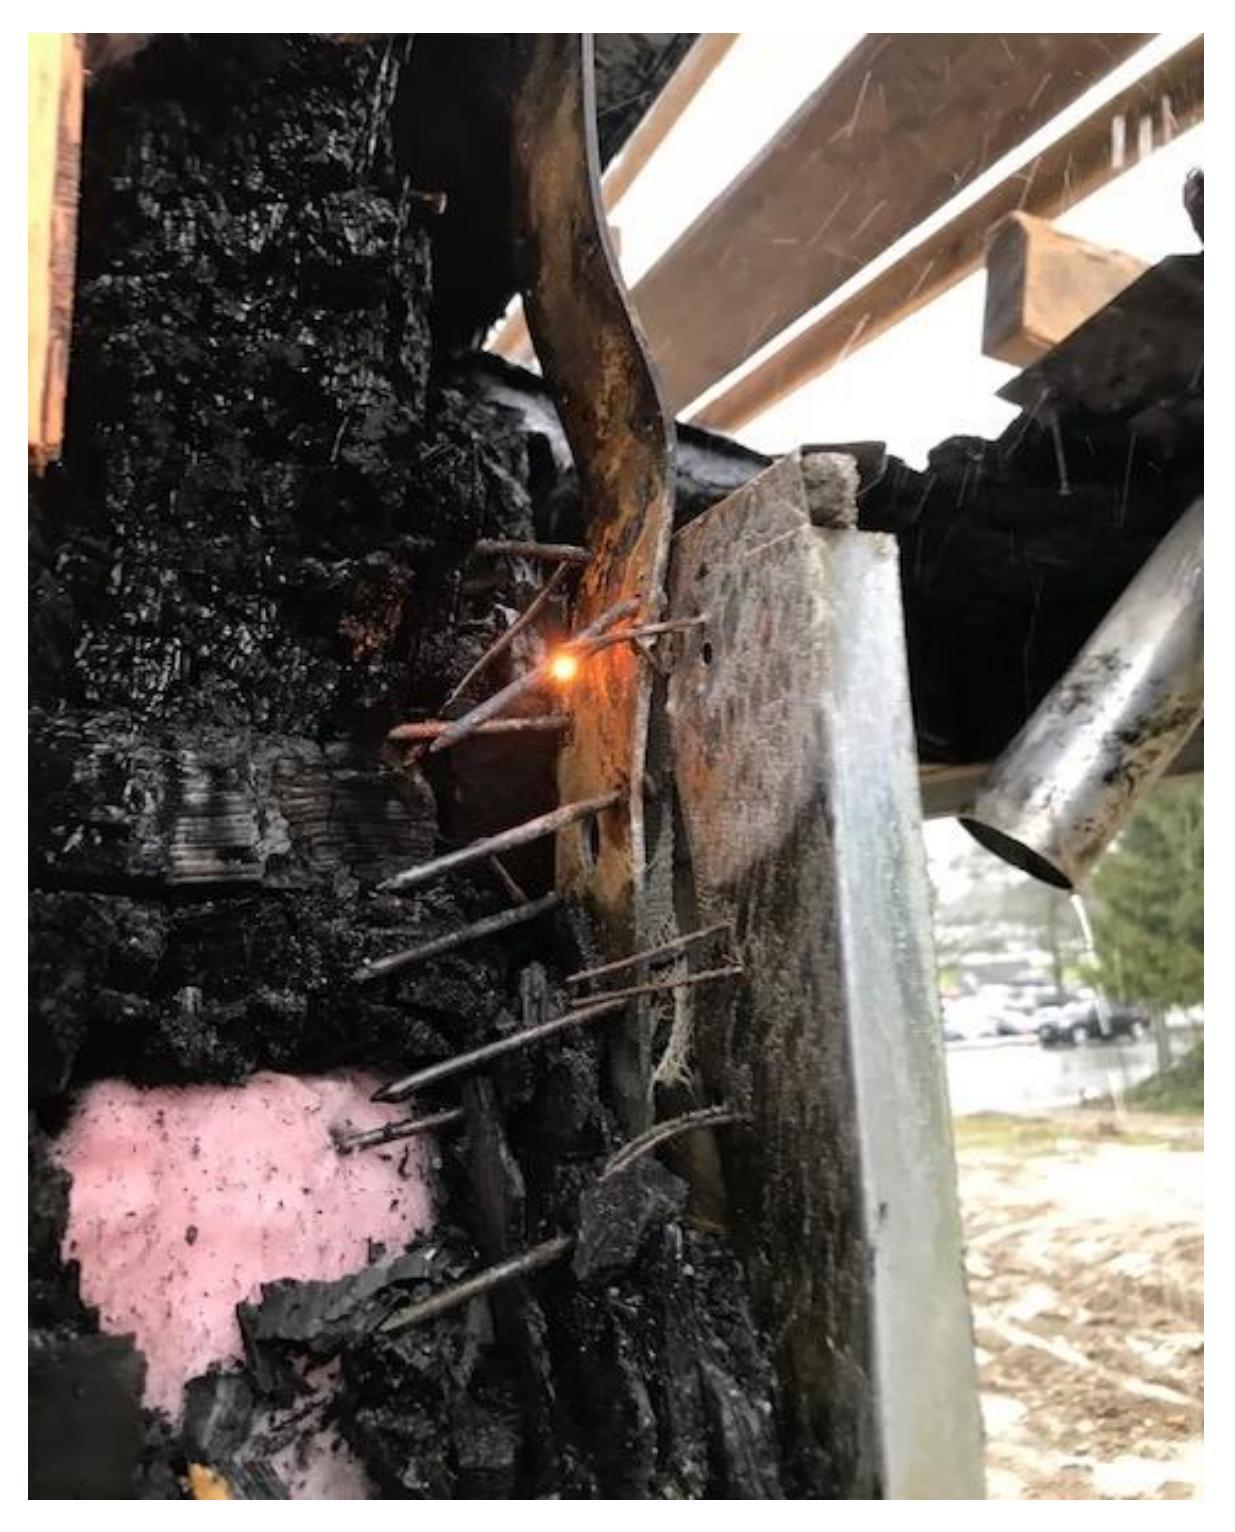
Photo #2 – Close up photo of the red hot nail.

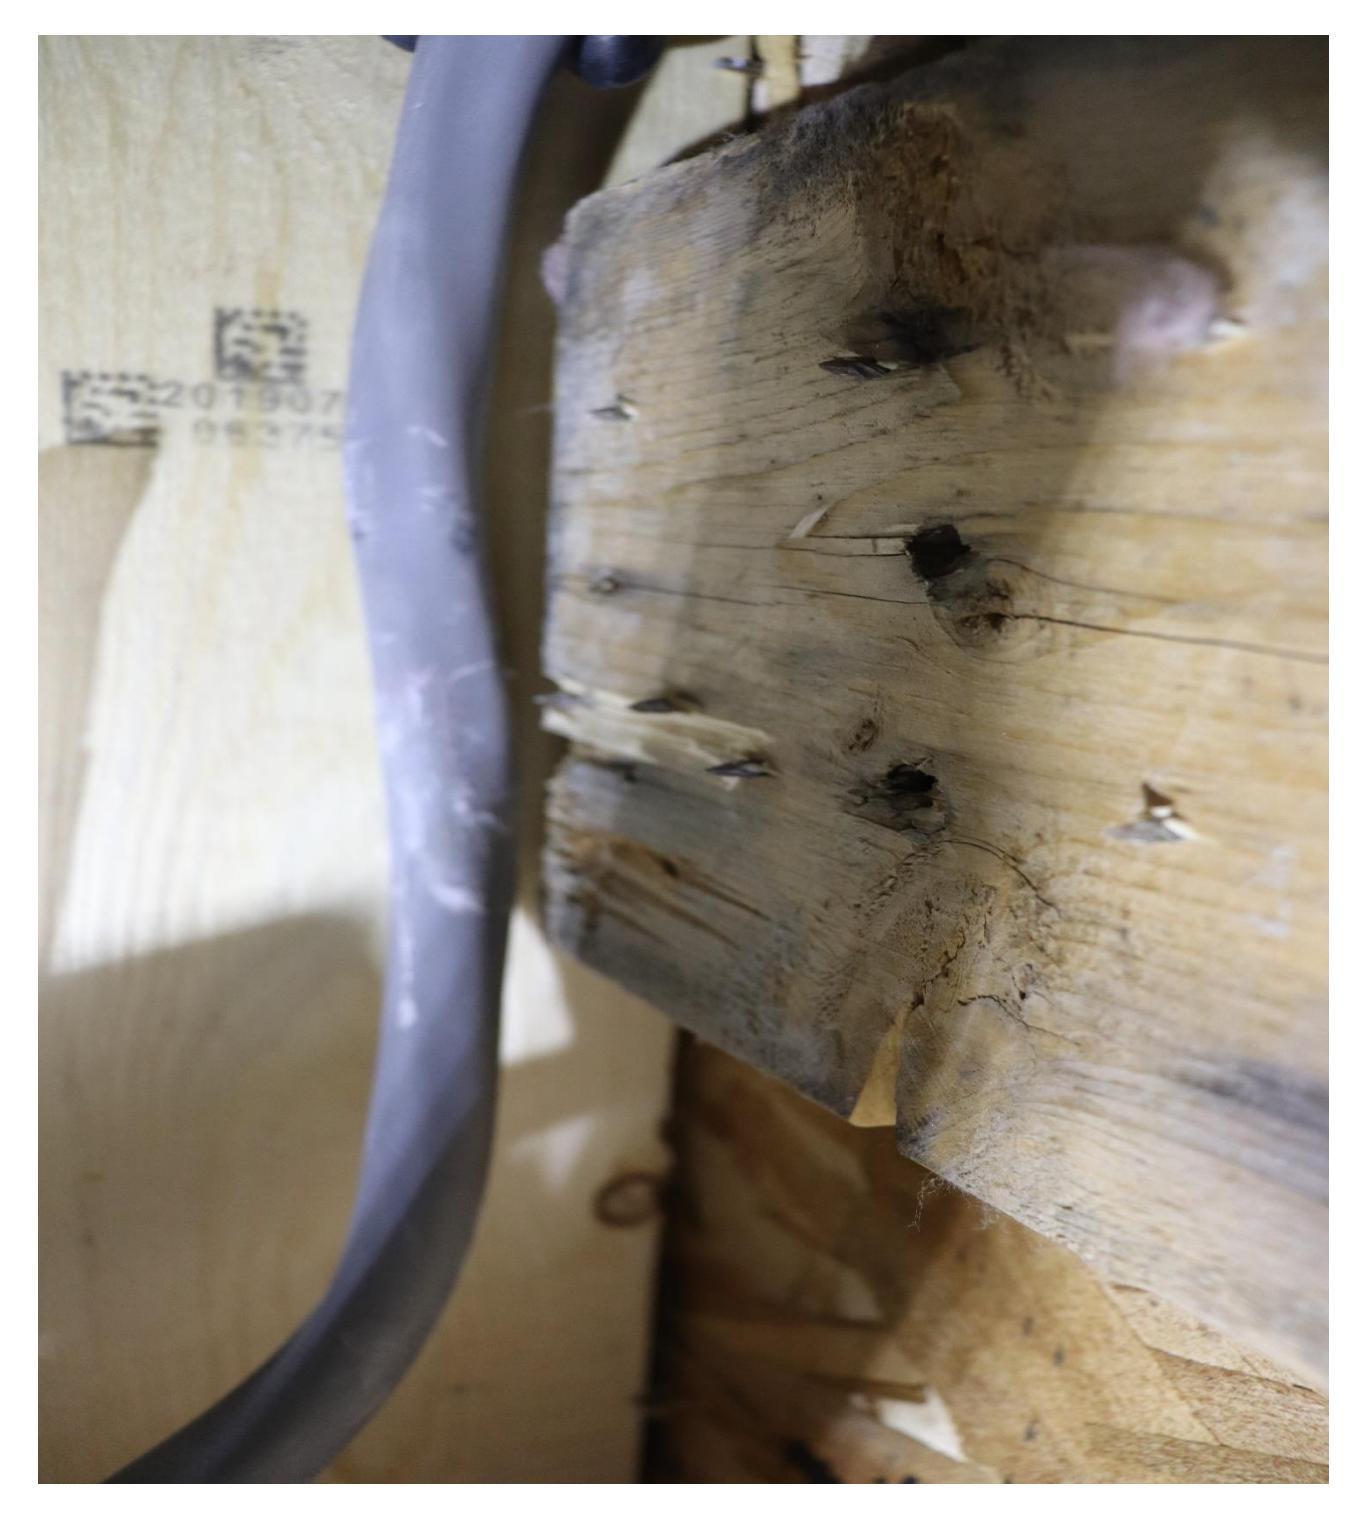
and heating can occur. This arcing and heating can reach temperatures high enough to ignite combustible surfaces
	There is also a potential shock hazard in this scenario from the potential voltage difference between the energized building, earth and other conductive surfaces.
	-After a fire in the south east corner of the building, electrical circuits in the area of the fire were reported to have been disconnected by the electrical contractor and power was restored to the building.
	-When the restoration company began work on the fire damaged south east corner of the building, a red hot nail was observed. (See Picture 1 and 2)
	-A damaged three conductor, aluminum, non-metallic sheathed cable for the range was found on the West side of the building. The cable was reported by the fire investigator to have been close or wedged between the 2x4 vertical framing and a 2x8 horizontal blocking plate. (See Picture 3 and 4)

Photo #3 – Location of the cable inside the kitchen exterior wall that was punctured by the exterior nail.

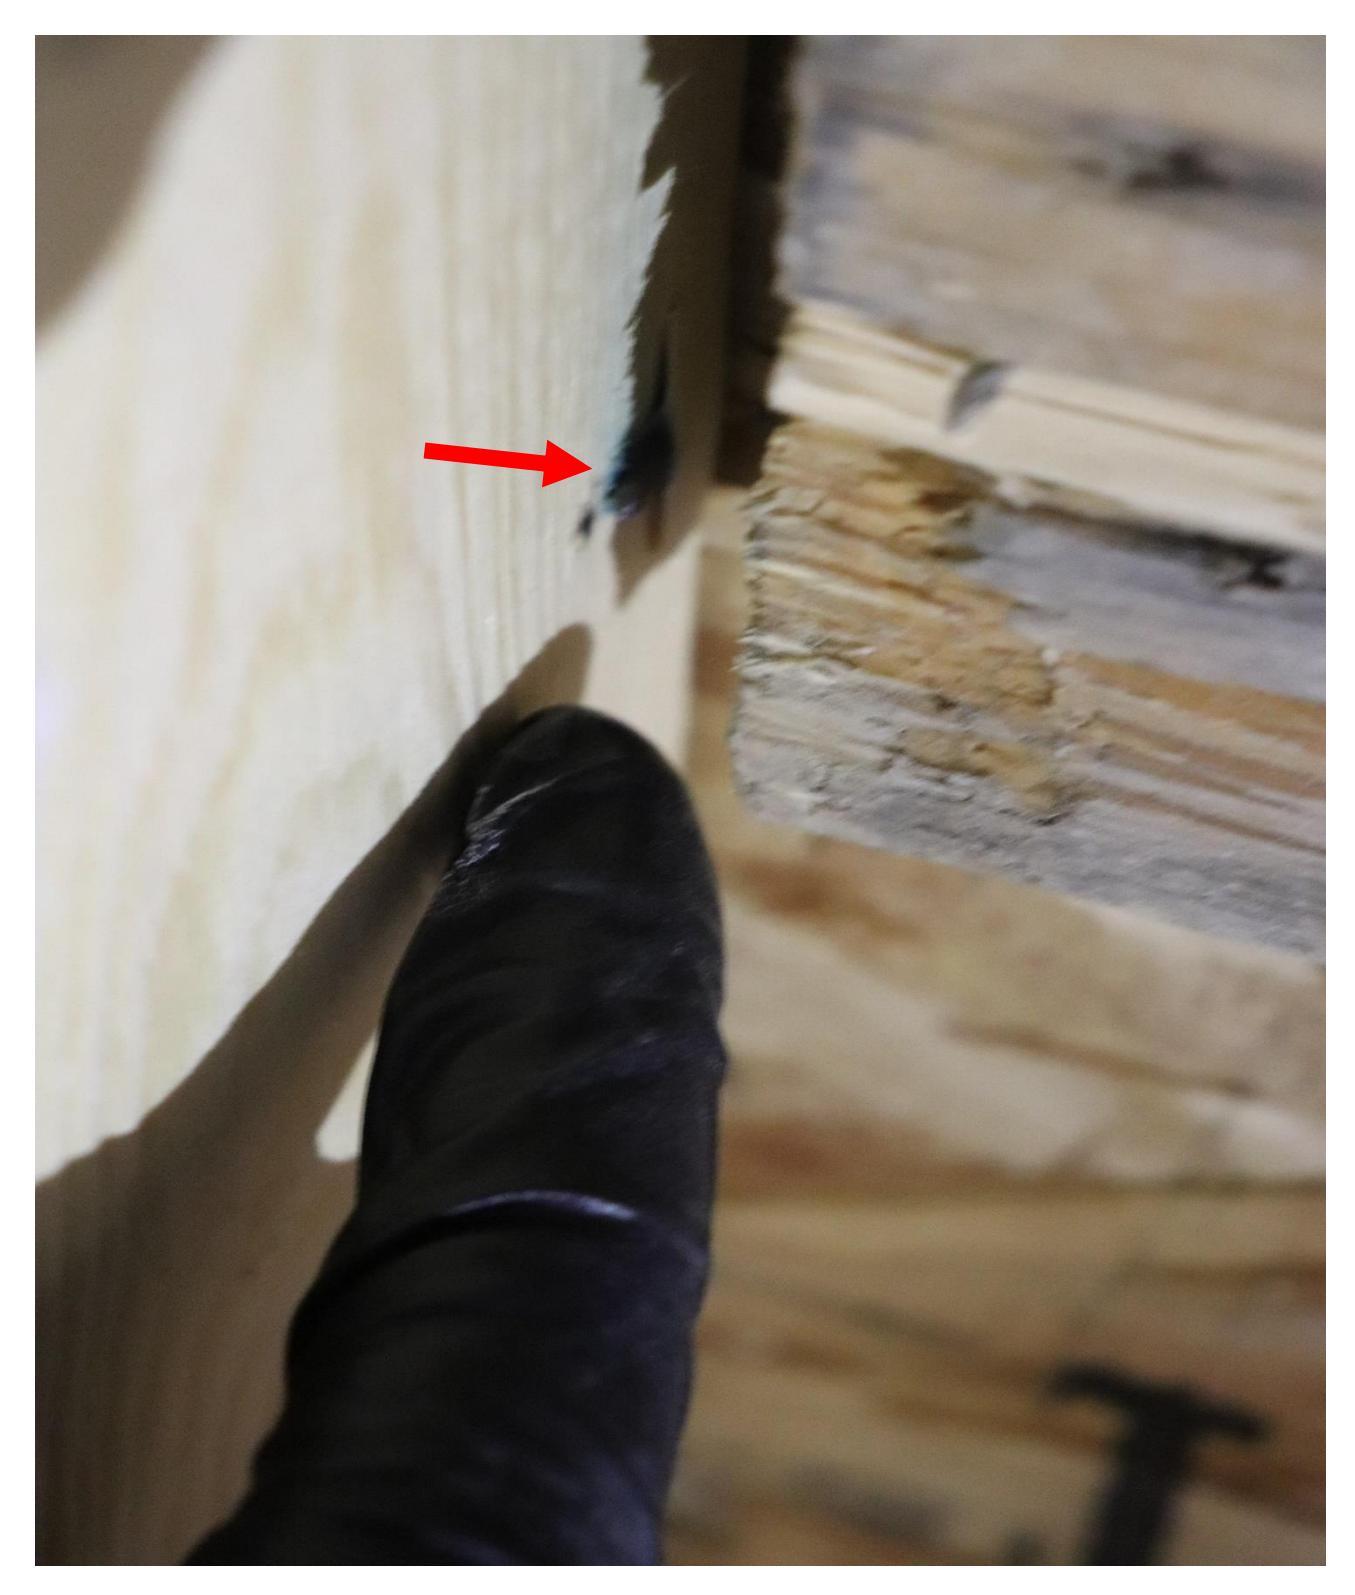
Photo #4 – Photo of the exterior nails coming through in location of where the cable was reported to have been installed / wedged.

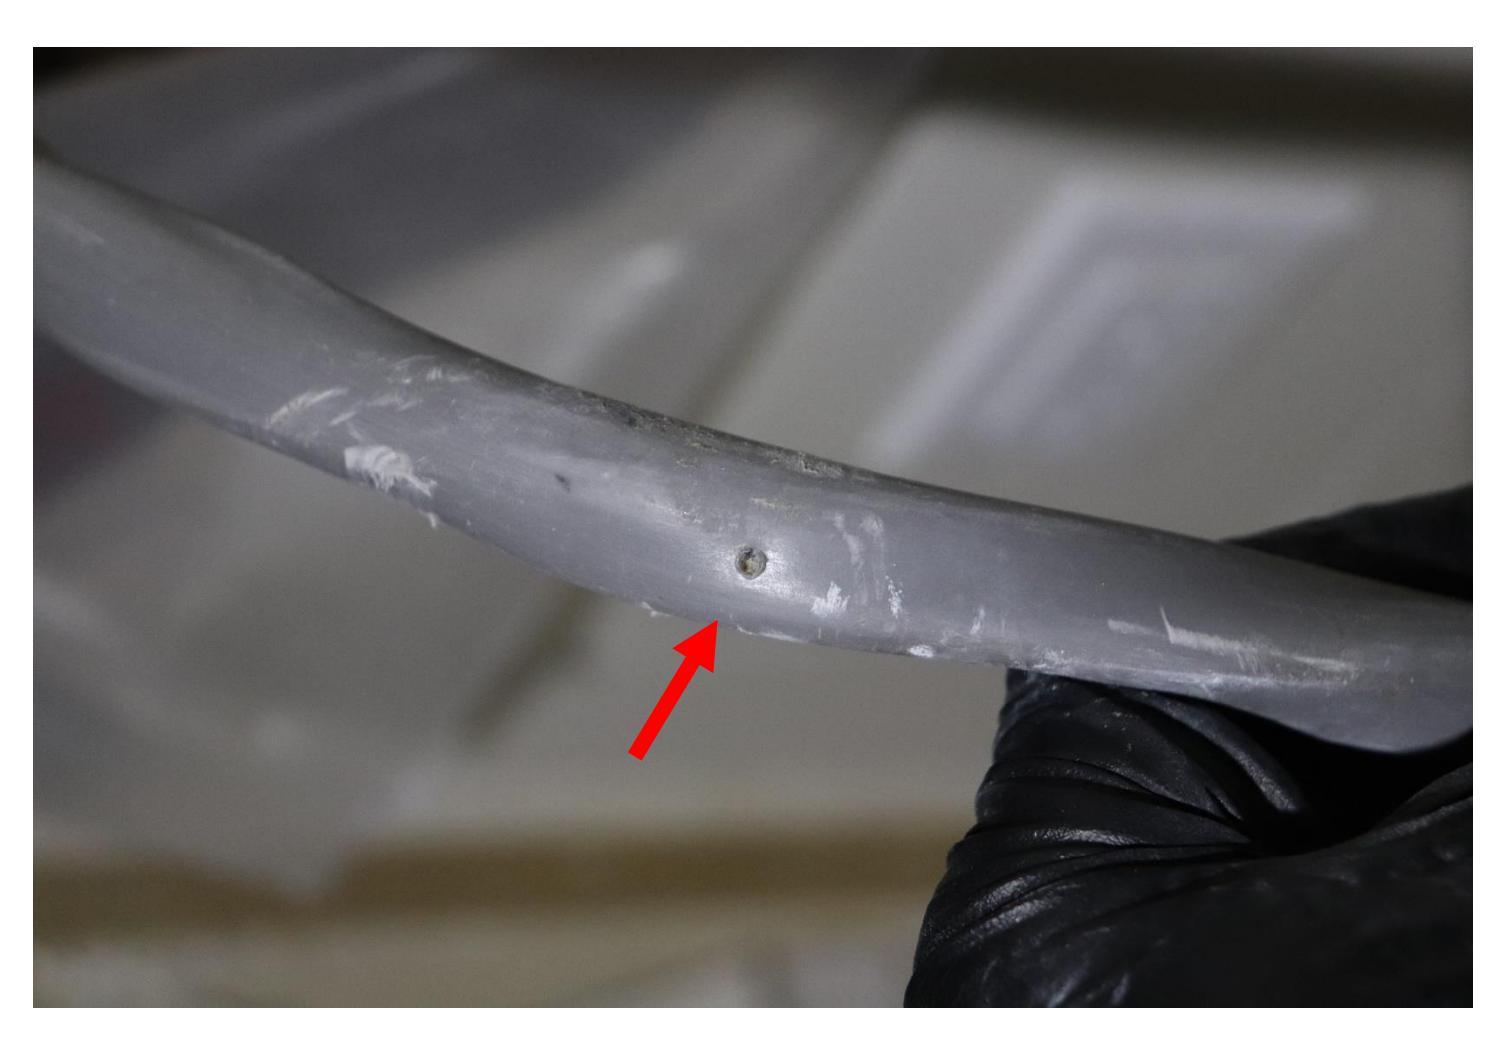
-A nail used to secure the metal stucco meshing to the building exterior was found puncturing the energized branch circuit cable in the kitchen exterior wall cavity on the west side. Found by fire investigator during investigation after the red hot nail was observed by the restoration company. (See Picture 5, 6, 7 and 8)
Facts and evidence	-Electrical contractor who's services were obtained to repair the damage found a voltage differences of 50V +or- between ground and the exterior metal stucco meshing after reports of arcing on the mesh. (See Picture 9 and 10)
	-The overcurrent protection for the damaged branch circuit cable did not operate (2pole 40A circuit breaker) which allowed current to flow. Indicating the path through the conductive building materials was not a low impedance path back to ground.
	-Fire investigator believes the nail located in the south east corner of the building appears to have been energized within that location for approximately two months prior to the fire incident. It would have been a smoldering fire within the structural framing until it consumed sufficient material to ventilate and progress at the exterior of the structure.

Photo #5 – Punctured cable, after the cable was removed from the wall.

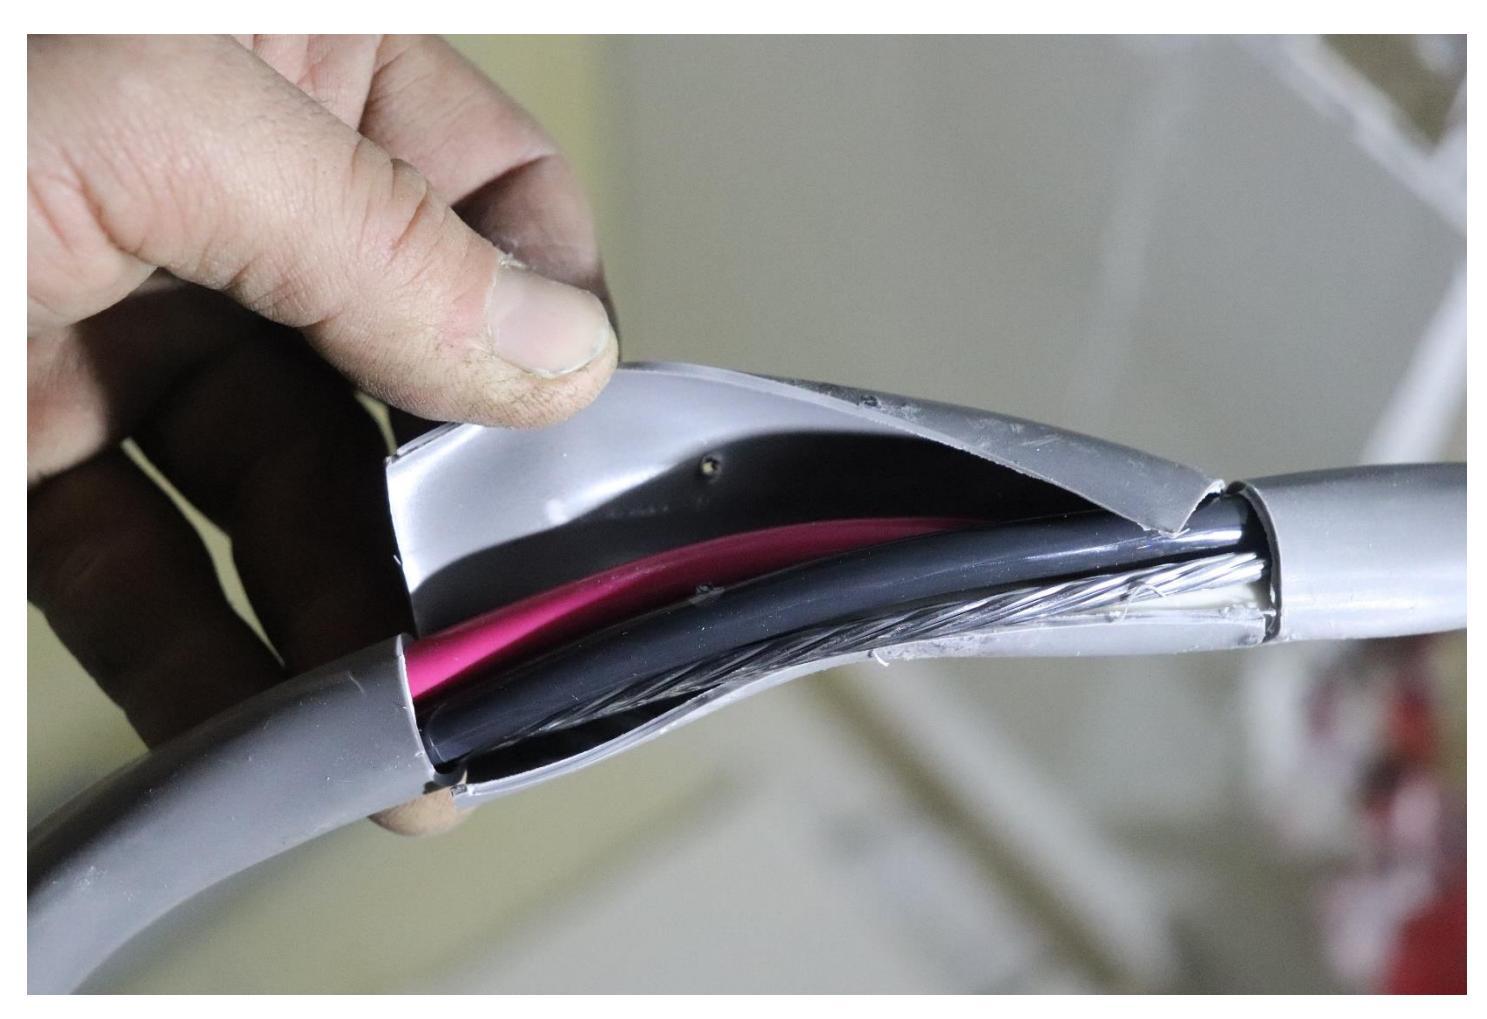
Photo #6 – Damage the nail caused to the ungrounded conductor once the cable jacket was stripped off.

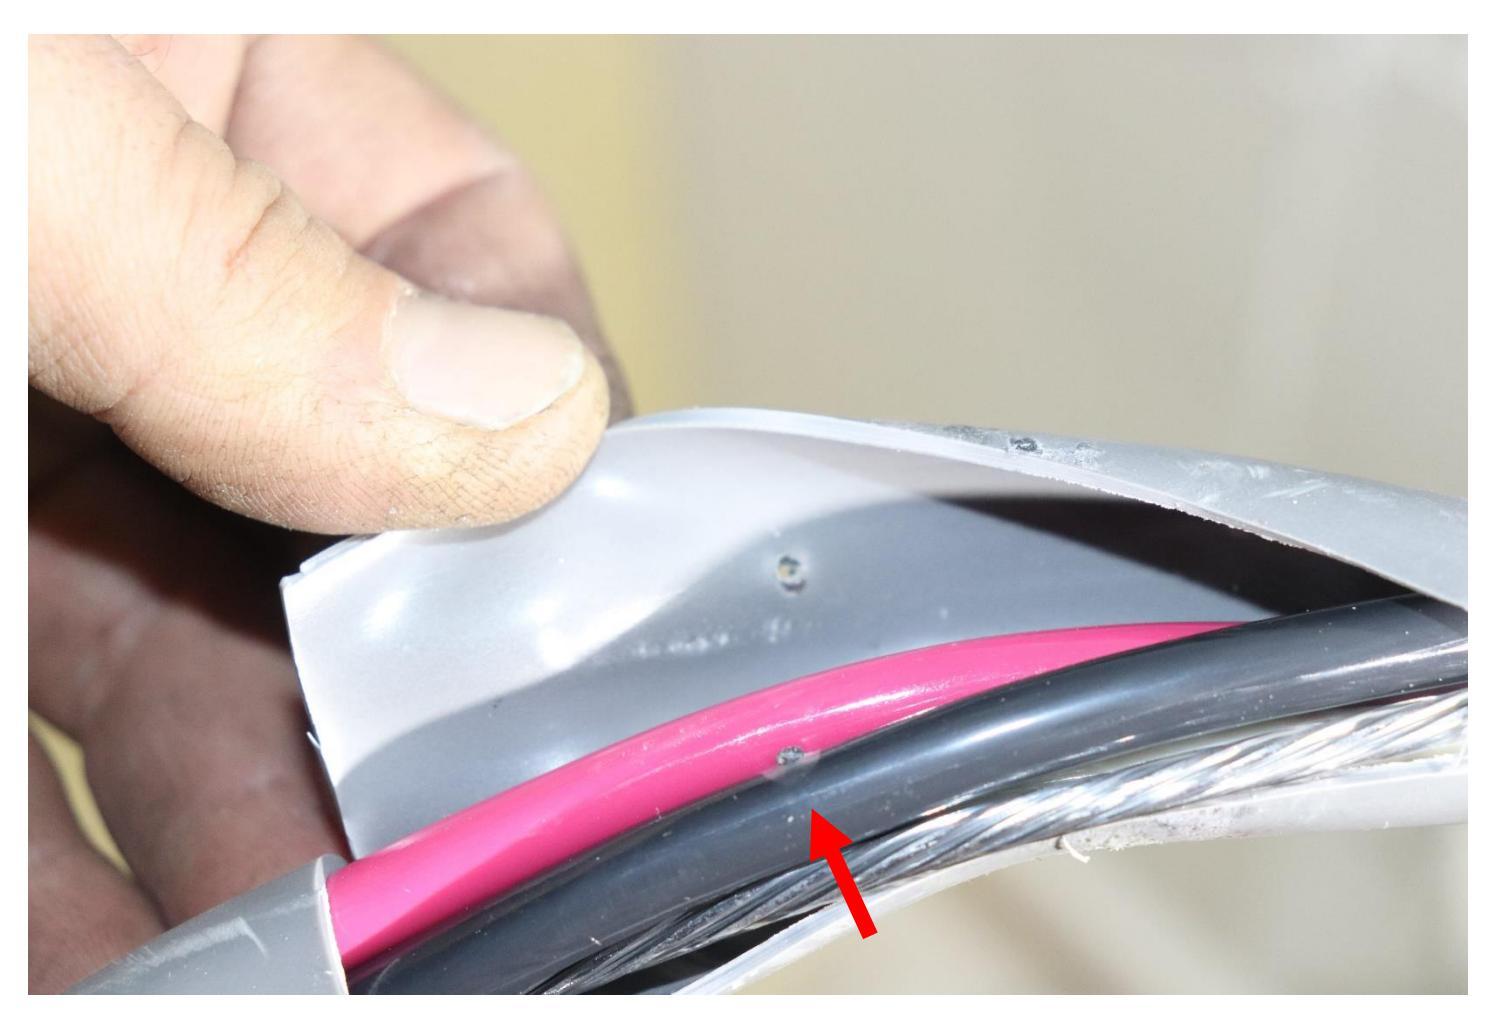
Photo #7 – Close up of the damaged to the cable and ungrounded conductor.

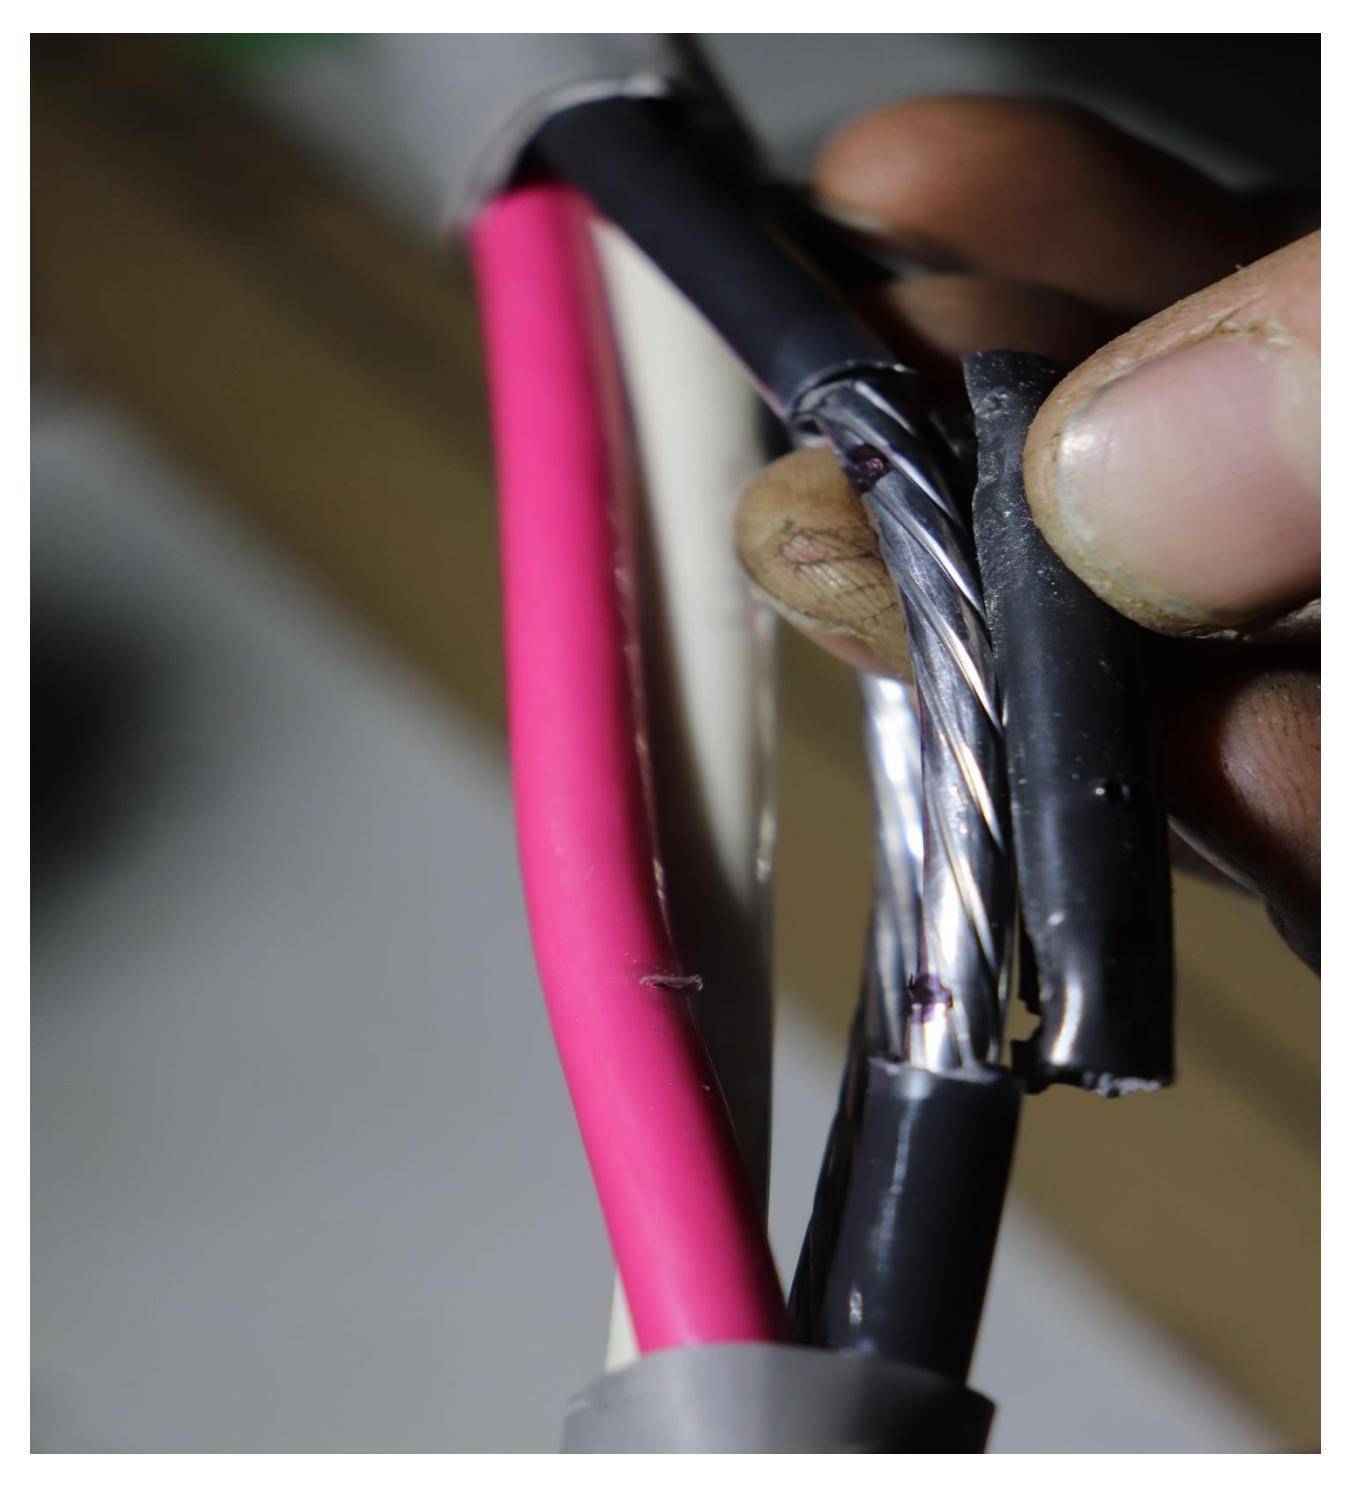
Photo #8 - Damaged to the ungrounded conductor after the conductor insulation was removed

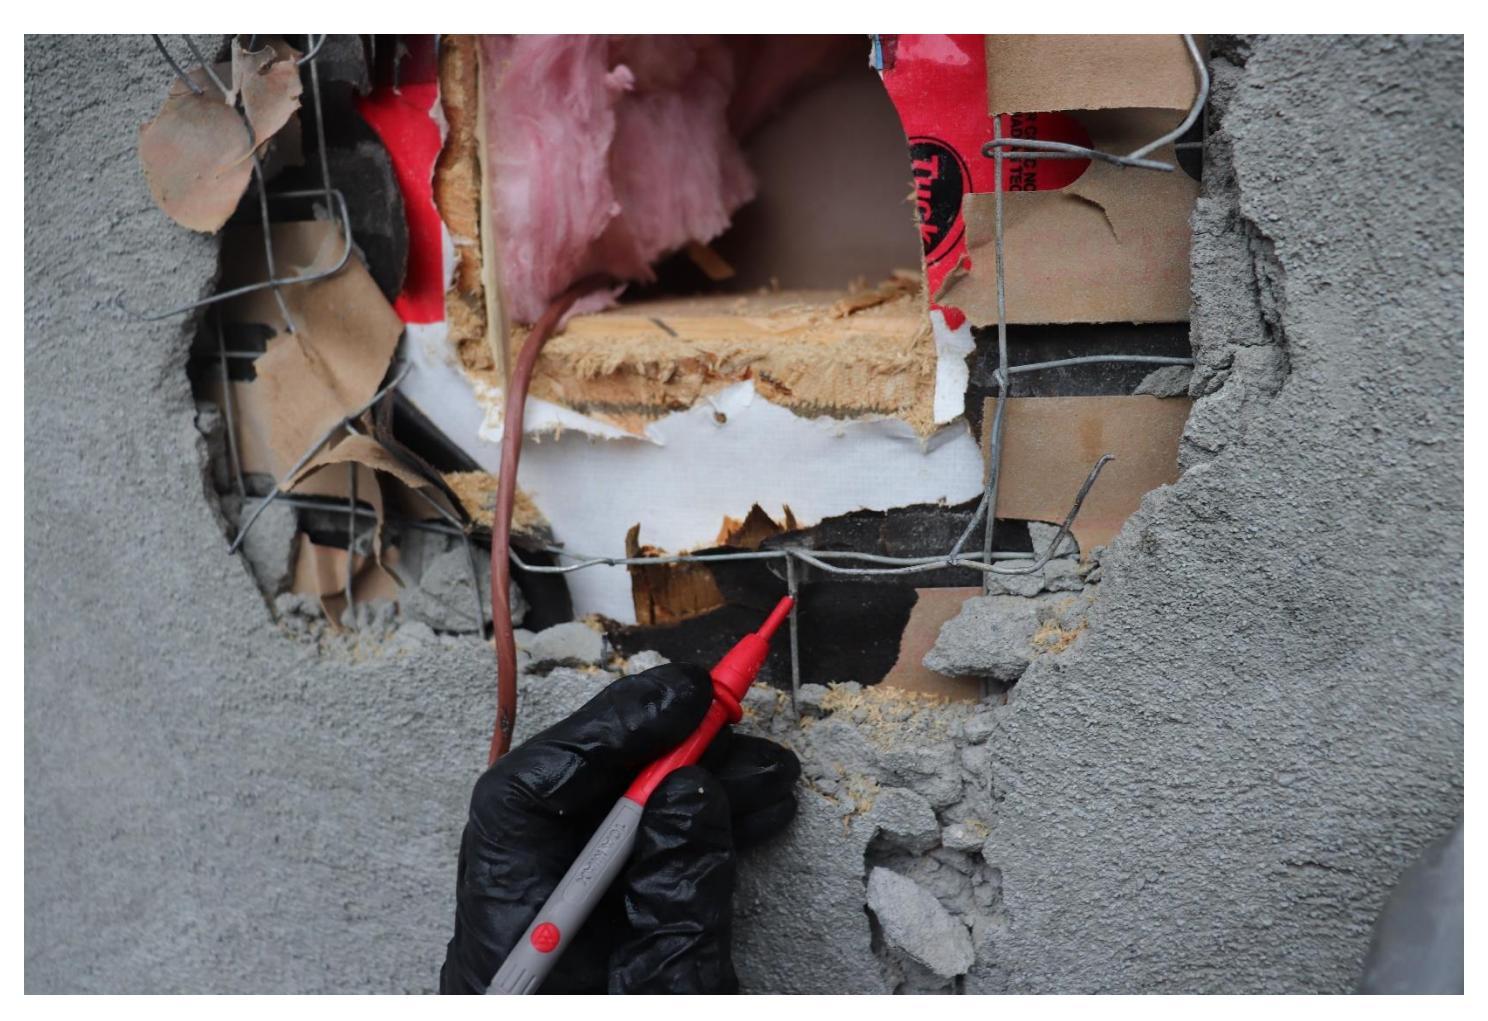
Photo #9-Measuring the voltage of the metal stucco mesh.

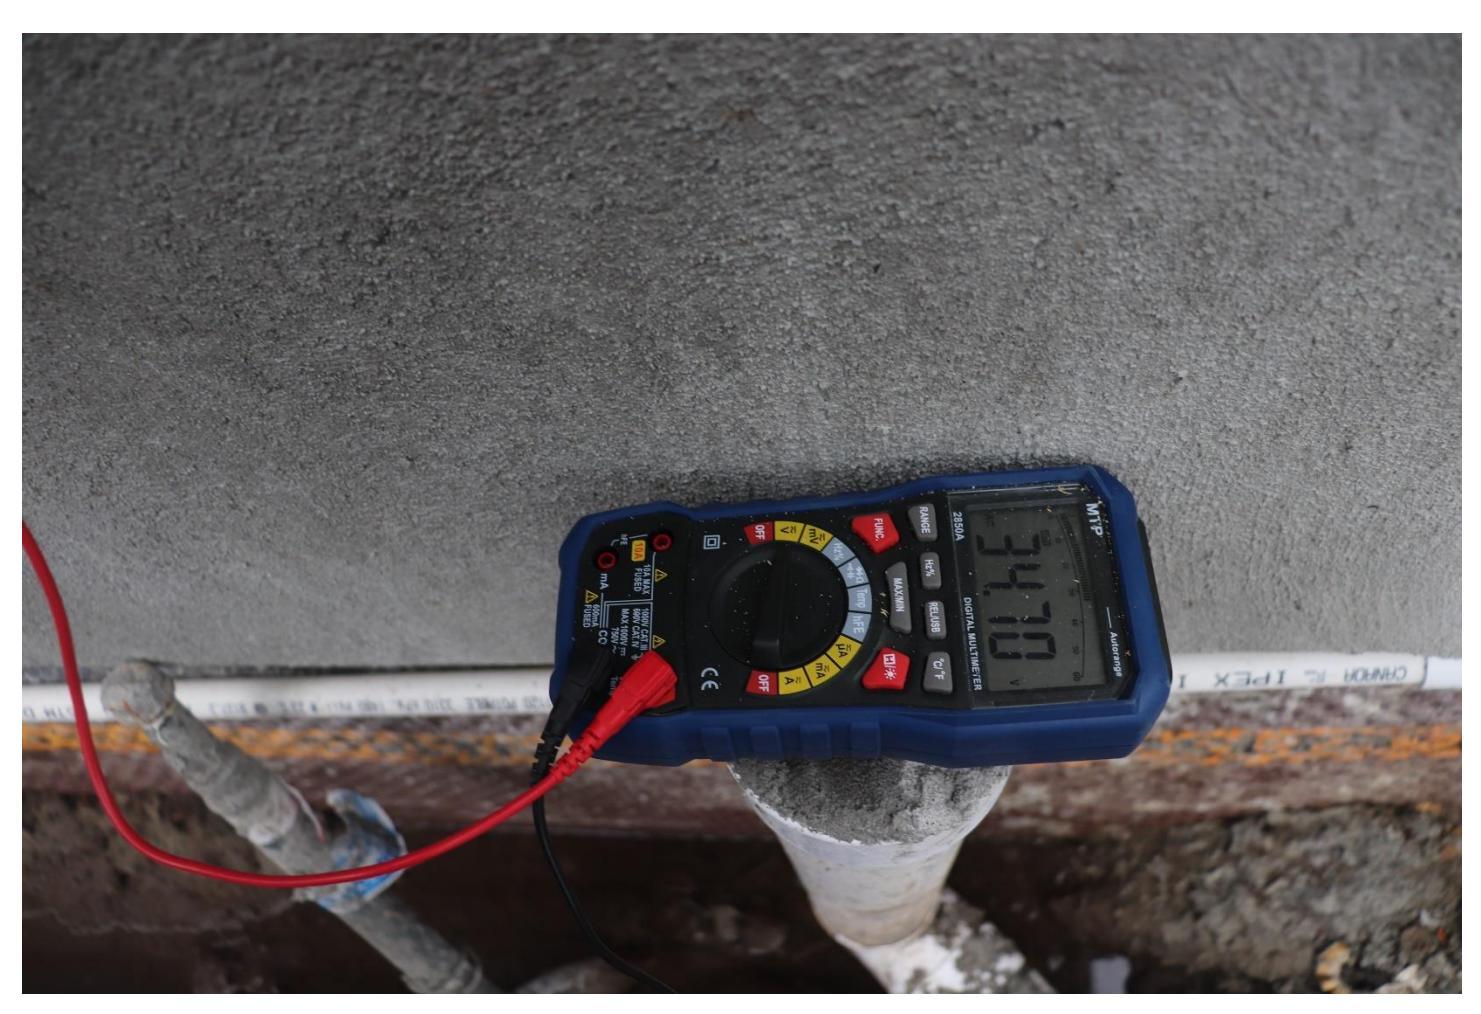
Photo #10 – Multimeter voltage reading of the metal stucco mesh.

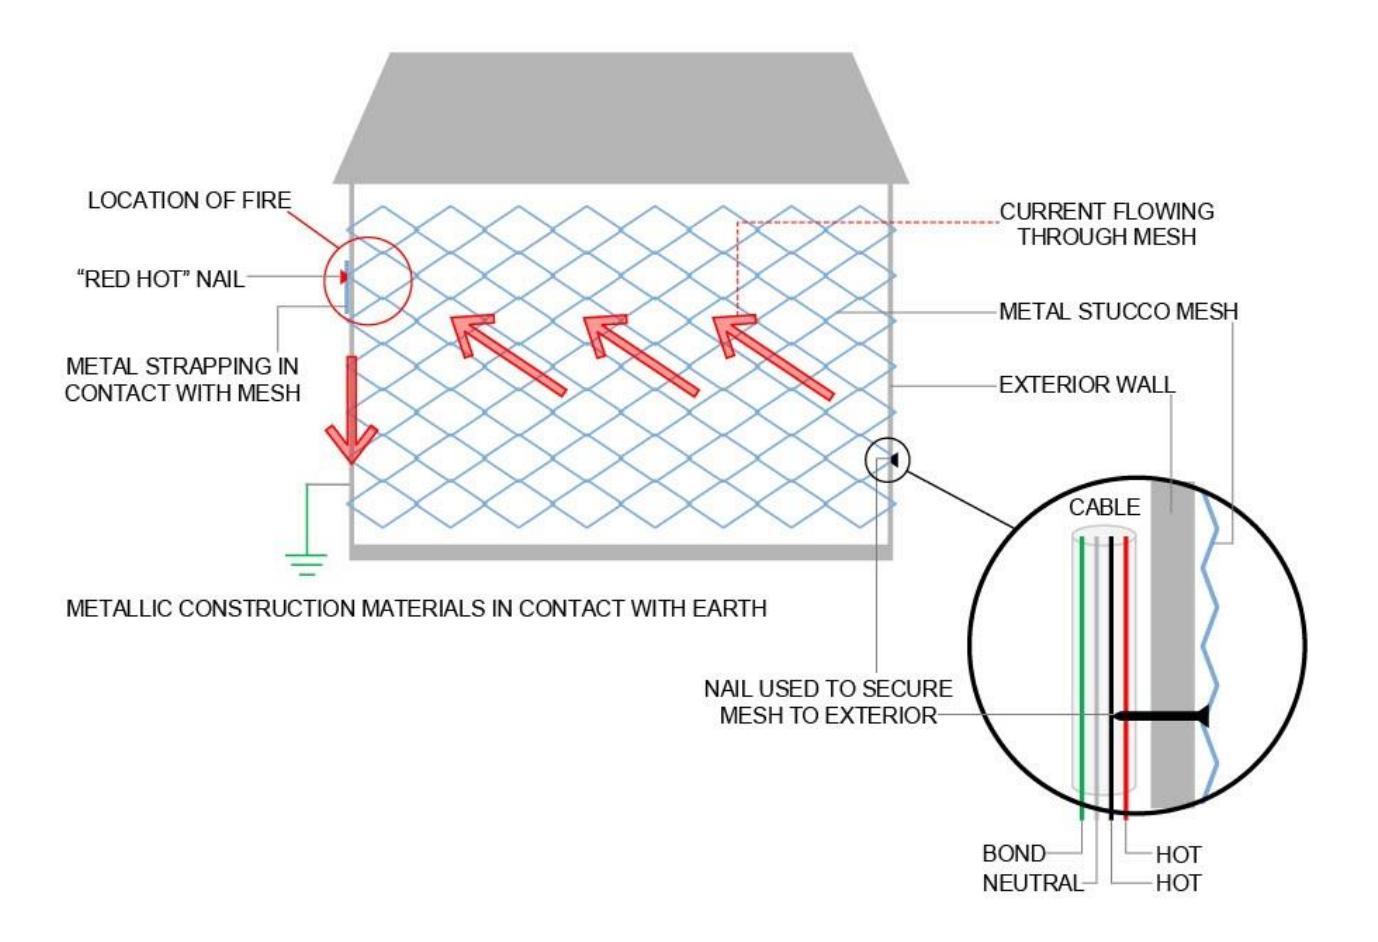
Remote Incident Investigation; Photos were supplied by the fire investigator.
	Diagram #1 not to scale.
Causes and contributing factors	The cause of the fire was likely due to an exterior metal nail puncturing through the exterior building sheathing and into an energized kitchen branch circuit cable that was reported to be installed to close or wedged against the exterior wall without mechanical protection. Unintended current flow through the path created by the metal nail being in contact with the metal stucco meshing and other conductive construction materials likely caused arcing or a high enough temperature to ignite a combustible surface in contact with the conductive construction materials.

Diagram #1 – The drawing is a representation of possible current flow; not to scale.
