SUPPORTING INFORMATION	Incident Date			February 21, 2023
	Location Regulated industry sector			Sun Peaks
				Electrical - High voltage electrical system (greater than 750V)
	Impact		Qty injuries	0
		Injury	Injury description	N/A
			Injury rating	None
		mage	Damage description	High voltage transformer damaged by snow grooming machine, limiting chairlift operational time by nearly a week.
		Da	Damage rating	Moderate
	Incident rating			Moderate
	Incident overview			While a snow grooming operator was clearing a recent snow fall at the base of a ski hill chairlift, a high voltage 25KV (25,000 volt) pad mount oil filed transformer was struck by a snow grooming machine, inflicting damage to the high and low voltage components of the transformer, releasing a portion of the oil filled component.
INVESTIGATION CONCLUSIONS	Site, system and components		stem and nents	 Site and Facility The ski hill has 13 lifts, including 3 high speed quad chairlifts, 4 quad chairlifts, and 6 surface lifts. Providing 138 trails, including 19 glade areas offering 4270 acres of terrain. To operate the ski hills electrical system, differing voltages may be required per the equipment employed. As many voltages may

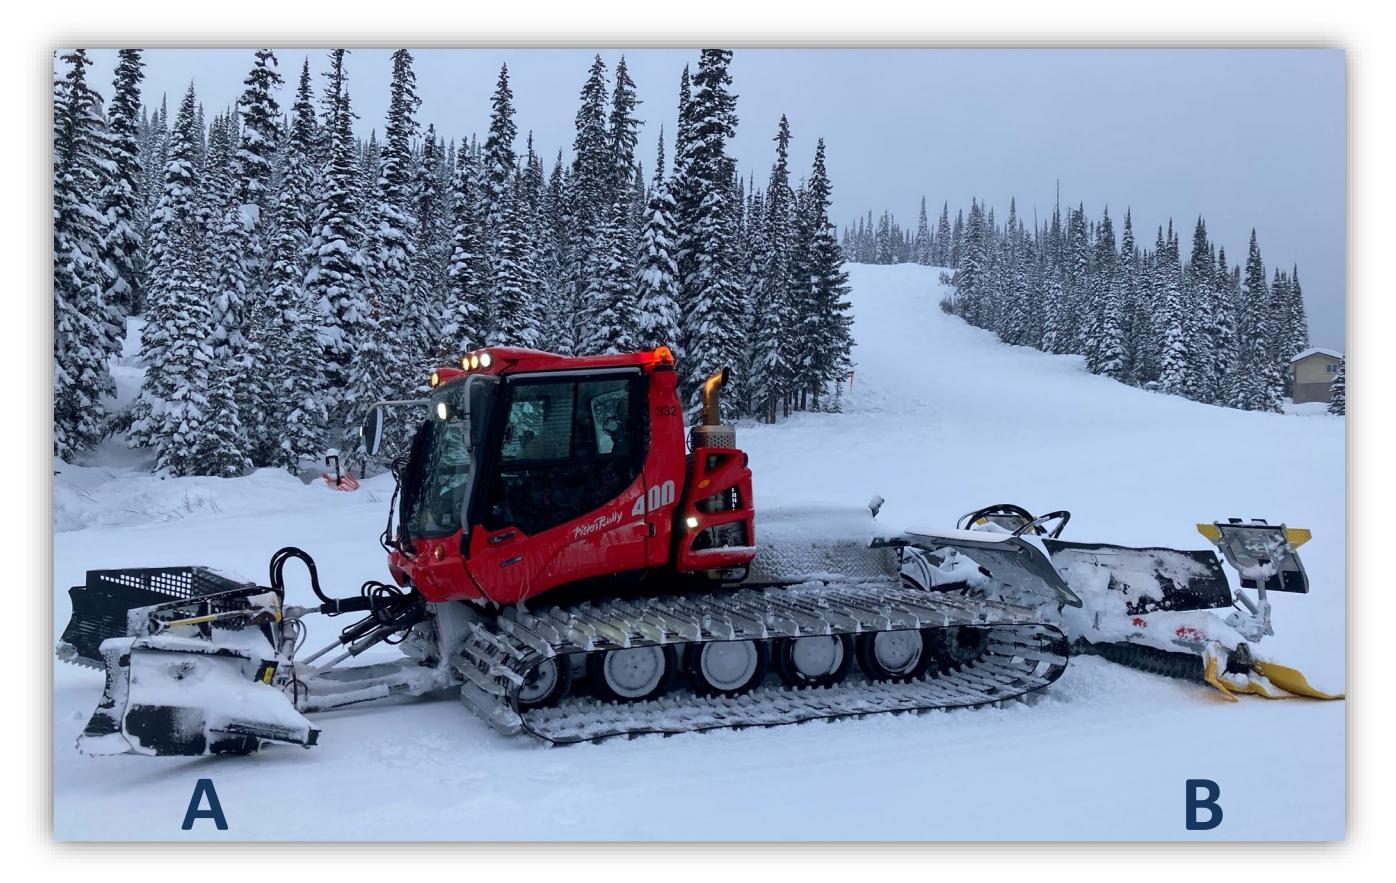
Image 1 – Nordic groomer, front blade (A) and back pans (B).

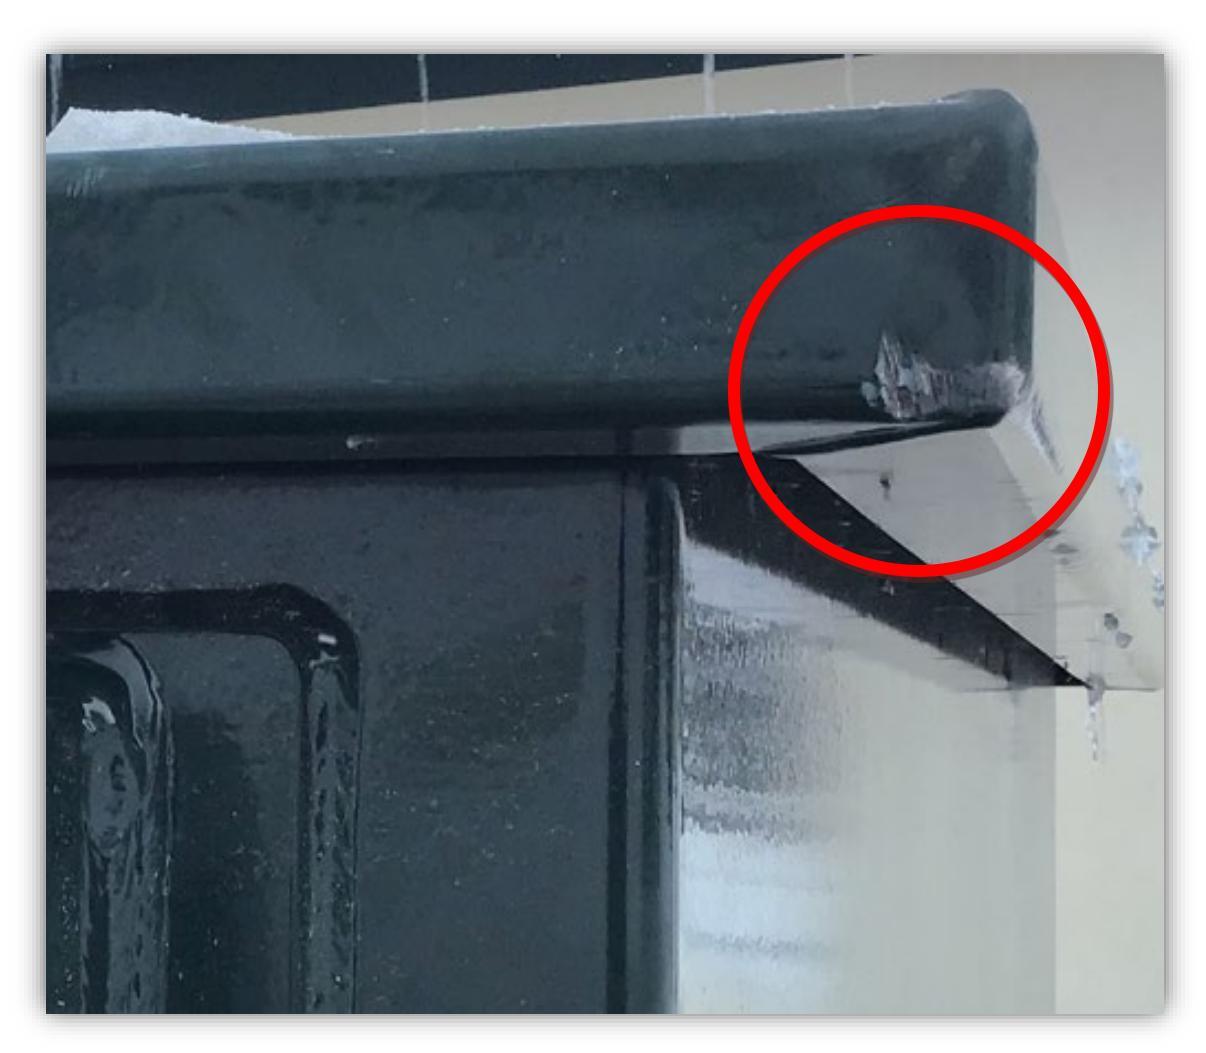
Attending Ski hill Site Personnel and Electricians Statements A snow grooming machine bumped the 150KVA high voltage transformer located at the base of the ski hill chairlift, damaging numerous components of the transformer. The snow grooming machine contacted the upper right side of the transformer, causing it to shift nearly 12 inches on its concrete pad.
	 The high voltage transformer was de-energized to allow for the required field repairs. The transformer leaked a portion of its oil component, environmental assessment and clean-up will be required.

Image 2 – Damage to upper right corner of the transformer where the snow groomer made contact.

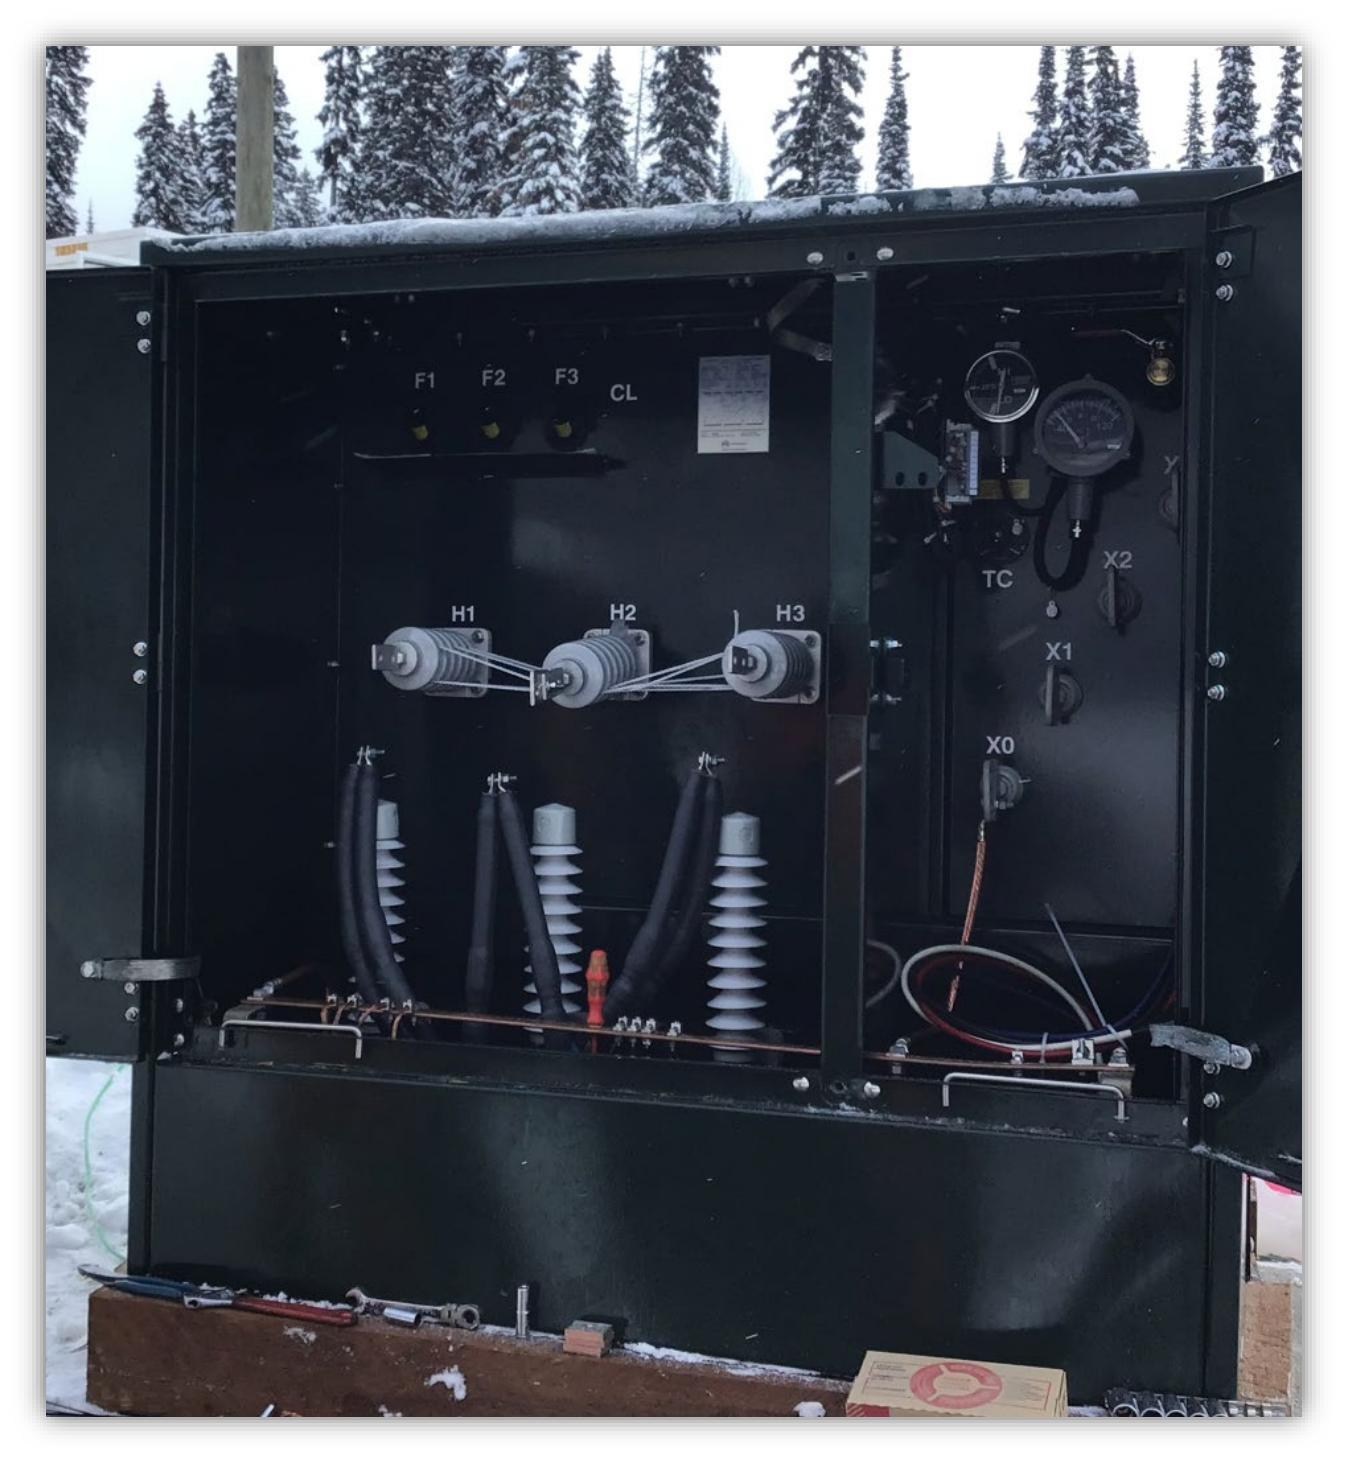
shifted nearly 12 inches on the concrete pad. This movement inflicted moderate damage to the internal components, later rendering the transformer inoperable. The primary damage occurred on the high voltage H2 connection point, damaging the bushing, allowing oil to leak from the transformer. Additional damage was also observed on the exterior of the transformer and the jacket / armour of the secondary low voltage cable supplying power to the chairlift building.
	Electrical component observations
Facts and evidence	 Transformer Damage Visible damage was present on the upper righthand corner where the grooming machine contacted the transformer (<u>Image 2</u>). Visible damage was present on the lower front compartment which provides access to the primary and secondary cables (<u>Image 3</u>). The high voltage H2 cable termination point was damaged (<u>Image 4</u>). The outer jacket and armour of the 600-Volt secondary cable was damaged during the shifting of the transformer (<u>Image 5</u>). Leakage of transformer insulating and cooling oil (<u>Image 6</u> and <u>Image 7</u>). Equipment Protection Flagging and/or mechanical protection was not provided around the high voltage transformer to limit access around the equipment.

Image 3 – The H2 connection point has been pulled down from force.

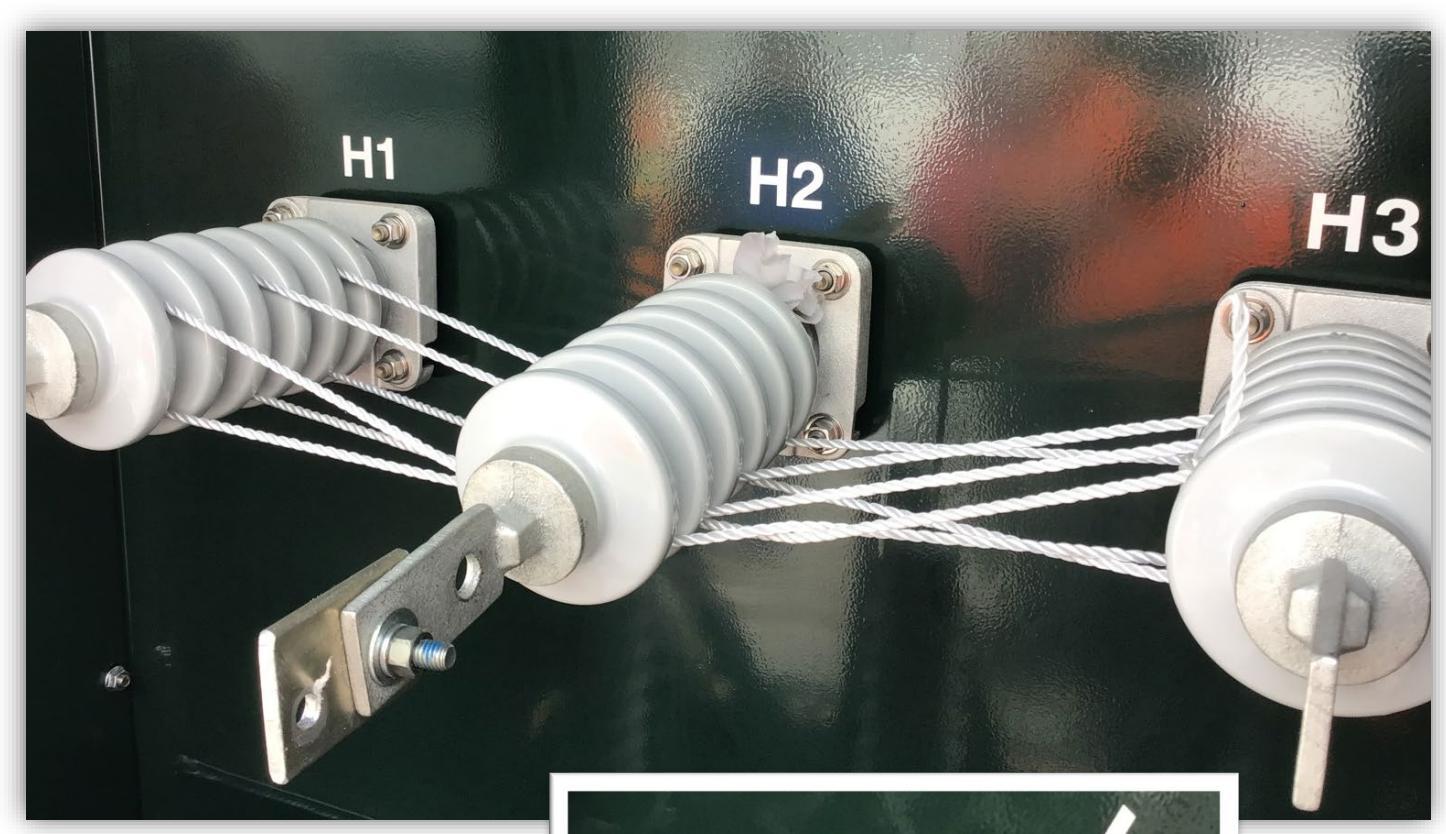
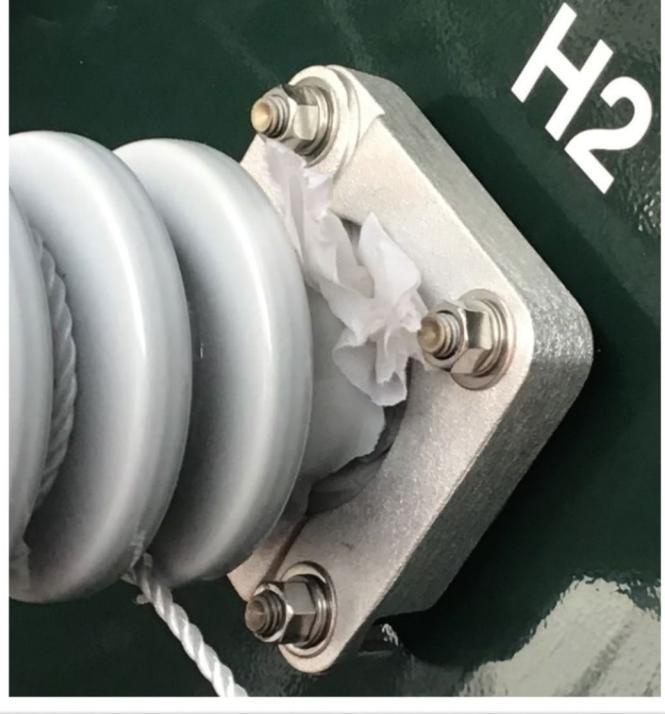
Image 4 – Internal H2 bushing damage.

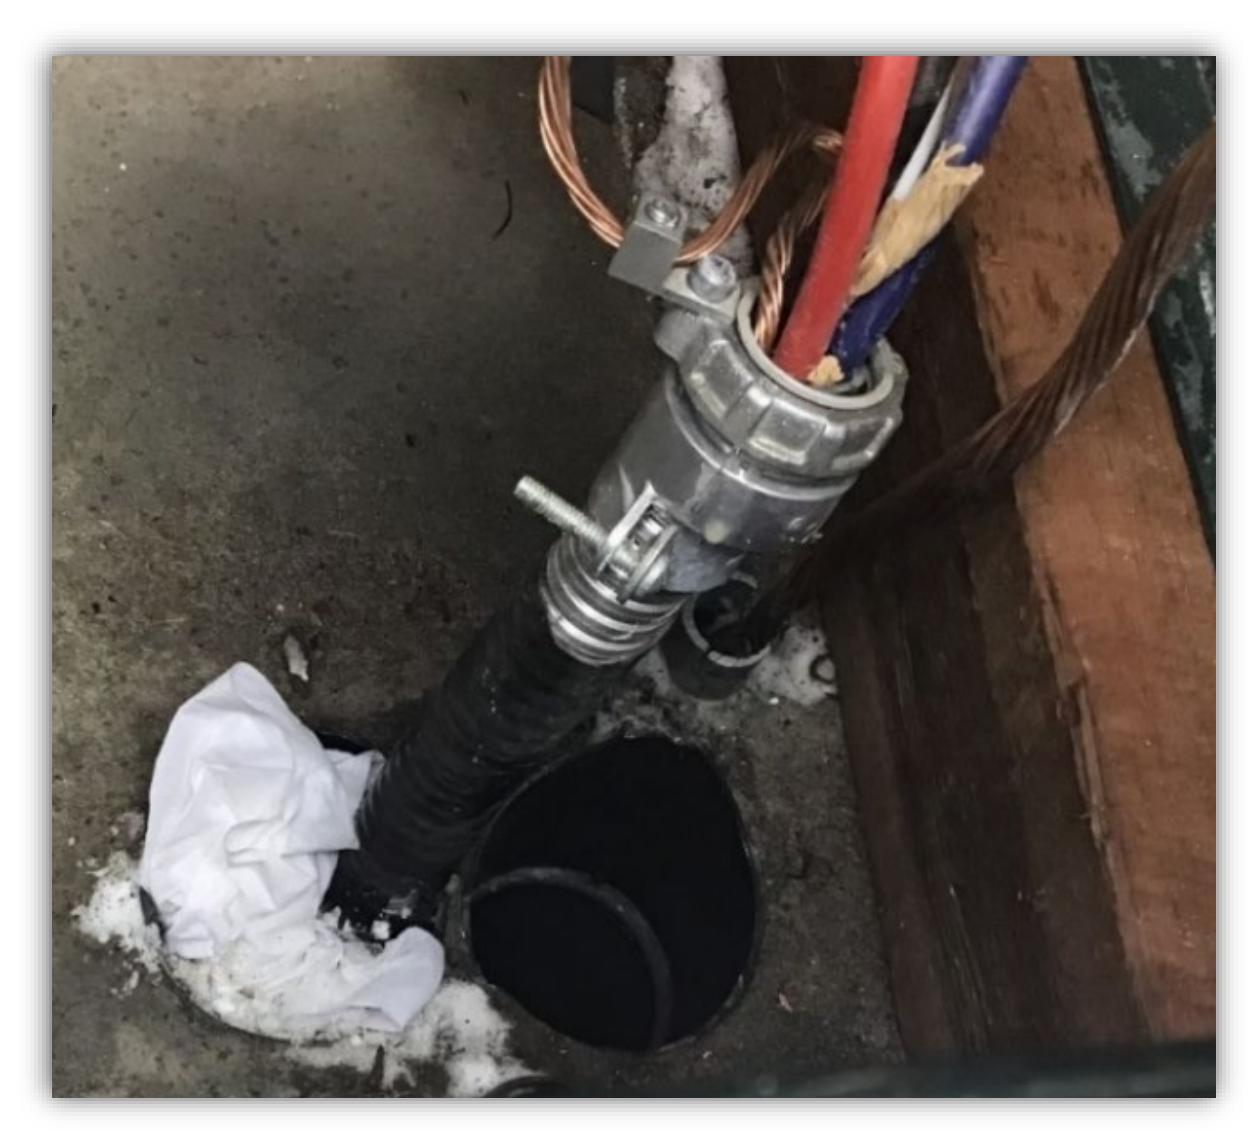
Image 5 – External damage to the secondary cable assembly.

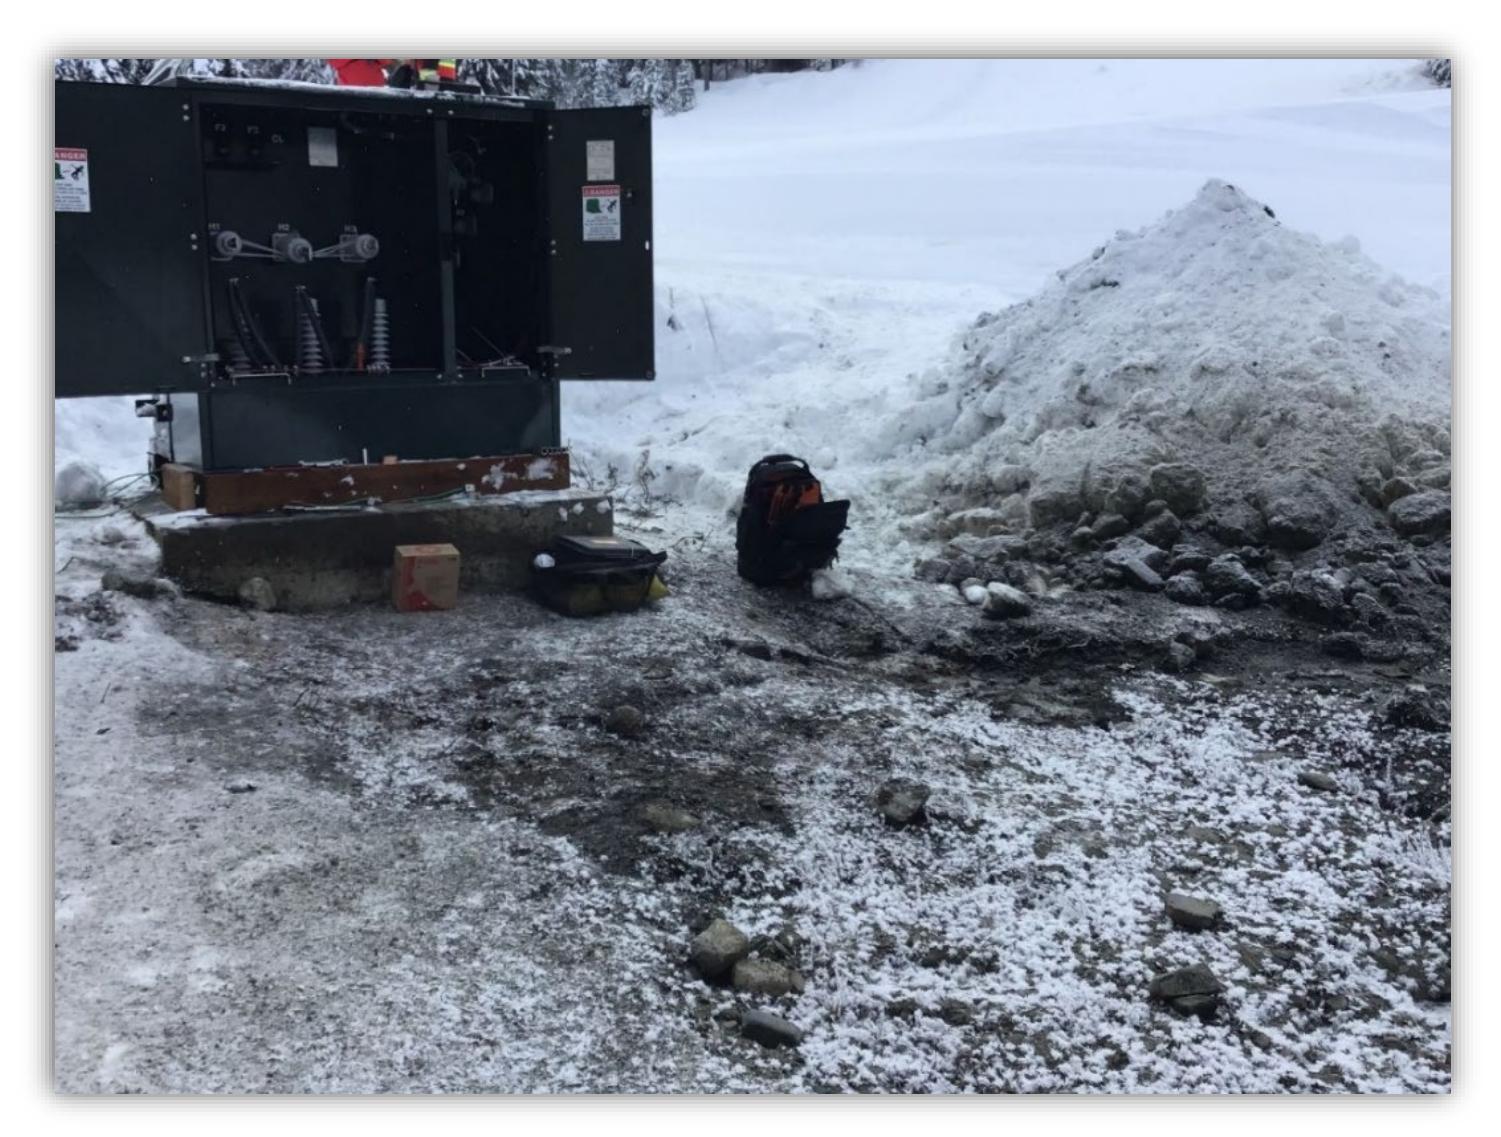
Image 6 – Transformer oil leakage.

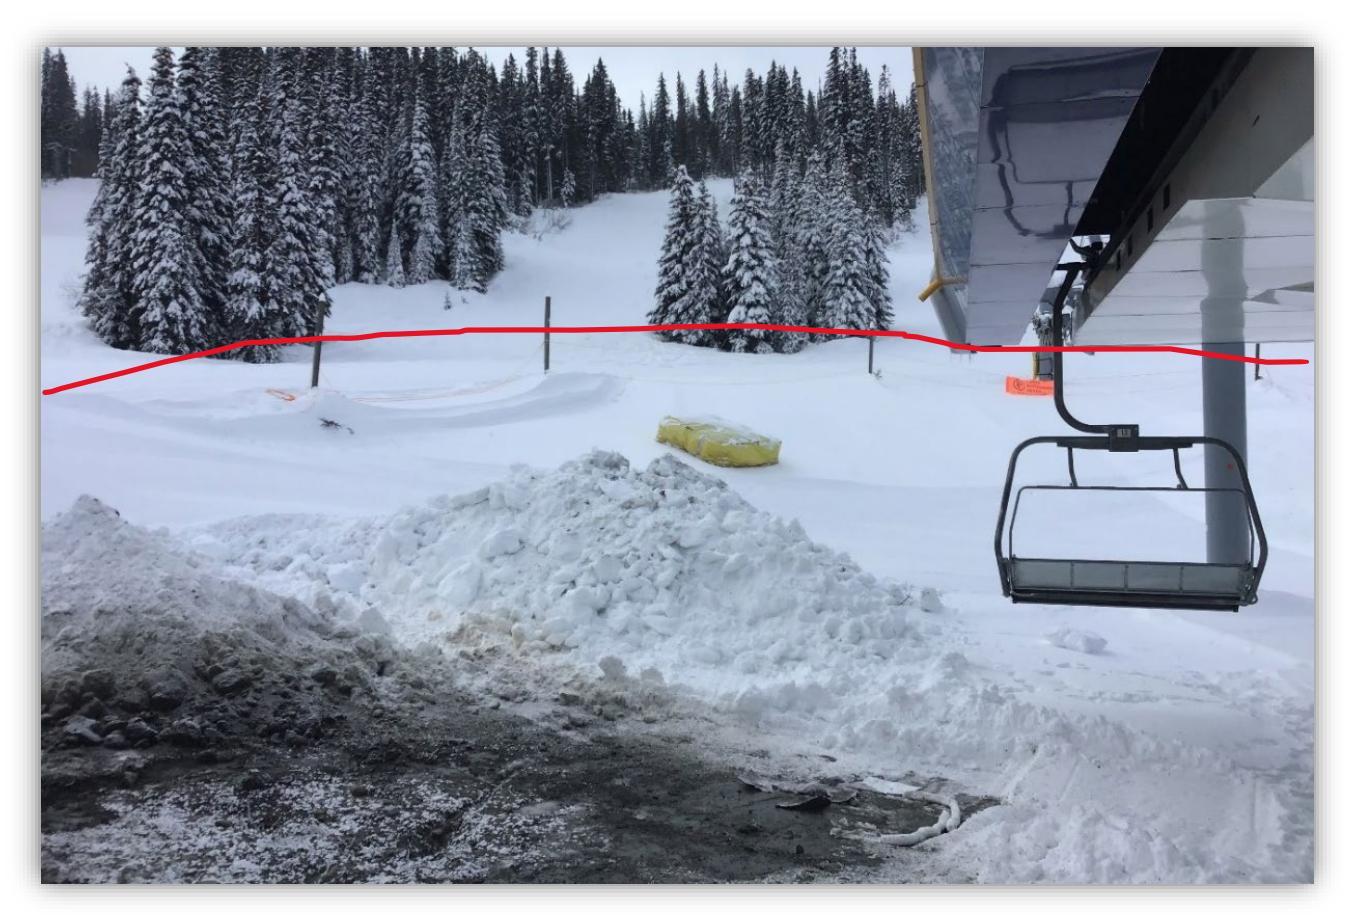
Image 7 – "Head Trap" area (**RED**) and transformer oil leakage area.
