SUPPORTING INFORMATION	Incident Date		July 1, 2020
	Location		Prince George
	Regulated industry sector		Electrical - Low voltage electrical system (30V to 750V)
	Impact Damage Injury	Qty injuries	0
		Injury description	None
		Injury rating	None
		Damage description	Fire and smoke damage to recreational vehicle. Most structural damage contained to the area where the fridge was located.
		Damage rating	Moderate
	Inciden	t rating	Moderate
	Incident overview		On the day of the incident, the owner of a Jayco recreational vehicle was preparing for a weekend of camping. They were packing the Recreational vehicle and decided to get some items from the store. The recreational vehicle was plugged into the home exterior receptacle and then they turned on the fridge and left. It was at the store they got a call from a neighbour stating the recreational vehicle was on fire. The fire was quickly extinguished.
INVESTIGATION CONCLUSIONS	Site, system and components		The Jayco recreational vehicle was located in the driveway of the owner's single family dwelling. The unit was purchased with a three way refrigerator, meaning it can operate on propane, 12 Volts DC or 120 volts AC. The fridge is a typi

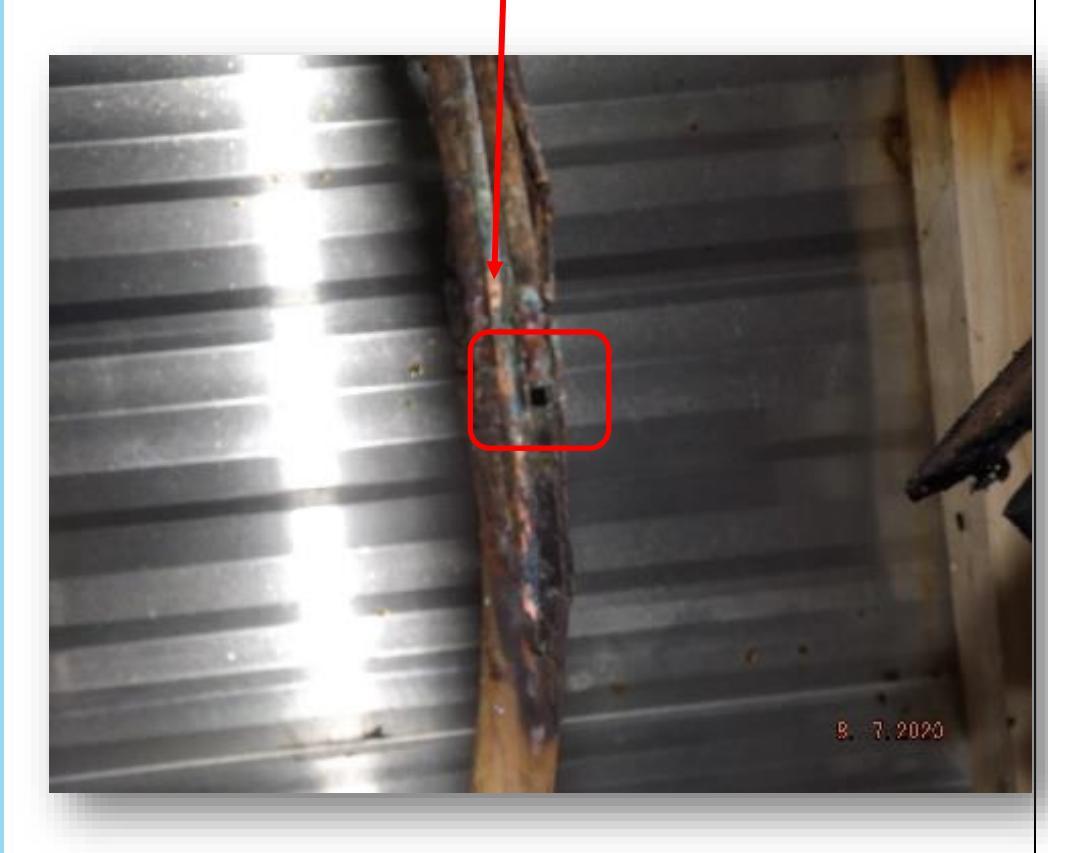
This fire did not burn hot enough to melt copper, and there was one conductor that had been severed. Here is arcing damage to the conductor. This must have been exposed to the bonded tubing of the refrigerator cooling system.

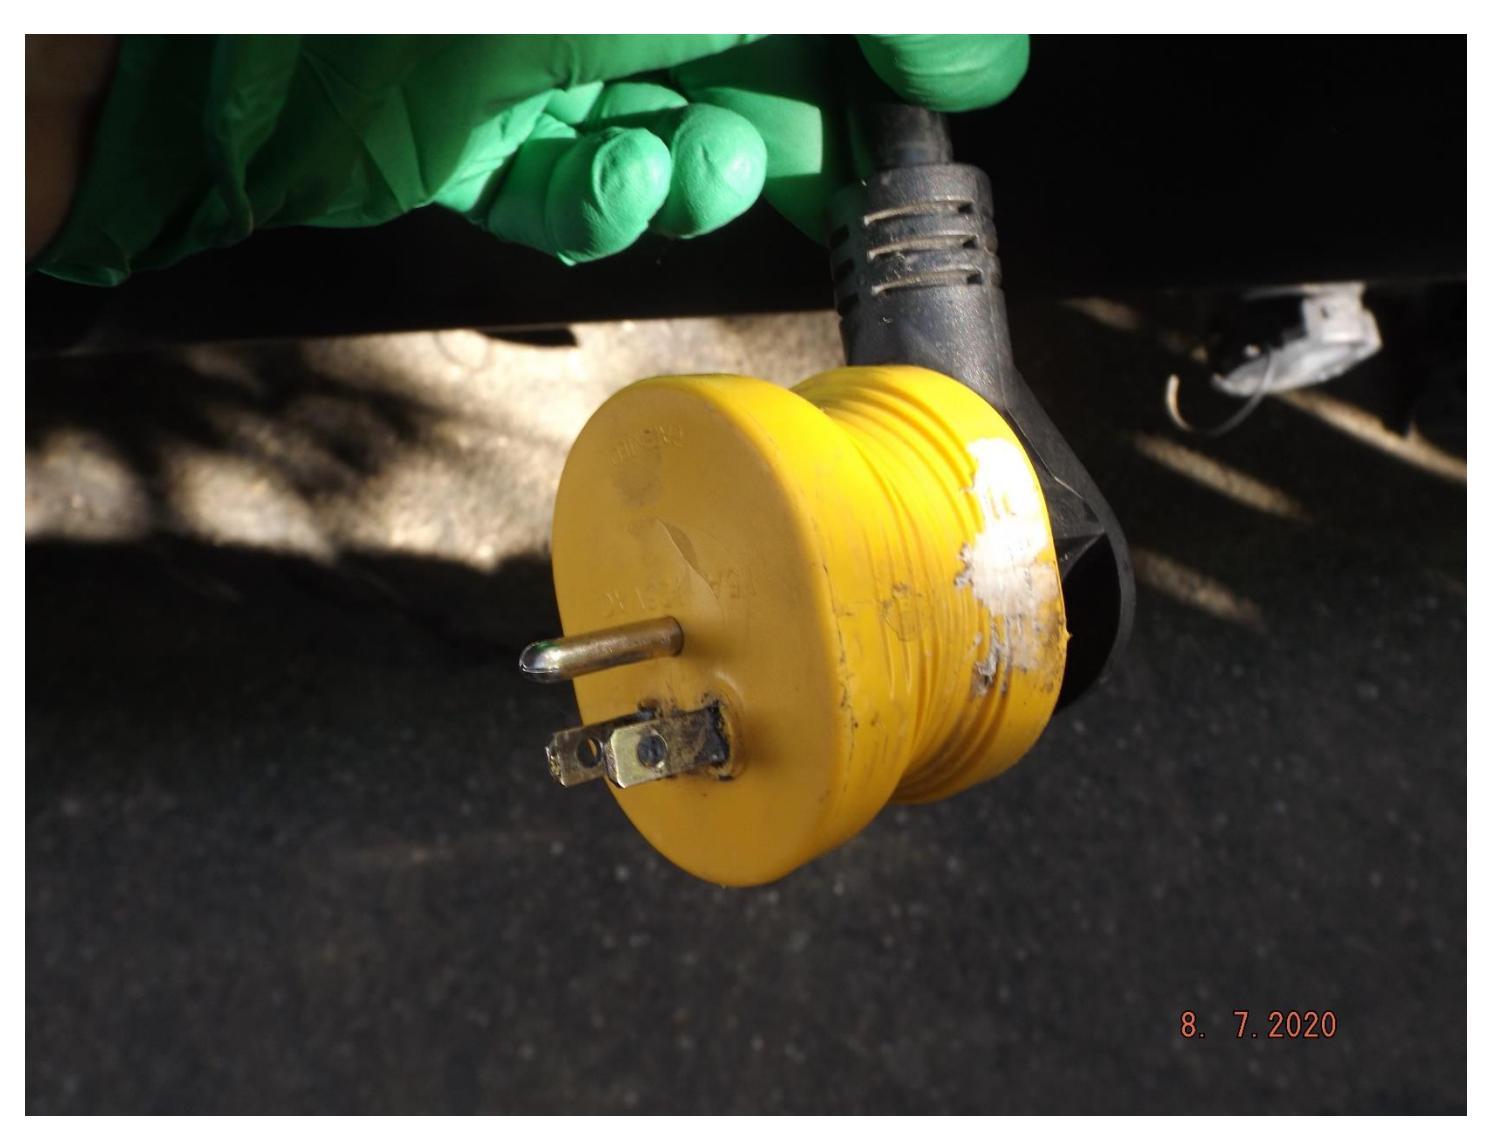
There was no damage to the receptacle or plug for the RV.

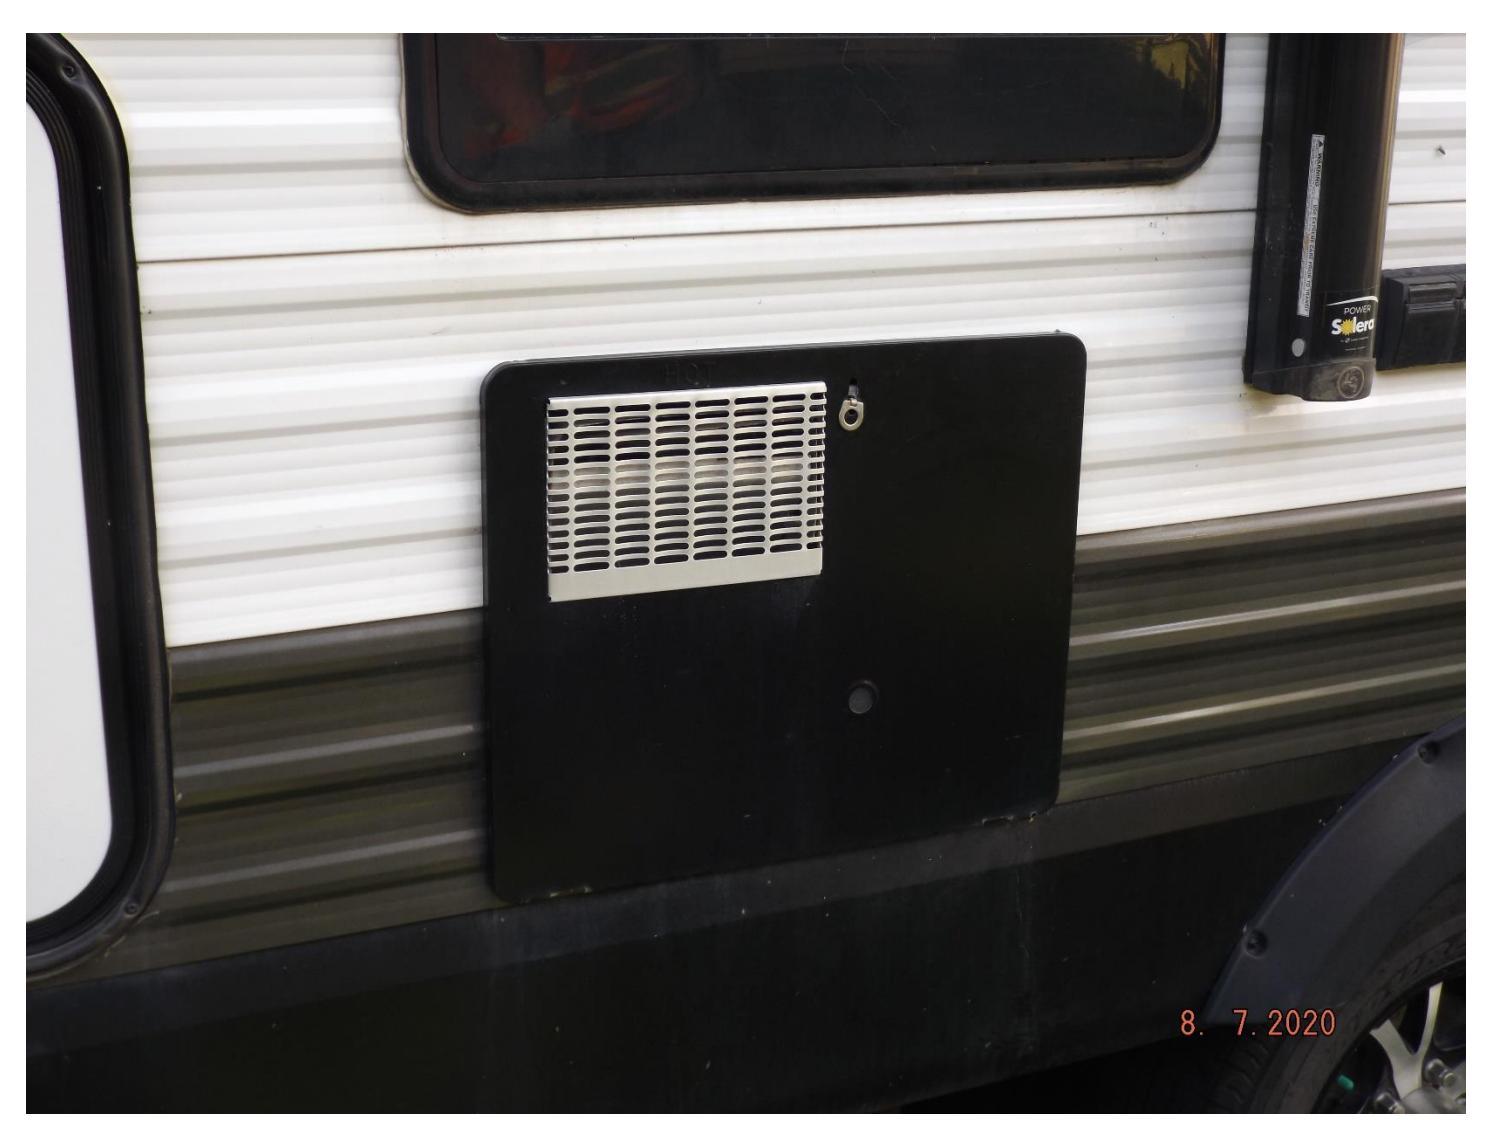
This is a picture of the cover for the hot water tank

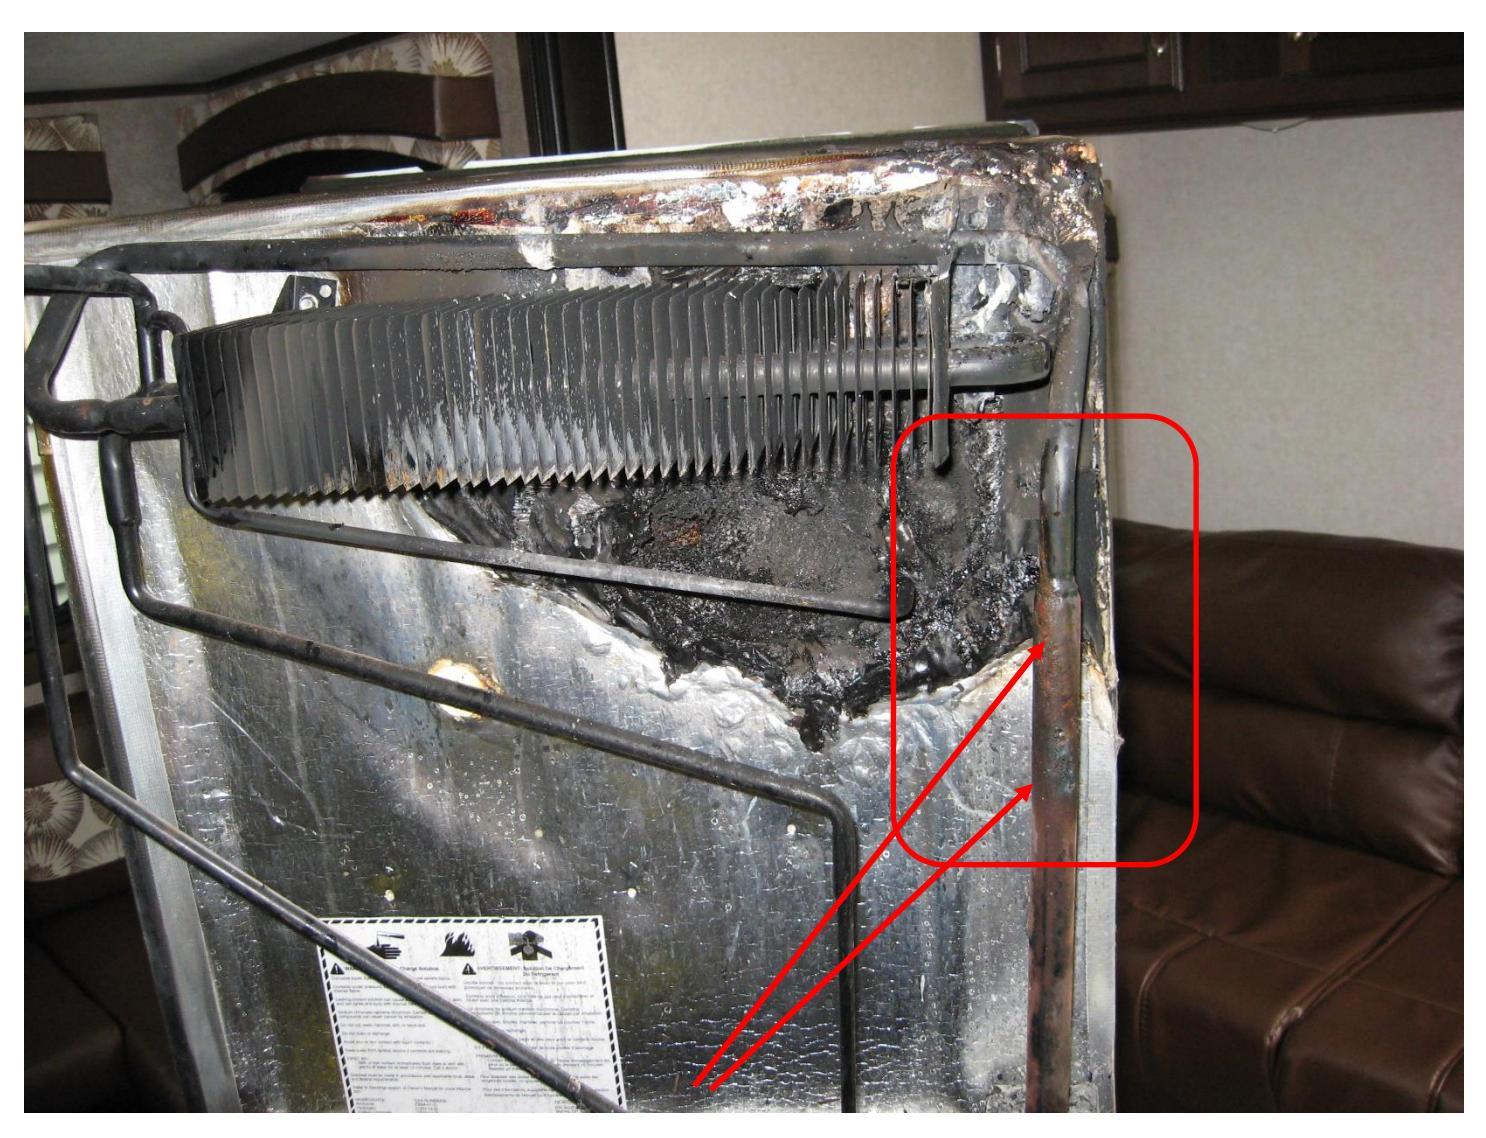
Failure scenario(s)		The configuration of the conductors running through the refrigerator enclosure caused an non-metallic sheathed cable to rest against the tubing for the cooling system. This tubing is hot and over time the non-metallic conductors would heat up and change the characteristics of the insulating material over the cable and over the individual conductors. This damage, if not addressed, would eventually expose the conductors to contact. The cable is energized only when the recreational vehicle is plugged in. On the day of the incident the owner wanted to cool the fridge down as they went shopping. They plugged in the recreational vehicle energizing the non-metallic cable and as the refrigerator cooled the cable heated up due to it touching the tubing. This process degraded the insulation to the point that a conductor in the cable started arcing against the tubing causing a number of pin holes and releasing the gasses in the cooling system causing an explosion and intense fire for a very brief time. After the gasses vacated the cooling system, the fire was quickly extinguished by a neighbour.

Cover shot of the back of the fridge showing the tubing and the cable "S" image and the arcing damage.
