Incident Summary #II-1173154-2021 (#21492) (FINAL)

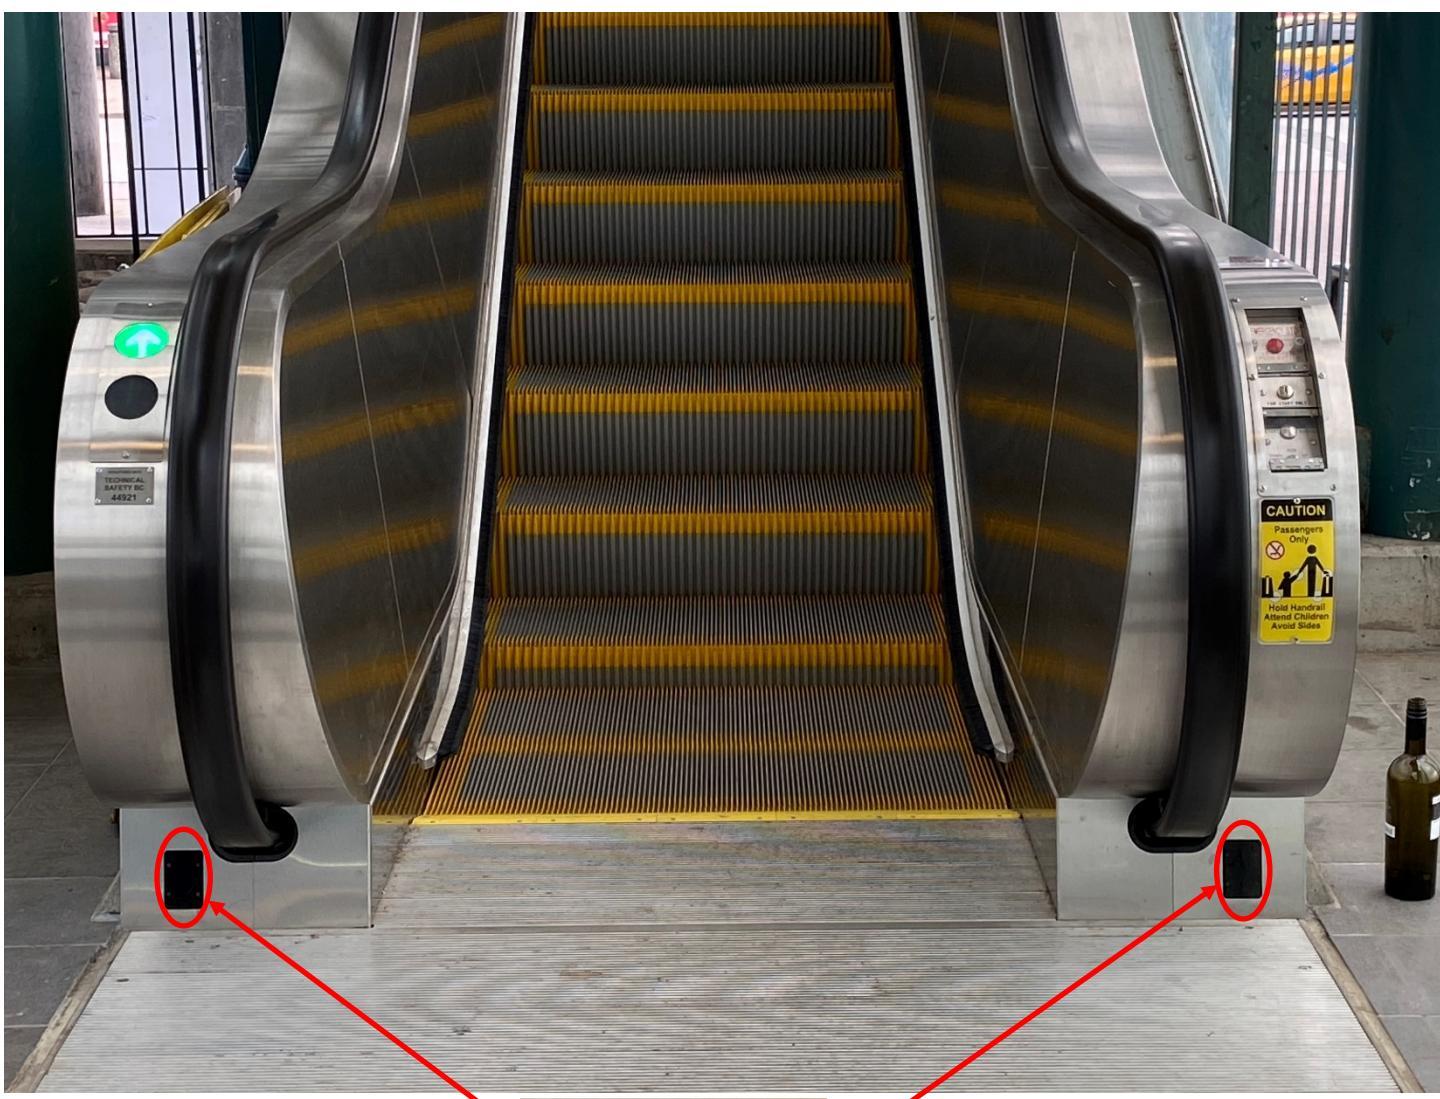
Escalator Entry/Exit

Failure scenario(s)		The sensors that detect approaching pedestrians were not adjusted properly and did not detect the passenger approaching.
	Facts and evidence		 Based on video evidence, the passenger approached the escalator, but the escalator sensor did not detect them approaching. As such, the escalator remained in power save mode and operated at a reduced speed. As per phone conversations, a station mechanic noticed the slow speed, and in attempt to assist the passenger, passed their foot across the escalator sensors. The sensors activated the unit out of power save mode which increased the speed, causing the passenger to fall backwards. The passenger was not using the handrail. An inspection with the elevator contractor was performed after the incident, and the unit was tested without making any changes to the sensors. Video footage showed

the sensors did not detect the incoming passenger. The sensors were then adjusted as per the manufacturer's instructions with the highest sensitivity, and the issue was resolved.
Causes and contributing factors	The cause of the incident was very likely the result of a station mechanic trying to aid the passenger by speeding up the escalator. The passenger was not holding the handrail and was unaware what the mechanic was attempting to do by accelerating the speed. When the escalator sped up, the passenger fell backwards and sustained minor injuries to their hand.
