Incident Summary #II-984561-2020 (#16727) (FINAL)

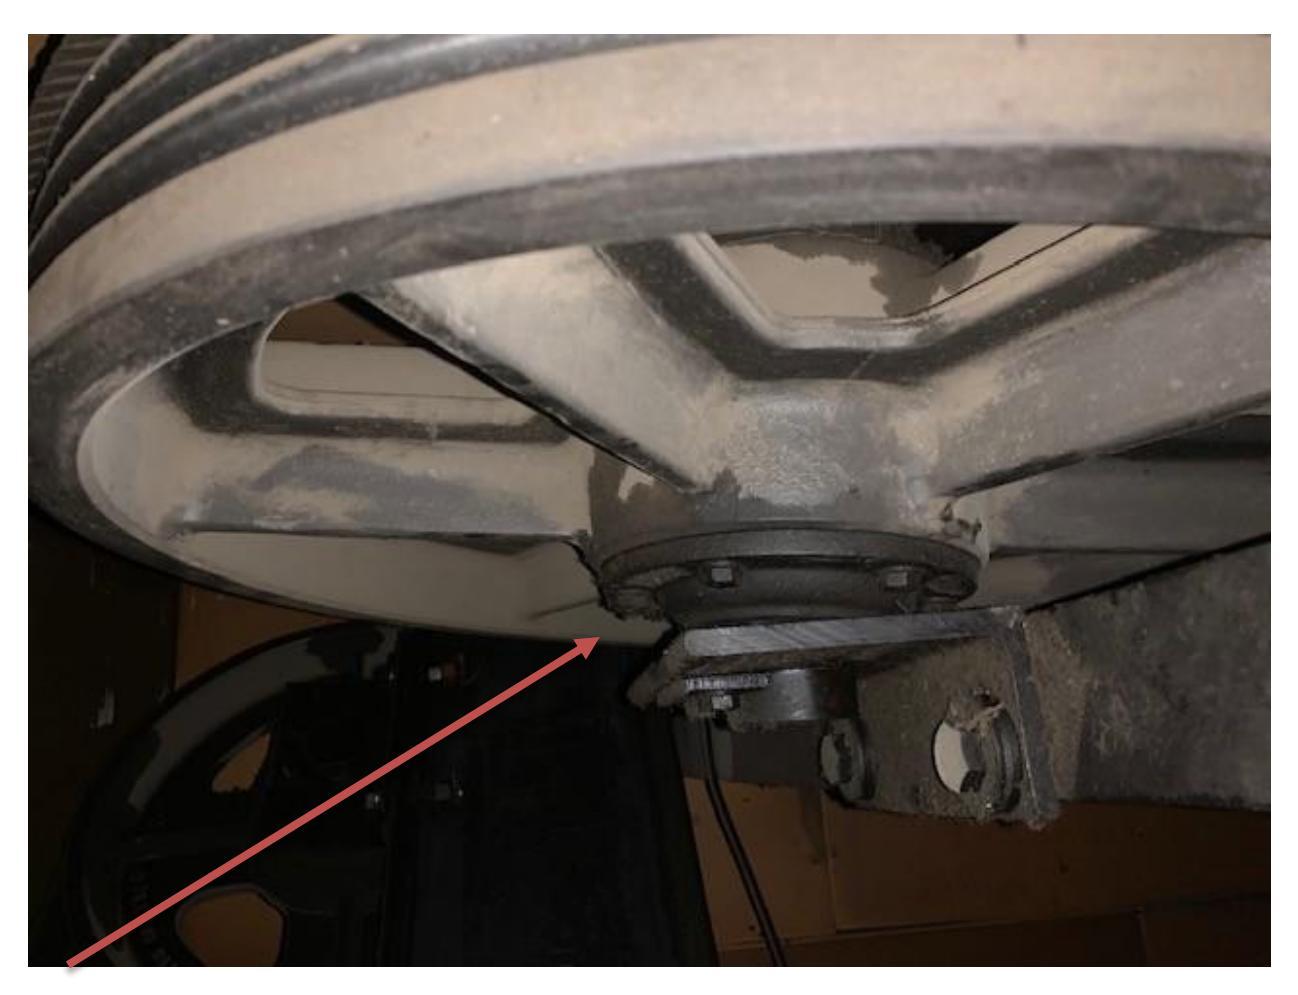
Upon onsite visit found the root cause of the incident was a failed bearing inside the deflector sheave between the counterweight and motor. This is a non-serviceable sealed bearing, with no grease nipples. (see photo #1 and #2 showing a collapsed bearing). Found elevator and counterweight suspended by one rope. (See photo #5) Mechanic indicated that he was aware that the door lock to machine room had been changed and had requested keys multiple times from office and had never received them. Mechanic indicated no one was performing maintenance in the hoistway during this time, maintenance did not get done for most of the year. Mechanic attended call for the initial entrapment and incident. Mechanic stated that the fire department had been called to get the passenger out. Mechanic reported that suspected noises from the elevator were heard a few days prior to the incident.
	 Property Manager stated they were unaware of requests from maintenance contractor for keys to new machine room door lock. Property Manager stated a new owner bought property recently and they weren't aware of machine room door lock being changed. Property Manager stated that Building Manager is new as well, and may not have been aware that machine room door lock was changed. Building Manager indicated previous Building Manager would not communicate with them and the new Building Manager was not made aware of outstanding work or work that needed attention. The new Building Manager stated they had started working at the property in December, 2019 and had no idea about the machine room door lock issue. Building Manager stated he does not recall being approached by maintenance contractor for keys to machine room door. Passenger that was in elevator at the time stated he heard loud "clanking noises" in the elevator while he was riding the elevator down. The elevator suddenly stopped. Passenger indicated it was not a hard stop but a sudden stop.

Photo 1: Damaged Bearings

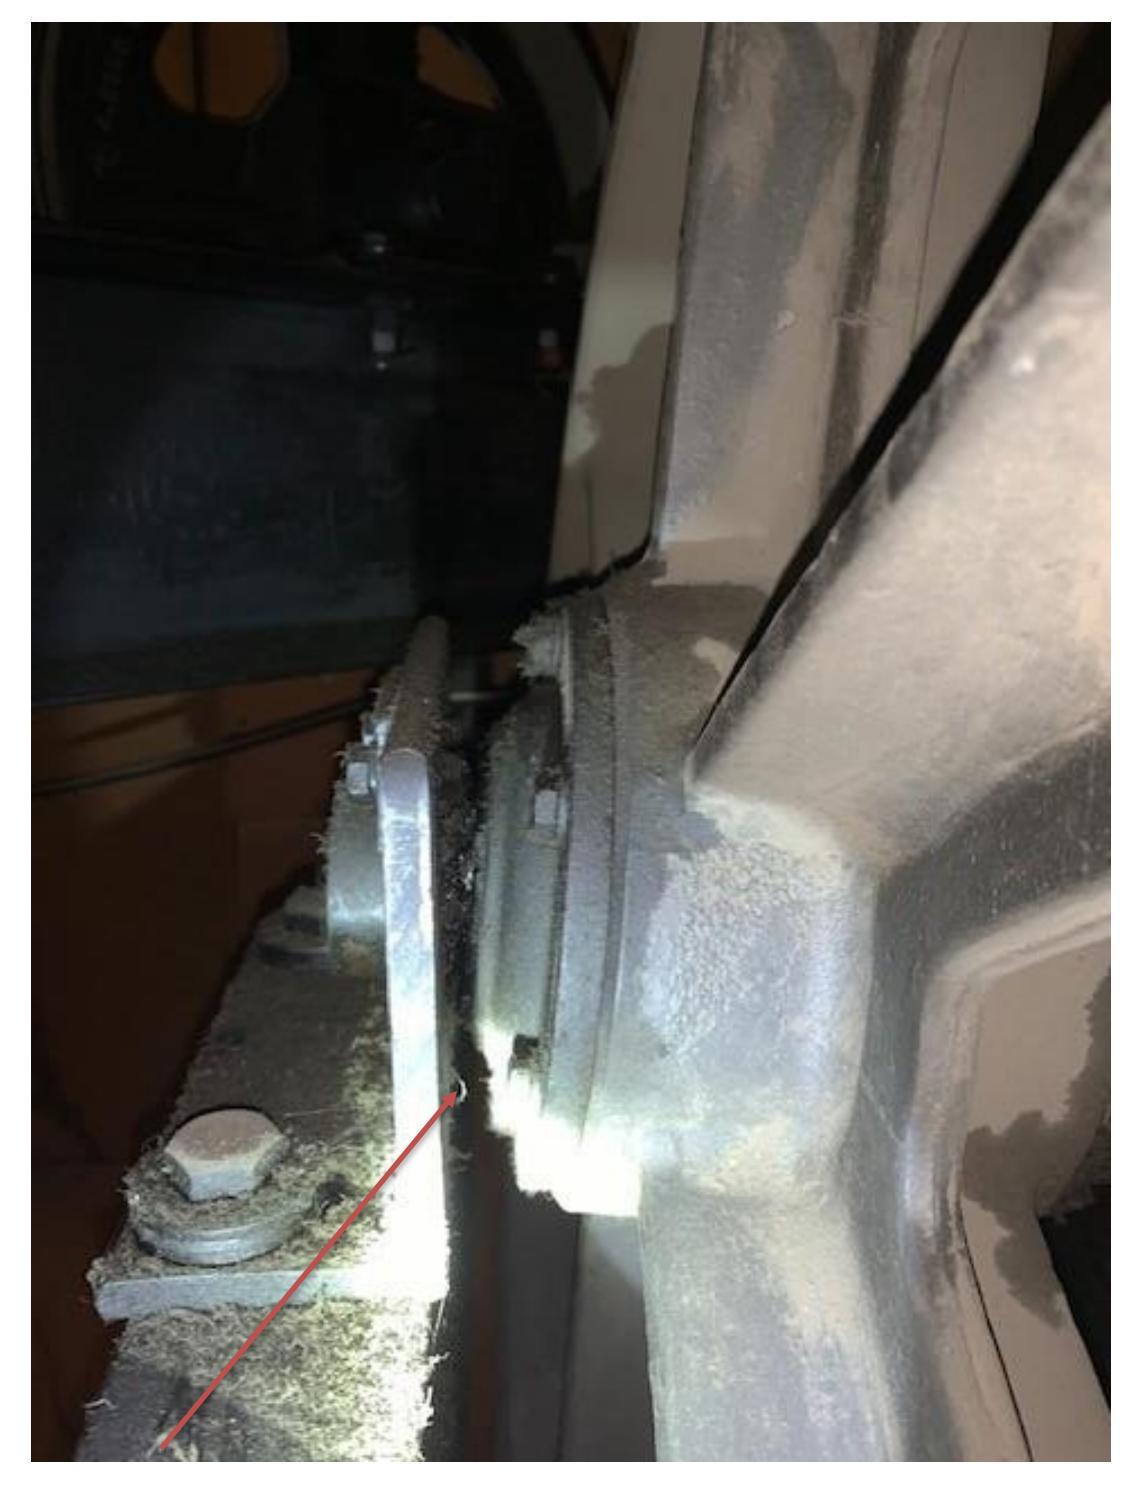
• Found the suspected damaged sheave out of plumb and slightly tilted to one of its sides. (See photos #1 and #2)
• Found three of the four ropes missing from the Sheave's grooves. (See photo #4)

Photo 2 - Photo shows the sheave out of plumb and tilted towards one of its sides.

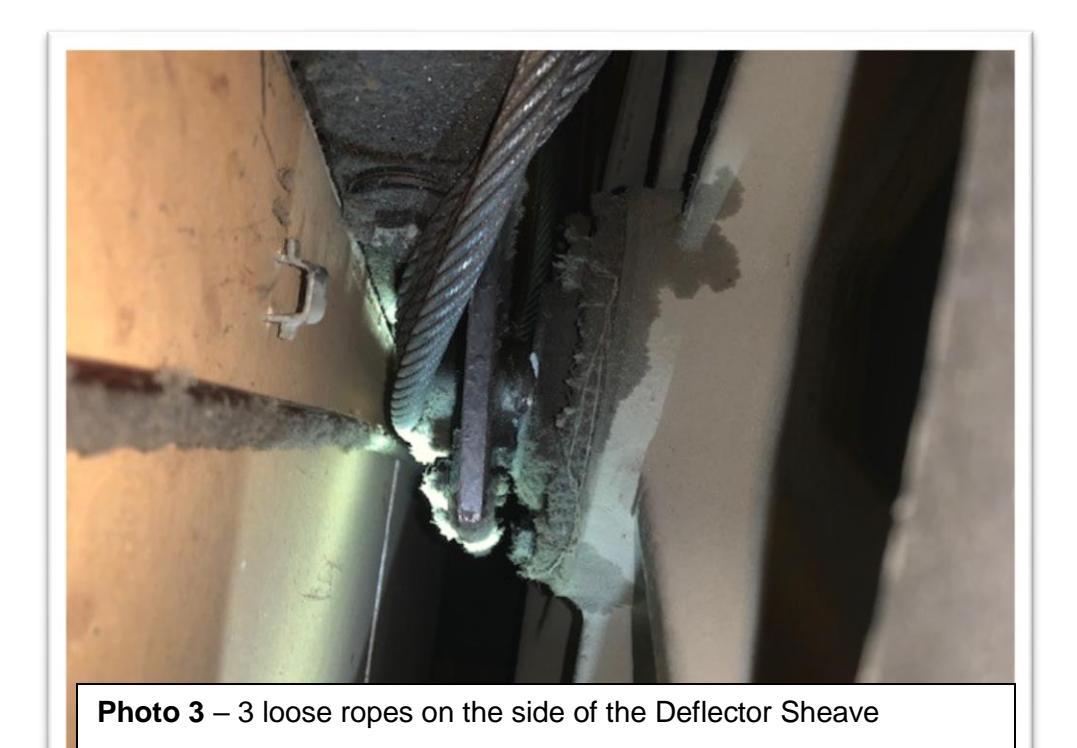
• Found the three loose ropes between the sheave holding bracket and back wall. (See photos #3 and #9)
• Ropes were hanging loosely in the hoistway (see photos #5 and #9)
Called foreman for information on maintenance contract for last 6 months and asked bin about new findings on the incident
 Foreman stated mechanic had secured the car after the first site visit and set up
a ladder to access the deflector sheave. The mechanic confirmed that the
sheave had damaged bearings. Because of the damaged bearings the deflector
sheave collapsed towards the wall which caused 3 of the 4 ropes to come out of their grooves
 Requested more nictures from maintenance contractor of deflector sheave to be
forwarded to Safety Officers prior to beginning repairs.
Communication with Maintenance Contractor

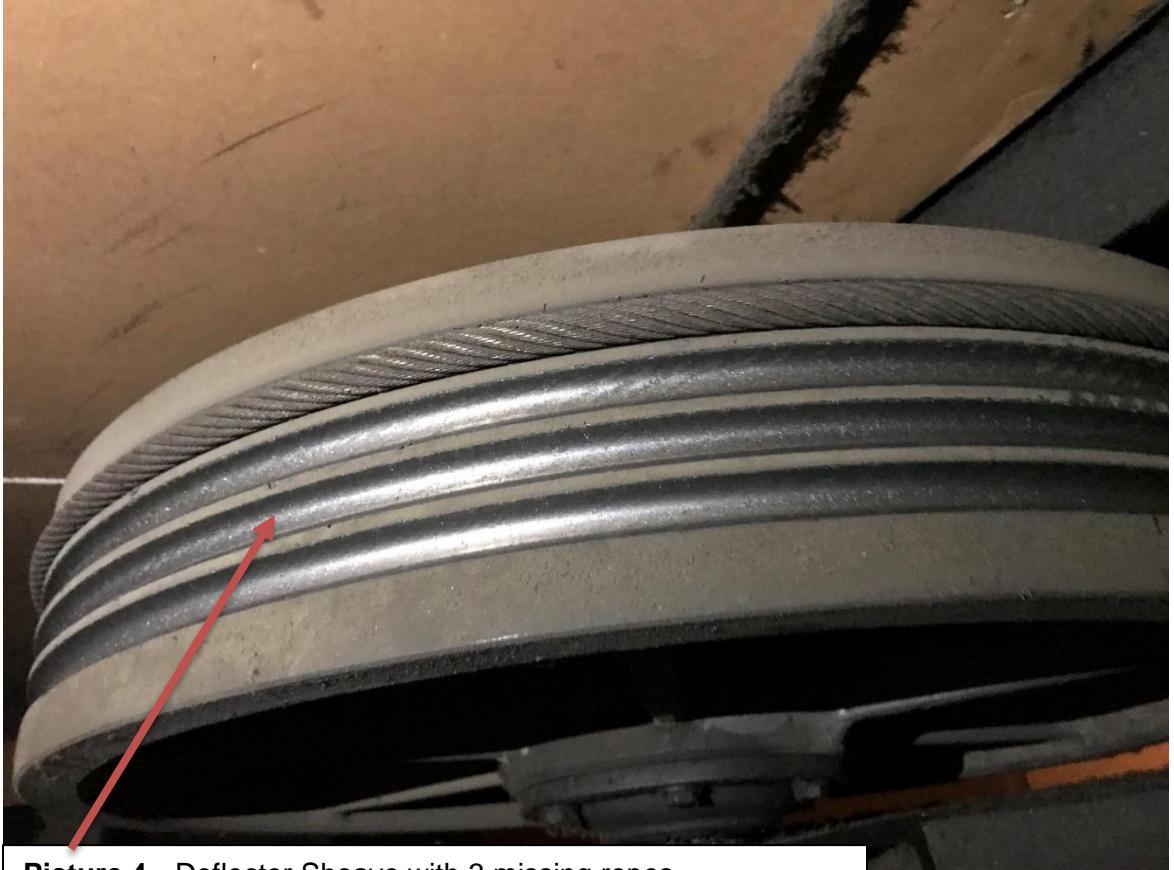
Picture 4 - Deflector Sheave with 3 missing ropes

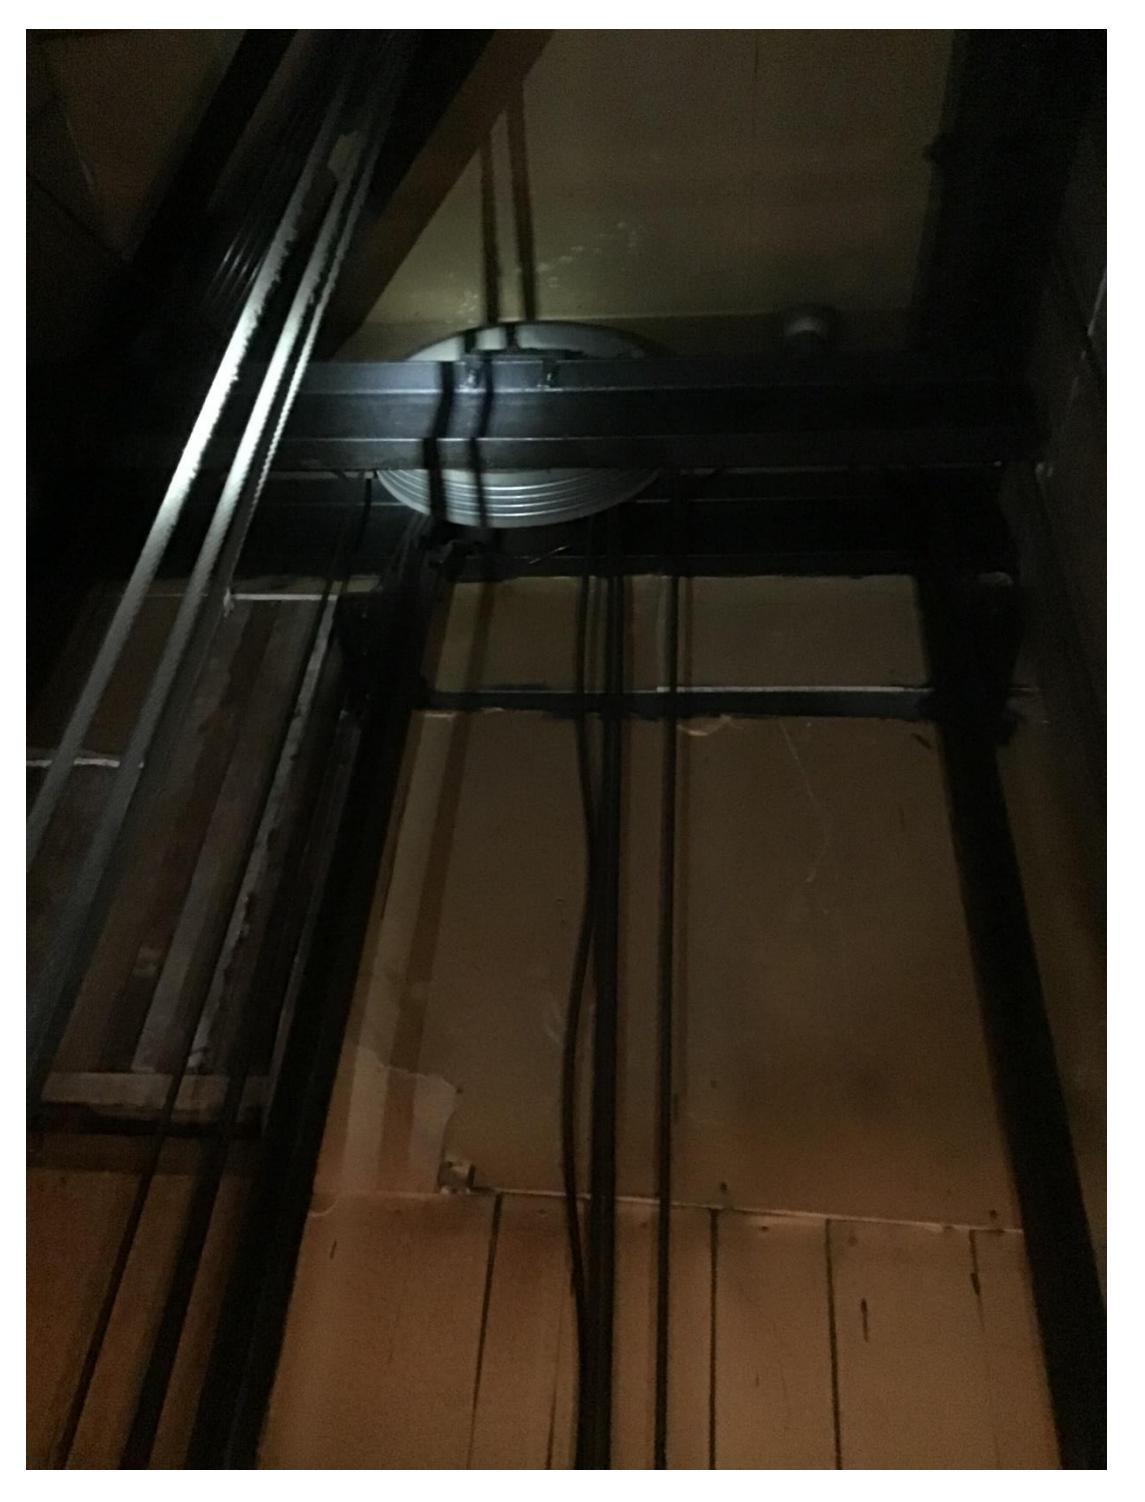
Photo 5 – showing the Overhead Deflector Sheave with only 1 rope in place, others hanging loosely.

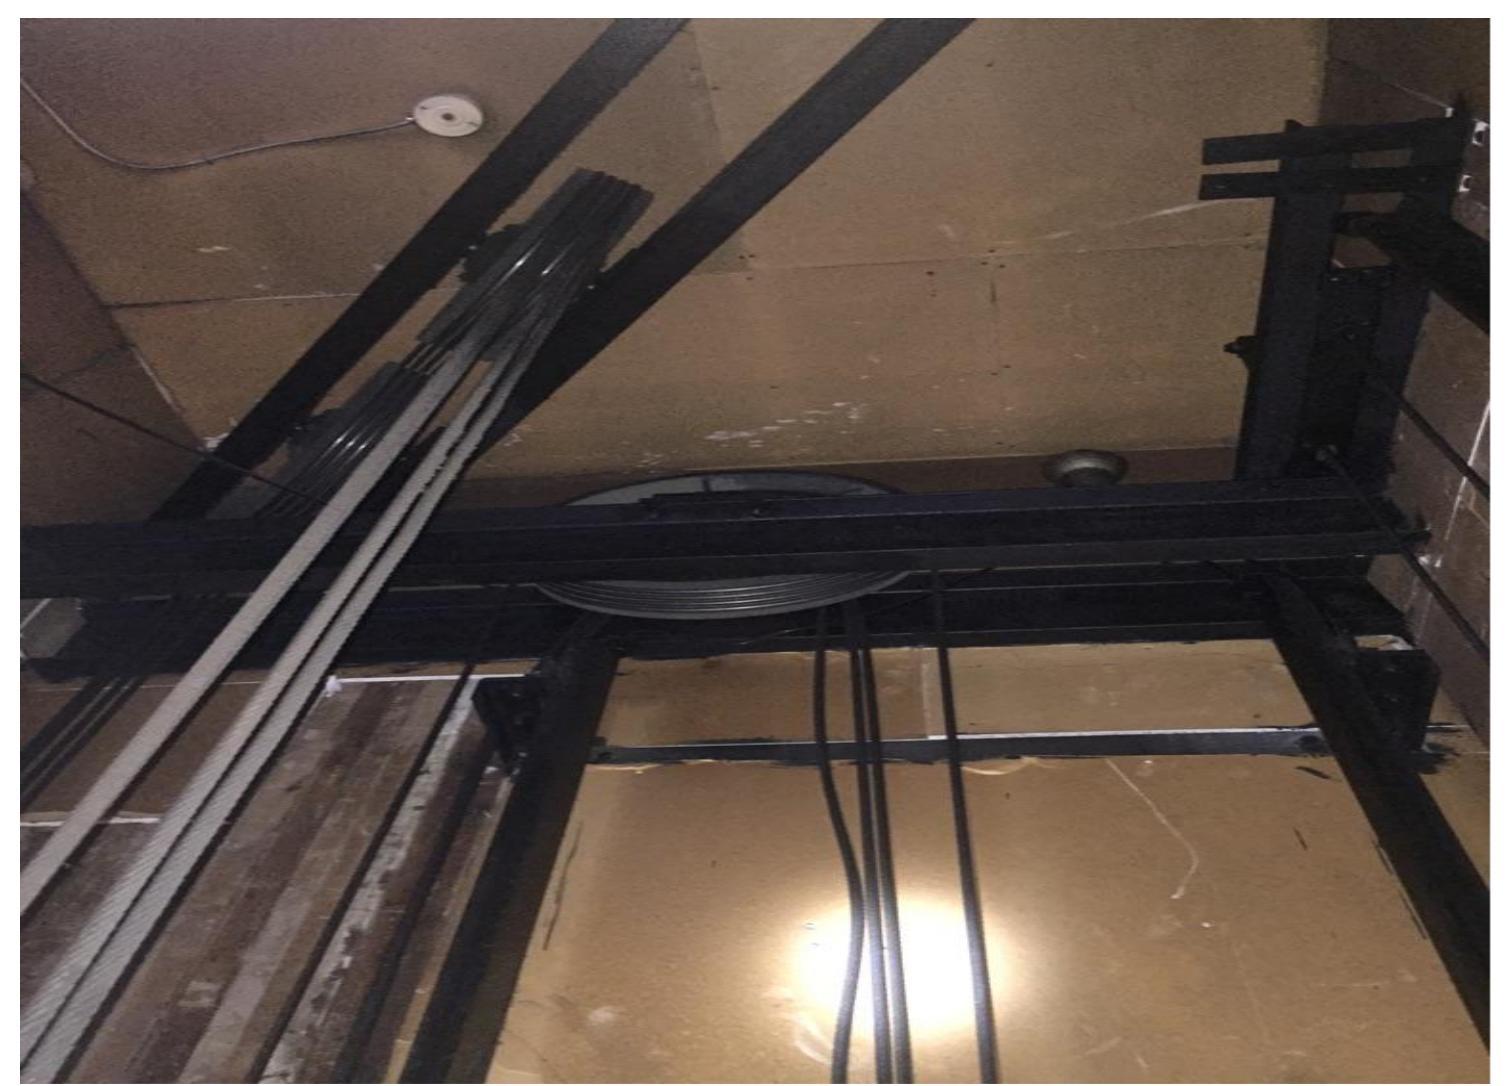
Photo 9- The three deflector sheaves mounted at the top of the hoistway. The sheave mounted furthest to the back wall is the sheave with the damaged bearings. Three ropes hang loosely to the side of the sheave while one remains in the groove.

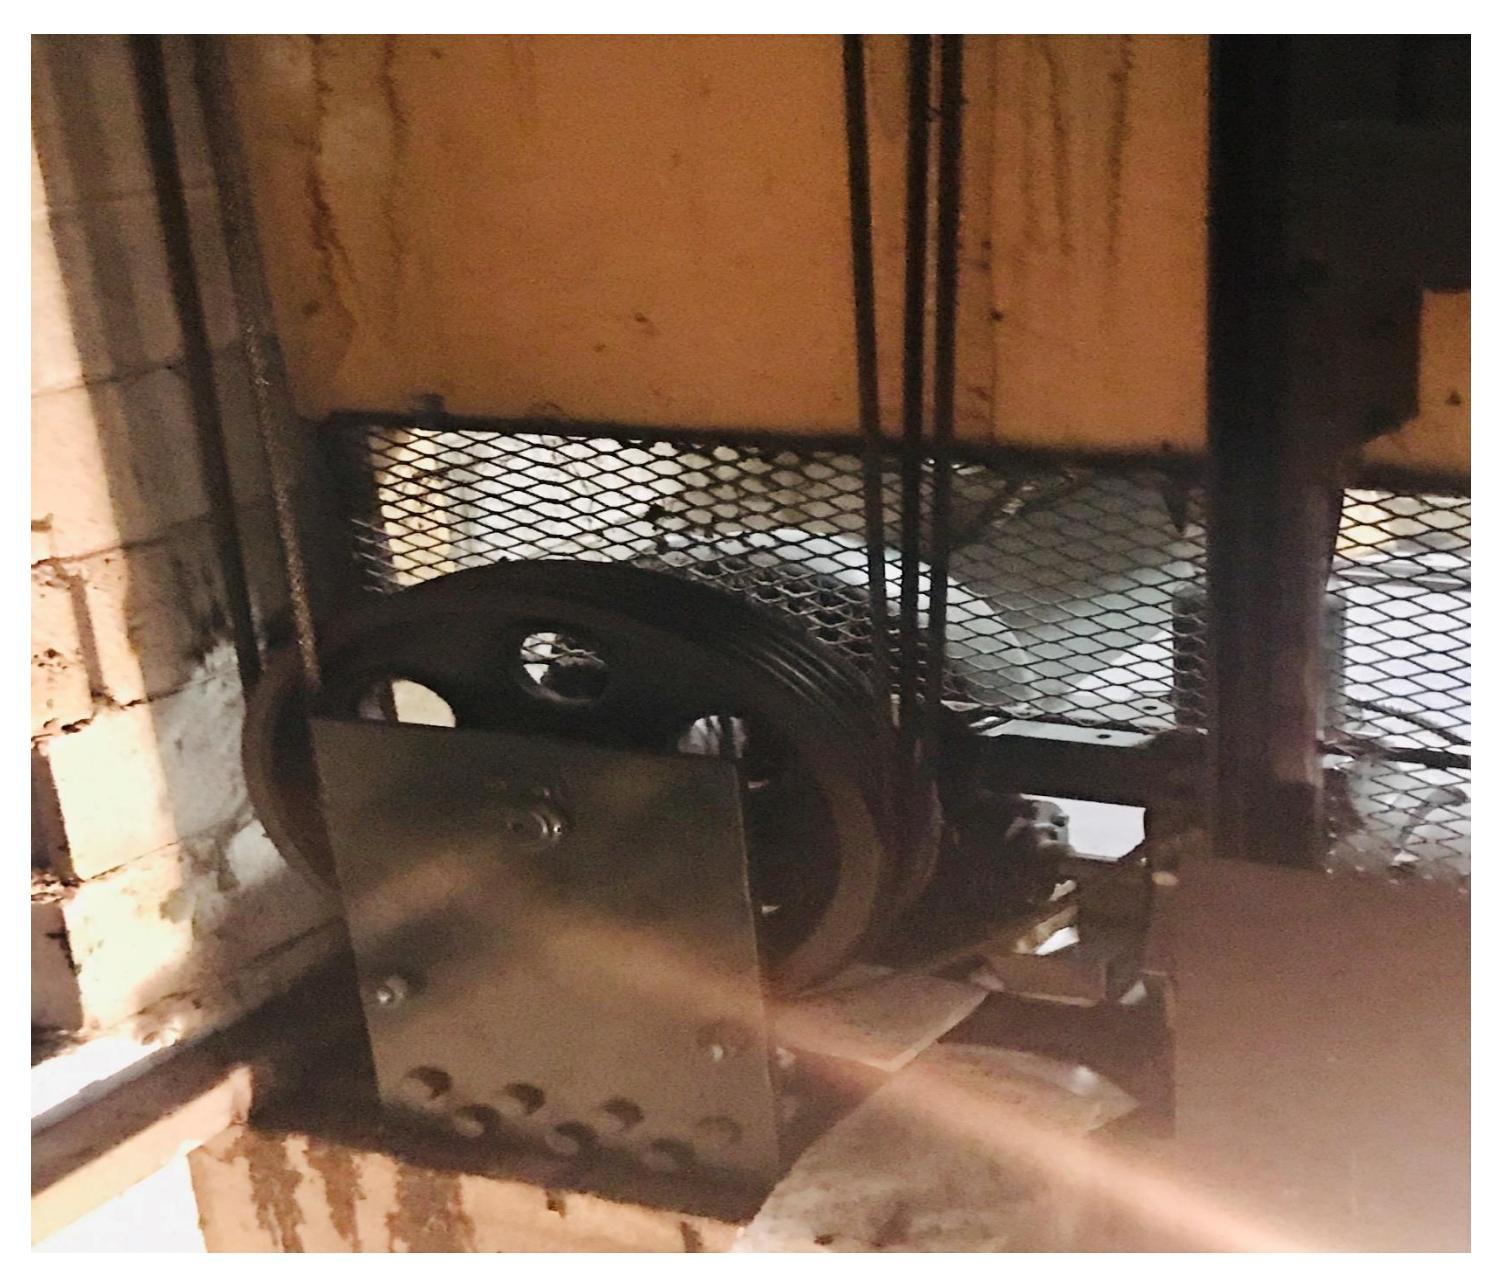
Photo 10- The traction elevator machine located in the basement. The drive sheave is positioned inside the hoistway while the motor end sits in the machine room. The ropes can be seen hanging loosely.
