Incident Summary #II-978216-2020 (#16586) (FINAL)

SUPPORTING INFORMATION	Incident Date		January 15, 2020
	Location		Spallumcheen
	Regulated industry sector		Electrical - Low voltage electrical system (30V to 750V)
		Qty injuries	0
	it Injury	Injury description	N/A
	bac	Injury rating	None
	In nage	Damage description	Fire damage destroyed standalone shed housing electrical equipment for airport beacon signal system
	Dan	Damage rating	Major
	Inciden	it rating	Major
	Incident overview		At a standalone structure that operates a beacon locator for the local airport houses electronic control/ monitoring equipment as well standard electrical installation with service, lighting, heating and ventilation components. It was reported that a suspected electric fan-forced heater mounted to the ceiling failed that caused the fire
INVESTIGATION CONCLUSIONS	Site, system and components		An electric fan forced heater in conjunction with a thermostat control is used to heat an area to maintain a safe operating temperature. The heater c/w a built in high limit switch designed to de-energize the unit during an over-temperature issue within the unit itself. The heater circuit is provided by a dedicated o

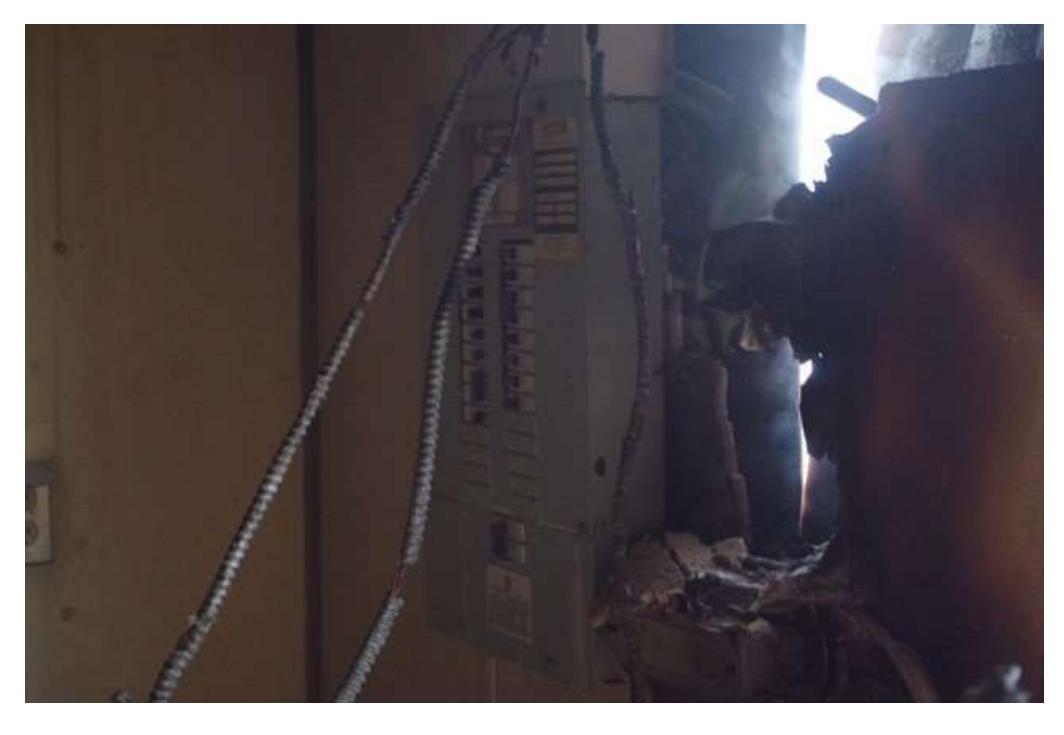
North side interior wall where main panel board is located. Heavily damaged wall.

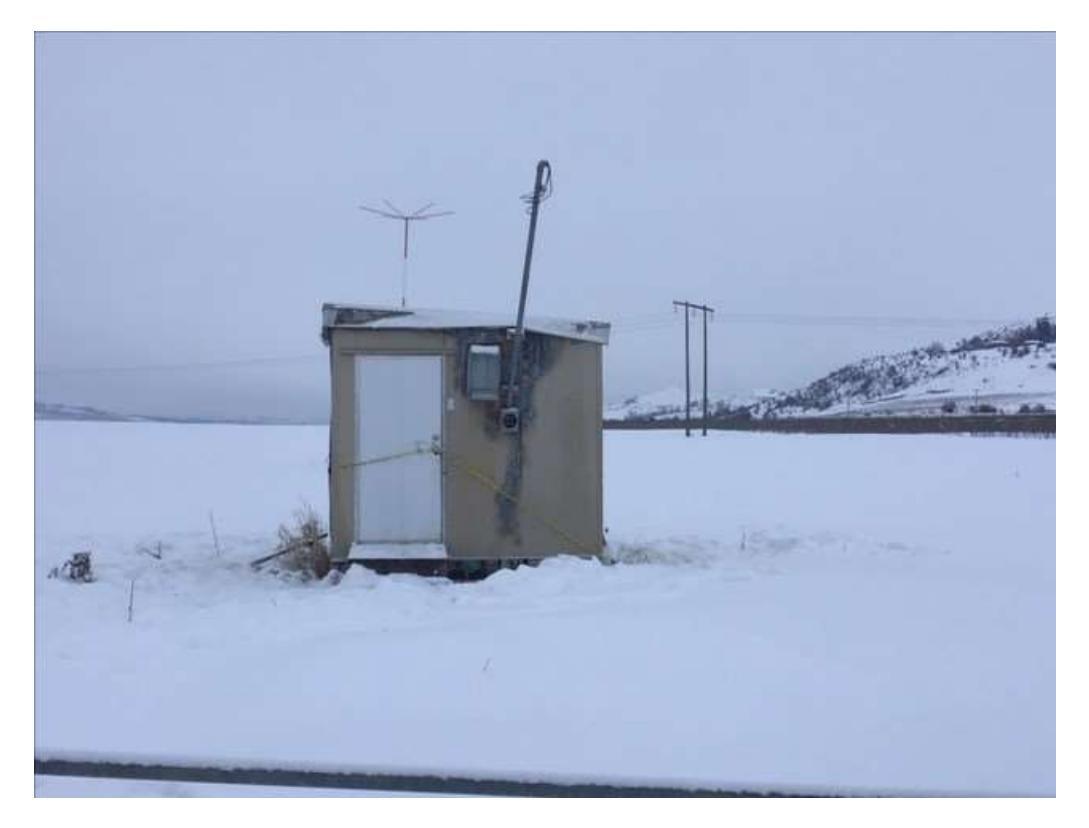
Building structure, exterior view of north wall

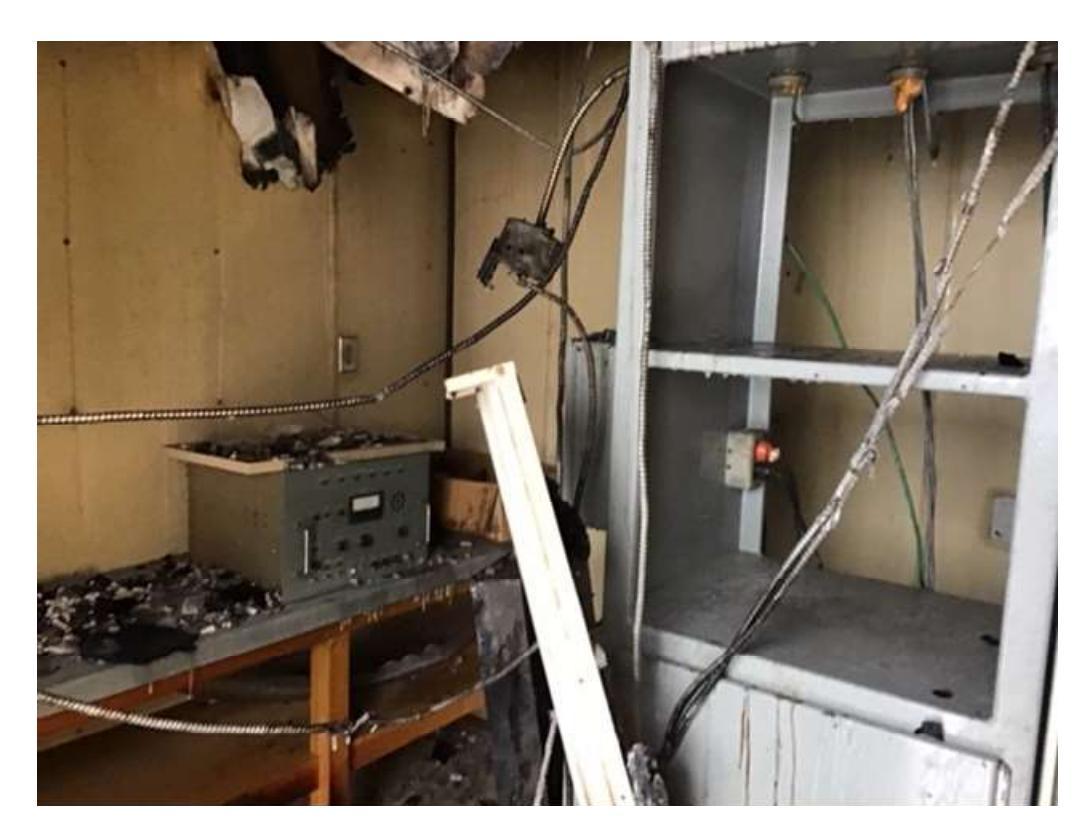
Looking at south-east interior wall

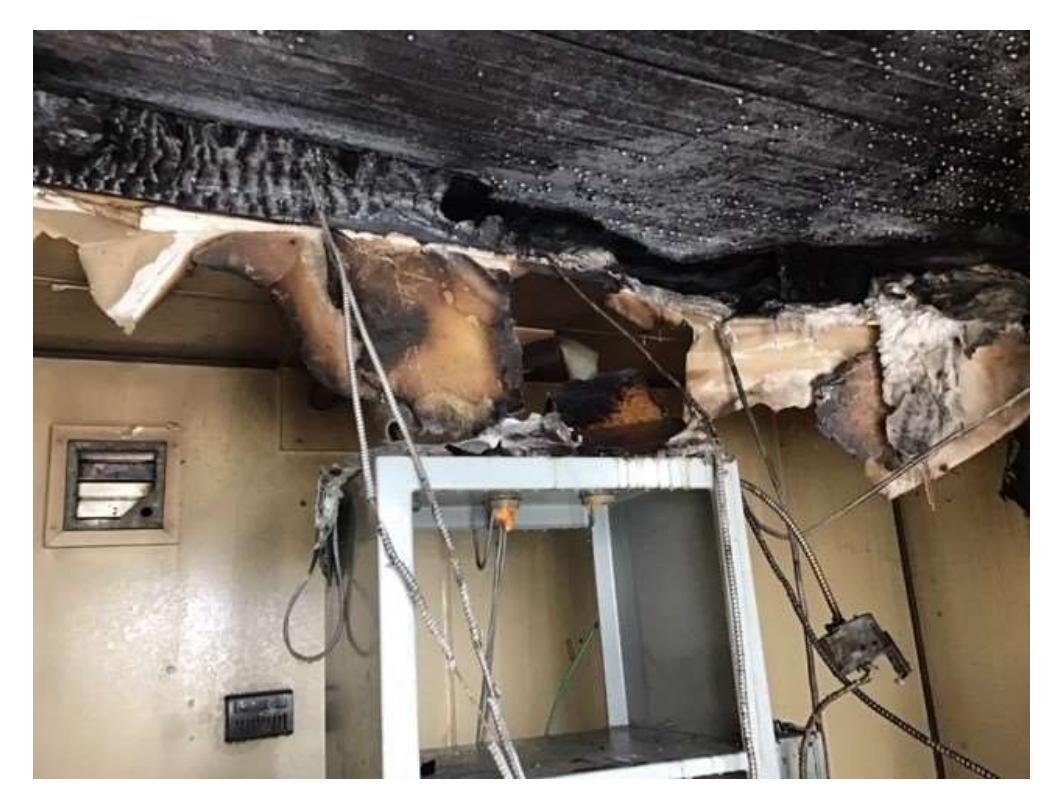
Entry view into structure, south wall/ ceiling area

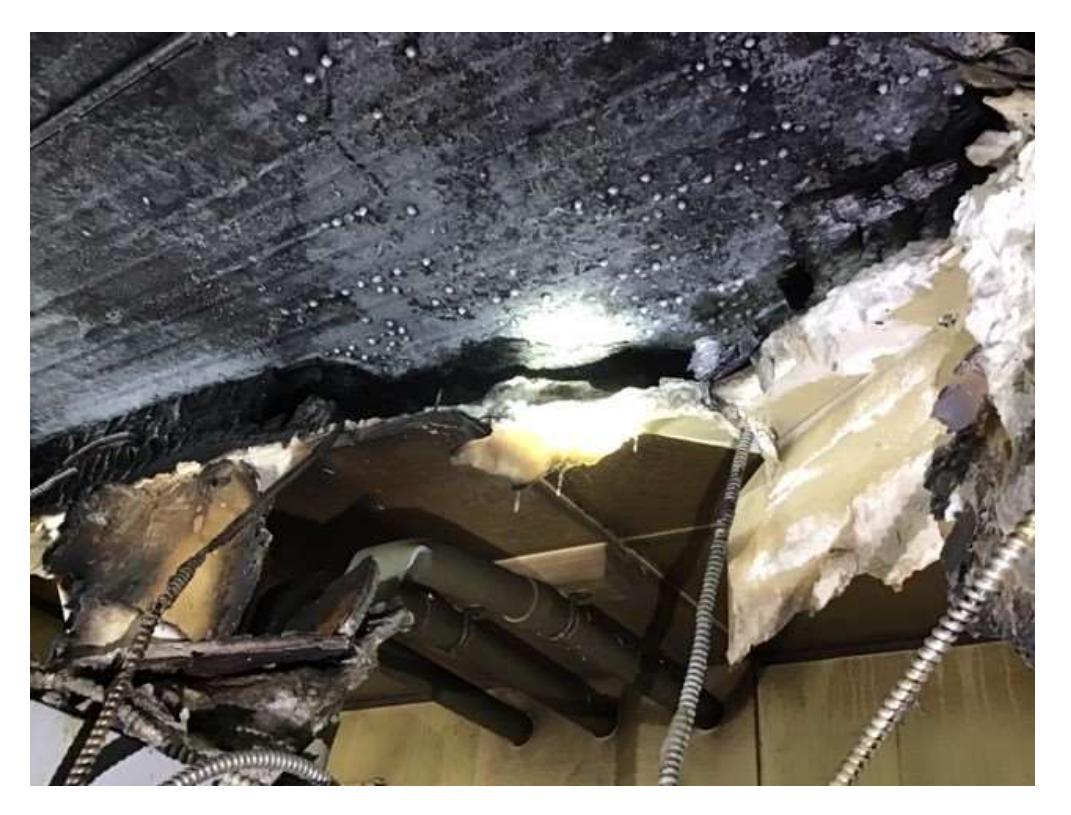
Ceiling damage at approx. heater location

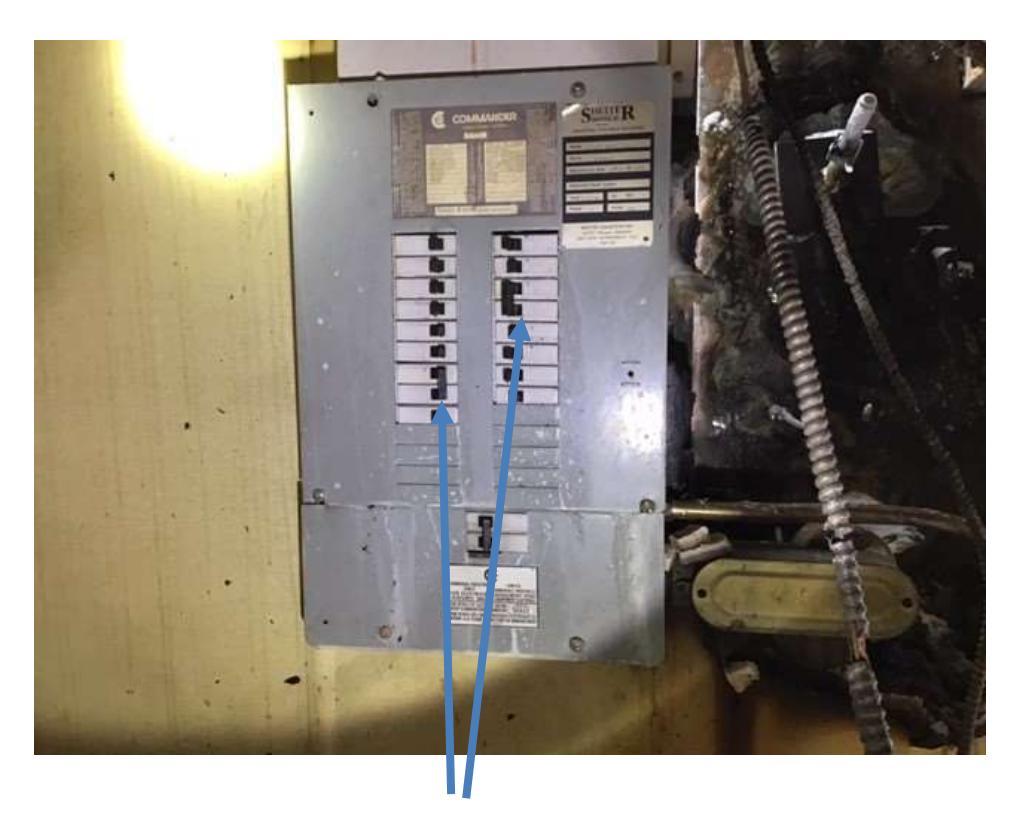
Electrical panel. 2 pole overcurrent devices in energized position

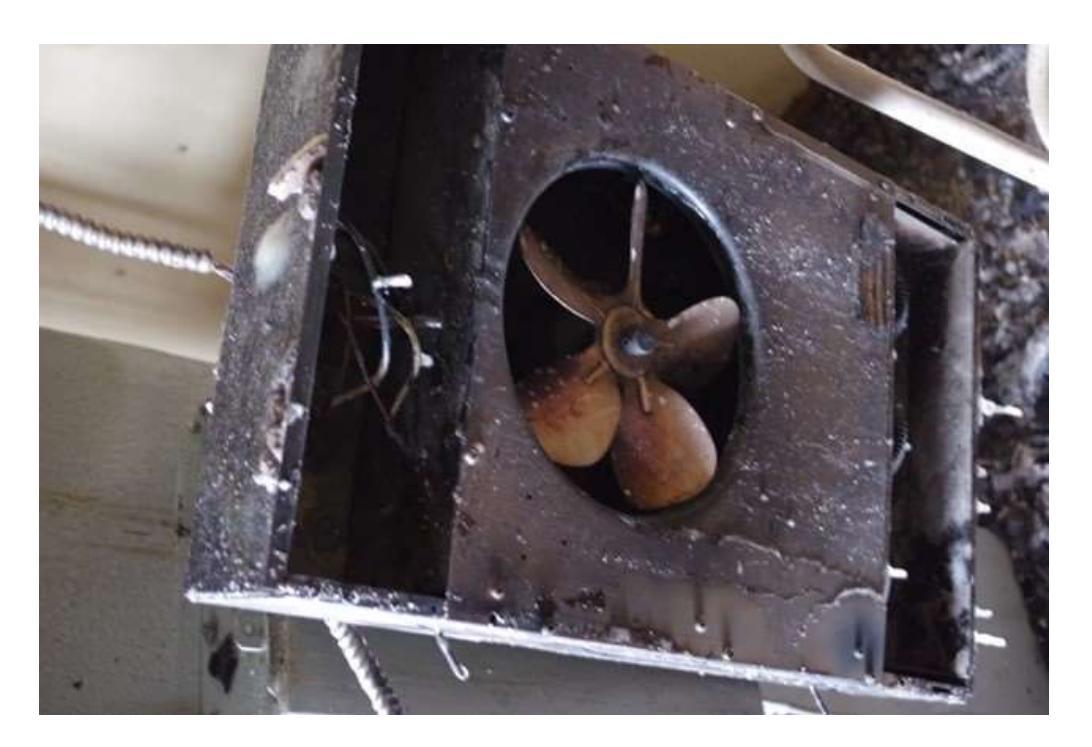
Causes and contributing factors	- Photos provide by others; The evidence gathered with interview discussions leads to the electric heater circuit as likely the cause. No other electrical equipment was noted in badly damaged areas, remaining electrical equipment showed little fire damage noted.

Fan forced heater, hanging from branch circuit wiring

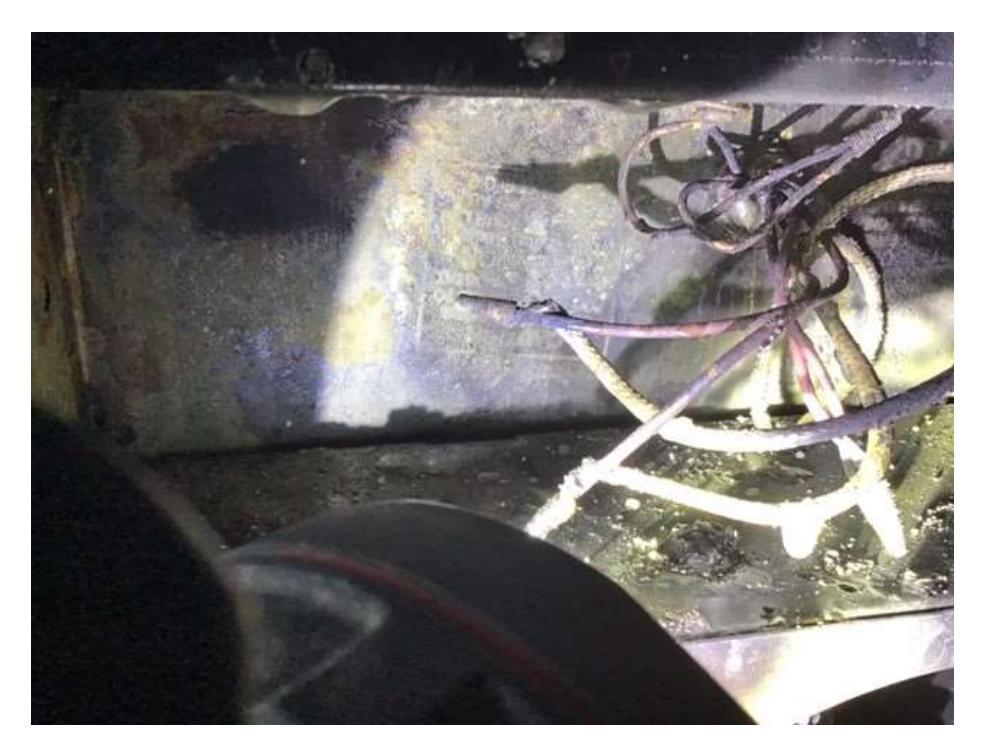
Heater junction box, direct power to heater connection, no built in thermostat wiring

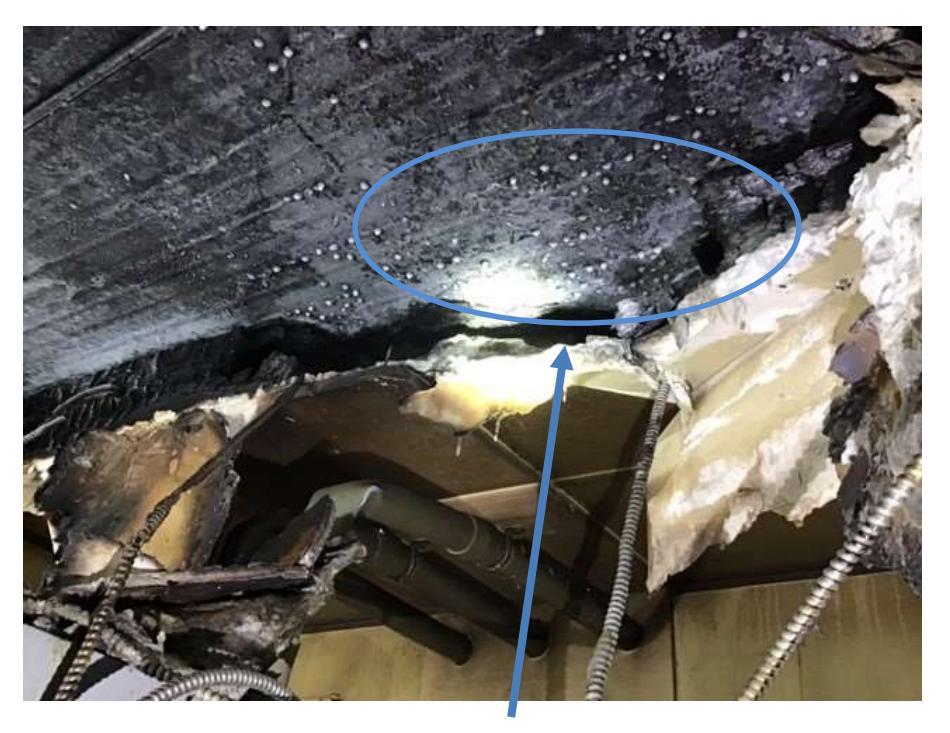
Badly damaged ceiling space approx. where heater was located

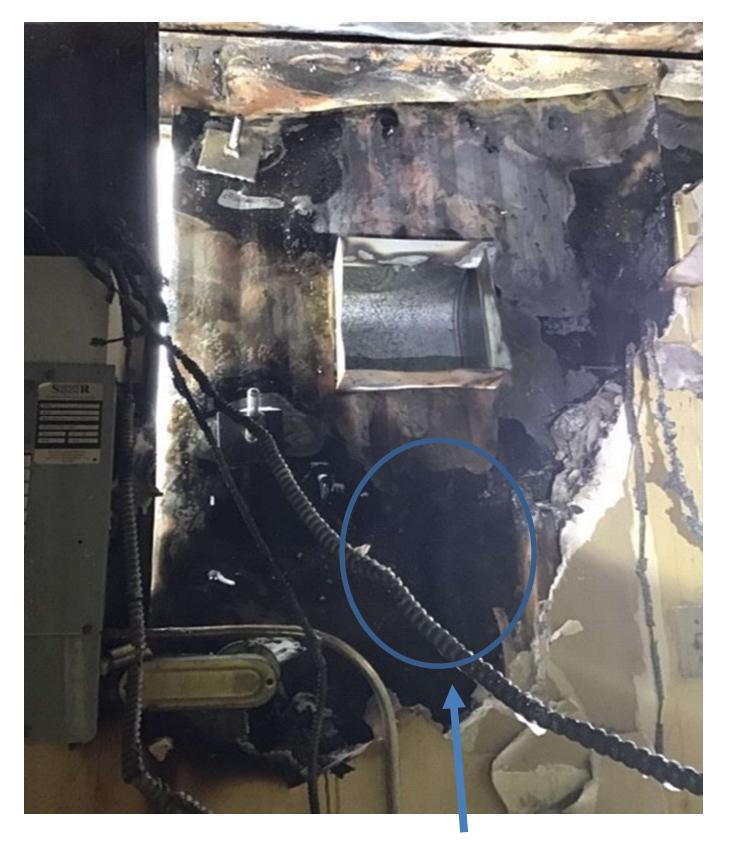
Failure scenario(s)		The branch circuit wiring left the electrical panel where the overcurrent device was installed and ran through the heavily fire damaged area where a remote thermostat was likely installed. From this heavily damaged area the branch circuit wiring continued to the force flow heater location. During a continued stretch of cold weather as low as -20 degrees Celsius, the requirement for the electric heater with an approx. 8'x8' standalone structure requires long operating times to maintain an acceptable operating temperature. The branch circuit overcurrent device for the force flow heater was still in the energized position and the area were the thermostat may have likely been located was where the fire damage appeared heavy.

Wall located beside panel, interior of wall damaged, approx. location of wall thermostat

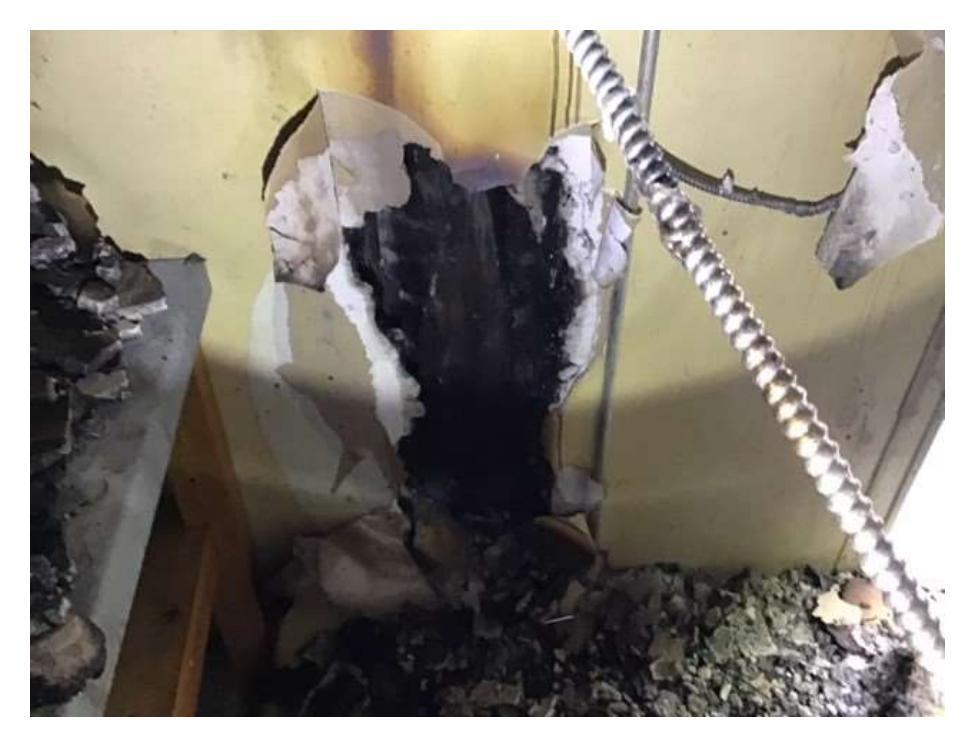
Wall opened by fire fighters below panel, damage to interior wall only
