Incident Summary #II-1649690-2023 (#42097) (FINAL)

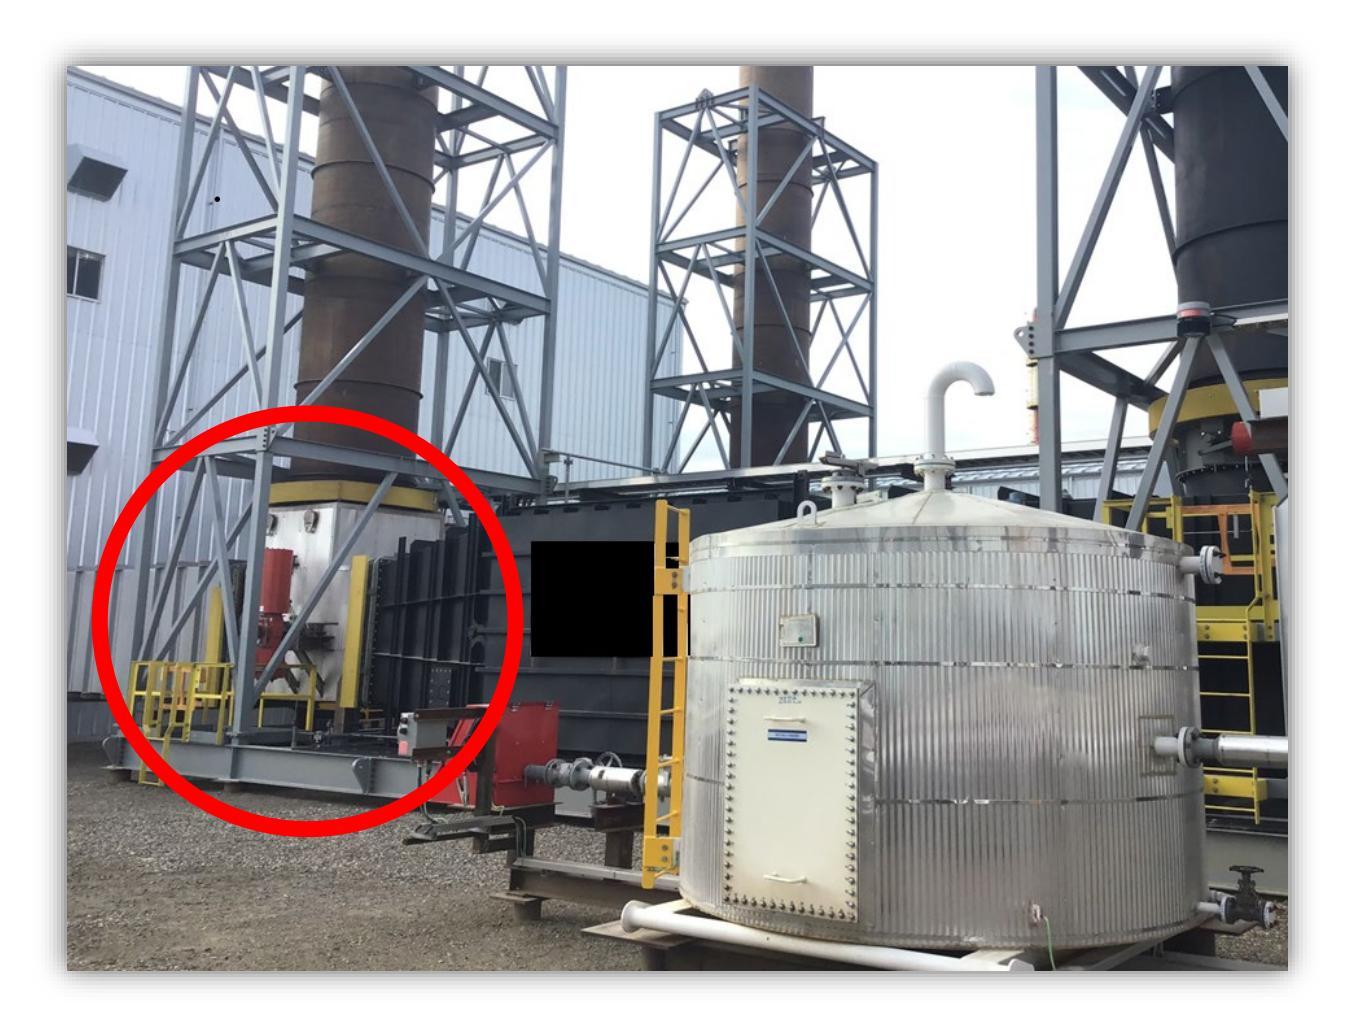
It is likely that the diverter plate design may have contributed to the uncontrolled rise in temperature during start-up of the first turbine and its waste heat exchanger.
Causes and contributing factors	It is also plausible that a weld defect occurred within the second waste heat exchanger at the weld attachment of the 2-inch drain nozzle, and that vibrations in transportation and operation of the waste heat recovery unit may have added to the weld crack propagation.

Image 1 - Example of equipment overview, this a twin system like that of the affected unit. Circled object illustrates diverter plate location – designed to divert excess heat to stack above. Diverter plate image has been withheld due to proprietary reasons.

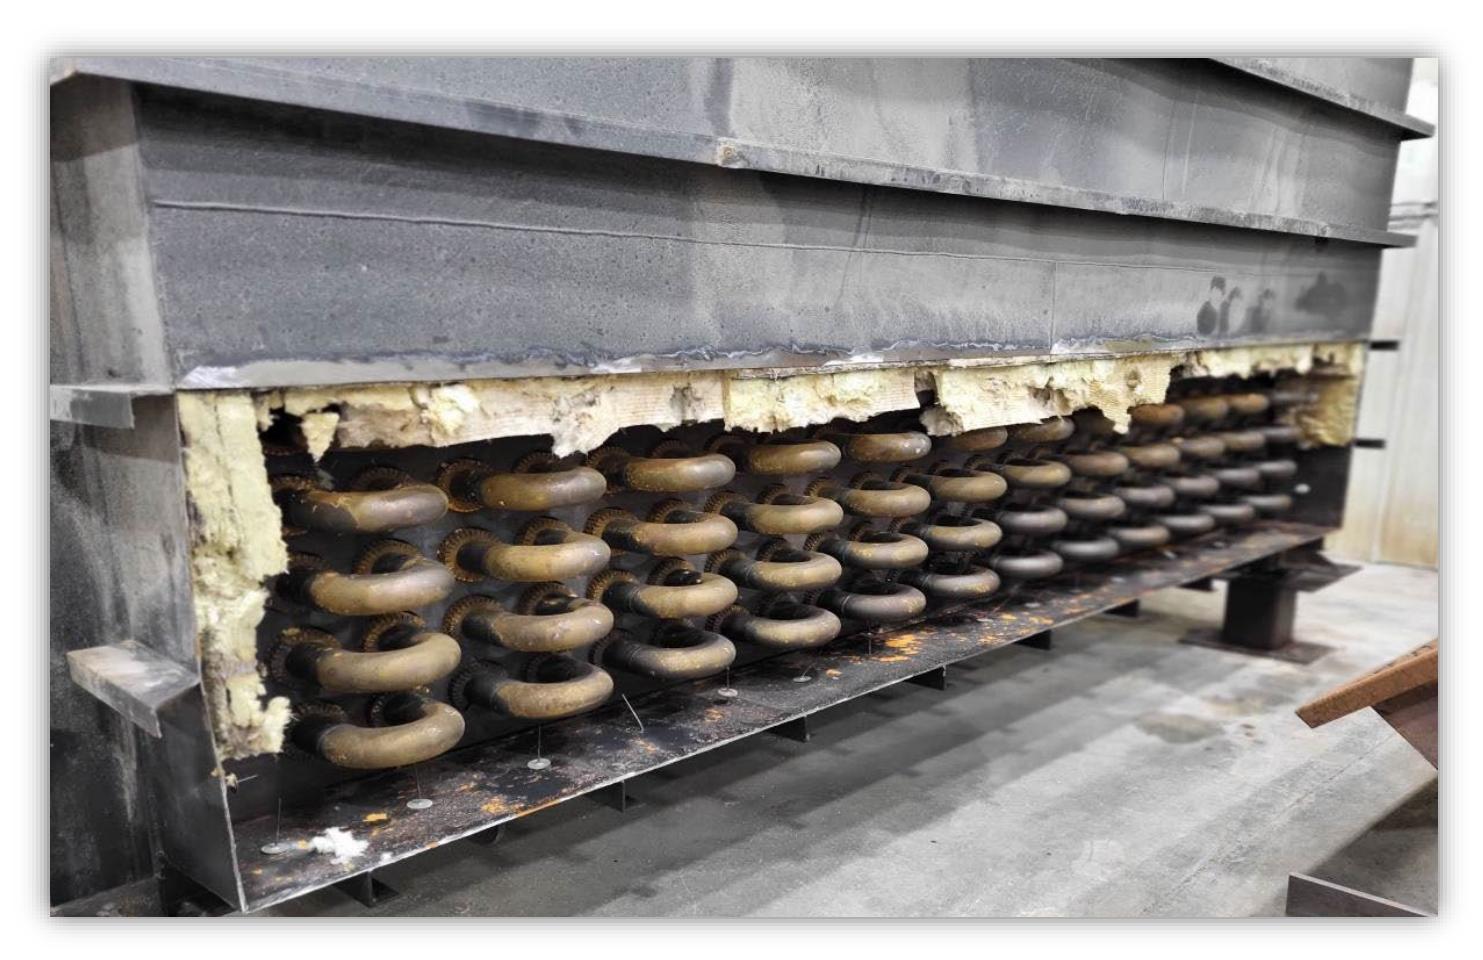
Image 2 – A general overview of the secondary waste heat recovery unit coil.

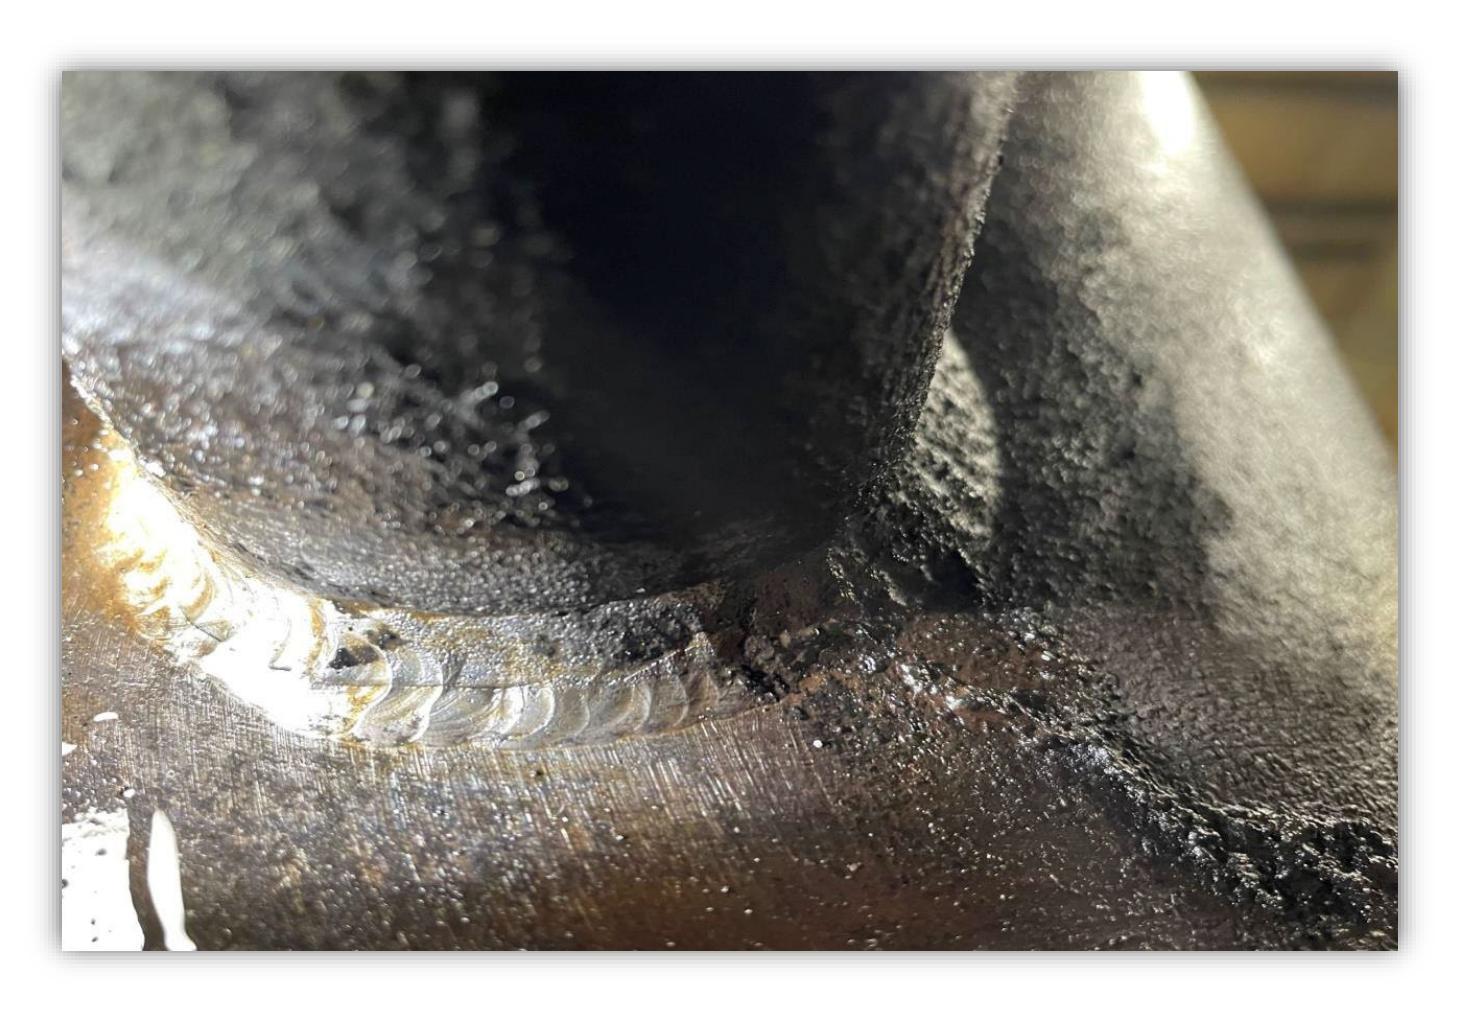
Field operations confirmed that the diverter valve on the first turbine was stuck approximately 76% in the open position. The spike in temperature activated the high temperature alarm at (242 degrees C) on the first WHRU 2-E-6255.
Facts and evidence	The diverter damper manufacturer, after further analysis, reported that the damper had made contact with the damper casing and caused resistance when attempting to fully stroke (open and close) the diverter damper during the warm-up phase. The report adds that that the damper blades get heat soaked (heat up) more quickly than the damper housing and therefore the blades expand fully while the housing does not until the equipment gets fully heat soaked.
	The second WHRU heat exchanger coil was examined further at the repair shop, and it was determined that a crack occurred on the 2-inch drain nozzle. The report from the repair shop suggests that the crack in the drain nozzle may have been due to an inherent defect within the weld attachment. This report also suggests that vibrations caused during transportation and normal operations may have added in the weld crack propagation.

Image 3 - Secondary Waste Heat Recovery unit - Weld crack discovered on the flue gas side 2-inch drain nozzle to header.
