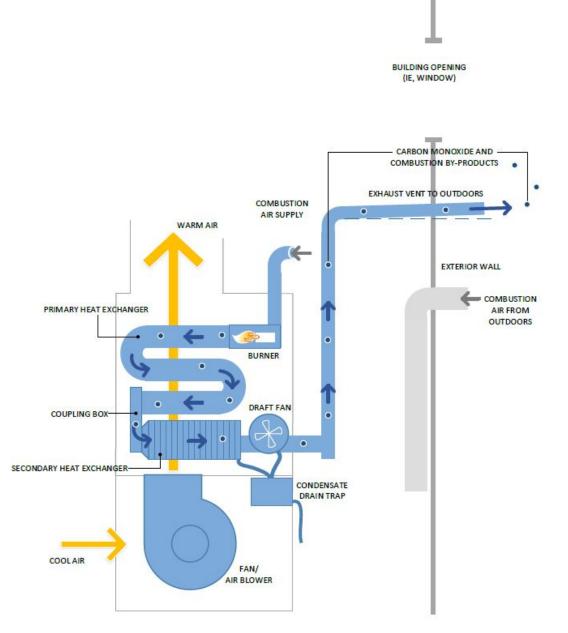
HIGH EFFICIENCY FURNACE INSTALLED IN AN "UP FLOW" ORIENTATION

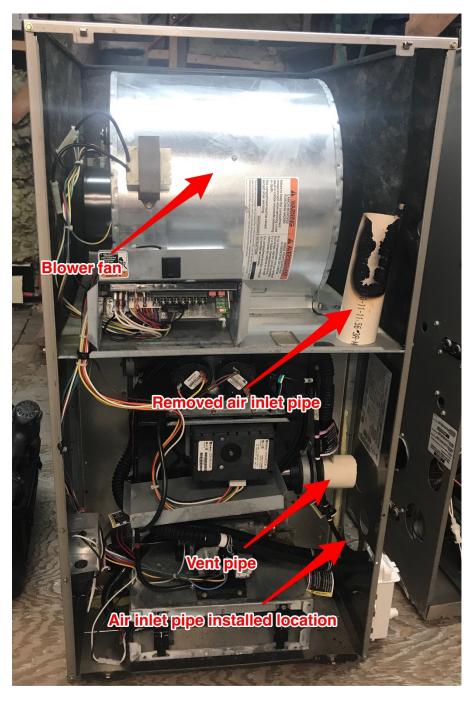
**Image 1** – Furnace after removal. Burn damage visible on the air inlet pipe which had been removed from its installed location.

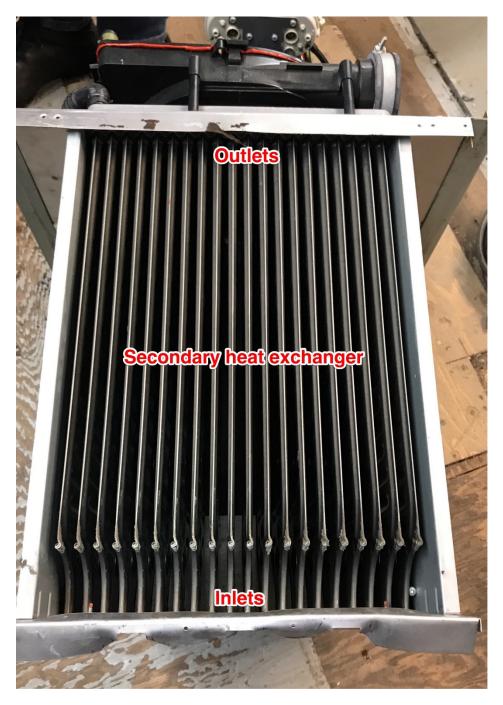
Image 3 - Secondary heat exchanger tubes that were replaced after five years of use.

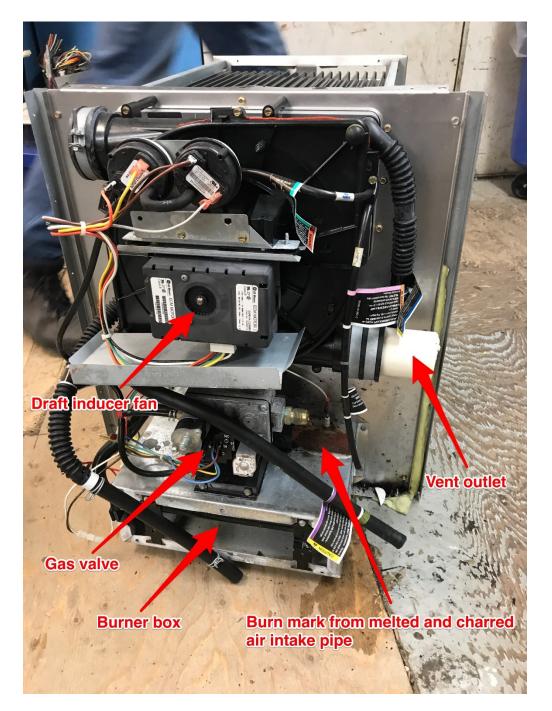
**Image 4** – Entire heat exchanger and burner assembly removed from furnace case for examination.

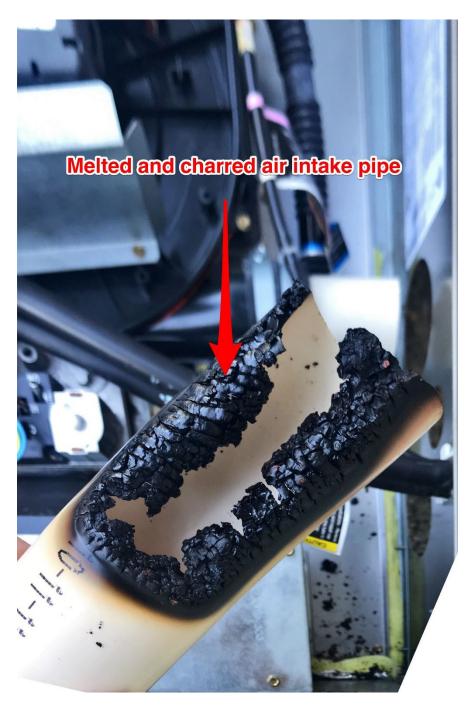
**Image 5** – Air inlet pipe removed from furnace.

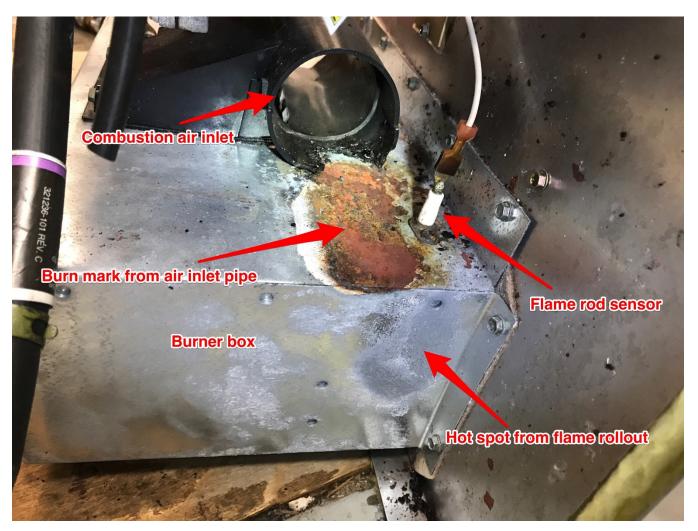
**Image 6** – Burner box showing original installed location of air inlet pipe (white PVC pipe had been removed in this photo).

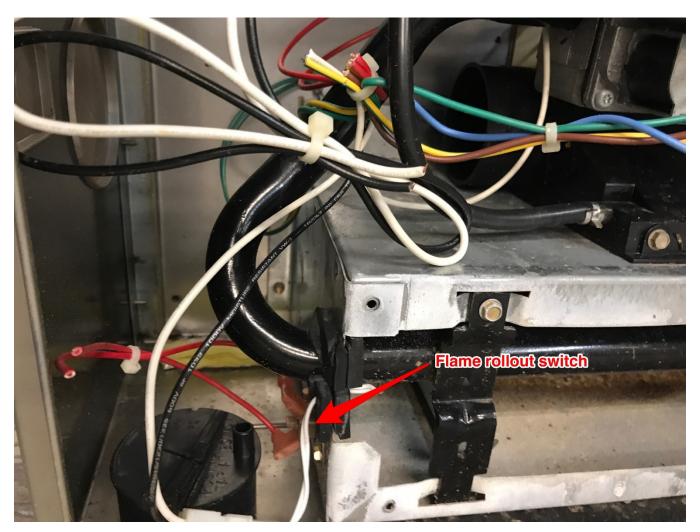
Image 7 – Flame rollout switch on opposite side of burner box from charred air inlet pipe.

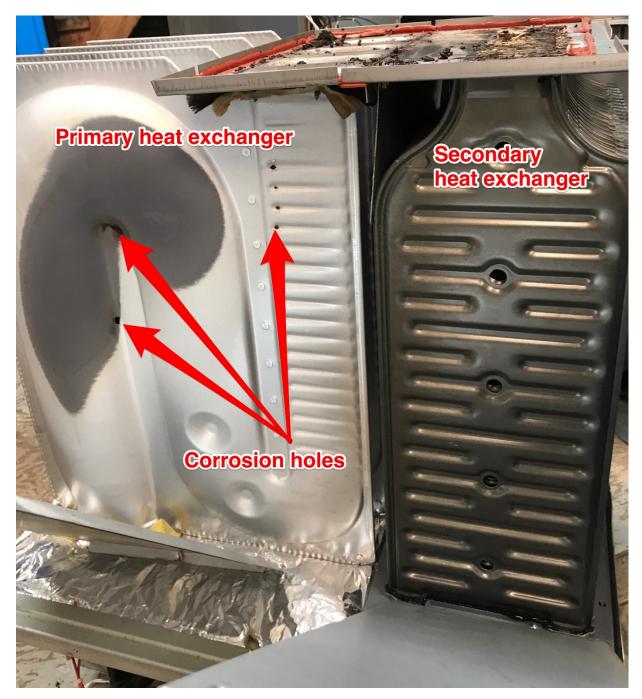
Image 8 – Heat exchangers.

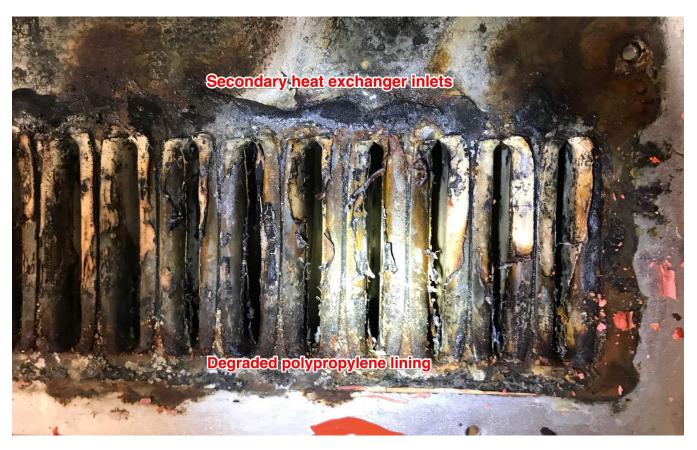
Image 9 – Replacement secondary heat exchanger tubes inlets after under 5 years of operation.

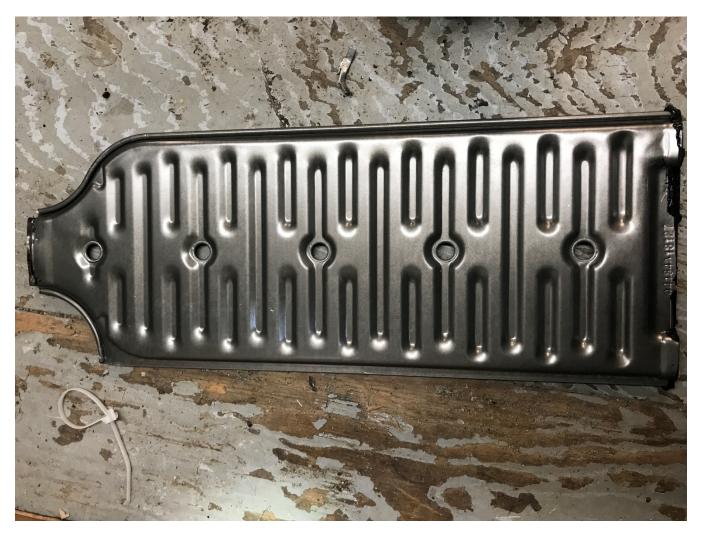
Image 10 - Replacement secondary heat exchanger tube removed for examination.

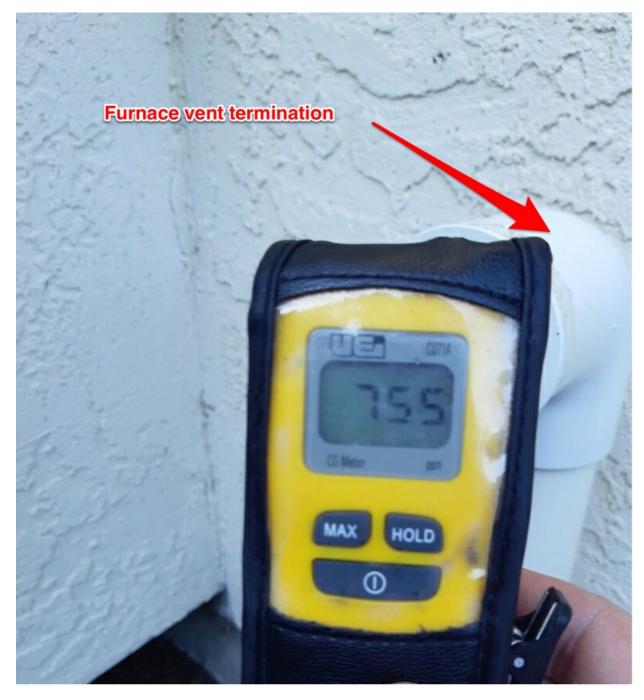
**Image 11** – Carbon monoxide meter registering 755 parts per million (ppm) at the furnace vent termination while the furnace was operating.
