## Incident Summary #II-1018194-2020 (#17917) (FINAL)

SUPPORTING INFORMATION	Incident Date		May 25, 2020
	Location		Burnaby BC
	Regulated industry sector		Gas - Natural gas system
	Impact Damage Injury	Qty injuries	0
		Injury description	NA
		Injury rating	None
		Damage description	Carbon Monoxide release into residential tower
		Damage rating	Minor
	Incident rating		Minor
	Incident overview		A boiler was producing high CO levels which were exhausted through the boiler exhaust system and carried in the ambient air by the wind currents to the inlet of the hallway pressurization unit where CO entered the building.
INVESTIGATION CONCLUSIONS	Site, system and components		<ul> <li>-A.O.Smith Copper fin tube type domestic water heater. One of two boilers that are used for heating the domestic hot water supply.</li> <li>-The boilers are not vented with atmospheric venting but are power vented to the exterior of the building. A power venter system has a motorized fan that pulls the products of combustion from the vent connection of the boiler through a horizontal vent and out through a combination, wall mounted, power venter and vent termination.</li> <li>-The hallway pressurization unit i

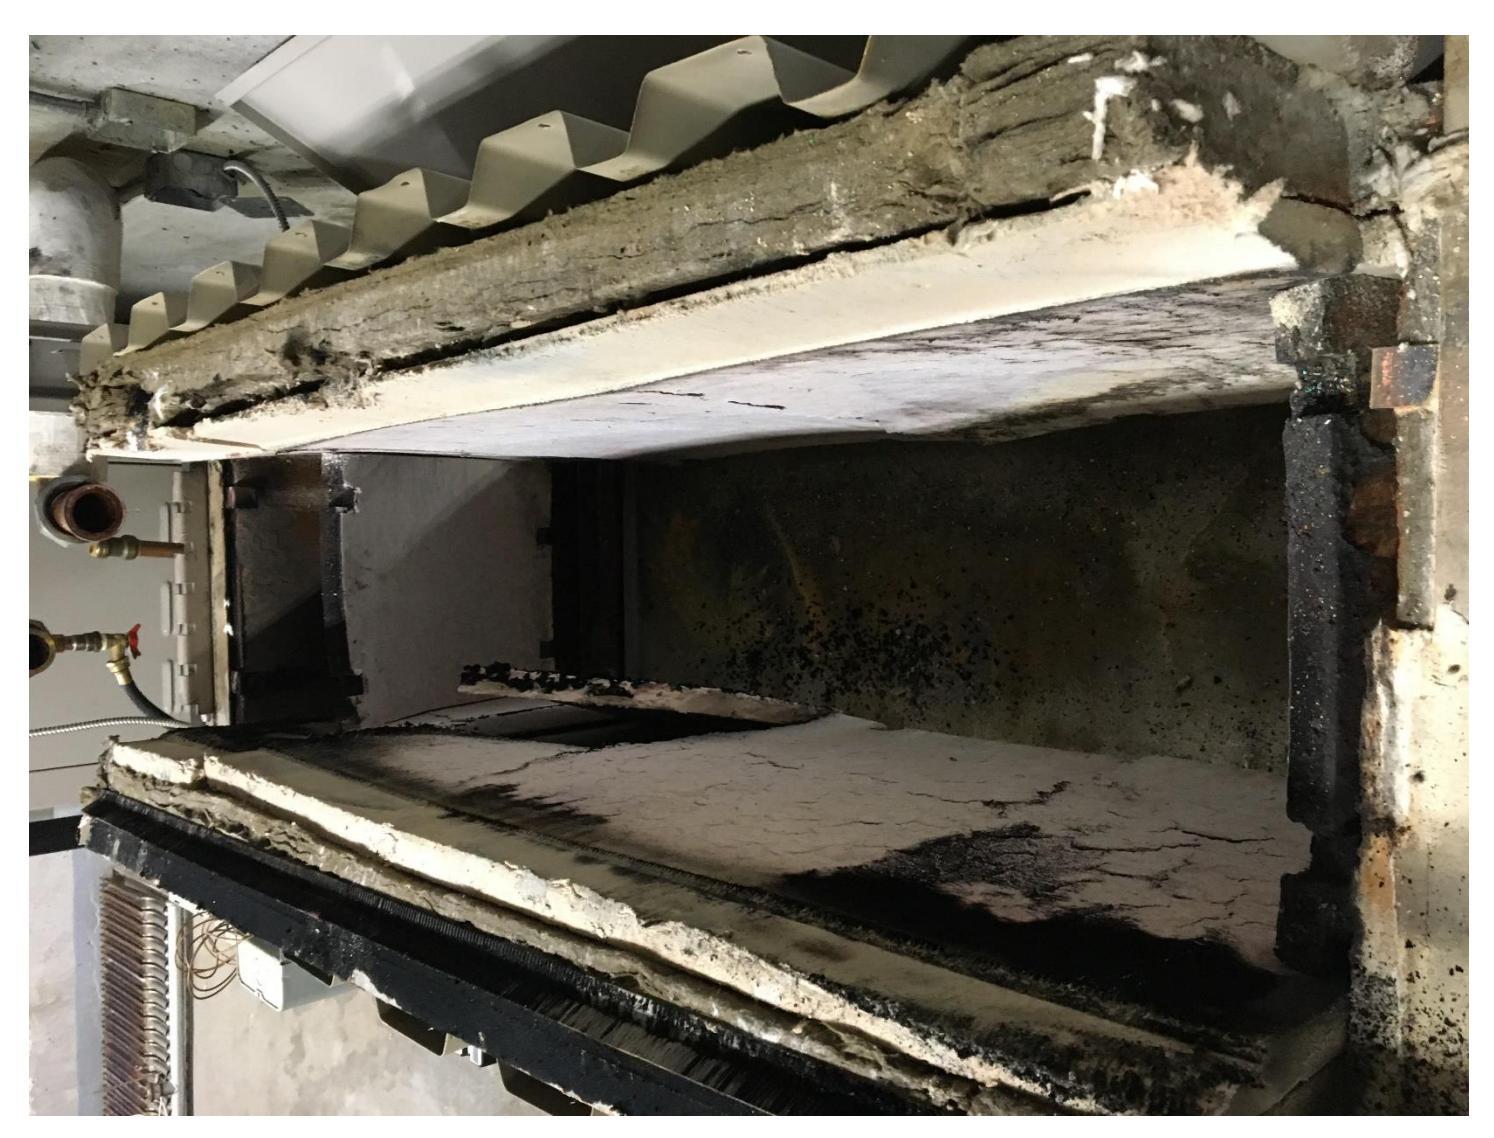
- A section of the internal boiler refractory material had fallen down on the burner tray disrupting the flames proper combustion characteristics and causing incomplete combustion creating high levels of carbon monoxide in the exhaust and soot on the heat exchanger.

Boiler with heat exchanger removed

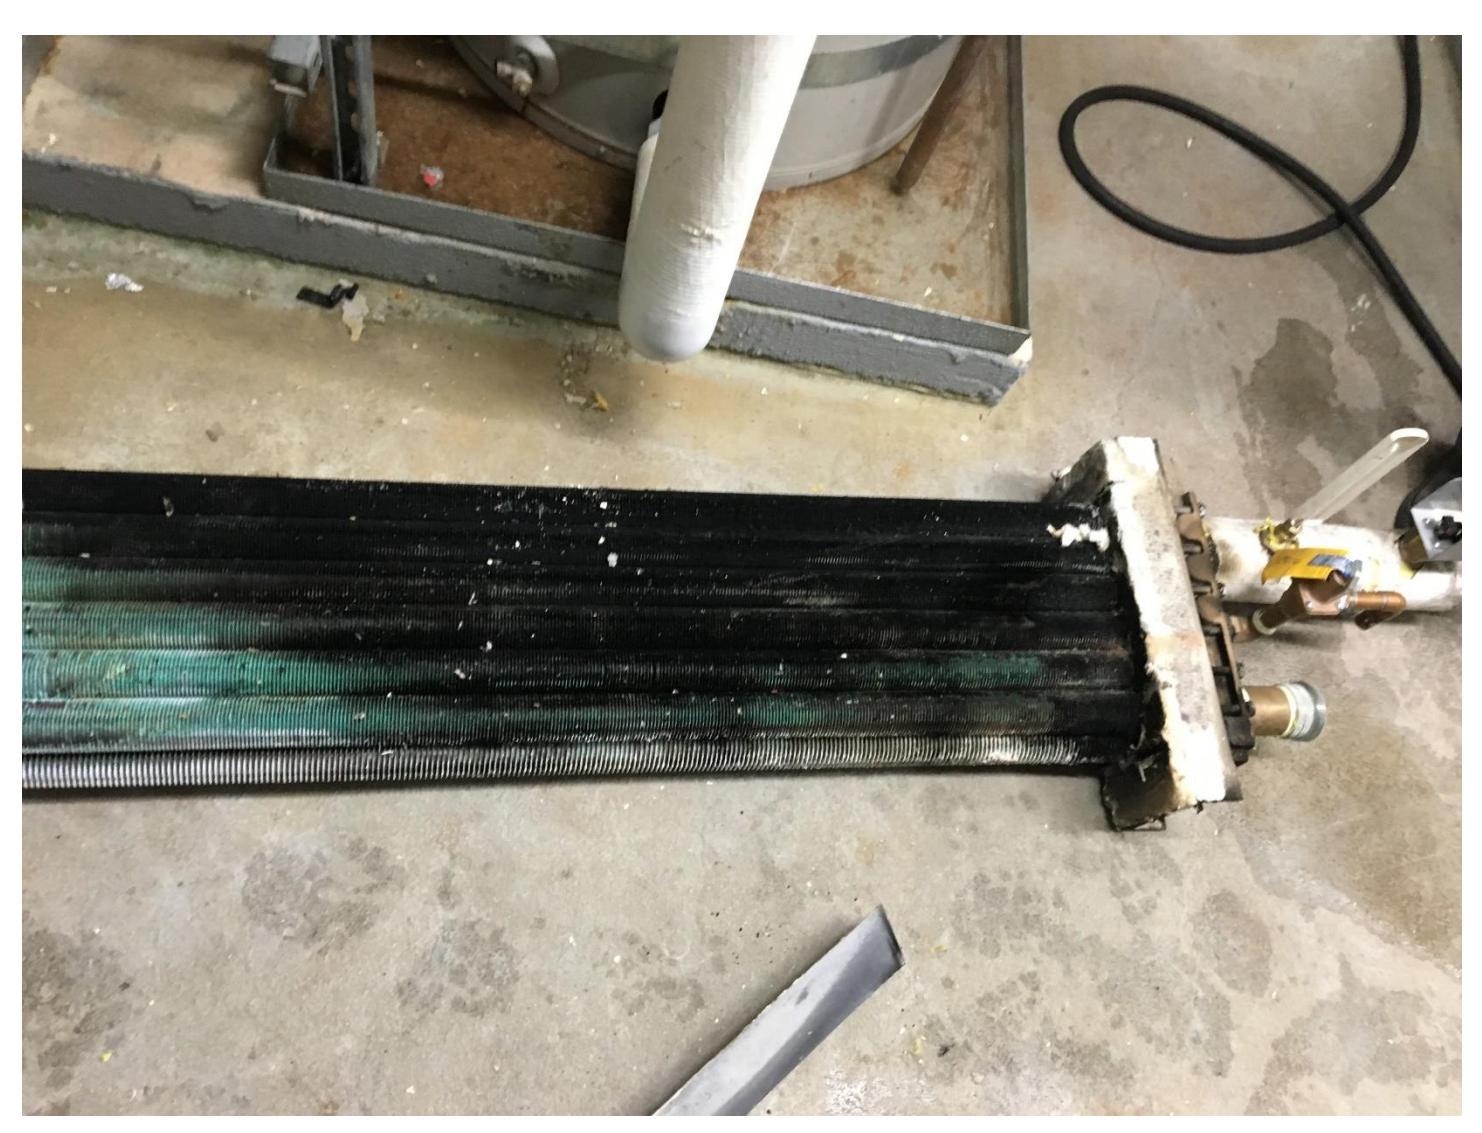
-Copper fin tube type boilers require regular cleaning of the buildup on the heat exchangers created from the reaction between the copper and the products of combustion.
	-The boiler did not appear to have been cleaned prior to the incident.
	-The heat exchanger was plugged with soot and the refractory material was visible resting on the burner tray.

Boiler heat exchanger showing soot and buildup on burner tubes

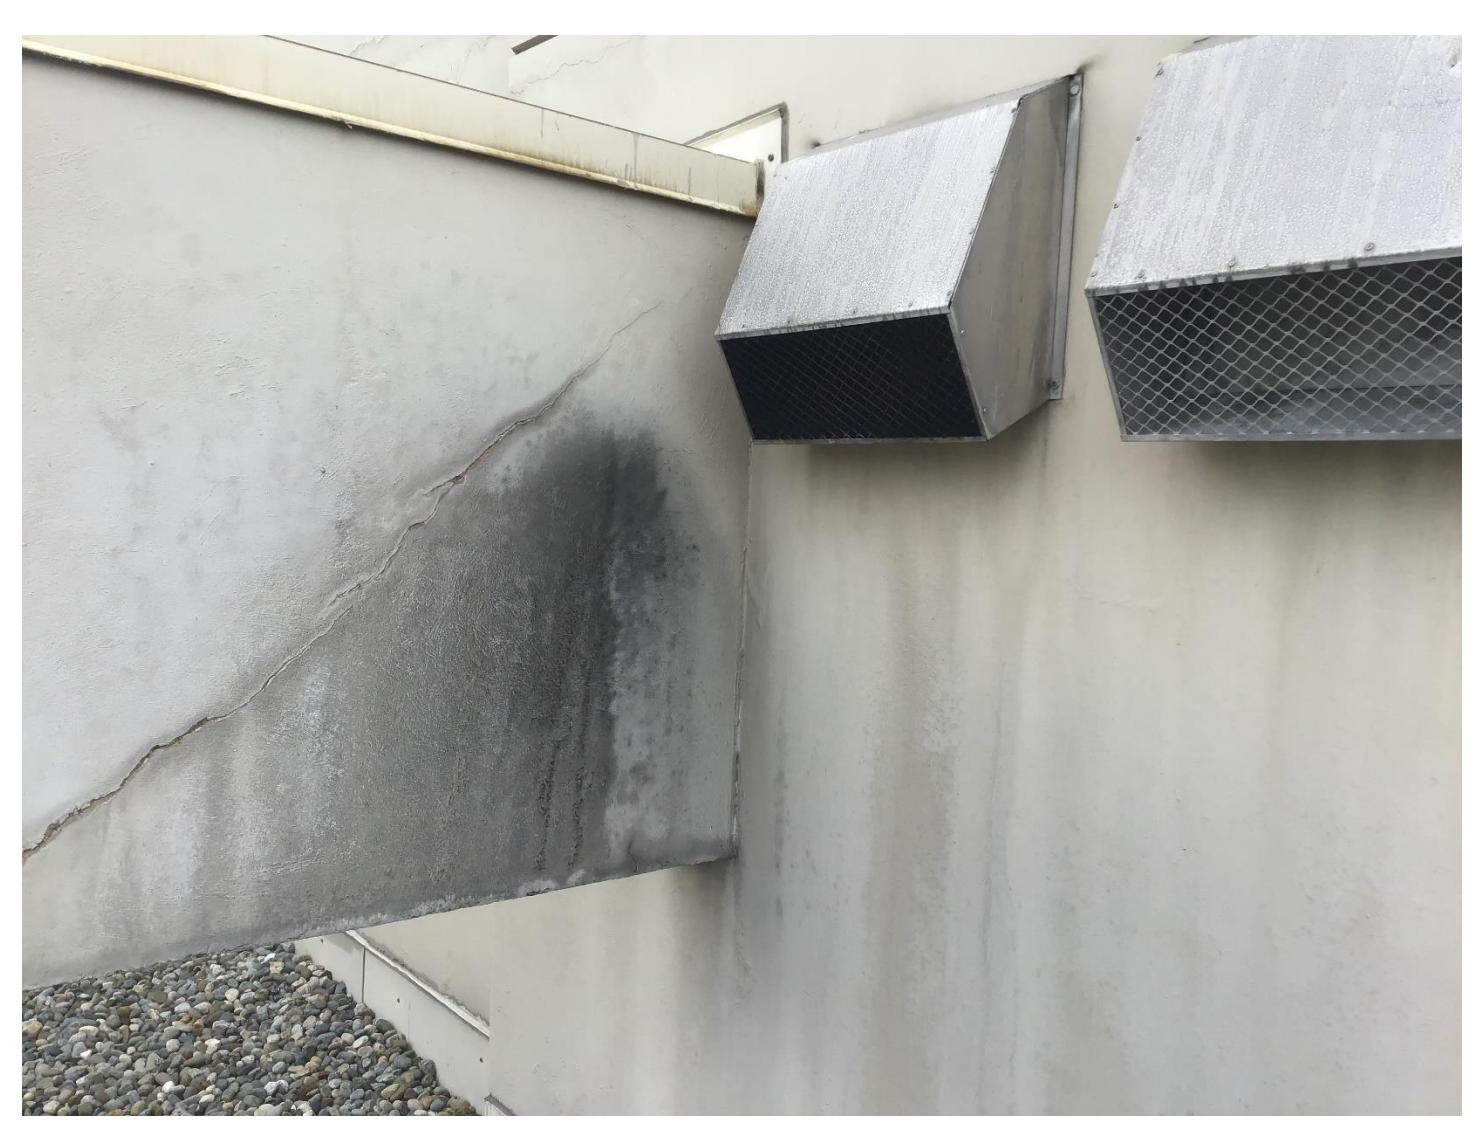
- Soot was evident on the boiler exhaust vent outlet and on the concrete above the opening into the roof well containing the hall pressurization unit.

Boiler exhaust vent termination with visible soot

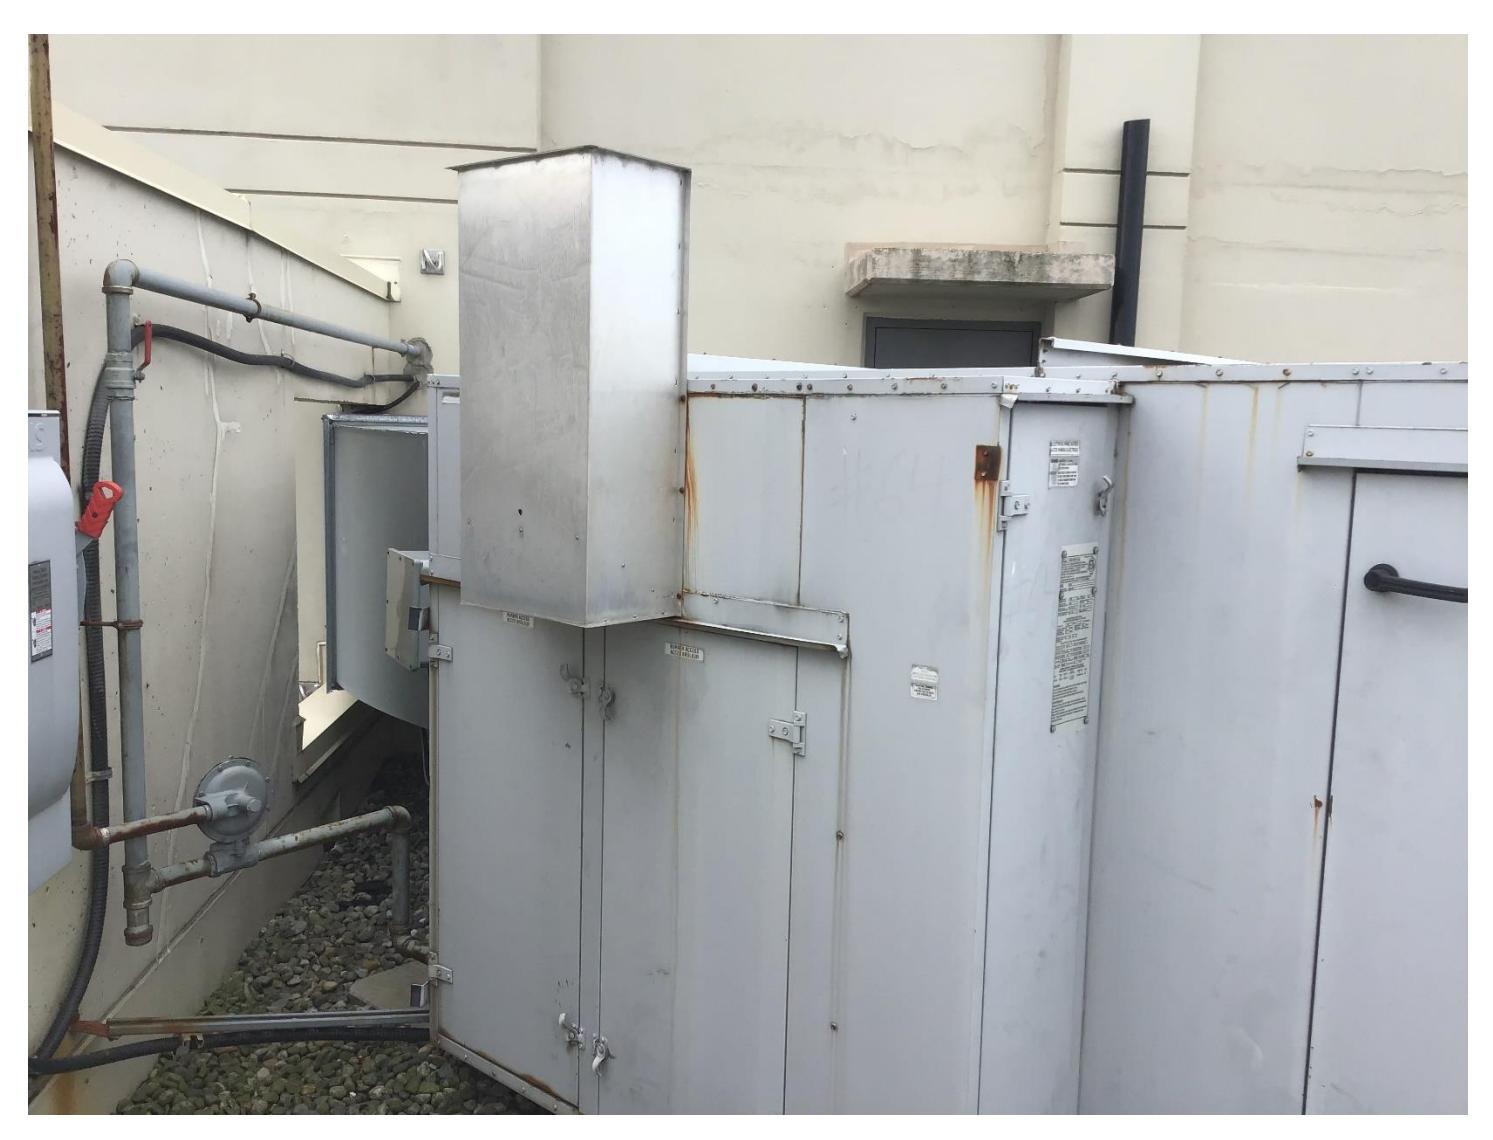
- The warmth from the products of combustion from the second boiler's exhaust outlet could be felt as the wind carried the exhaust gases through the opening into the roof well enclosure containing the hall pressurization unit.
	<ul> <li>The installation meets Code clearance requirements between the boiler exhaust outlets on the exterior of the building and the hall pressurization unit.</li> </ul>
Causes and contributing factors	It is very likely that the refractory material falling onto the burner tray created flame impingement which resulted in incomplete combustion, soot formation on the heat exchanger and high levels of carbon monoxide in the exhaust gases. Prevailing winds carried the exhaust gasses towards the inlet of the make-up air unit

Make-up air unit for hallway pressurization
