Incident Summary #II-1377385-2022 (#27952) (FINAL)

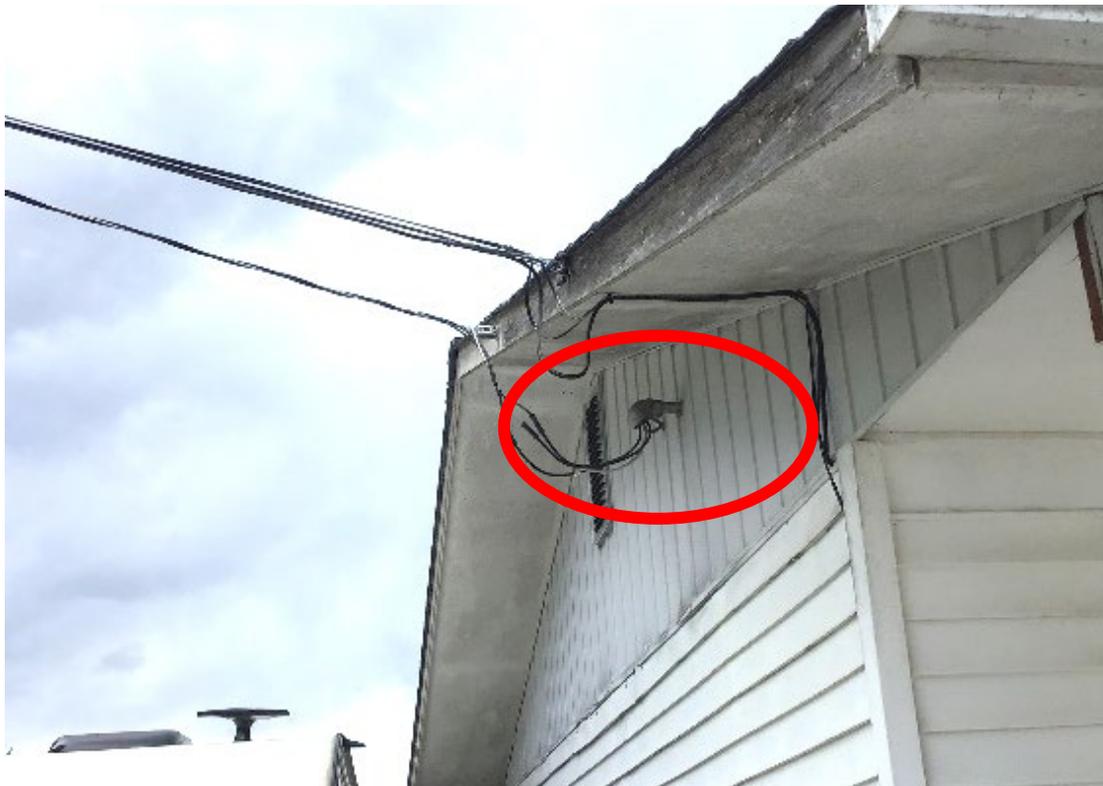
Photo 1 - Existing utility connection point overhead

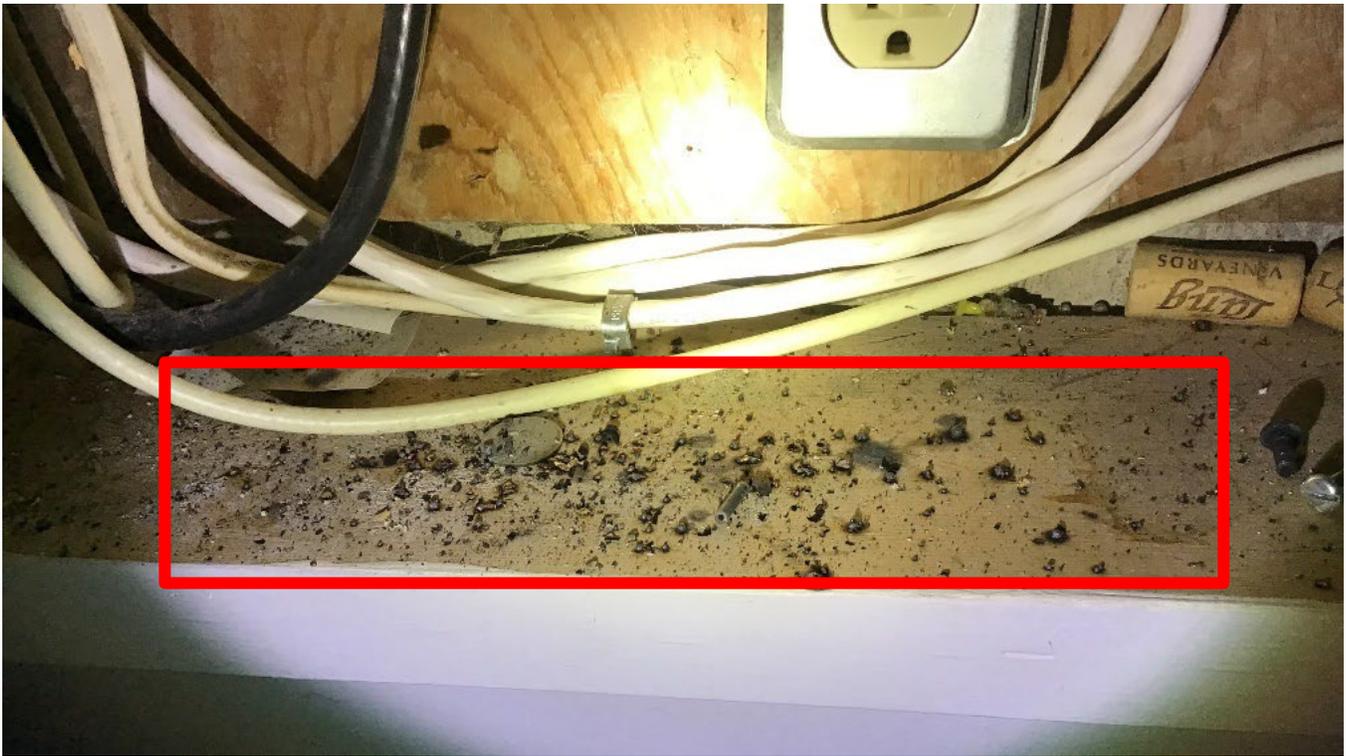
Photo 5 - Slag found below panel board.

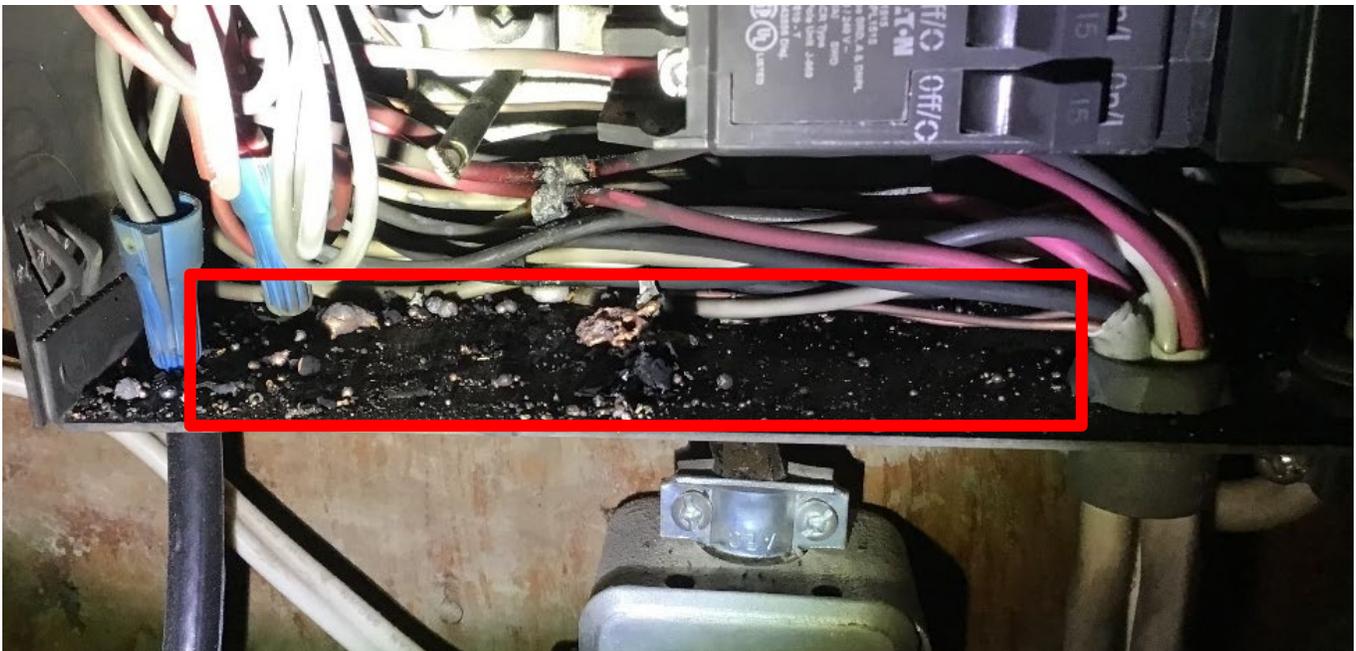
Photo 6 - Slag located inside bottom of panel board

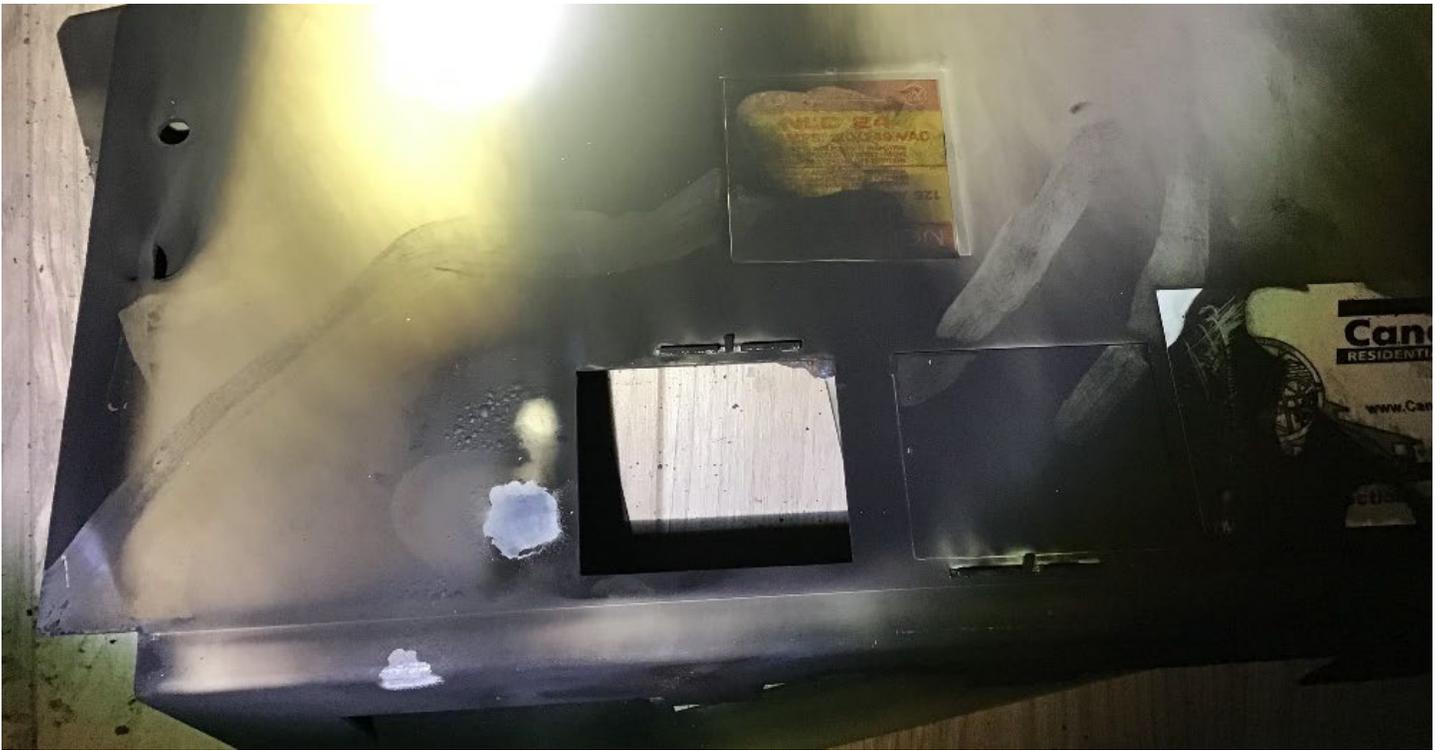
Photo 7 - Smoke damaged can be seen on the outside of the main breaker section cover.

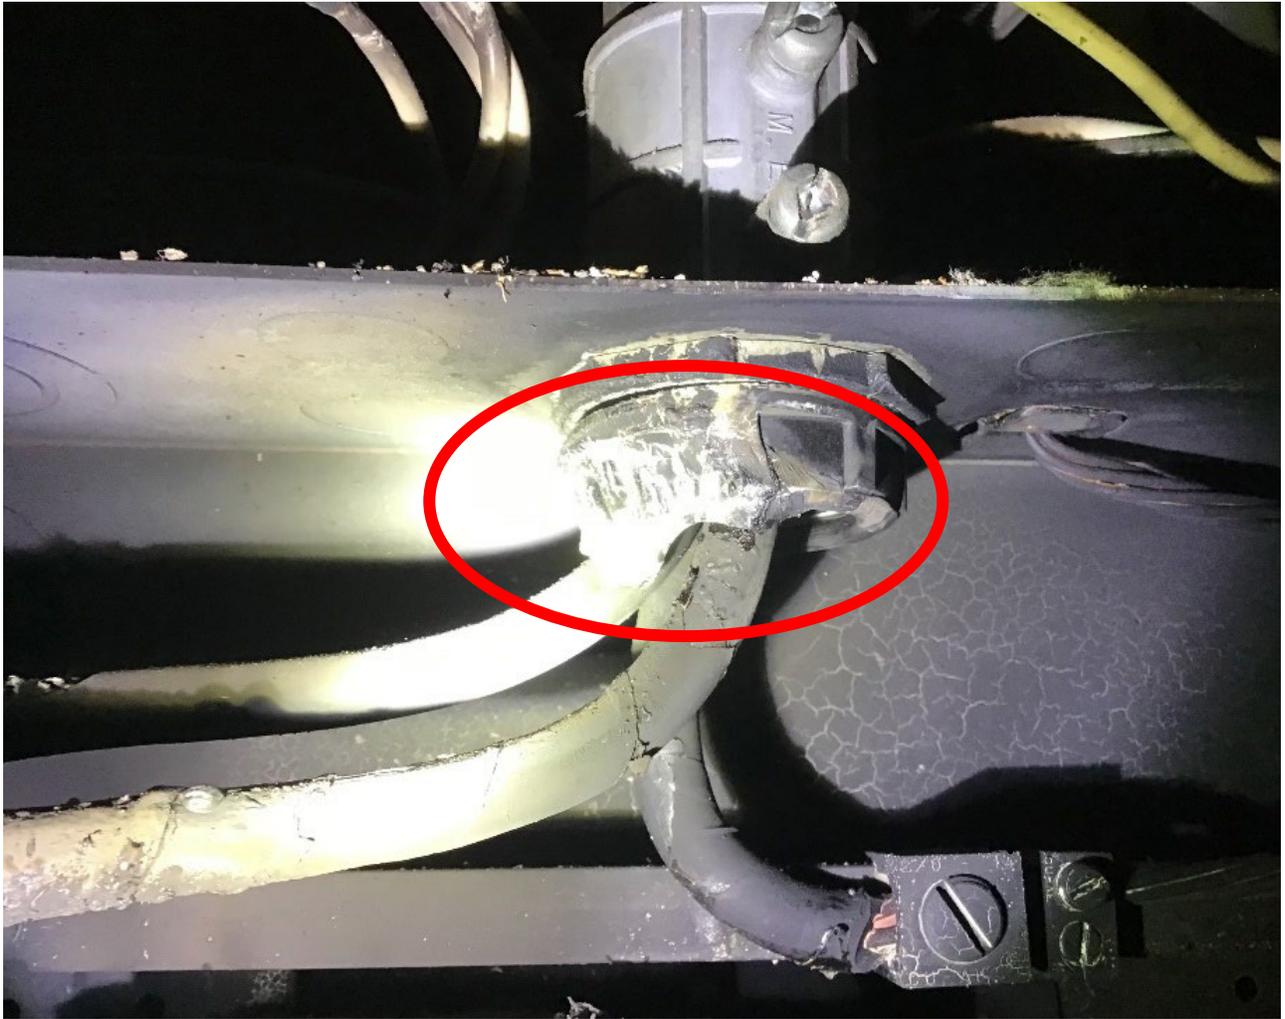
Photo 8 - Consumer service conductors entering top of panel. Visible melting of plastic bushing and smoke damage.

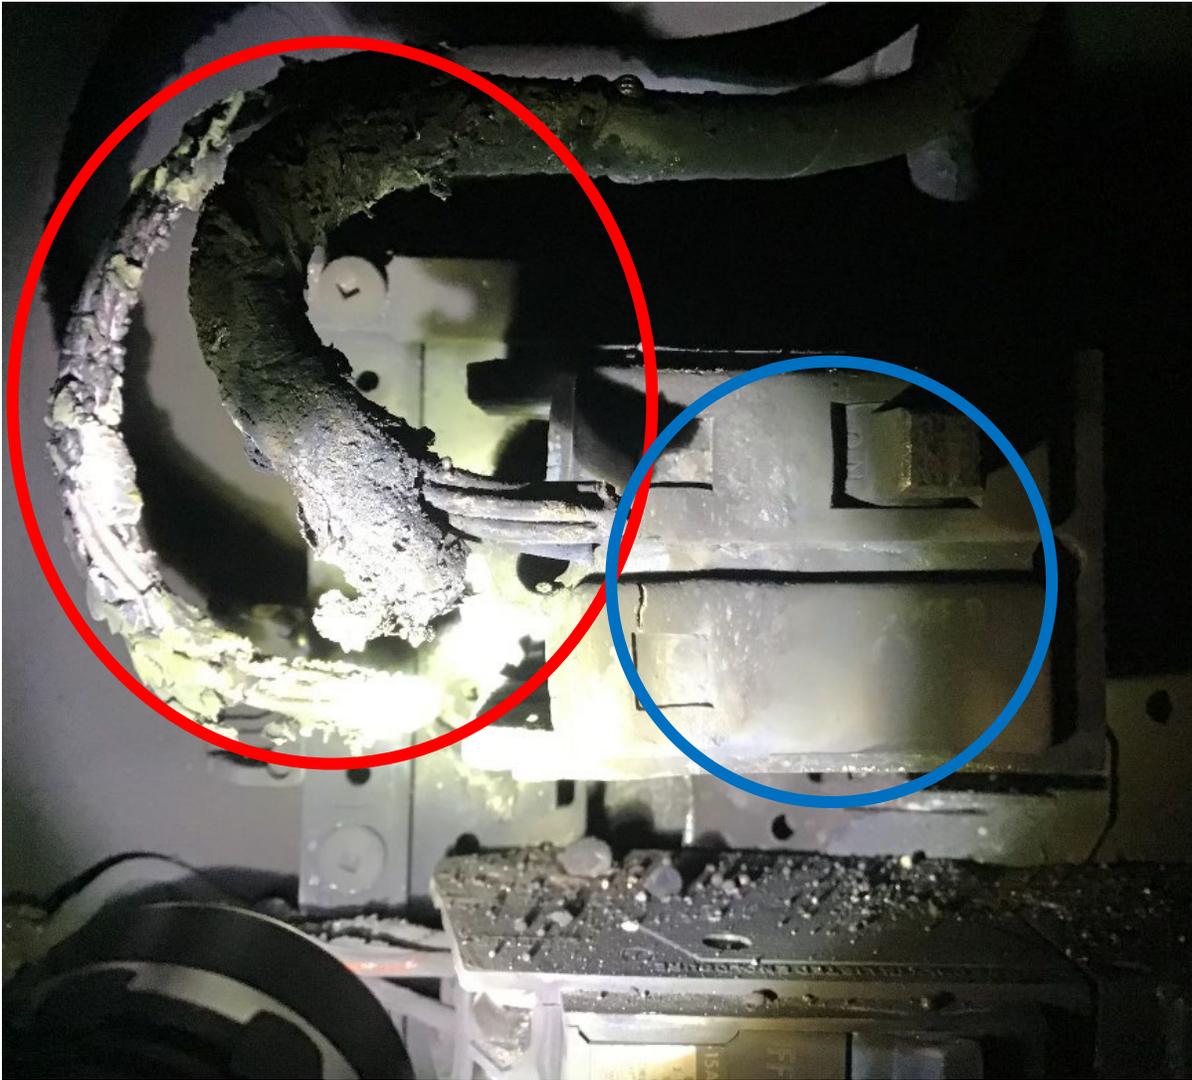
Photo 9 – **RED:** Burnt service conductors. **BLUE:** Main breaker and burnt

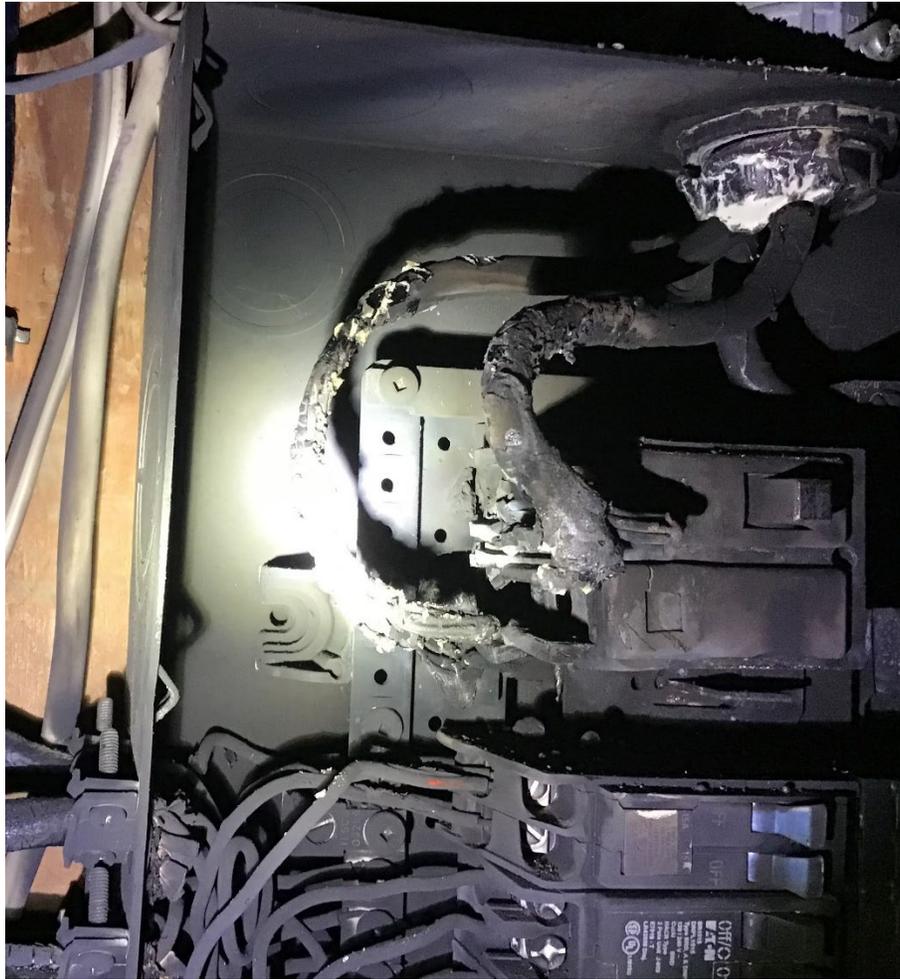
Photo 9 – Main Breaker section showing burnt service conductors and smoke damage throughout electrical panel.
