Incident Summary #II-1266942-2021 (#24374) (FINAL)

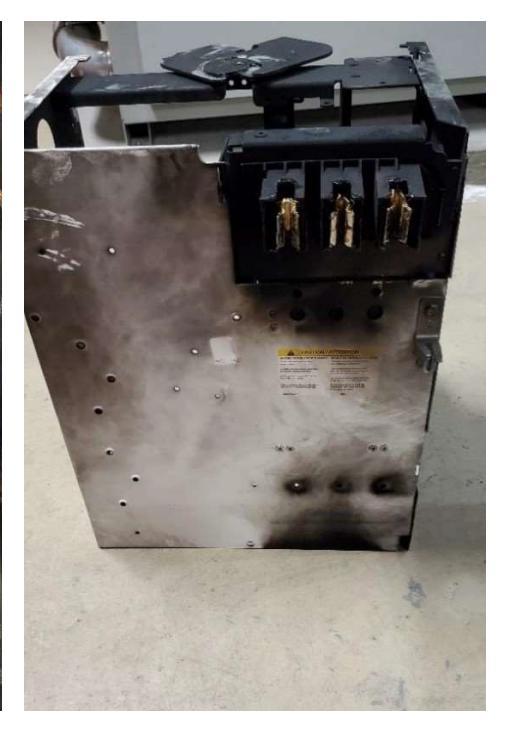
The damaged 200amp MCC bucket was removed from the New MCC and inspected.
	It was during this removal procedure that the lead electrician performed an inspection, and that it was seen that 2x phases of the line side terminals of the 200amp molded case circuit breaker were found loose and that the conductors from the breaker terminals to the frame jaw assembly were not effectively tightened/torqued (frame terminals were tight) (<i>see figure 3</i>).

Figure 3 – MCC Bucket rear view showing what components attach to the buss assembly.

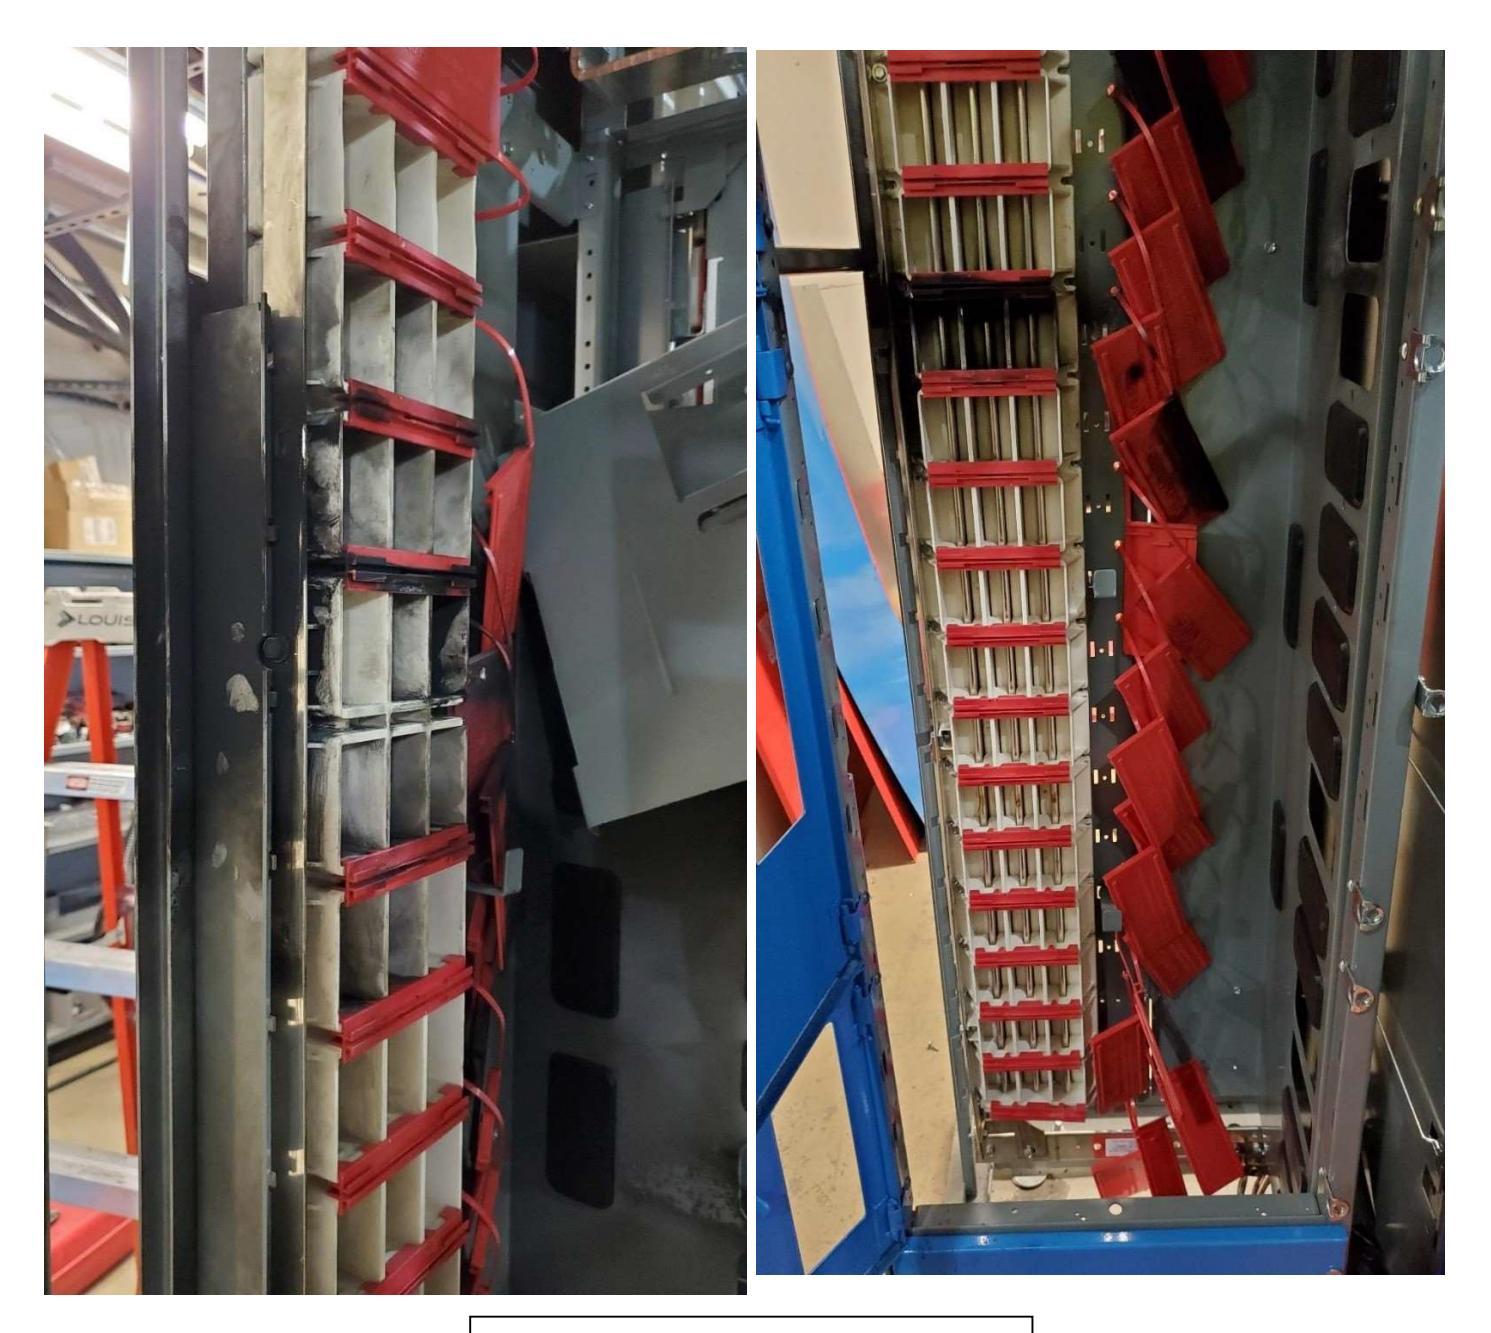
Figure 4 – MCC Buss-bar assembly located within the MCC enclosure behind the buckets.

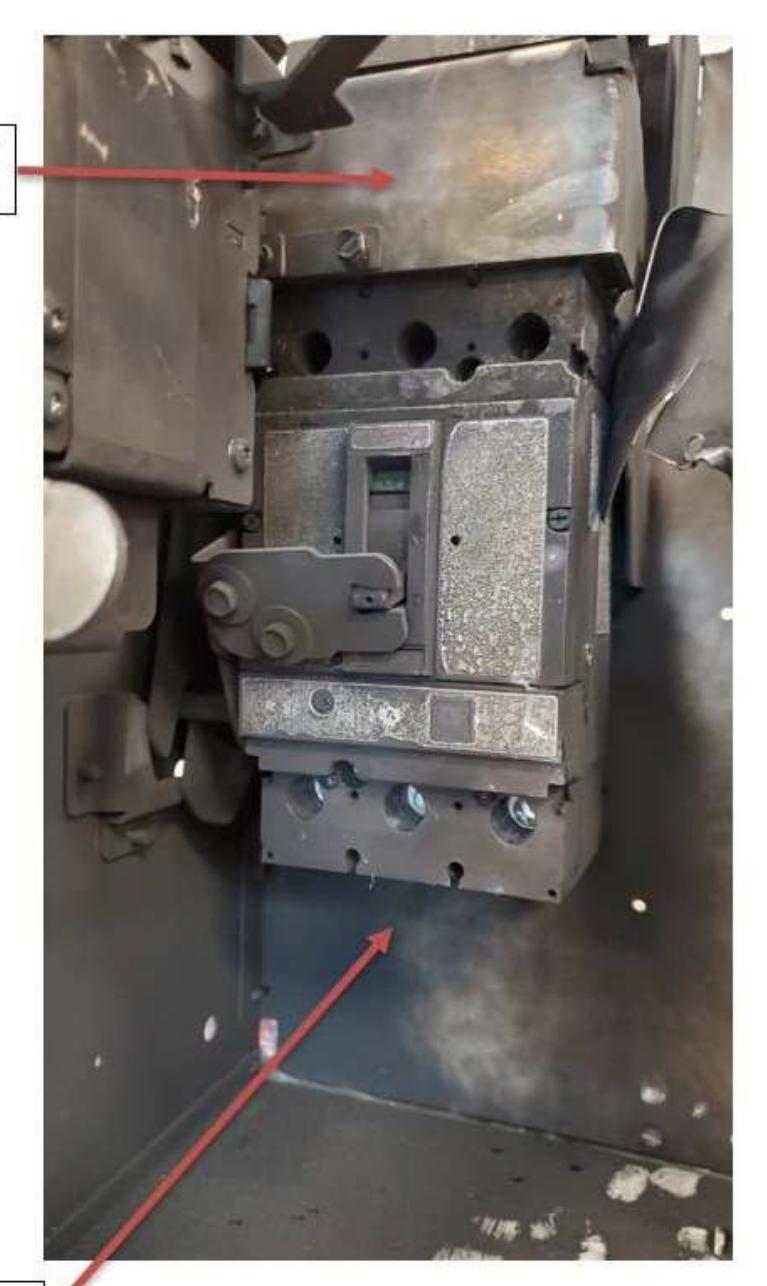
LINE side connections from manufacturer take place within this compartment here.

Figure 5 – MCC Bucket 200amp 3pole molded case circuit breaker.

LOAD side connections from the Duty Holder take place within this compartment here on the load side of the breaker.

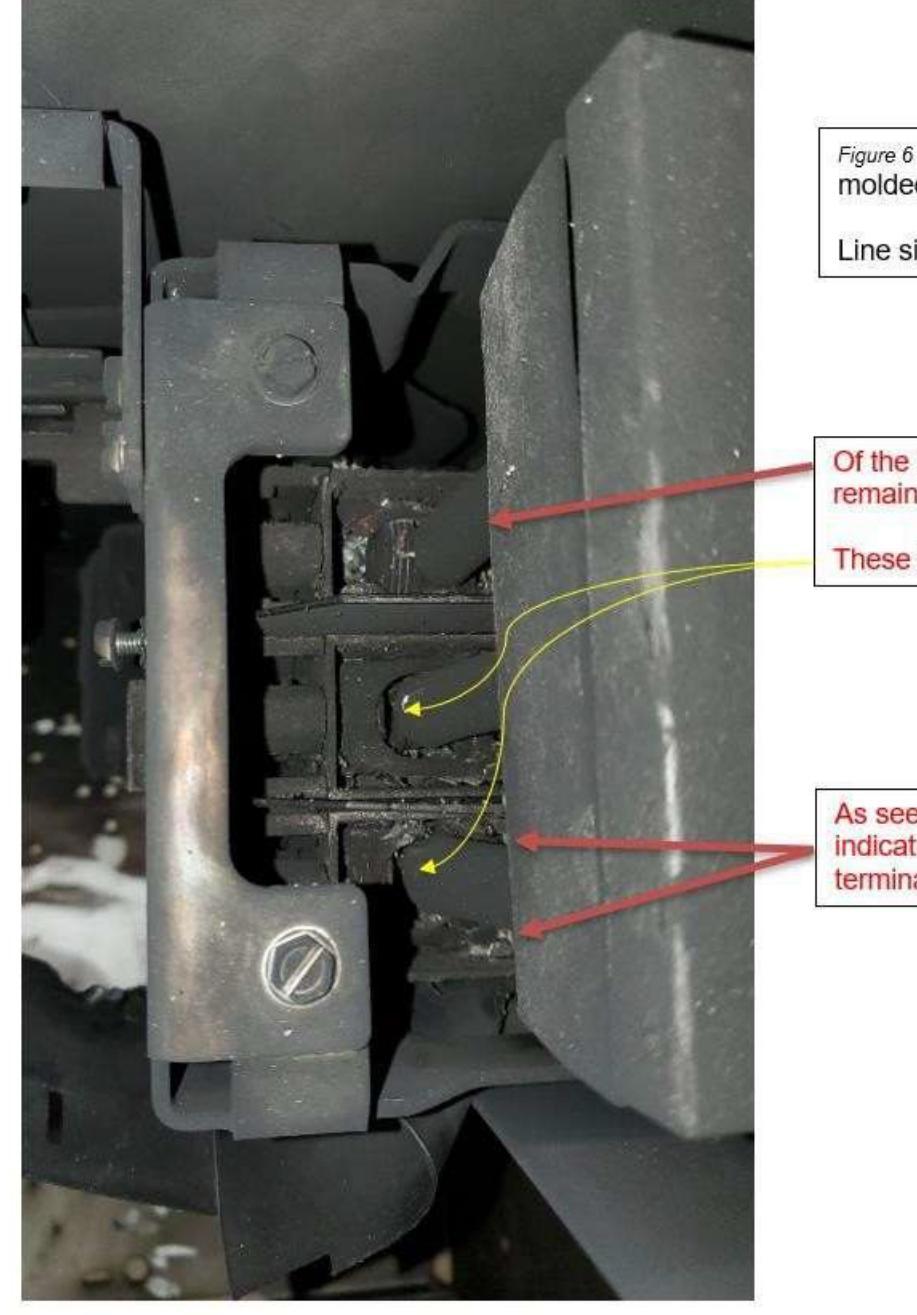
When the electricians energized the MCC 200amp breaker without the PDC load connected, the test readings revealed 600volts phase to phase and 347volts phase to ground. Upon energizing with a load, potentially caused the breaker line side terminal, 2x phase conductors that were not tightened to their respective terminals** to arc over (<i>see figure 6</i>). ** When a conductor carries a load, it requires a solid connection wherever multiple components intersect. If that connection point is loose, arcing may occur at the loose connection resulting in increasing heat, resistance and current.
Causes and contributing factors	It is highly probable that the factory built MCC bucket/breaker assembly was assembled, having the terminal connections of that particular circuit breaker bucket not being adequately torqued/tightened.

Figure 6 – MCC Bucket 200amp 3-pole molded case circuit breaker.

Line side factory installed connections.

Of the 3 phases, as found, this one remained torqued tight.

These 2 were found too not be tight.

As seen, there are no "welding" marks indicative of a short circuit condition, just terminal alloy destruction.
