Incident Summary #II-1441519-2022 (#29935) (FINAL)

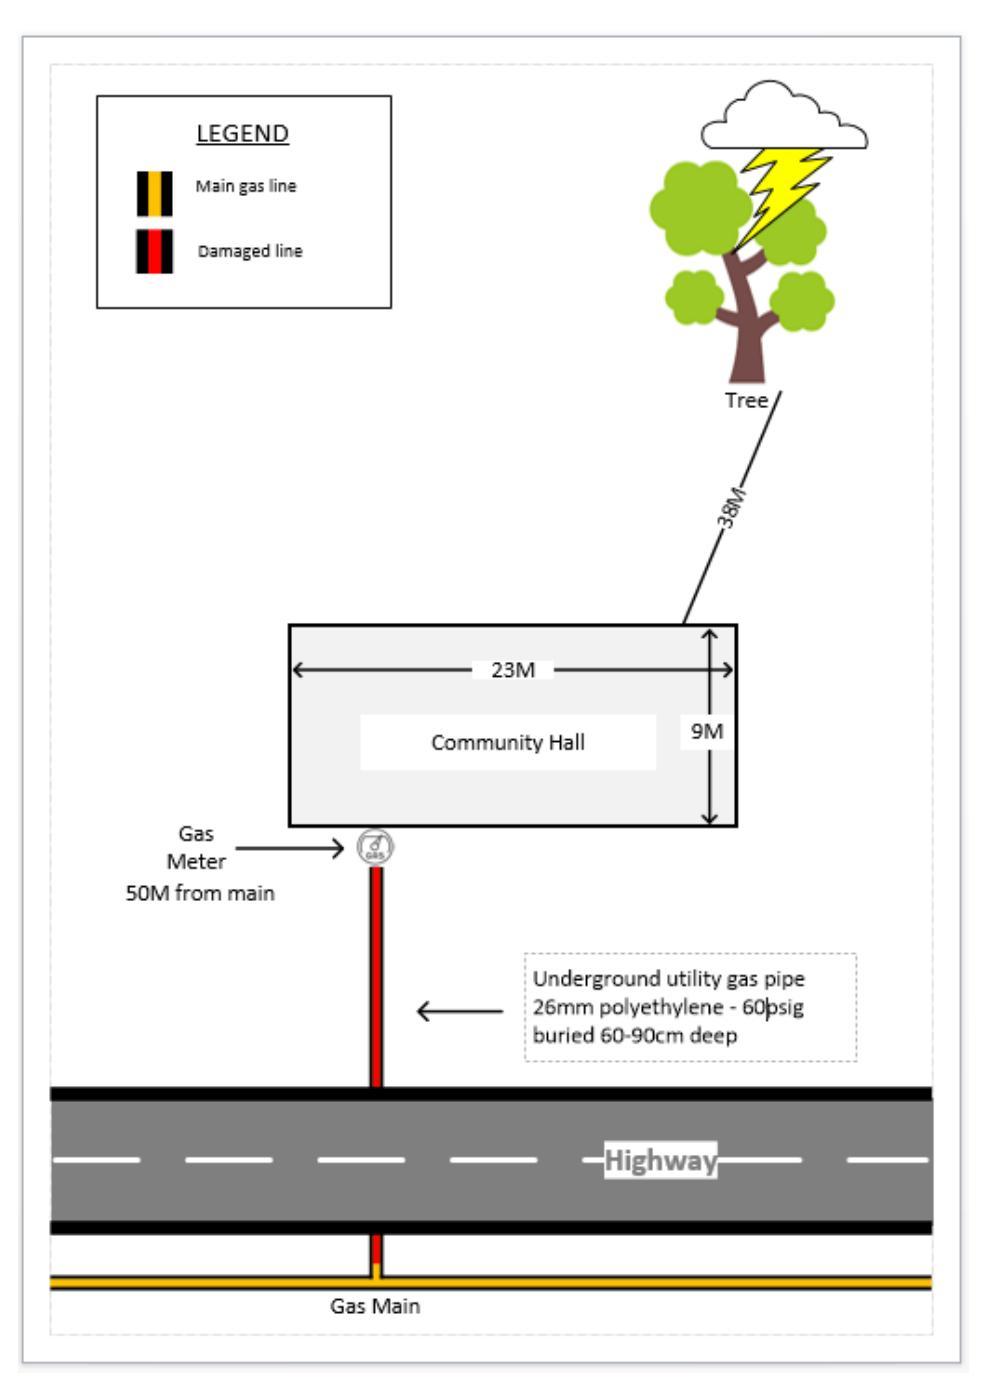
Photo 1 – shows locations of the damaged gas line and a tree that was struck by lightning.

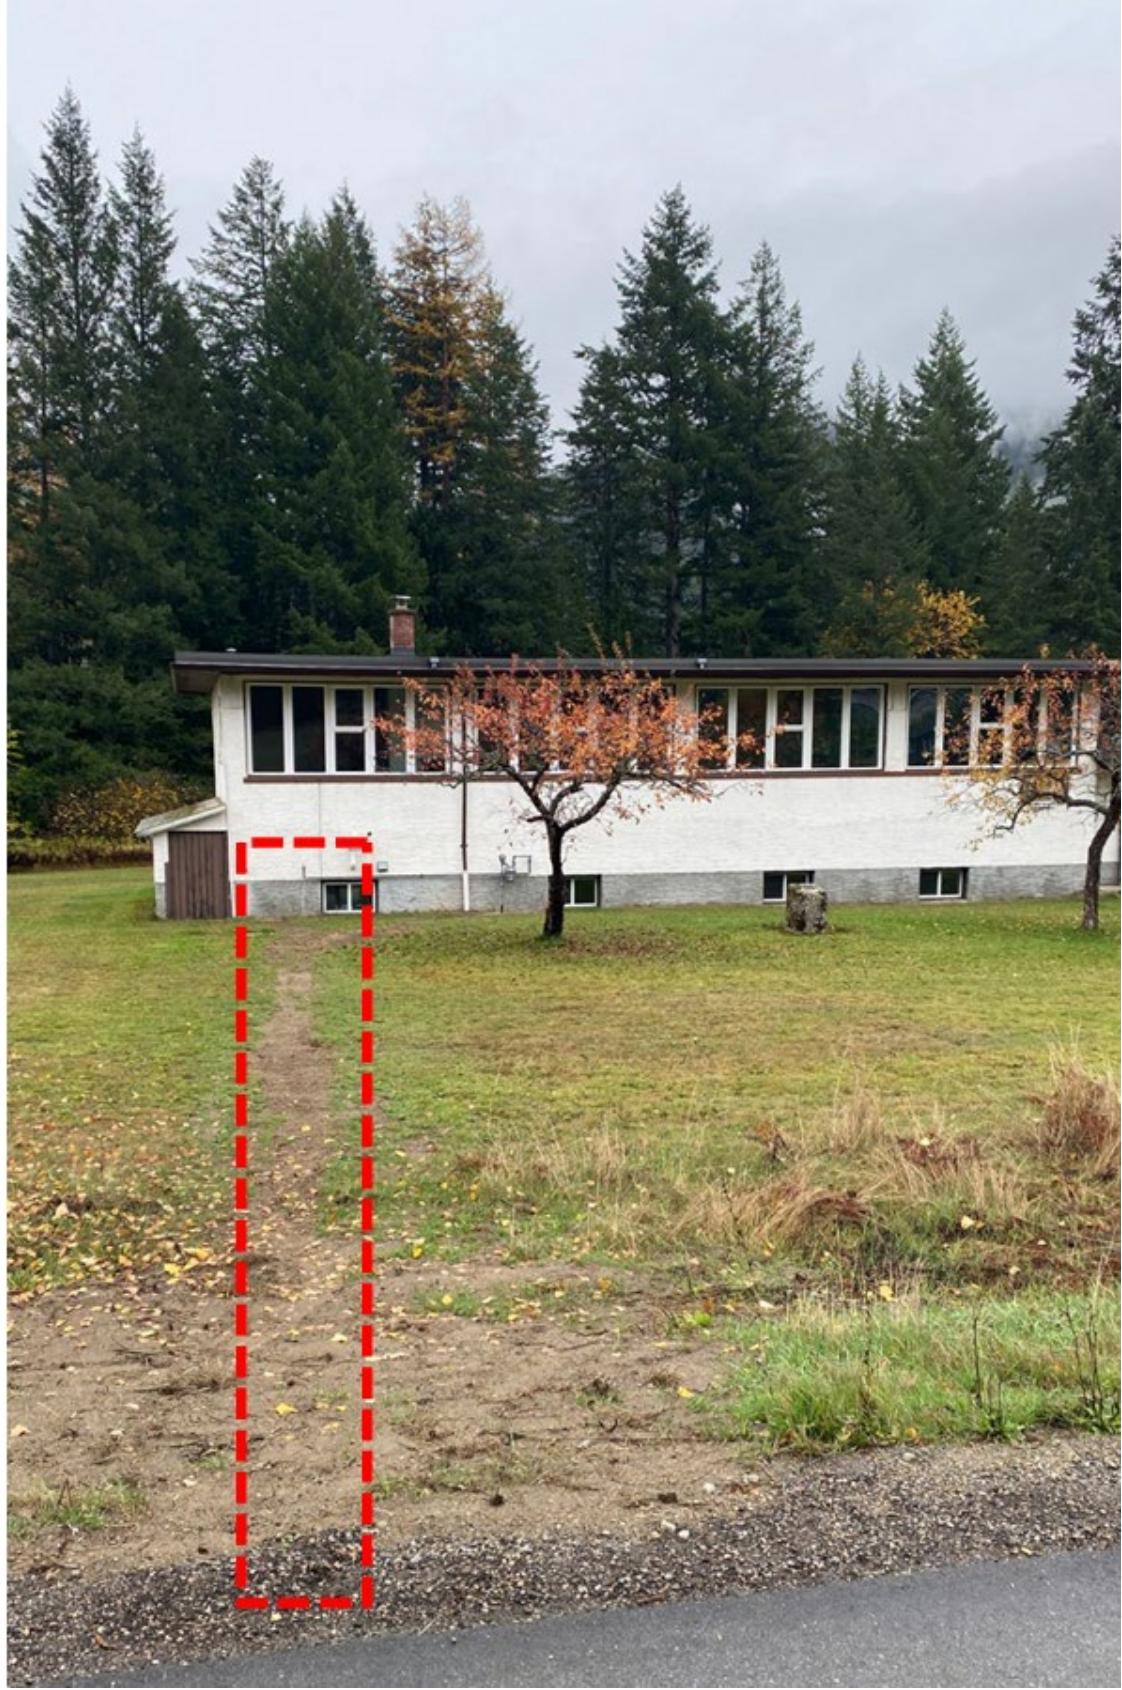
Photo 2 – Community Hall from highway after repairs were completed. **RED** - shows original location of gas meter at building and path of leaking underground gas line.

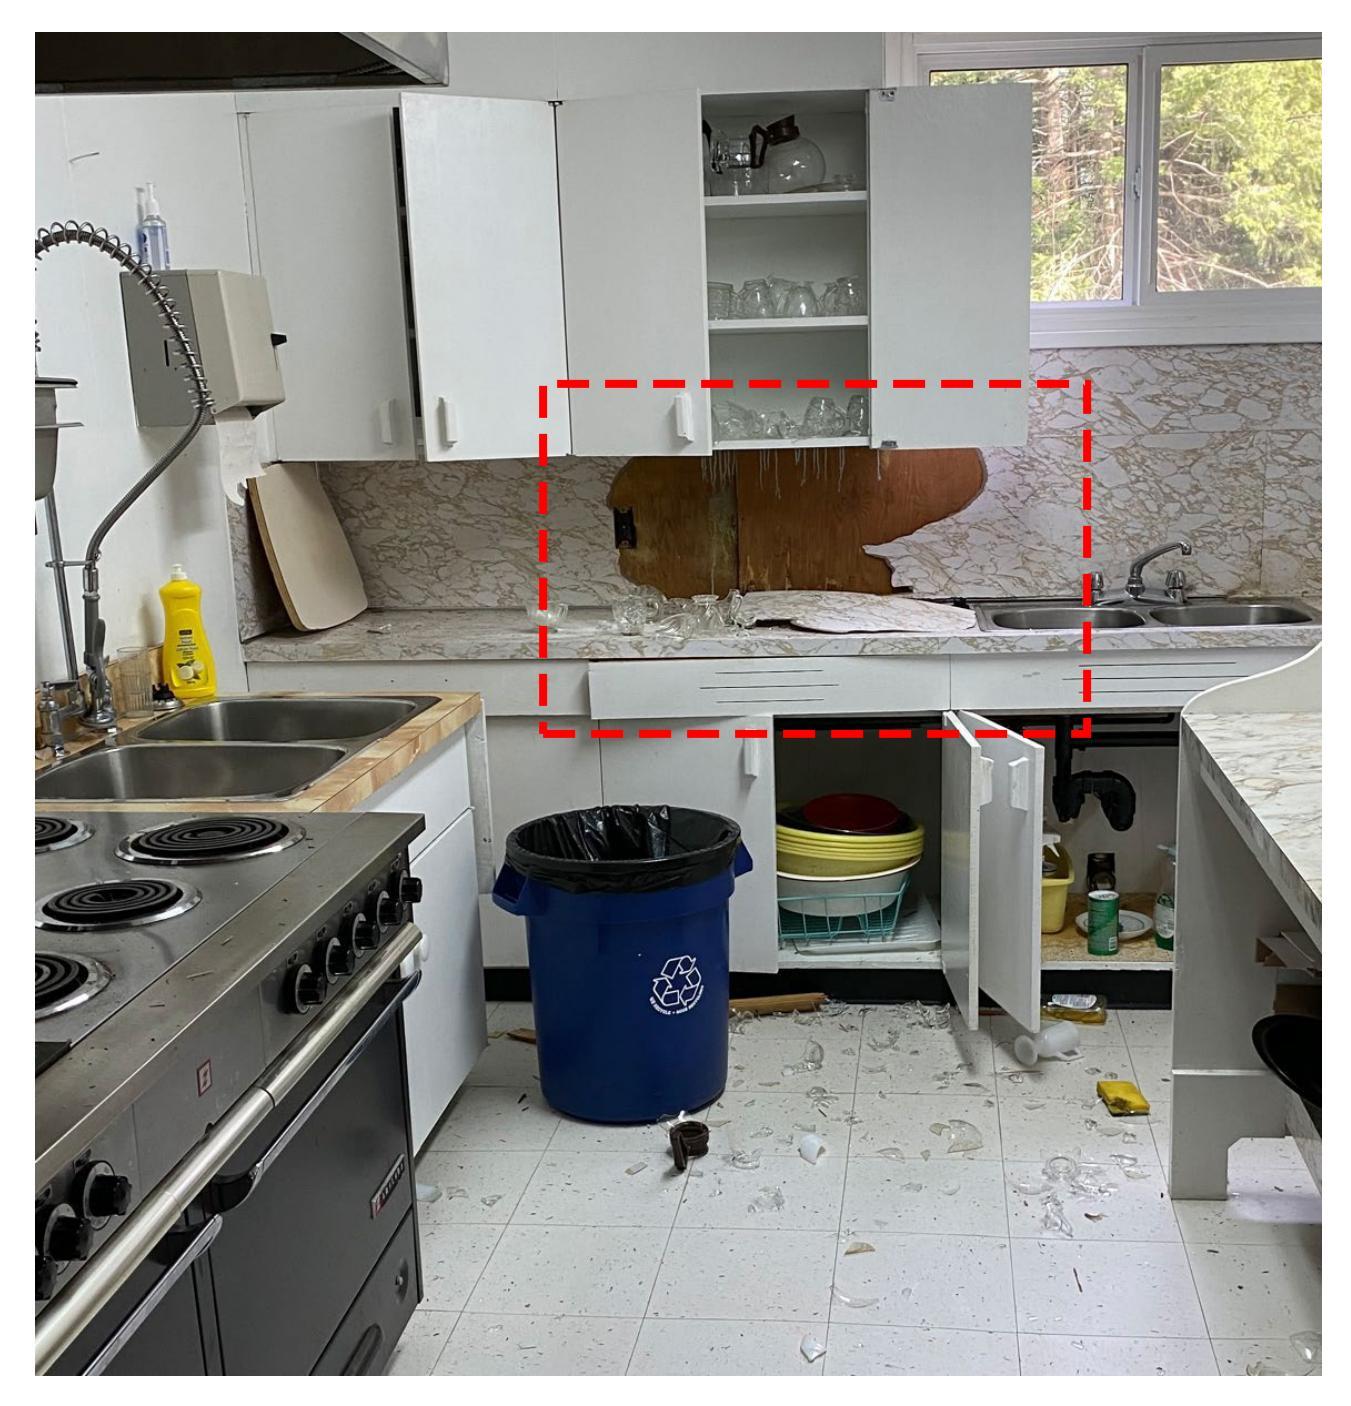
Photo 3 – Community Hall kitchen. **RED** - shows area of wall and counter that cover a metal drainpipe and vent that was damaged from a lightning strike.

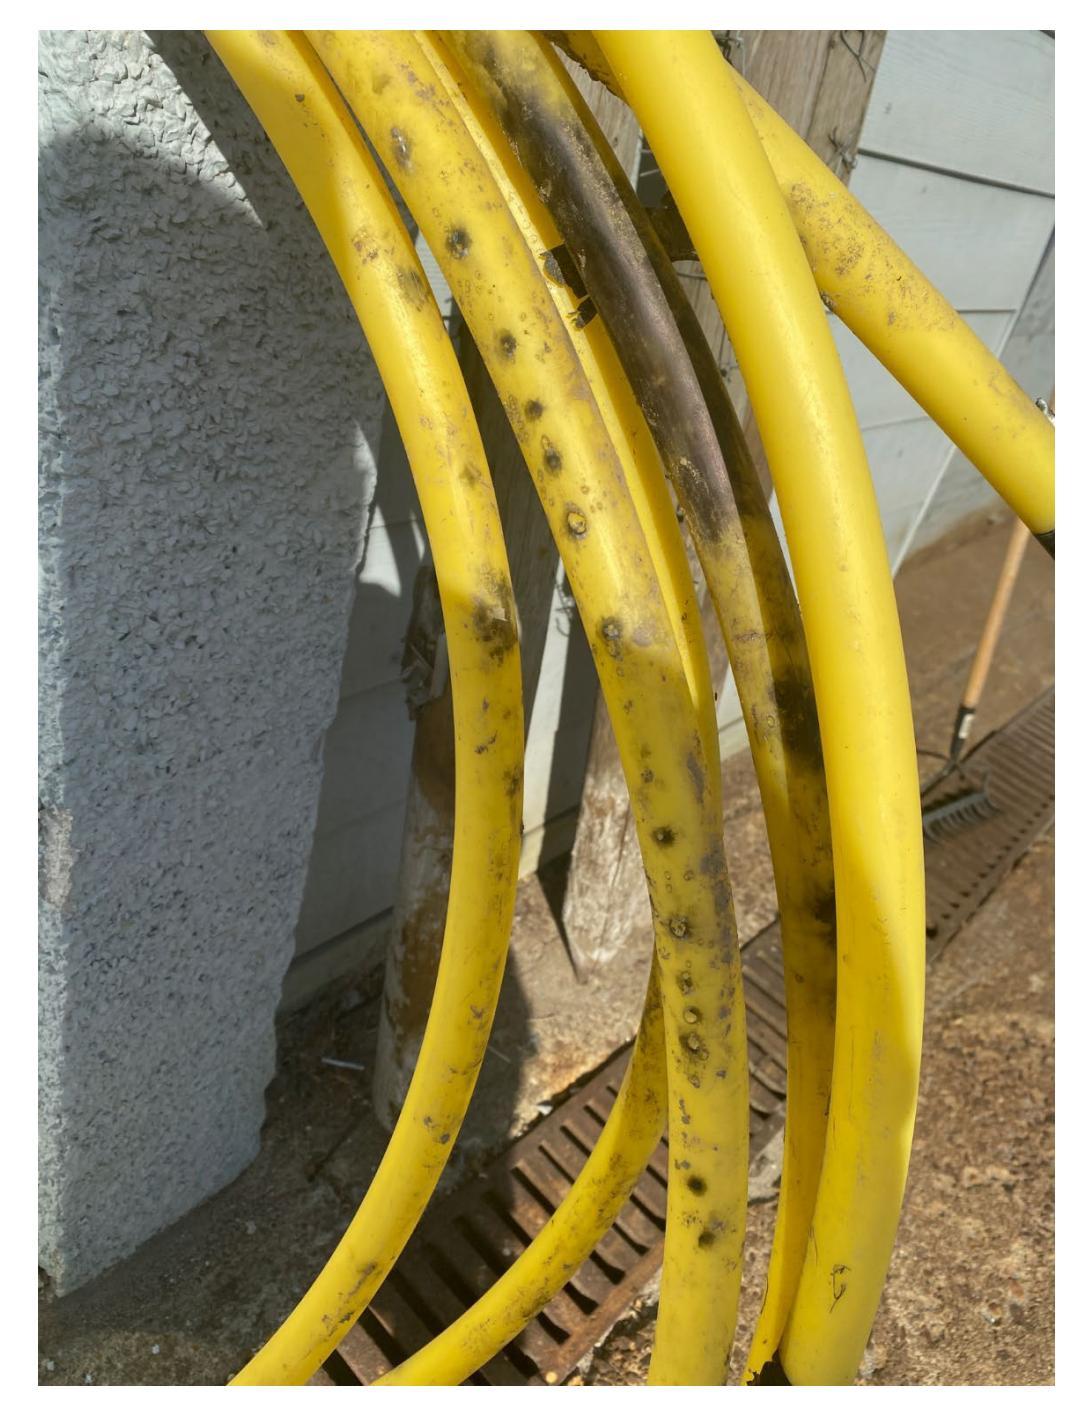
Melted copper spatter was observed along the length of the gas pipe where the wire was affixed and only pieces of the wire remained (<u>Photo 6-7</u>). The gas pipe had blackened pitted marks along its entire length. There were melted deformations along the entire length of plastic pipe, with many pinholes that melted all the way through (<u>Photo 4-7</u>).
	Statements from gas utility employees
	 The underground pipe to the address runs from the building to the adjacent Highway about 100ft away. The gas pipe crossed under the highway where it connected into a mainline on the other side. When they arrived at the site, they could smell gas along the full length of the underground pipe.
Causes and contributing factors	It is very likely that the tracer wire being directly affixed to the underground pipe without any separation, as per the gas utilities installation procedure, caused the incident, as the lightning induced current melted the wire and created holes into the plastic line causing gas leaks.

Photo 4 – Gas service line after removal from ground.

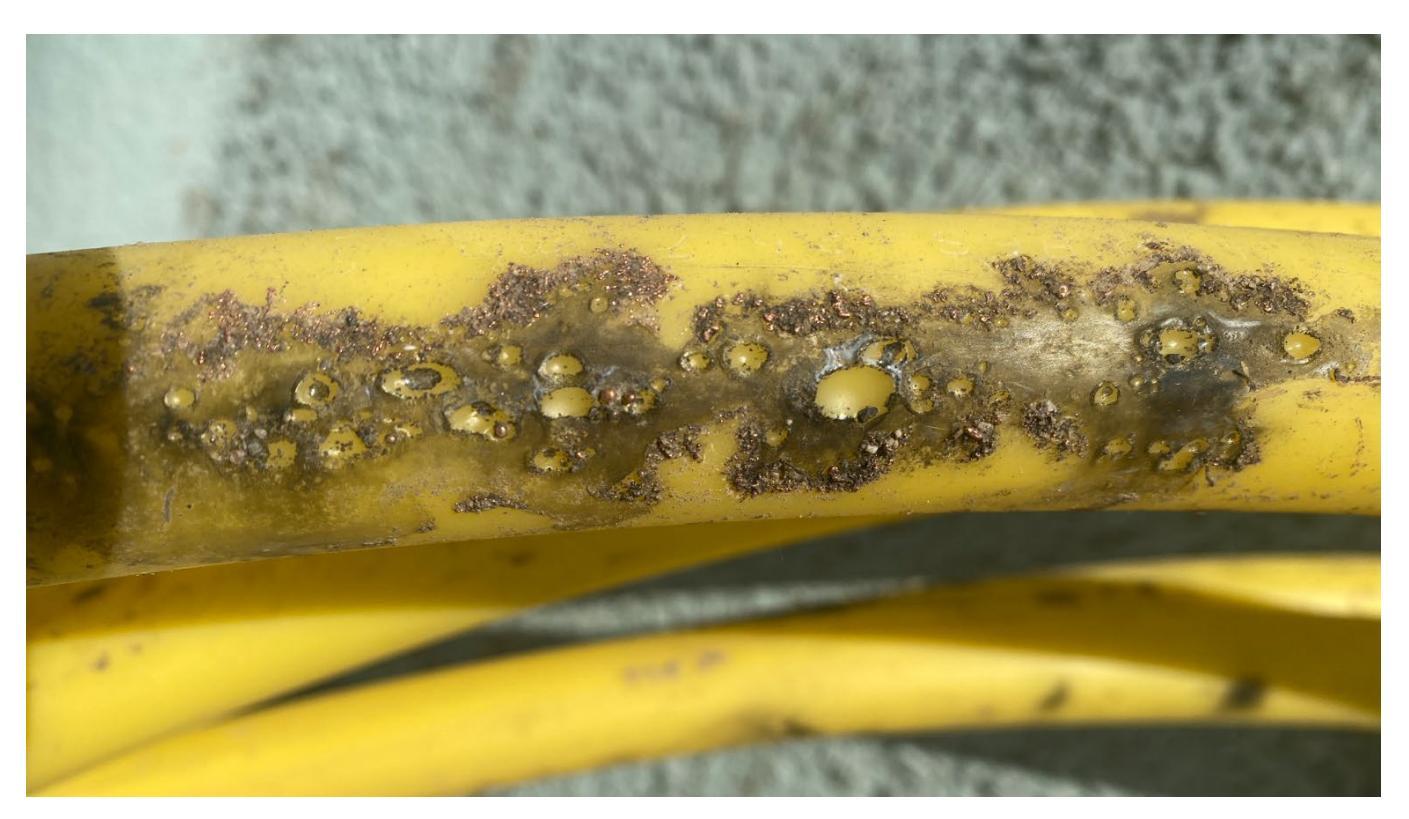
Photo 5 – Closeup of copper spatter from tracer wire, charring and melting on gas pipe.

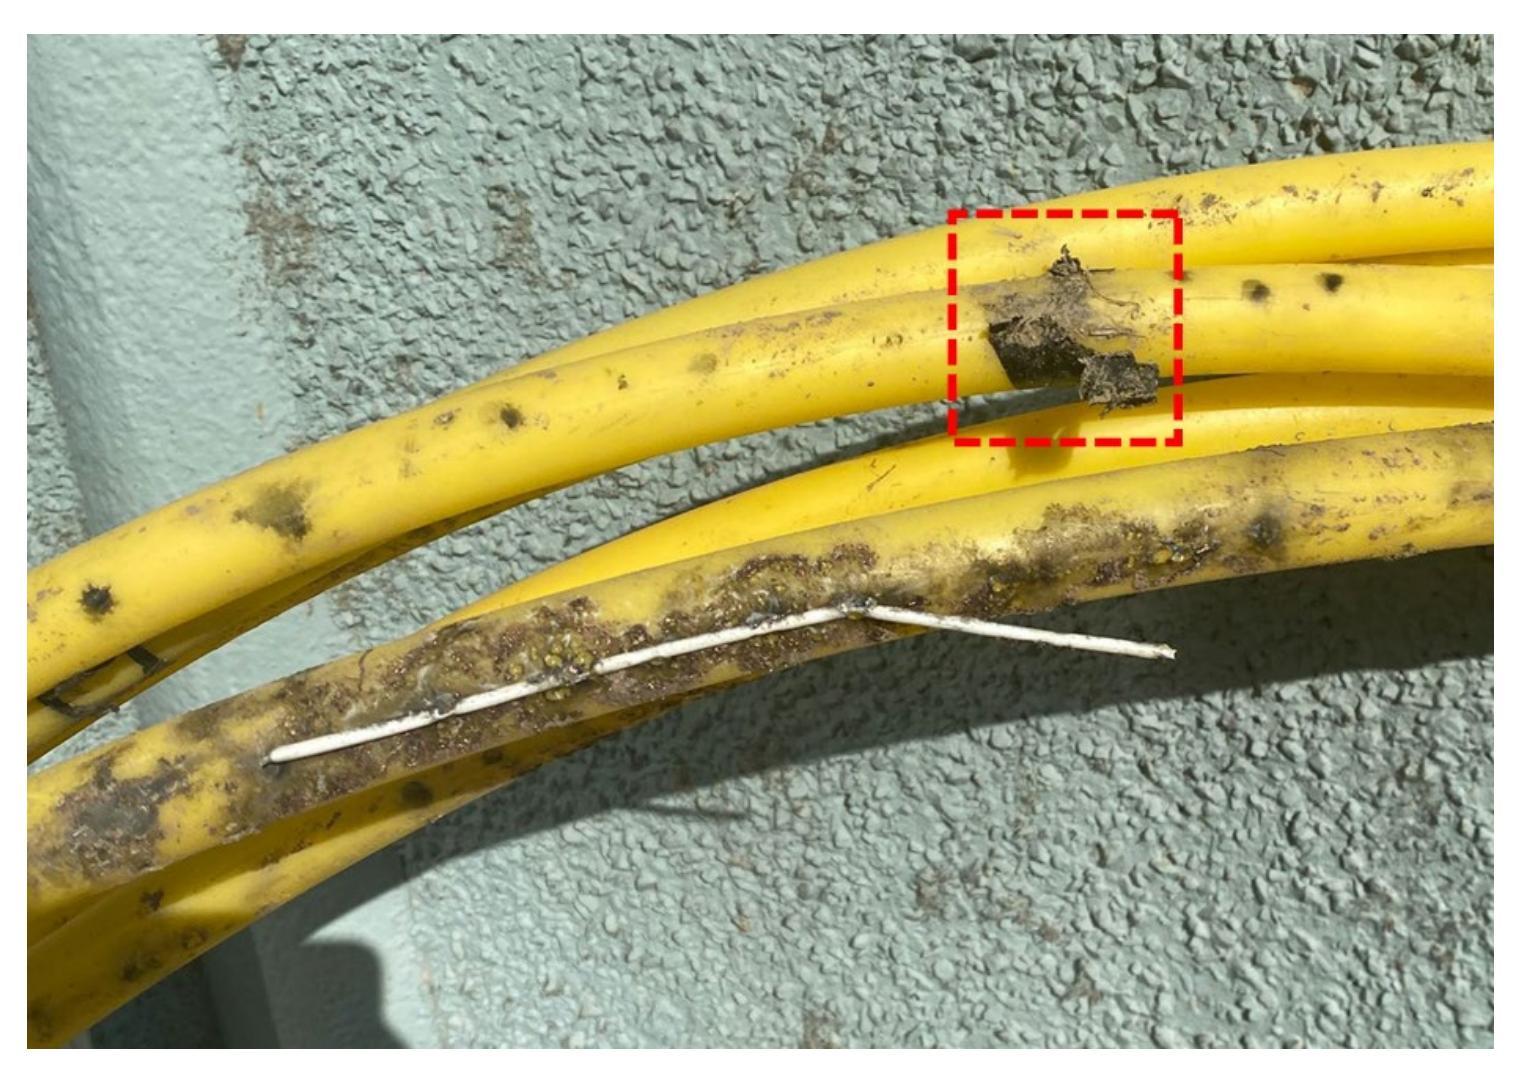
Photo 6 - Remnants of tracer wire melted to pipe. Red box shows tape used to affix tracer wire to pipe.

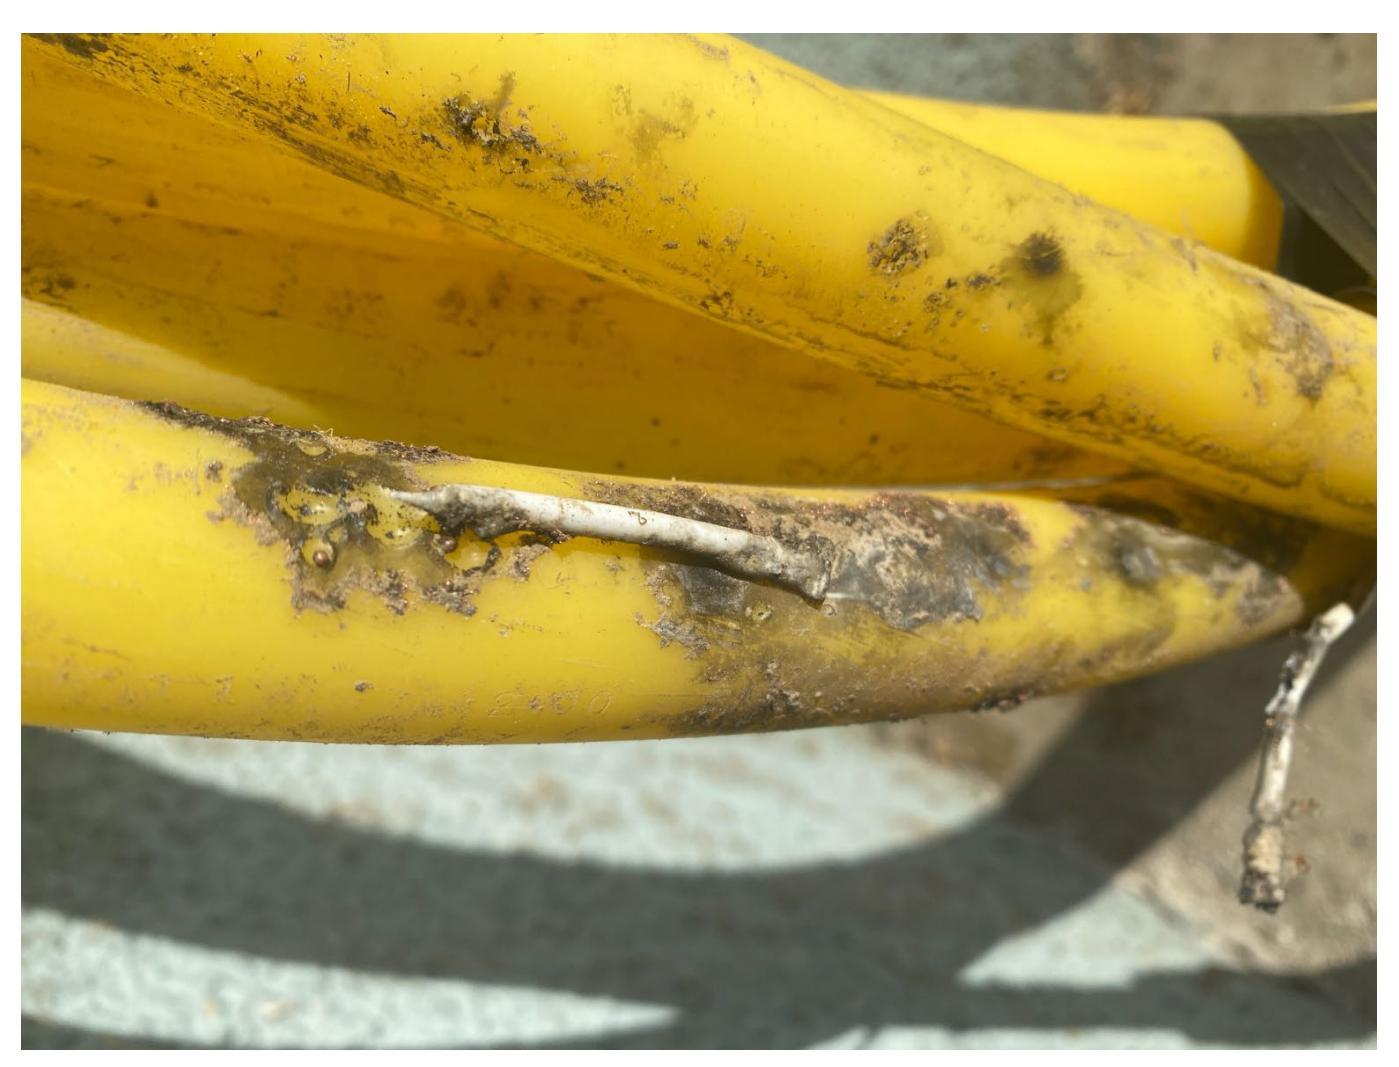
Photo 7 – Closeup of tracer wire and melted pipe.

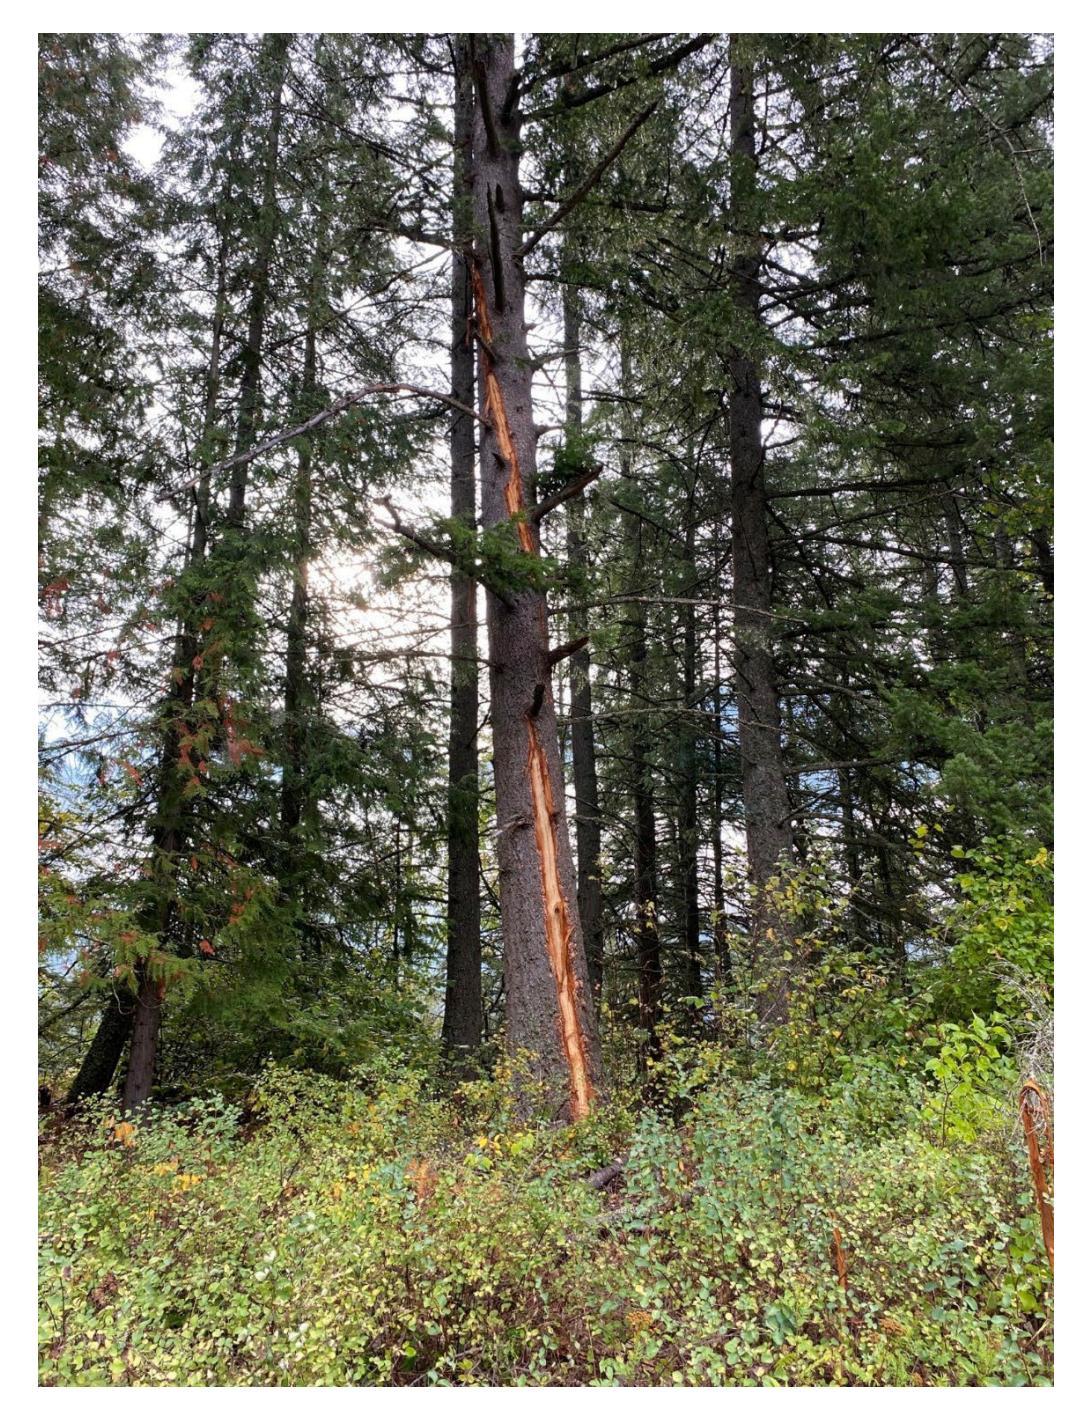
Photo 8 – Tree showing damage from lightning strike.

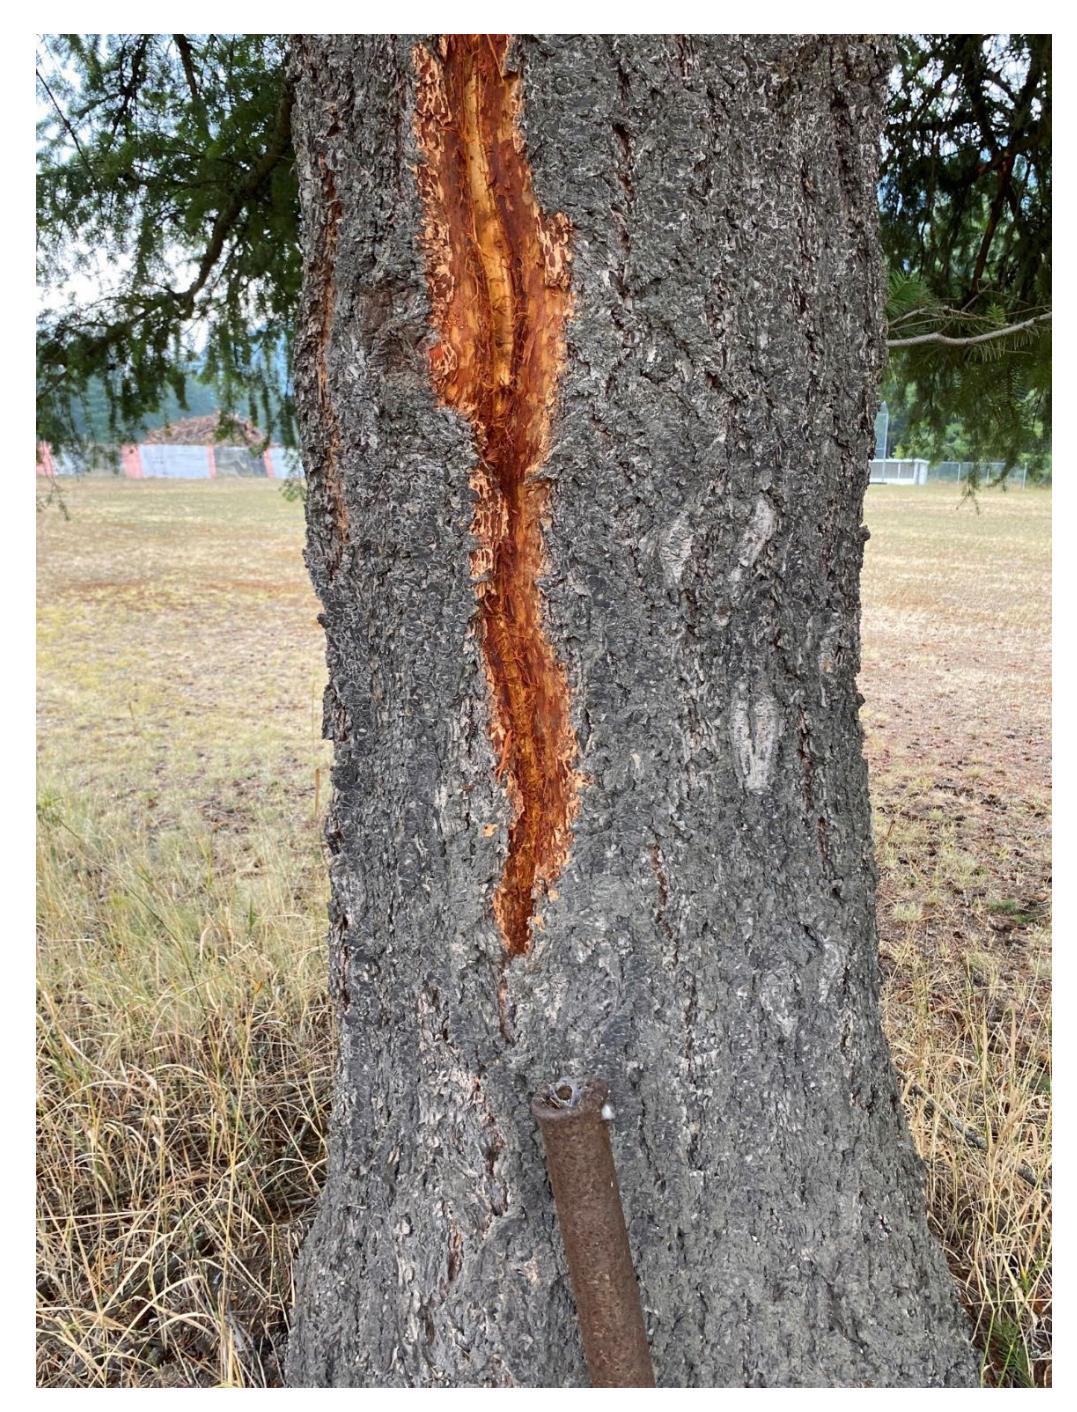
Photo 9 – Lightning damage at tree base and scrap metal piping in the ground.
