## Incident Summary #II-1244996-2021 (#23770) (FINAL)

SUPPORTING INFORMATION	Incident Date		August 30, 2021	
	Location		100 Mile House B.C.	
	Regulated industry sector		Gas - Natural gas system	
	Impact	Injury	Qty injuries	2
			Injury description	Two individuals within dwelling brought to hospital for potential carbon monoxide poisoning with nausea and headache symptoms.
			Injury rating	Moderate
	Damage	Damage	Damage description	Free-standing fireplace firebox warped from overheating and gasket material failed.
			Damage rating	Moderate
	Incident rating		Moderate	
Incident overview		A natural gas fired free standing fireplace released carbon monoxide (CO) into the ambient air of the mobile home living space. Two occupants were exposed and were taken to the hospital for treatment.		
INVESTIGATION CONCLUSIONS	Site, system and components		<p>A free-standing gas fireplace with a continuous pilot was installed in the living room of the mobile home and vented vertically through the roof to outdoors (<a href="#">Photo 1</a>). The appliance would be susceptible to vent spillage when operating in a negative pressure environment.</p> <p>A single pipe portable air conditioner was installed

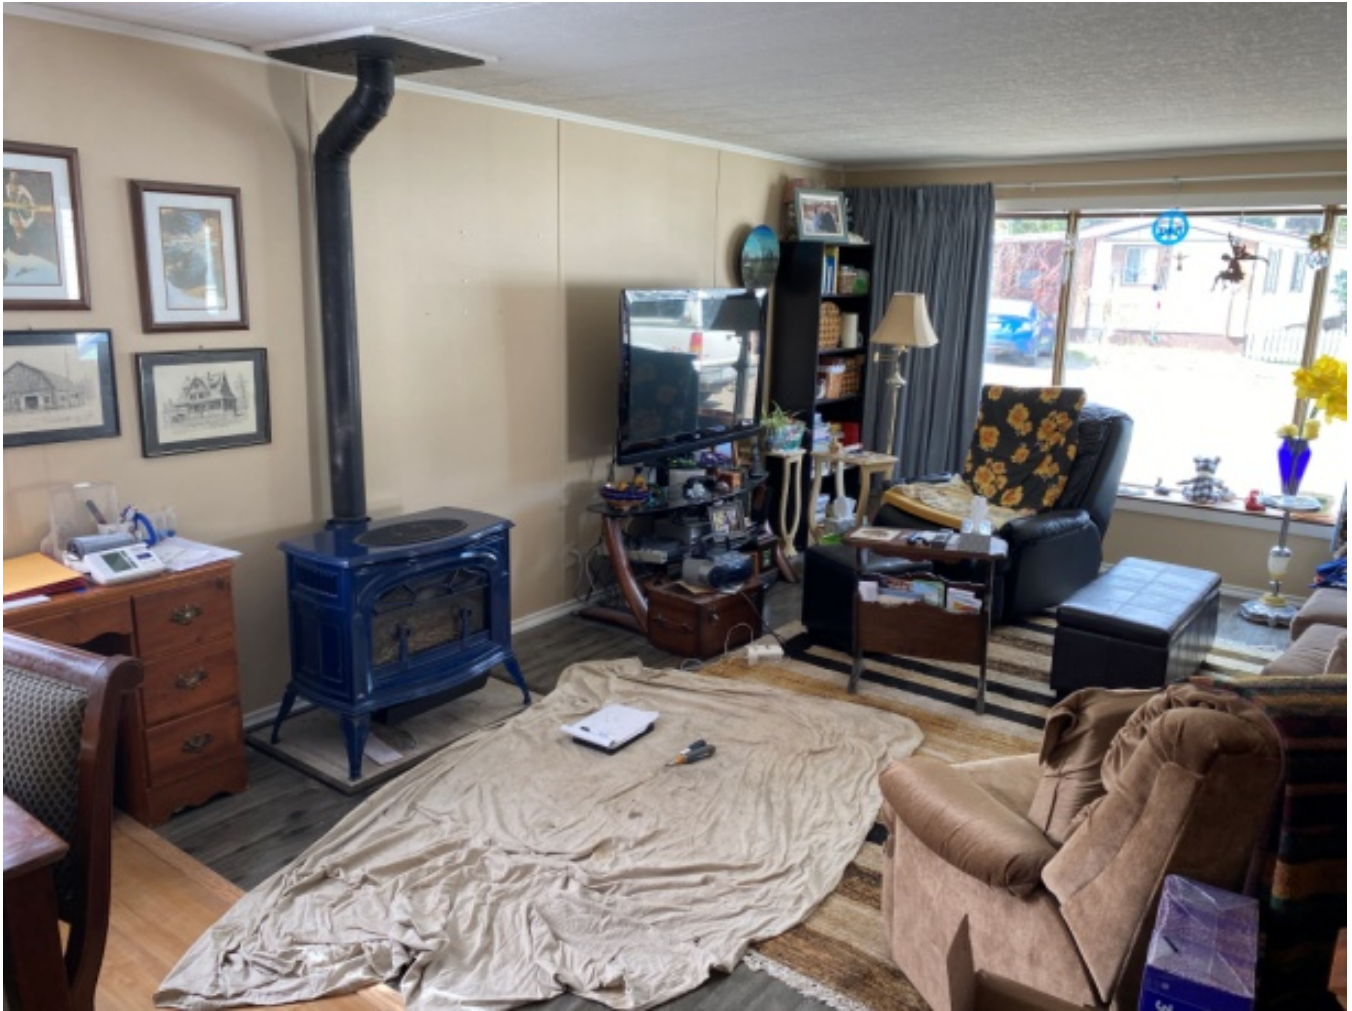
Image 1 – Fireplace installed in living room of mobile home

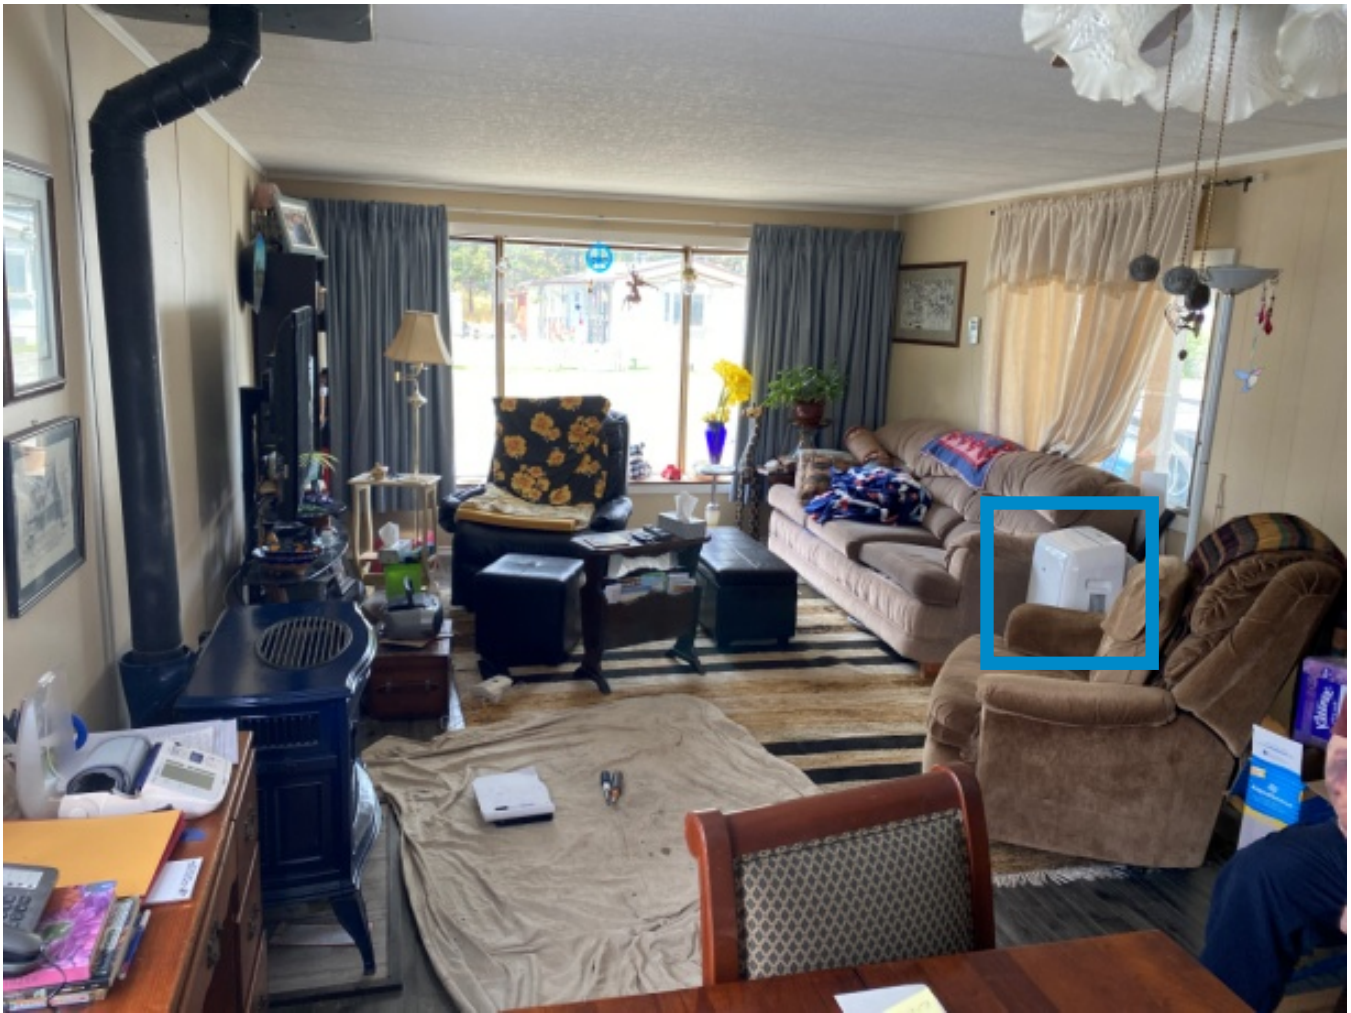
Photo 2 – Living room showing fireplace and air conditioner (Blue box).

<p><b>Fresh Air:</b> air that enters a home from the outdoors by natural or mechanical means to replace air that is being used by appliances or exhausted by fans.</p> <p><b>Spillage Susceptible appliance:</b> an appliance, be it natural gas, oil, propane, or wood, is spillage susceptible if it is possible for negative pressure in the house to cause flue gas to flow into the house rather than up the chimney.</p>
Failure scenario(s)	<p>During the summer months the occupants used a single pipe air conditioner unit that exhausts warm room air through a sealed window opening, to cool down the living room. The exhausted air was not being replaced by fresh air in the proper manner, fresh air was being drawn in through the venting of the fireplace causing the fireplace to spill products of combustion into the space.</p> <p>Even though the free-standing fireplace was not being used in heat mode the continuous pilot was left on. Due to lack of maintenance, improper set up and a failing gasket, the pilot burning in this type of environment caused CO to be drawn into the room.</p>

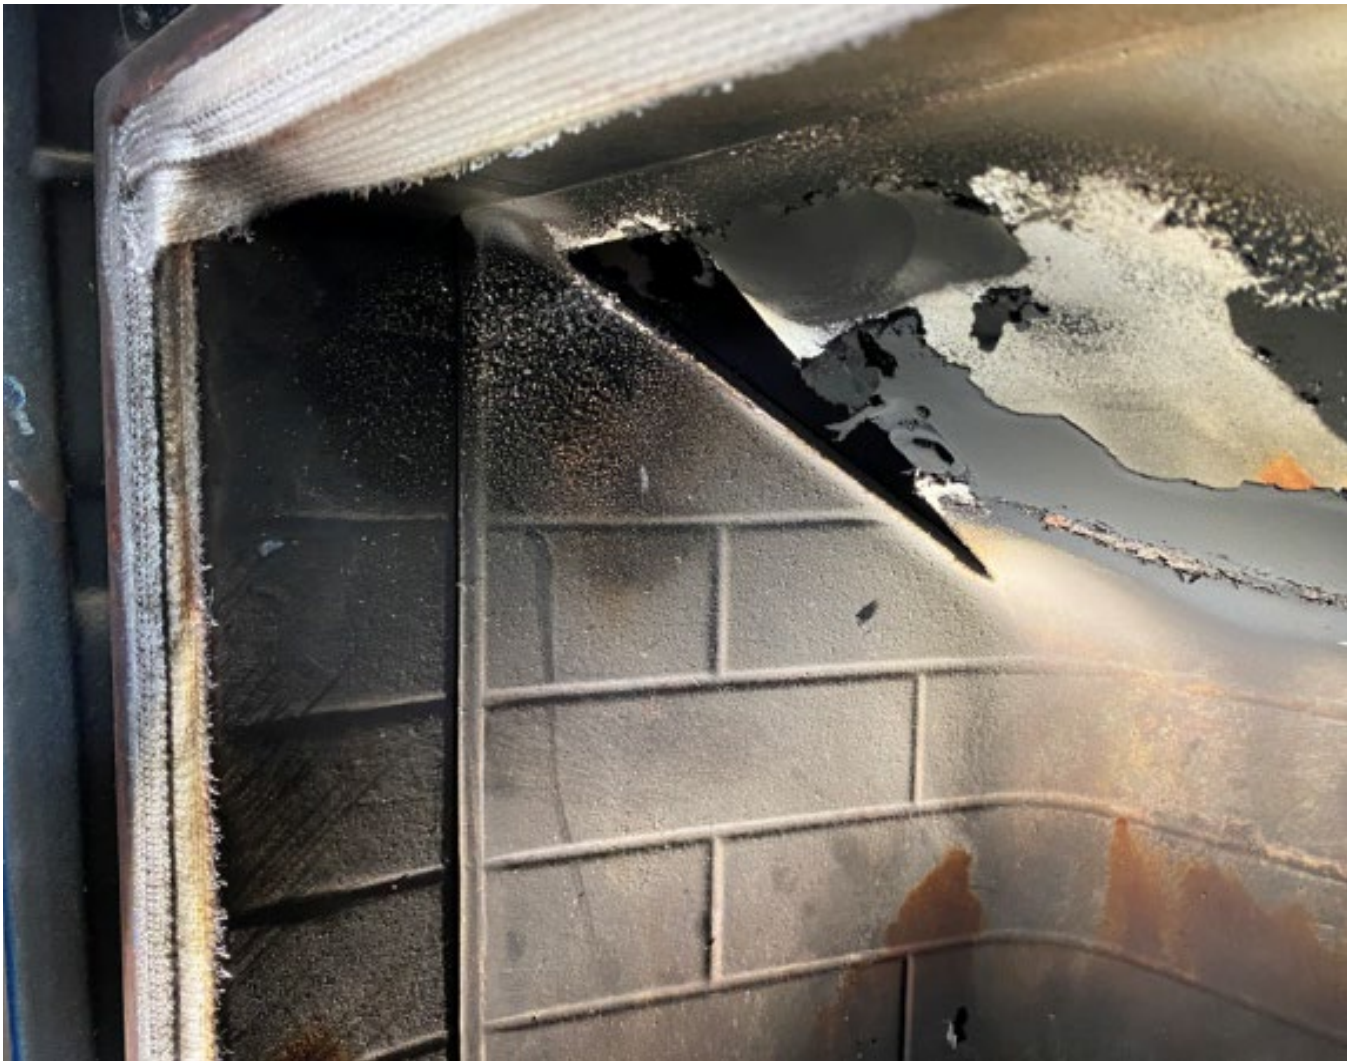
Photo 3 - Top of firebox flue port

Facts and evidence	<p>After first responders sent occupants to the hospital, the gas utility technician performed CO measurements and readings at the unit were measured at 120 parts per million (PPM) from the fireplace with the pilot on.</p> <p>Safety Officer and contractor went to site and measured 829 PPM CO leaking from the heat exchanger when portable air conditioner was in use and the doors and windows were closed. (<a href="#">Photo 4</a>)</p> <p>The gas manifold pressure and input of the fireplace was measured during testing. The input was measured at 34,363 BTU/H, which is above the maximum allowance to the manufacture requirements of 27,000 BTU/H.</p>
Causes and contributing factors	<p>The incident most likely occurred due to a portable air conditioner causing building depressurization which allowed the products of combustion from the fireplace into the dwelling.</p> <p>A contributing factor was that the heater was installed incorrectly, contrary to the manufacture requirements, and was over-fired which likely caused the failure to the firebox and gaskets.</p>

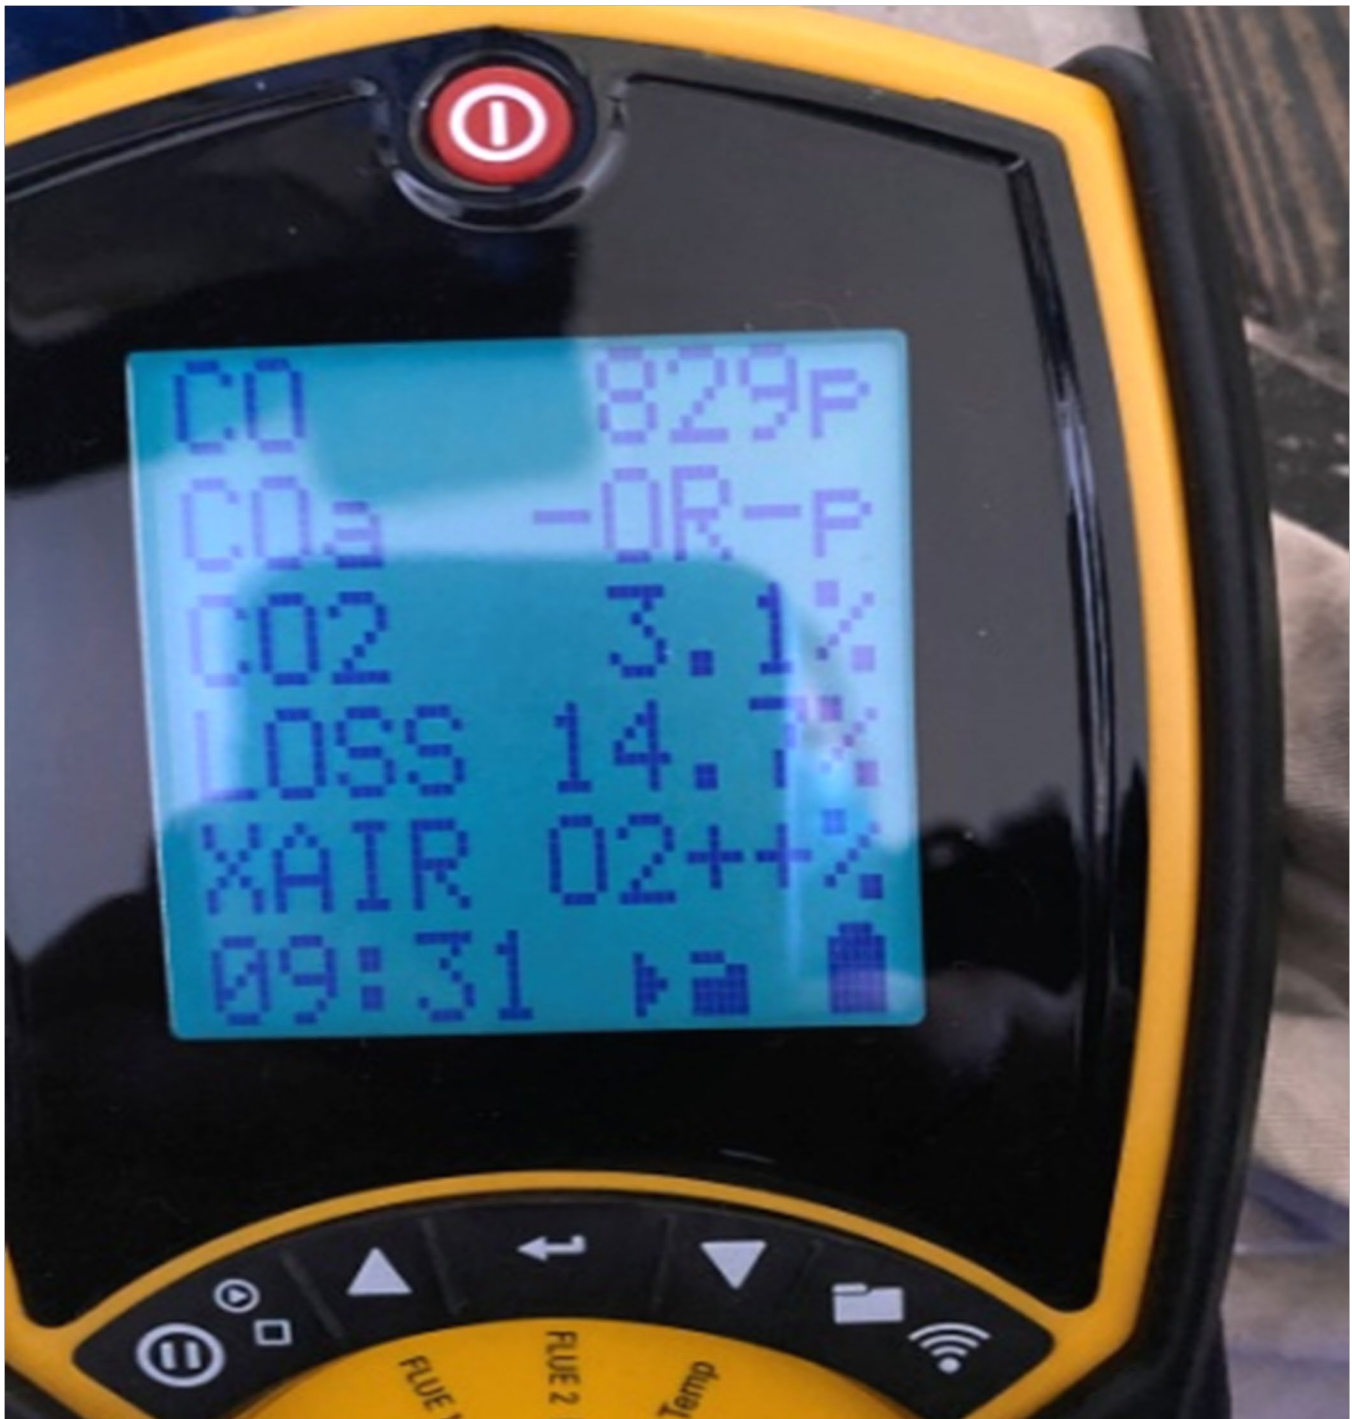
Photo 4 - CO reading (829ppm) at high fire as found setting with portable air conditioner on.

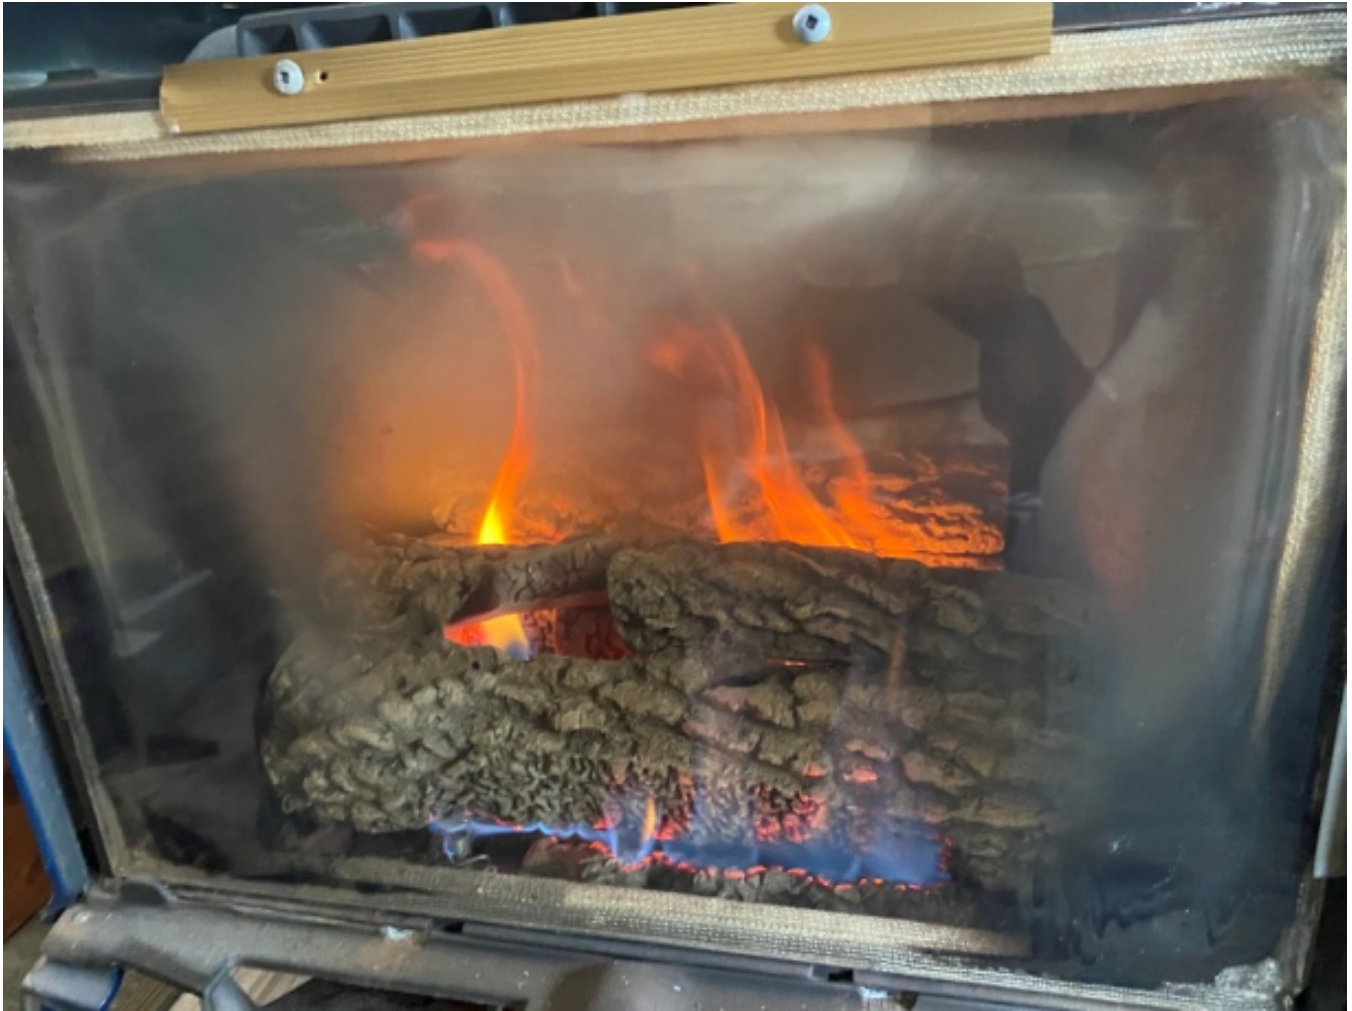
Photo 5 - Space heater burner on at high fire as found setting showing lazy yellow and orange flame indicating incomplete combustion.
