## Incident Summary #II-927063-2019 (#15727) (FINAL)

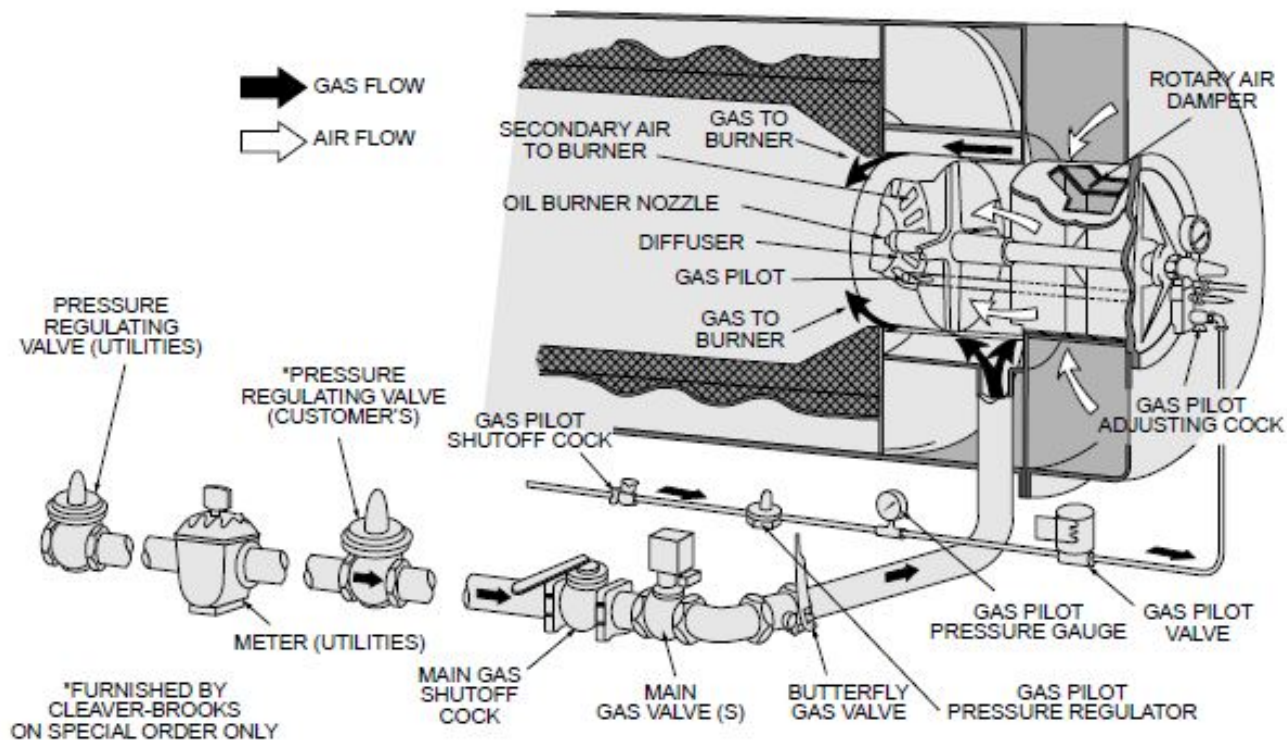
**Image 1** - From the boiler manual, showing air and gas flow paths to boiler combustion chamber. The gas flows through the burner ring gap around the diffuser to mix with the air. (*Boiler operation, service and parts manual*)

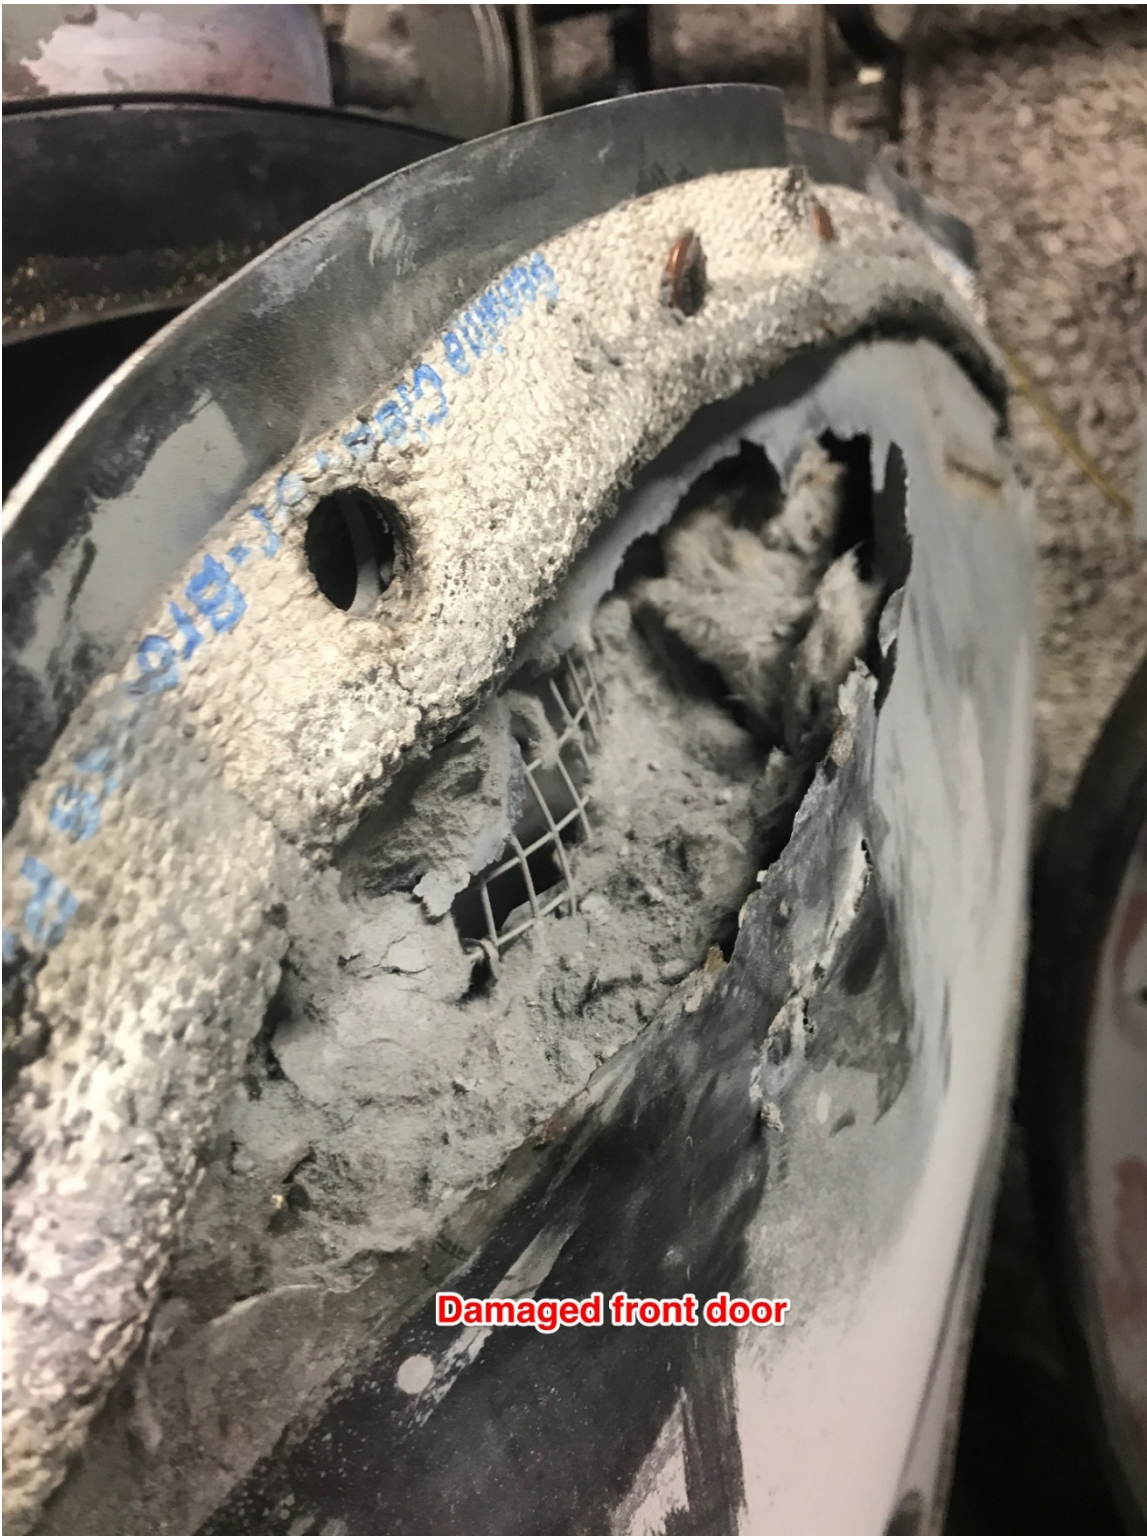
Image 7 - Damage to boiler front door

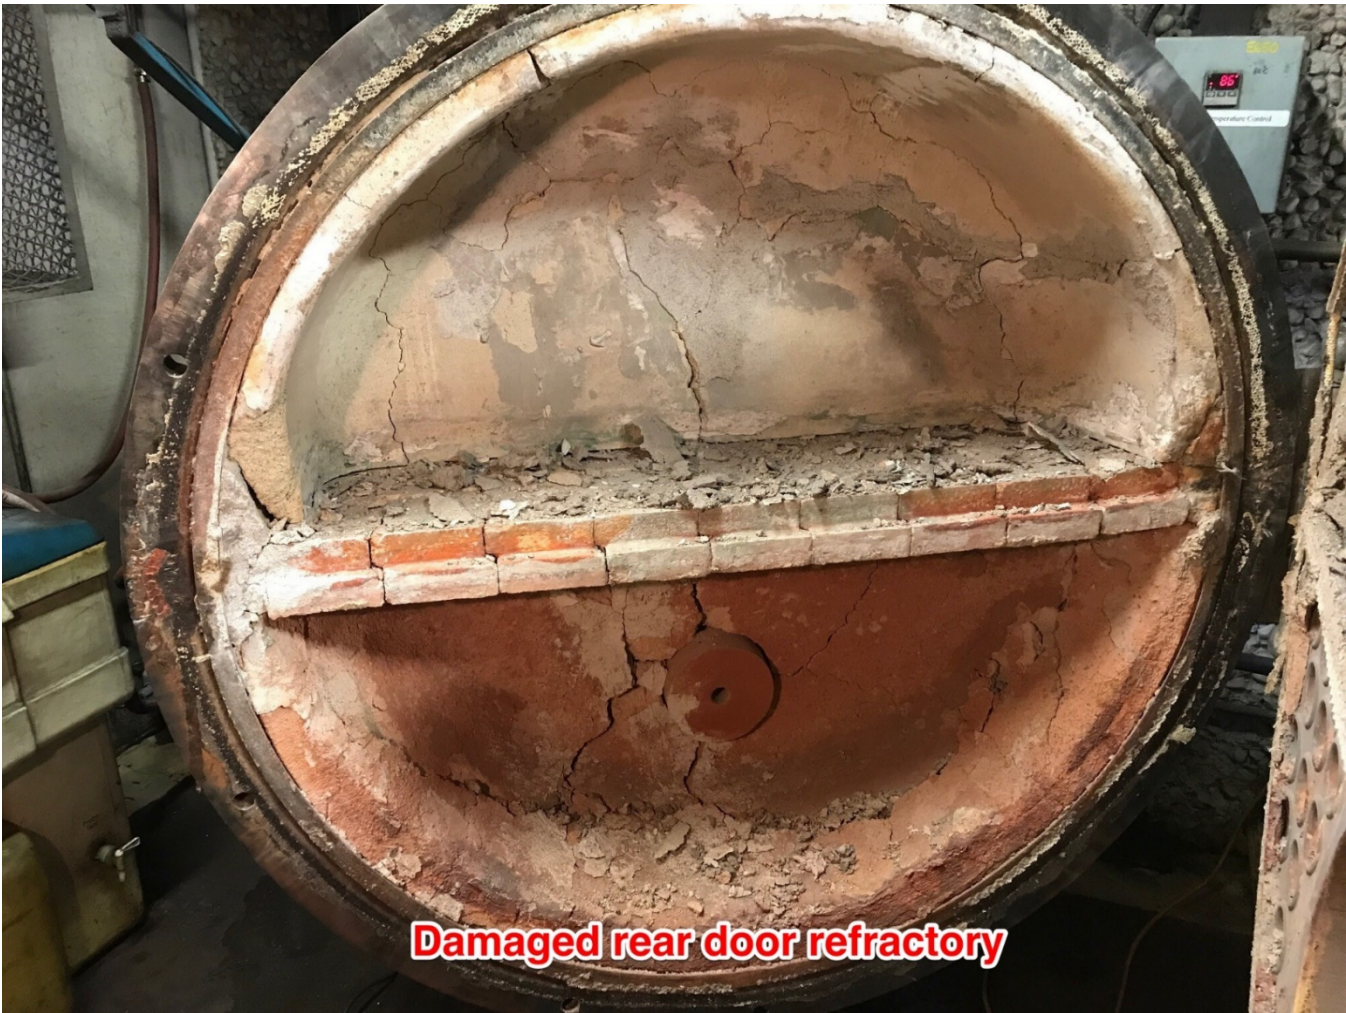
**Image 8 - Cracked and broken rear door refractory insulation**

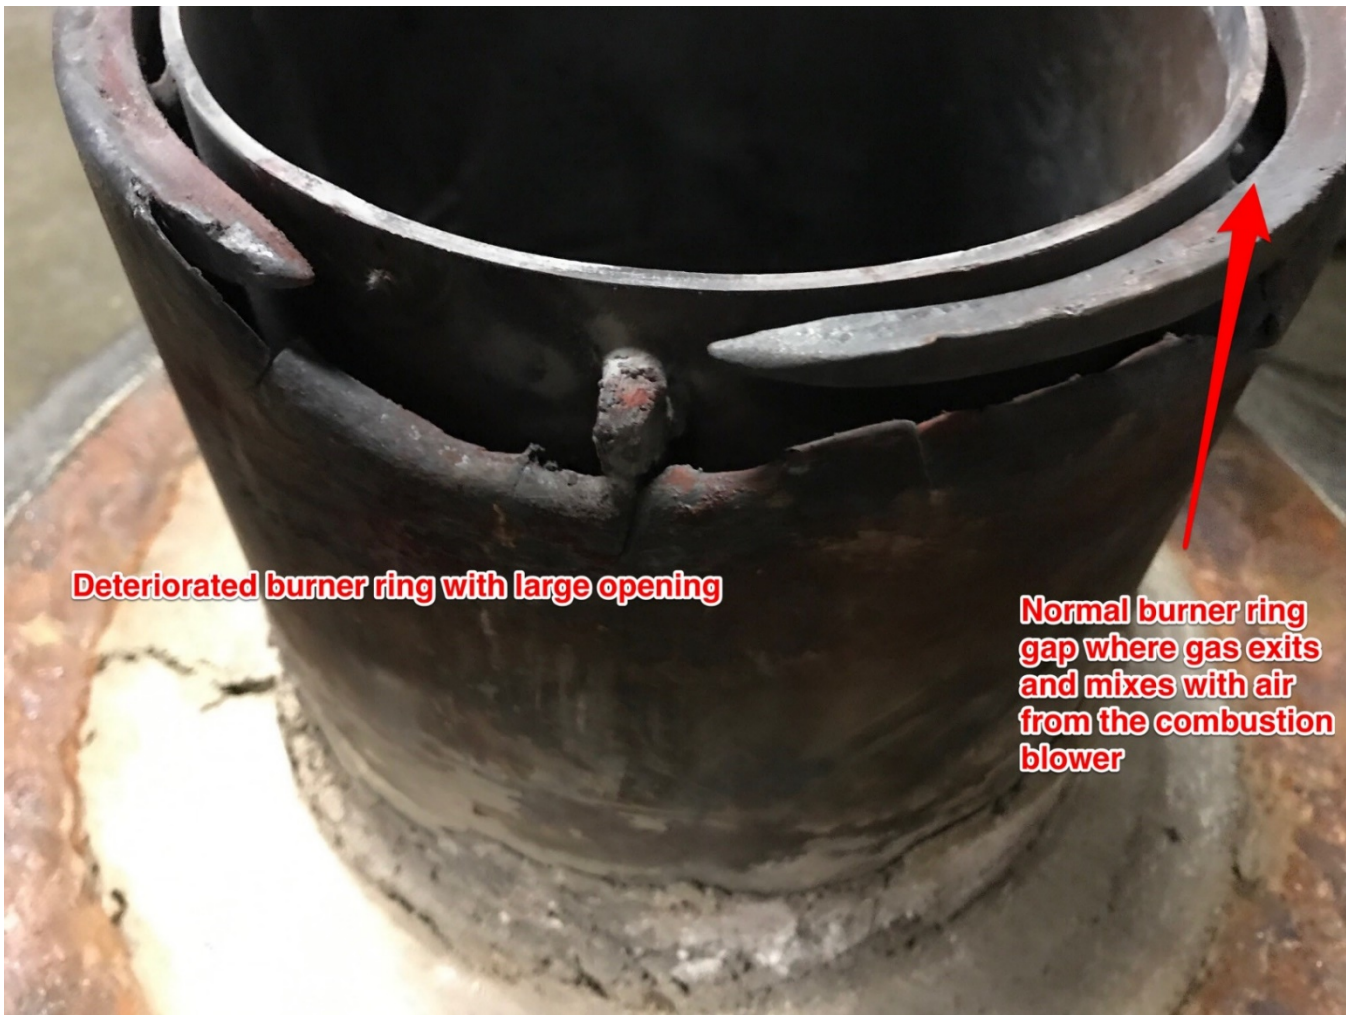
**Image 10** - Burner housing with deteriorated ring and large gas port opening. The air diffuser gets positioned in the middle circular area of the burner housing.

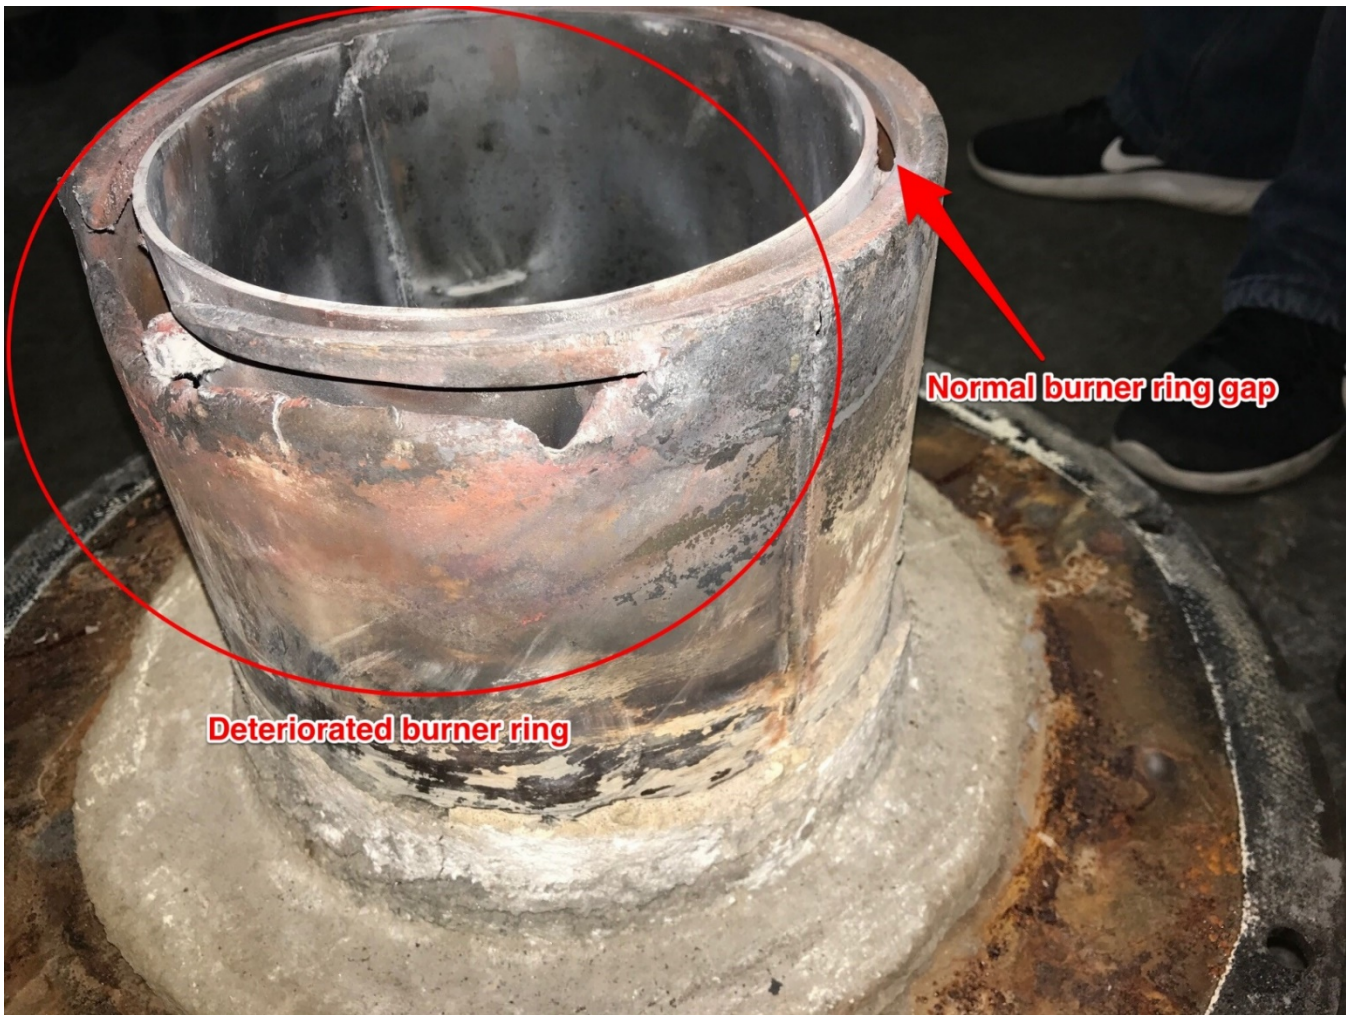
**Image 11** - Burner housing with deteriorated ring and large gas port opening

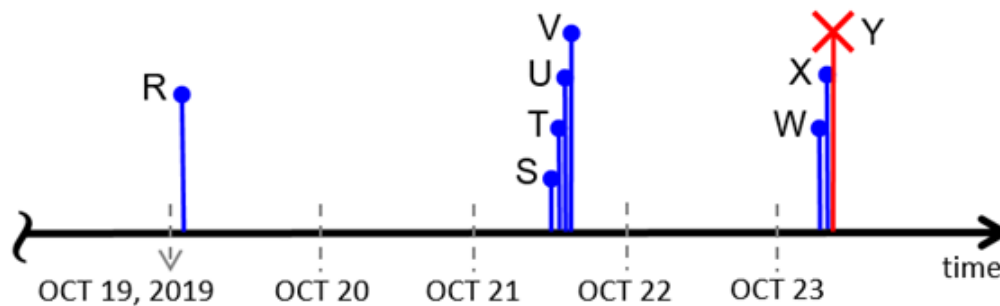
**Figure 2** - Event timeline (October 19-23, 2019) Red X indicates explosion
