Incident Summary #II-1160703-2021 (#21095) (FINAL)

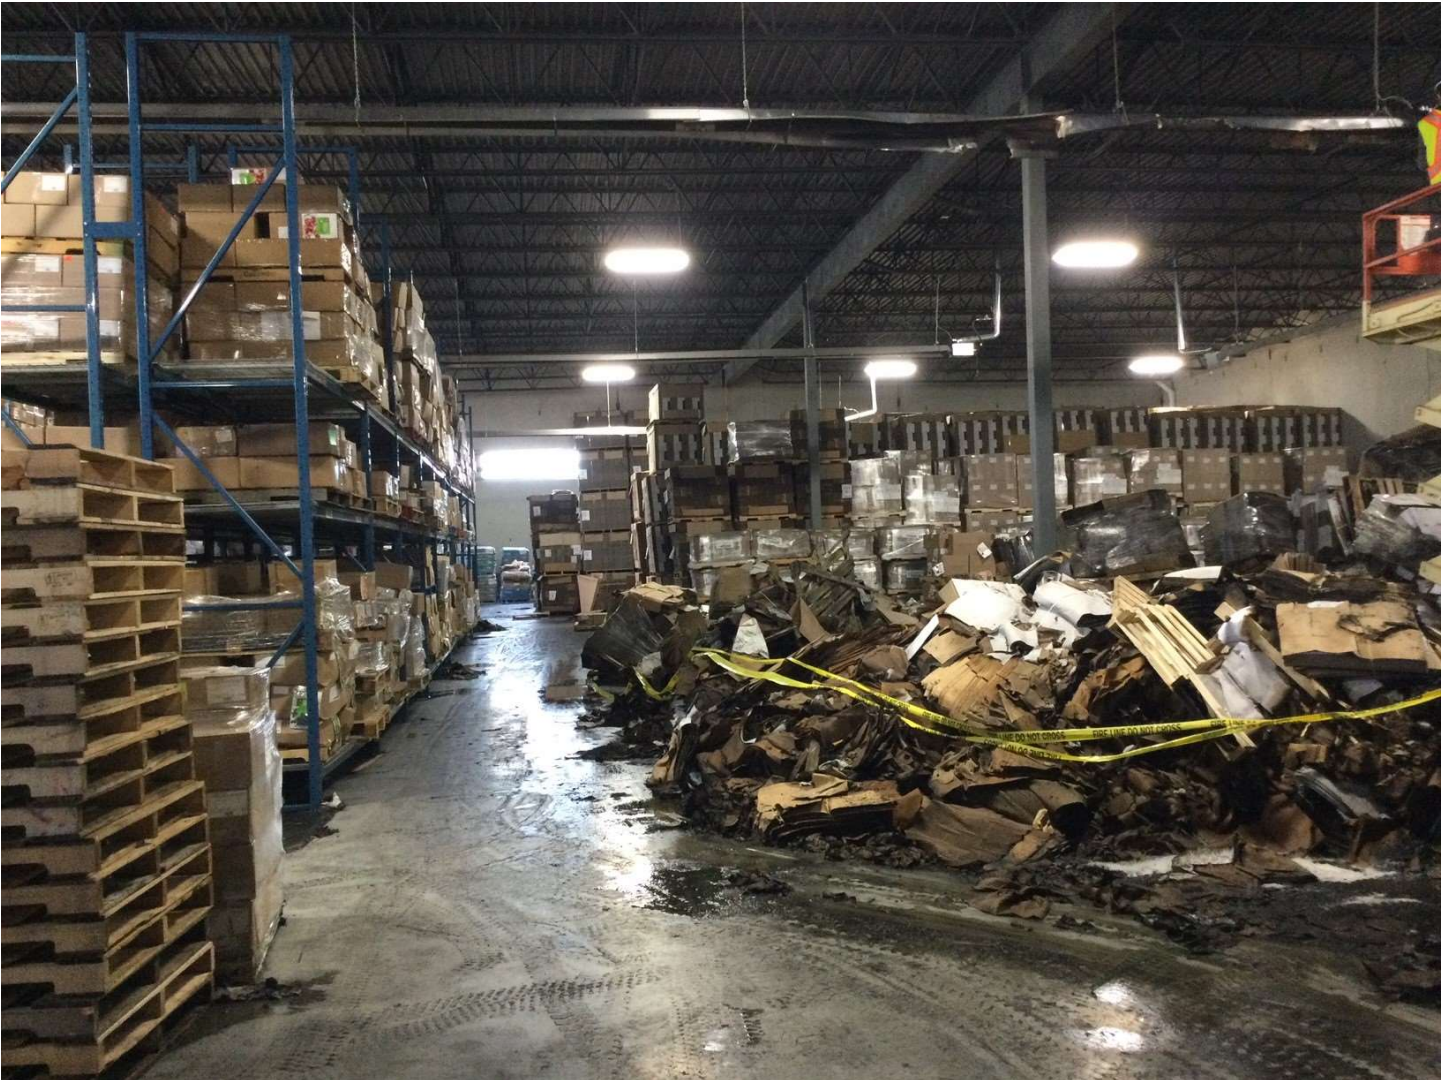
Fire damage to tube heater and burnt cardboard below heater.

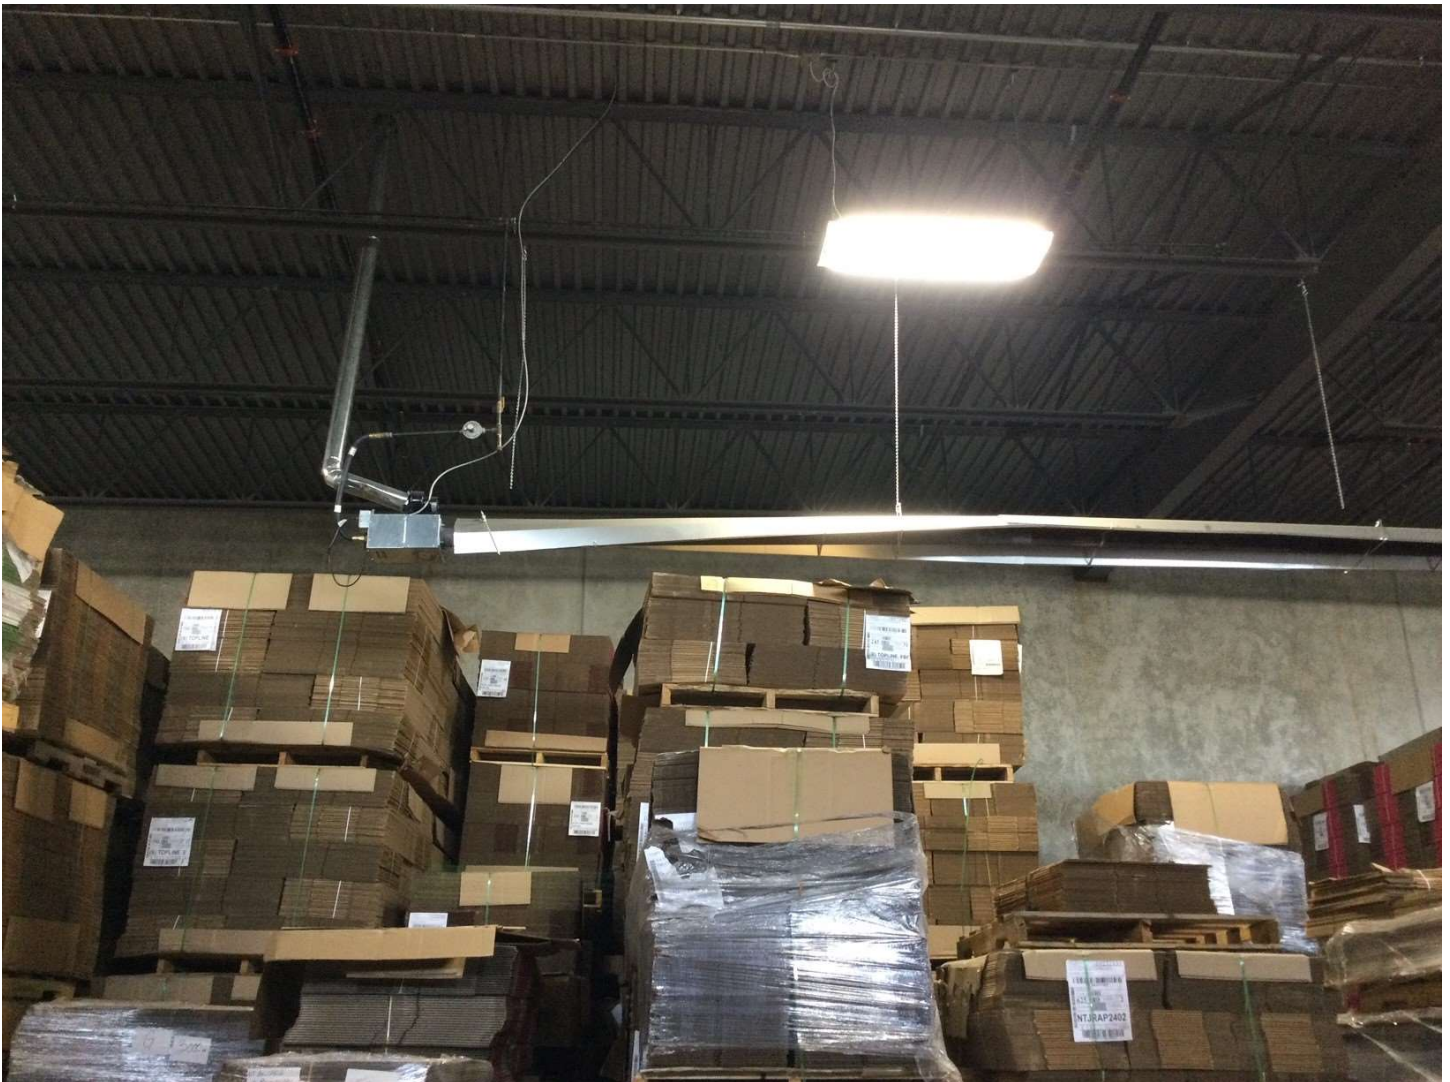
Tube heater in close proximity to combustibles (less than 80 inches). This is another heater that was not damaged but shows how close the combustible materials may have been to the heater.

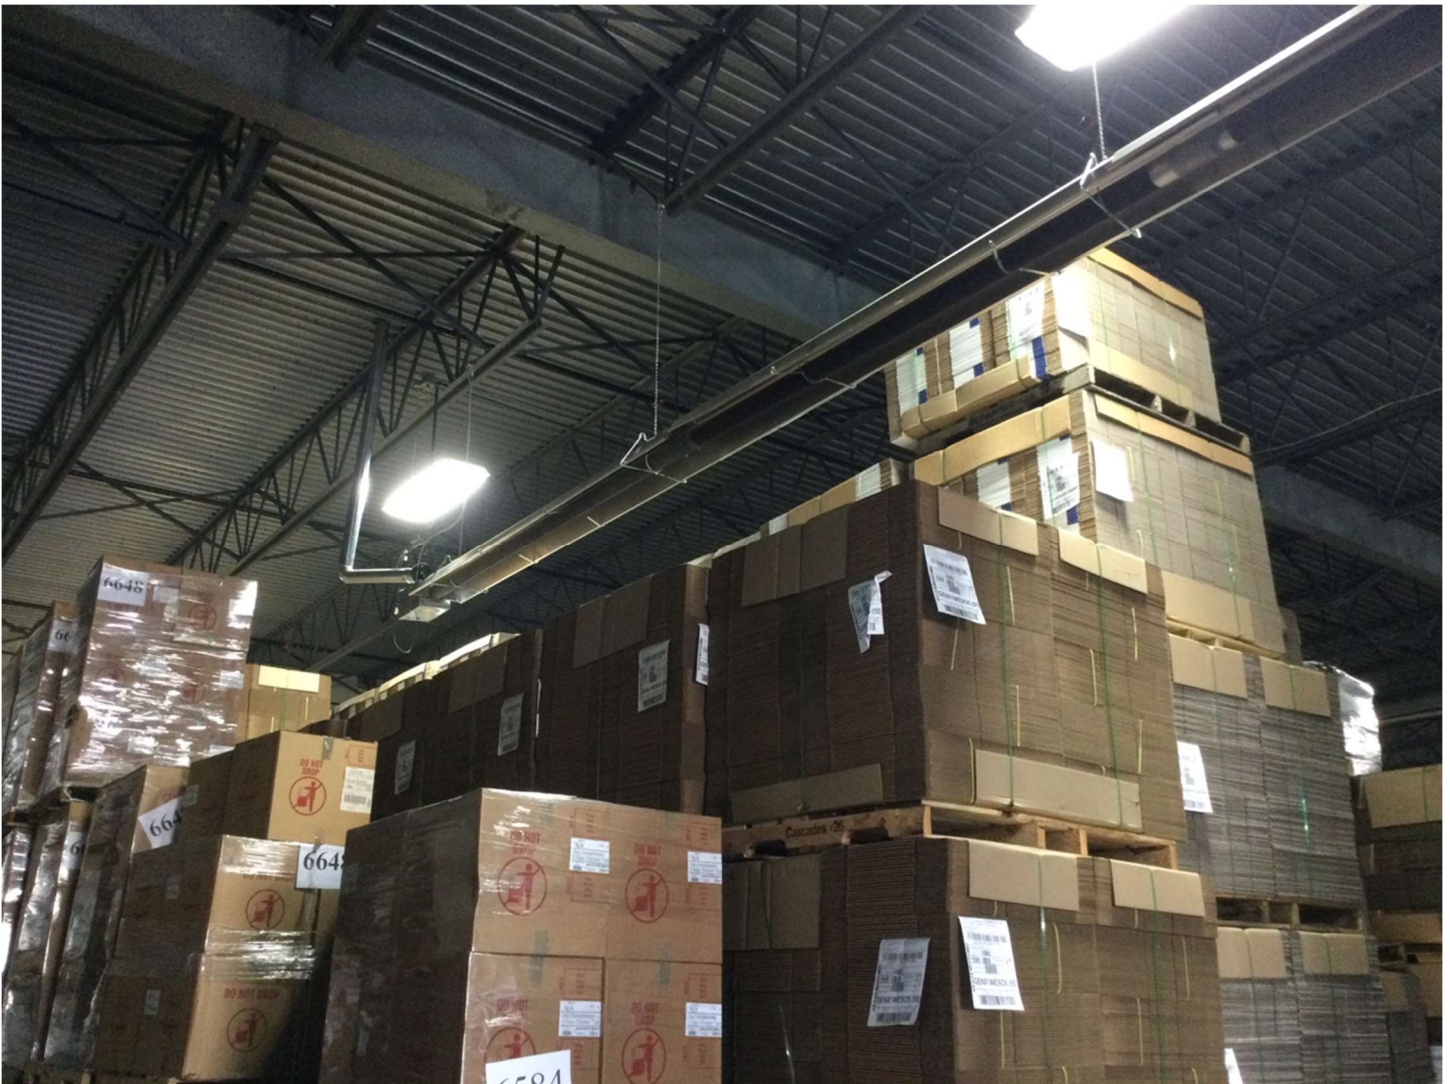
Tube heater in close proximity to combustibles (less than 80 inches)
